25th International Cryogenic Engineering Conference and the International Cryogenic Materials Conference in 2014, ICEC 25–ICMC 2014

Failure mechanism and consolidation of the compensation bellows of the LHC cryogenic distribution line

K. Brodzinski^{a*}, P. Cruikshank^a, J.L. Fournel^b, L. Taviani^a, N. Veillet^c,

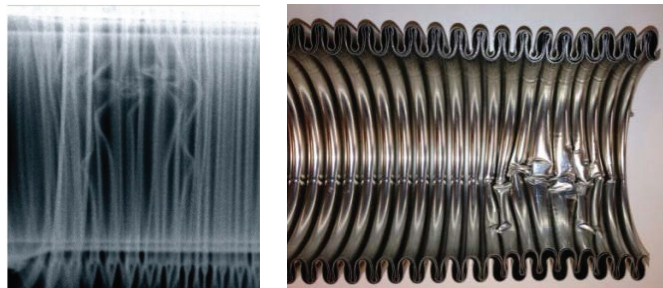
The X-rays of the suspected interconnection confirmed visually deformations on the header C. The X-ray and photo of later removed bellow are presented in Figs. 2a and 2b. Because of tight LHC run schedule the interconnection was not repaired and additional pumping capacity has been put in place to compensate the leak. The damage mechanism for this singular case was not understood at that time.

Fig. 2. (a) X-ray of first leaky bellow; (b) photo of the first leaky extracted bellow.

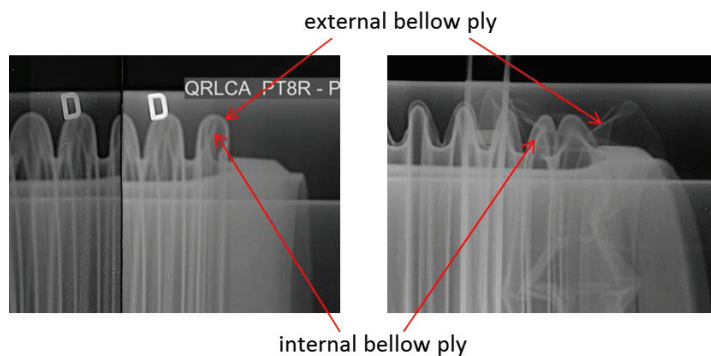
After the long shut-down warm-up the situation required full investigation and understanding of the origin of the problem. The first step of methodology was the same as in the case of the first leak – helium time-of-flight calculation combined with X-rays of all interconnections within the affected vacuum subsectors. In all seven cases X-ray showed bellow deformation on the header C. The detailed analysis of the X-rays confirmed clear damage of the bellow plies, see Fig. 4.

Fig. 4. X-rays of damaged compensator plies.

This finding lead to presume that during three years of operation some bellows faced a helium tightness problem into the inter-ply volumes. These leaks were not visible in the monitored vacuum space since the leaks were not traversing from the helium volume to the vacuum. As additional investigation, one of the first bellows was submitted to the metallurgical analysis. This analysis confirmed the existence of a crack on the double weld between the plies extremity and the flange, see Fig. 5.

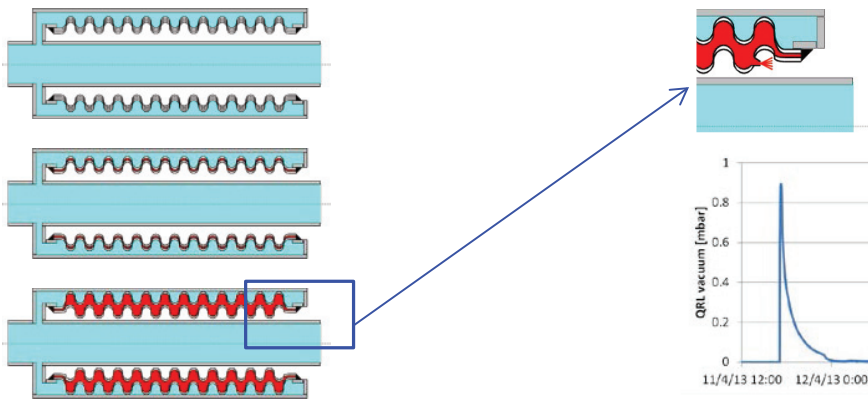
During warm up the supercritical helium trapped in-between the plies did not have enough time to escape via the micro leaks. The increasing inter-ply pressure lead first to bellow deformation and secondly to the creation of a traversing leak from the helium to the vacuum volume. Visual representation of the damage sequence is presented in Fig. 6. The effect of the helium discharge from the inter-plies volume to the vacuum was visible on vacuum pressure monitoring and is shown on the graph in Fig. 6.

Fig. 6. The bellows damage sequence with the insulation vacuum pressure evolution .

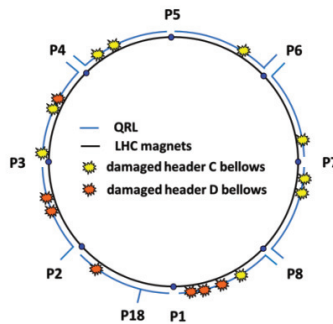
In order to not to miss any deformed compensator which could stay in the intermediate damage state (deformed but not leaky to the vacuum) the decision was taken to make an X-rays campaign on entire machine length. This investigation confirmed intermediate damage of two additional compensators on header C and seven compensators on header D (constituted of 5 plies), rising up the total number of damaged compensators to sixteen. Fig. 7 shows the repartition of the damaged compensators in the different LHC sectors and Table 2 presents summary on helium leak rates. No correlation was identified with respect to compensator production batches. Given the total number of compensators on these headers, a failure rate of 1.4% has been reached (taking into consideration the total number of installed bellows).

Fig. 7. Repartition of damaged compensators.

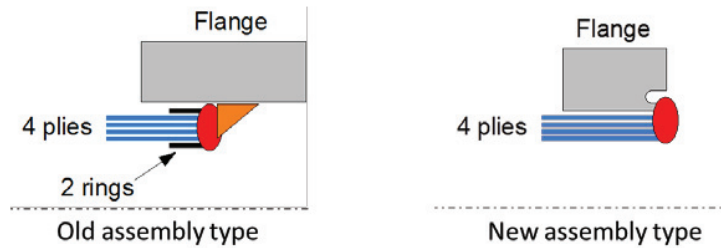
The old design required two superposed welds to separate mechanical withstanding (the rings reduces the stress on the bellows weld) and tightness. The cause of the crack is not clearly identified. The micrographic of welds shows an important lack of fusion of the second weld. This defect generates a notch effect which could explain the start-up of a crack. Further investigation would be necessary to identify the root causes of this defect.

The repairs required the order of additional spares. In parallel with existing old spares validation, CERN, together with the original bellows supplier, applied improvements in the compensator design. The new spares have a modified flange shape and weld between the plies extremity and the flange, see Fig. 8. The new design allows welding of the 4 plies in one passage. A similar design was successfully applied to the 5000 thermal compensators produced for the LHC cryo-magnets and based on DN80 non-perforated multiply bellows operated with superfluid helium. The other modification is to keep only one ply tight (on the helium side) and all other plies are perforated to create ventilation holes.

Fig. 8. The modified assembly procedure for new type of spare bellows.
