A Metallurgical Inspection Method to Assess the Damage in Performance-Limiting Nb₃Sn Accelerator Magnet Coils

Alice Moros, Mickael Denis Crouvizier, Ignacio Aviles Santillana, Stefano Sgobba, Susana Izquierdo Bermudez, Nicholas Lusa, Jose Ferradas Troitino, Attilio Milanese, Ezio Todesco, Arnaud Devred, Giorgio Ambrosio, Maria Baldini, Paolo Ferracin, Jesse Schmalzle, and Giorgio Vallone

Index Terms—Metallurgical inspections, HL-LHC, accelerator magnets, MQXF coils, Nb₃Sn, quench damage assessment

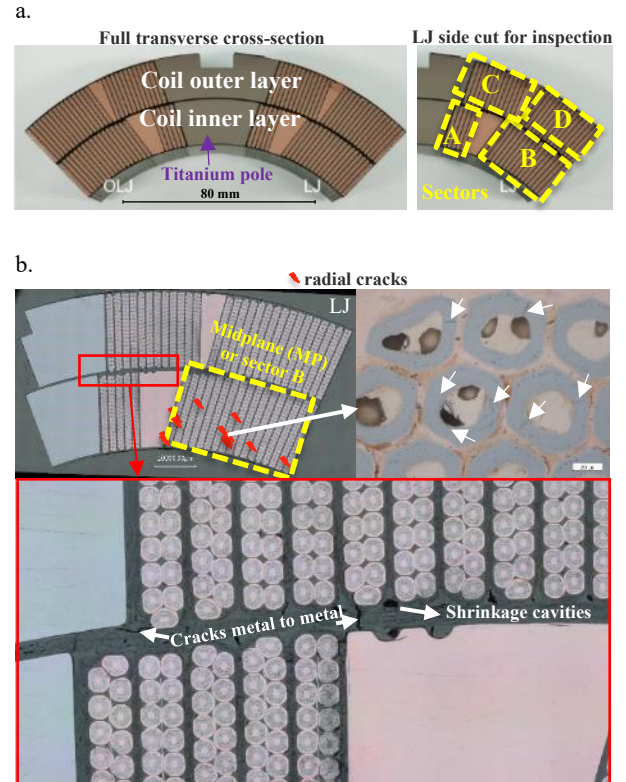
At first, the transverse cross-sections of the four coil slices were finely polished to reveal the presence of radial cracks and evaluate the status of the resin. The observed radial micro-

cracks did not always cross fully the Nb₃Sn phase in the sub-elements and clustered mainly in cables of the Midplane Block (MB) of the coil. The resin showed decohesion and metal-to-metal cracks for 3 of the 4 examined specimens. As all slices showed similar results, two representative images for the examination of radial cracks and resin status over a transverse cross-section (LJ side) are shown in Figure 1.

Fig. 1. MQXFBP1 quadrupole magnet coil CR108: (a) as-prepared coil transverse cross-section displaying the inner/outer layer and the Ti pole (left), and coil LJ side cut for the inspection (right). The yellow dashed frames and the letters A, B, C, D identify the four sectors containing 5, 17, 12, and 16 Rutherford-type cables, respectively. (b) Representative images of the radial cracks observed over the transverse cross-section of coil LJ side cut (top). These cracks are mostly clustered in the cables of the MB or sector B (red pins and white arrows). The resin shows shrinkage cavities and metal-to-metal cracks (bottom).

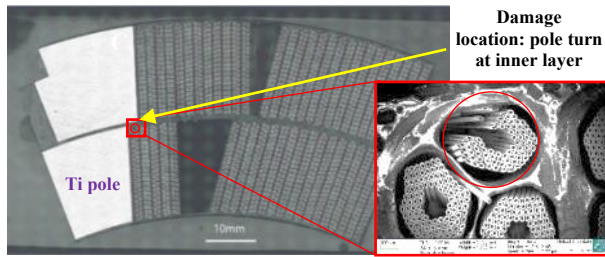
The progressive dissolution of the Cu matrix allowed the identification of strands with broken sub-elements for three of the prepared transverse cross-sections. A very specific damage location was observed: the same and only top strand of the pole turn cable facing the titanium pole at the outer radius of the inner layer.

This location is identified in Figure 2 as “pole turn at inner layer” shown along with a SEM close-up of the damaged strand with broken sub-elements. The identified damaged strands are included in a 60 mm long section of the coil (along its main axis) where the limiting quench origin was localised.

Fig. 2. MQXFBP1 quadrupole magnet coil CR 108: typical aspect of the transverse cross-section after deep Cu etching. The inset in the red frame shows a SEM close-up of the damaged strand with broken filaments at the recurrent position, the pole turn at inner layer (top edge of the cable facing the Ti pole). Portions of intact strands are visible as well.

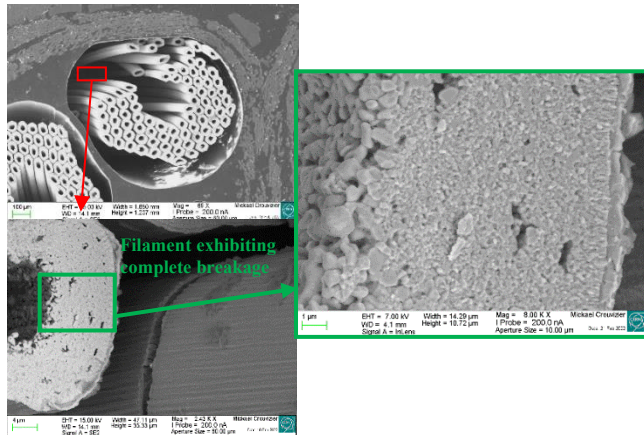
SEM analysis of these strands showed the broken sub-elements to have the typical Nb₃Sn intergranular fracture aspect (see Figure 3).

Fig. 3. MQXFBP1 quadrupole magnet coil CR 108: a broken Nb_3Sn filament observed by SEM. The close-up image enclosed by the green frame clearly shows the typical intergranular aspect of Nb_3Sn , found in all cases of complete transverse breakage.

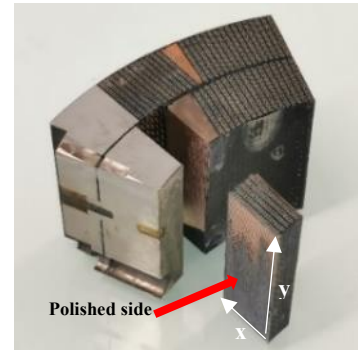
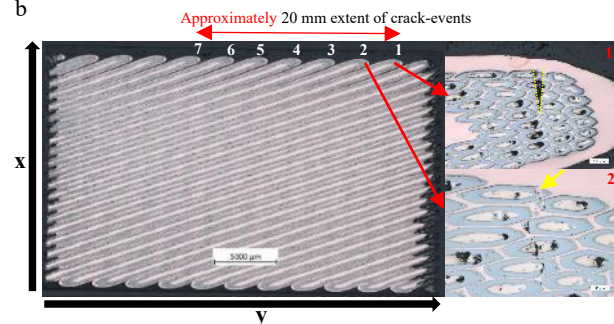
The extent at the level of the first midplane row was found to be approximately 20 mm in one sample and 15 mm in the adjacent one. The major events were at the crests of seven top strands as shown in the representative image of Figure 4.

The close-up at the top right of Figure 4 reports a crack-event resembling a “V” shape fracture (yellow dashed lines): this feature was observed in both specimens and might be related to a flexural stress acting in the coil axial direction following reaction and impregnation [9]. No cracks were detected at the second row midplanes.

Fig. 4. MQXFBP1 quadrupole magnet coil CR 108: (a) Extracted longitudinal sample where the side to be polished is displayed; (b) Longitudinal cross-section finely polished at the midplane of the first row of strands within the damaged cable (left). The extent of the events is about 20 mm. The major events are located at the crests of seven top strands. Strand numbering starts from the closest strand to the damaged one observed in the transverse cross-section after Cu etching. The two close-up images on the right represent observed crack-events and are highlighted by yellow dashed lines (top), and a yellow arrow (bottom).

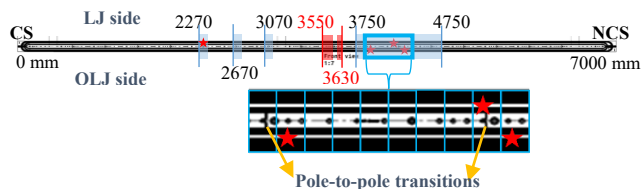
A systematic study with twenty additional samples (50 mm thick) covering one metre coil-length being inspected aimed at verifying the potential presence of broken filaments further away from the central quench region [26]. In three samples, cracked filaments were identified at the same location (top of inner-layer pole turn) as in the quench region. Moreover, the three samples had in common that they were located close to Ti pole-to-pole transitions included in this 1-metre segment. Fig 5 illustrates the positions of the identified damaged strands along the coil: in addition to the three above mentioned (at the coil

NCS), another strand with broken filaments was found at the top of inner-layer pole turn in the vicinity of a pole-to-pole transition towards the coil CS.

Such pole-to-pole transitions are discontinuity points, thus likely creating a risk for stress-concentration. The poles are approximately 400 mm long and there is an axial overlap of approximately 20 mm between the inner layer pole and the outer layer one [26],[9].

Fig. 5. Scheme of the 7 m long coil CR108 from the magnet MQXFBP1: the light blue rectangles represent the inspected samples, and the red stars display the locations of damaged strands with broken sub-elements. The light blue rectangle on the right shows the analyzed 1-m-segment with its 3 damaged strands (at the top of the inner-layer pole turn). A close-up view of this affected area highlighting the pole-to-pole transitions is shown as well. The red rectangles point out the damages in the areas of quench start localisation.

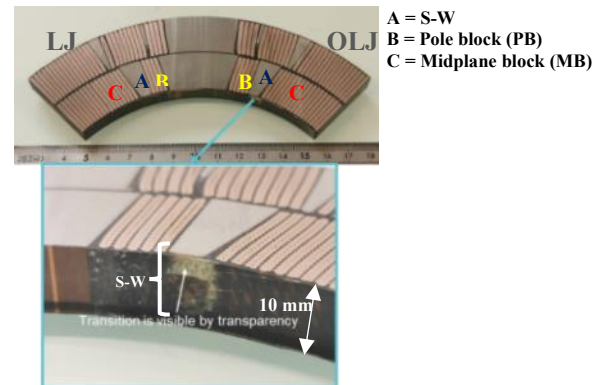
Fig. 6. MQXFA07 quadrupole magnet coil AUP 214: 10 mm thick coil-slice including the S-W transition and cut by DWS (top); close-up image showing that the S-W transition is already visible by transparency through resin (bottom).

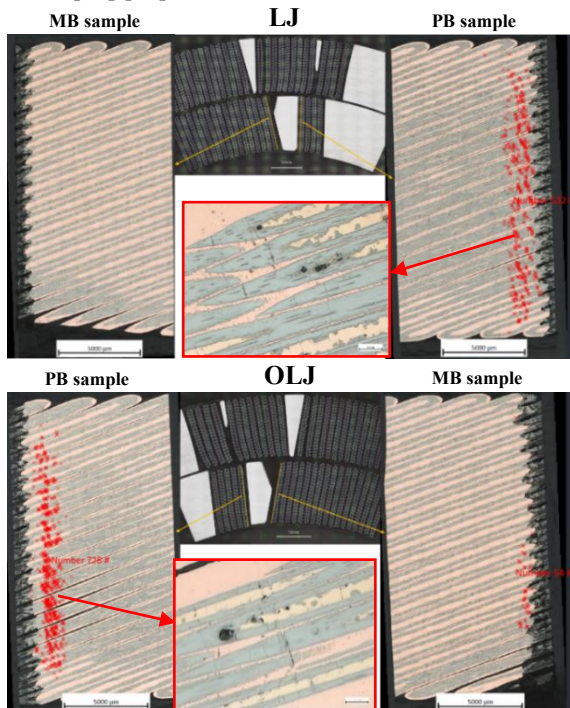
The cracks detected by optical microscopy over the LJ and OLJ longitudinal samples are shown in Figure 8 (top) and Figure 8 (bottom), respectively. Each red mark corresponds to an observed transverse crack going entirely through a Nb_3Sn sub-element for the LJ-MB sample, no cracks were identified. The LJ-PB sample showed instead 532 transverse crack-events confined in a field of approximately 2 mm. Similar results were found for the OLJ specimens: only few crack-events (54) were observed for the OLJ-MB, whereas 728 were counted for the OLJ-PB. For the latter sample with the greatest number of cracks at the midplane of the first row of strands (within the cable facing S-W), also the second row of strands was inspected for possible damage. The same metallurgical inspection did not reveal any crack-event in this case. These observations can be put in parallel with the results of the FE simulations presented

in [24],[25]: the location of the dense field of transverse cracks (about 2 mm wide) that is observed at the bottom of the PB for both the LJ and OLJ sides corresponds to the area where a strain peak approached 0.4%. In addition, the inspection of the second row did not reveal any field of cracks: this confirmed that the stress field was localised at the interface between the S-W transition and the 1st row of the Rutherford-type cable facing it.

The exact location of the crack field with respect to the S-W transition appeared to be in correspondence of the interface between the resin and the Cu wedge. Other related details are given in [24],[25].

Fig. 8. MQXFA07 quadrupole magnet coil AUP 214: transverse crack-events (red marks) over the longitudinal cross-sections prepared for the LJ-PB and LJ-MB samples (top) and for the OLJ-PB and OLJ-MB samples (bottom). Representative close-up images of the observed crack-events are pointed out with red arrows and squares. The cracks were counted manually through the analysis software of the optical microscope AXIO Imager from Zeiss.

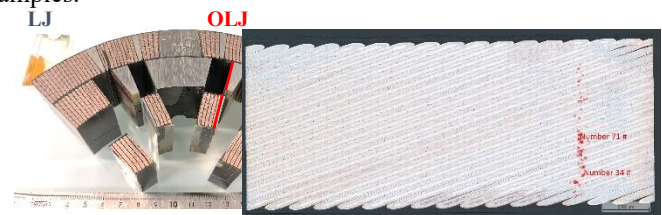
transition and then observed by optical microscopy. Figure 9 shows that 105 transverse crack-events were identified over the PB longitudinal cross-section. Also, this field of cracks (about 2 mm wide) was found to be at the interface between the resin and the Cu wedge as seen for AUP 214.

Fig. 9. MQXFA08 quadrupole magnet coil AUP 213: OLJ side inspection. The red marks on the prepared longitudinal cross-section represent all transverse crack-events (approximately 105) within a narrow field (2 mm wide) at the resin-Cu wedge interface.

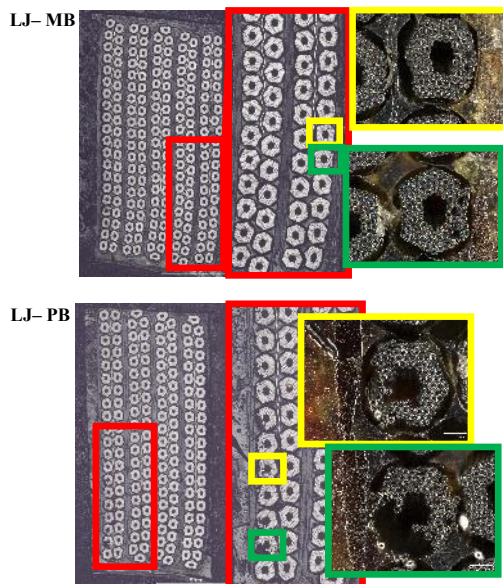
In the LJ-MB cross-section 5 damaged strands and a total of 15 broken sub-elements were identified, whereas in the LJ-PB 15 damaged strands and a total of approximately 100 broken sub-elements were found. This outcome is very consistent with observations on the OLJ side, and on the previous specimens from AUP 214. Moreover, these results confirm that inspection of longitudinal cross-sections and observation of transverse cross-sections after deep Cu etching are methods that reveal the same events from different cross-sections [9]. A given number of cracks observed in a longitudinal plane correspond to the same number of broken filaments visible after deep Cu etching in one or more damaged strands on the transverse cross-section.

Fig. 11. MQXFA08 quadrupole magnet coil AUP 213: LJ-MB (top) and LJ-PB (bottom) after Cu etching. The red squares highlight a portion of the damaged area, and the images enclosed by yellow/green frames display a zoom in on the type of damage observed.
