A Metallurgical Inspection Method to Assess the Damage in Performance-Limiting Nb₃Sn Accelerator Magnet Coils

Index Terms—Metallurgical inspections, HL-LHC, accelerator magnets, MQXF coils, Nb₃Sn, quench damage assessment

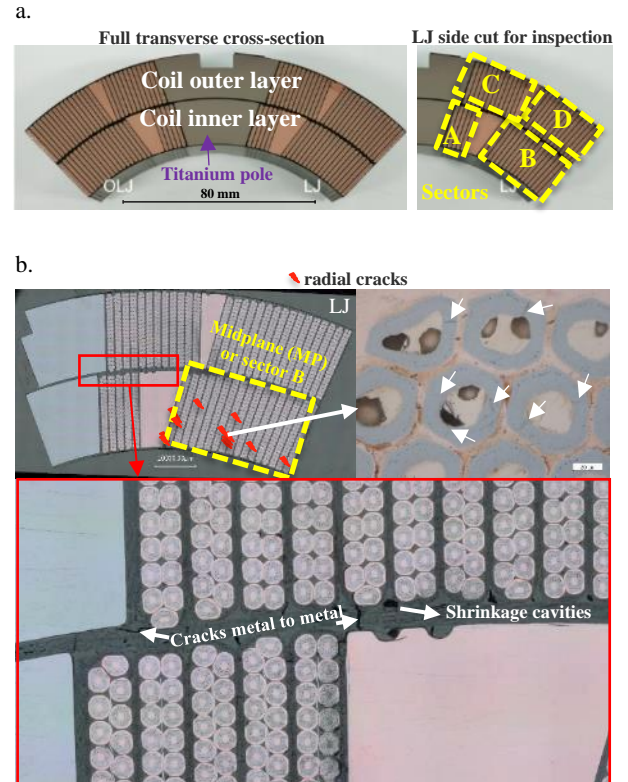
cracks did not always cross fully the Nb₃Sn phase in the sub-elements and clustered mainly in cables of the Midplane Block (MB) of the coil. The resin showed decohesion and metal-to-metal cracks for 3 of the 4 examined specimens. As all slices showed similar results, two representative images for the examination of radial cracks and resin status over a transverse cross-section (LJ side) are shown in Figure 1.

Fig. 1. MQXFBP1 quadrupole magnet coil CR 108: (a) as-prepared coil transverse cross-section displaying the inner/outer layer and the Ti pole (left), and coil LJ side cut for the inspection (right). The yellow dashed frames and the letters A, B, C, D identify the four sectors containing 5, 17, 12, and 16 Rutherford-type cables, respectively. (b) Representative images of the radial cracks observed over the transverse cross-section of coil LJ side cut (top). These cracks are mostly clustered in the cables of the MB or sector (red pins and white arrows). The resin shows shrinkage cavities and metal-to-metal cracks (bottom).

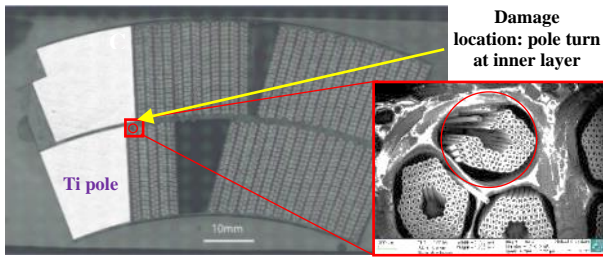
The progressive dissolution of the Cu matrix allowed the identification of strands with broken sub-elements for three of the prepared transverse cross-sections. A very specific damage location was observed: the same and only top strand of the pole turn cable facing the titanium pole at the outer radius of the inner layer.

This location is identified in Figure 2 as “pole turn at inner layer” shown along with a SEM close-up of the damaged strand with broken sub-elements. The identified damaged strands are included in a 60 mm long section of the coil (along its main axis) where the limiting quench origin was localised.

Fig. 2. MQXF BP1 quadrupole magnet coil CR 108: typical aspect of the transverse cross-section after deep Cu etching. The inset in the red frame shows a SEM close-up of the damaged strand with broken filaments at the recurrent position, the pole turn at inner layer (top edge of the cable facing the Ti pole). Portions of intact strands are visible as well.

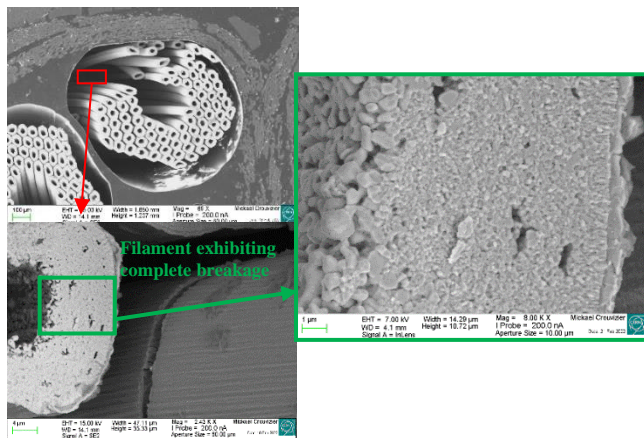
SEM analysis of these strands showed the broken sub-elements to have the typical Nb₃Sn intergranular fracture aspect (see Figure 3).

Fig. 3. MQXF BP1 quadrupole magnet coil CR 108: a broken Nb₅Sn filament observed by SEM. The close-up image enclosed by the green frame clearly shows the typical intergranular aspect of Nb₅Sn, found in all cases of complete transverse breakage.

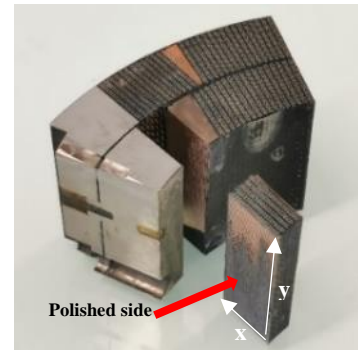
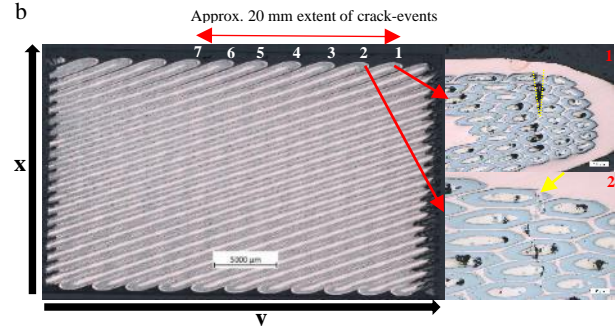
The extent at the level of the first midplane row was found to be approx. 20 mm in one sample and 15 mm in the adjacent one. The major events were at the crests of seven top strands as shown in the representative image of Figure 4.

The close-up at the top right of Figure 4 reports a crack-event resembling a “V” shape fracture (yellow dashed lines); this feature was observed in both specimens and might be related to a flexural stress acting in the coil axial direction following reaction and impregnation [9]. No cracks were detected at the second row midplanes.

Fig. 4. MQXF BP1 quadrupole magnet coil CR 108: (a) Extracted longitudinal sample where the side to be polished is displayed; (b) Longitudinal cross-section finely polished at the midplane of the first row of strands within the damaged cable (left). The extent of the events is about 20 mm. The major events are located at the crests of seven top strands. Strand numbering starts from the closest strand to the damaged one observed in the transverse cross-section after Cu etching. The two close-up images on the right represent observed crack-events and are highlighted by yellow dashed lines (top), and a yellow arrow (bottom).

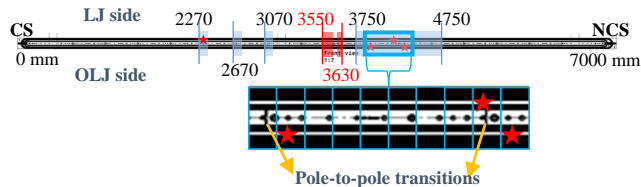
Such pole-to-pole transitions are discontinuity points, thus likely creating a risk for stress-concentration. The poles are approx. 400 mm long and there is an axial overlap of approx. 20 mm between the inner layer pole and the outer layer one [26],[9].

Fig. 5. Scheme of the 7 m long coil CR108 from the magnet MQXFBP1: the light blue rectangles represent the inspected samples, and the red stars display the locations of damaged strands with broken sub-elements. The light blue rectangle on the right shows the analyzed 1-m-segment with its 3 damaged strands (at the top of the inner-layer pole turn). A close-up view of this affected area highlighting the pole-to-pole transitions is shown as well. The red rectangles point out the damages in the areas of quench start localisation.

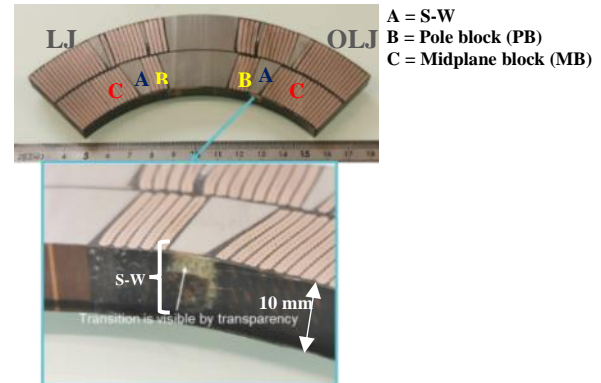
Fig. 6. MQXFA07 quadrupole magnet coil AUP 214: 10 mm thick coil-slice including the S-W transition and cut by DWS (top); close-up image showing that the S-W transition is already visible by transparency through resin (bottom).

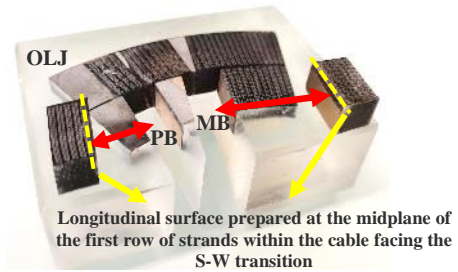
Fig. 7. MQXFA07 quadrupole magnet coil AUP 214: 10 mm thick OLJ side embedded in epoxy resin for the metallurgical inspection. In this case, the extraction of longitudinal samples is illustrated. The red arrows point out the two samples extracted from the PB and MB, respectively. The yellow dashed lines represent the plane to be polished with the cables facing S-W.

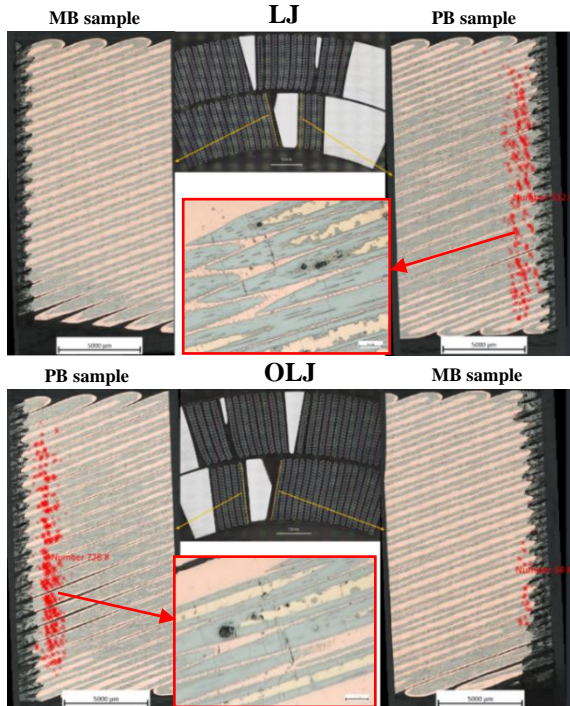
The cracks detected by optical microscopy over the LJ and OLJ longitudinal samples are shown in Figure 8 (top) and Figure 8 (bottom), respectively. Each red mark corresponds to an observed transverse crack going entirely through a Nb_3Sn sub-element for the LJ-MB sample, no cracks were identified. The LJ-PB sample showed instead 532 transverse crack-events confined in a field of approx. 2 mm. Similar results were found for the OLJ specimens: only few crack-events (54) were observed for the OLJ-MB, whereas 728 were counted for the OLJ-PB. For the latter sample with the greatest number of cracks at the midplane of the first row of strands (within the cable facing S-W), also the second row of strands was inspected for possible damage. The same metallurgical inspection did not reveal any crack-event in this case. These observations can be put in parallel with the results of the FE simulations presented in [24],[25]: the location of the dense field of transverse cracks (about 2 mm wide) that is observed at the bottom of the PB for

both the LJ and OLJ sides corresponds to the area where a strain peak approached 0.4%. In addition, the inspection of the second row did not reveal any field of cracks: this confirmed that the stress field was localised at the interface between the S-W transition and the 1st row of the Rutherford-type cable facing it.

The exact location of the crack field with respect to the S-W transition appeared to be in correspondence of the interface between the resin and the Cu wedge. Other related details are given in [24],[25].

Fig. 8. MQXFA07 quadrupole magnet coil AUP 214: transverse crack-events (red marks) over the longitudinal cross-sections prepared for the LJ-PB and LJ-MB samples (top) and for the OLJ-PB and OLJ-MB samples (bottom). Representative close-up images of the observed crack-events are pointed out with red arrows and squares. The cracks were counted manually through the analysis software of the optical microscope AXIO Imager from Zeiss.

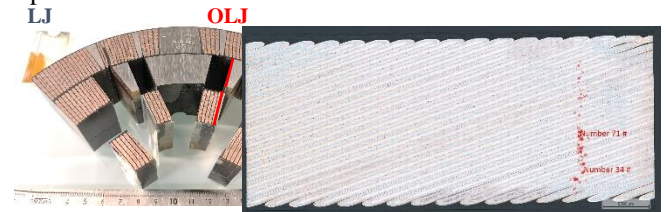
Based on the outcome of the inspections performed on coil AUP 214, the inspection of the S-W transition was carried out by cutting the 4 longitudinal samples (2 at the LJ side, 2 at the OLJ side) containing the 4 cables facing these transitions in the coil connection side. As a first step, the OLJ side of the AUP 213 was examined in the same way as coil AUP 214 was examined: the PB and MB longitudinal samples were polished down to the midplane of the first row of strands facing the S-W transition and then observed by optical microscopy. Figure 9 shows that 105 transverse crack-events were identified over the PB

longitudinal cross-section. Also, this field of cracks (about 2 mm wide) was found to be at the interface between the resin and the Cu wedge as seen for AUP 214.

Fig. 9. MQXFA08 quadrupole magnet coil AUP 213: OLJ side inspection. The red marks on the prepared longitudinal cross-section represent all transverse crack-events (approx. 105) within a narrow field (2 mm wide) at the resin-Cu wedge interface.

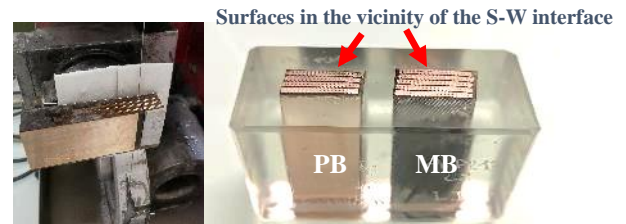
Fig. 10. MQXFA08 quadrupole magnet coil AUP 213: LJ-PB cut by DWS at the level of the resin-Cu wedge interface where the events are expected (left); LJ-PB and LJ-MB surfaces embedded in epoxy resin for the following Cu etching process (right).

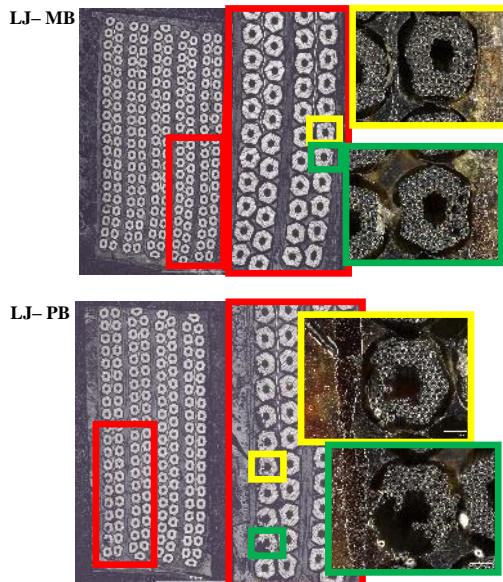
Figure 11 presents the results obtained by etching the LJ-MB (top) and LJ-PB (bottom) transverse cross-sections.

In the LJ-MB cross-section 5 damaged strands and a total of 15 broken sub-elements were identified, whereas in the LJ-PB 15 damaged strands and a total of approx. 100 broken sub-elements were found. This outcome is very consistent with observations on the OLJ side, and on the previous specimens from AUP 214. Moreover, these results confirm that inspection of longitudinal cross-sections and observation of transverse cross-sections after deep Cu etching are methods that allow to highlight the same events from different cross-sections [9]. A given number of cracks observed in a longitudinal plane correspond to the same number of broken filaments visible after deep Cu etching in one or more damaged strands on the transverse cross-section.

Fig. 11. MQXFA08 quadrupole magnet coil AUP 213: LJ-MB (top) and LJ-PB (bottom) after Cu etching. The red squares highlight a portion of the damaged area, and the images enclosed by yellow/green frames display a zoom in on the type of damage observed.
