# Hot spot visual evaluation of breakdown locations in ATLAS18 ITk strip sensors and test structures

A. Fournier <sup>a,b,\*</sup>, V. Fadeyev, J. Fernandez-Tejero <sup>a,b</sup>, Bart Hommels <sup>g</sup>,  
C. Jessiman <sup>c</sup>, J. Keller <sup>c</sup>, C. Klein <sup>c</sup>, T. Koffas <sup>c</sup>, S. O'Toole <sup>a,b</sup>,  
J. Osieja <sup>a,b</sup>, L. Poley <sup>a,b</sup>, E. Staats <sup>c</sup>, B. Stelzer <sup>a,b</sup>, M. Ullan <sup>d</sup>, Y. Unno <sup>e</sup>

## Abstract

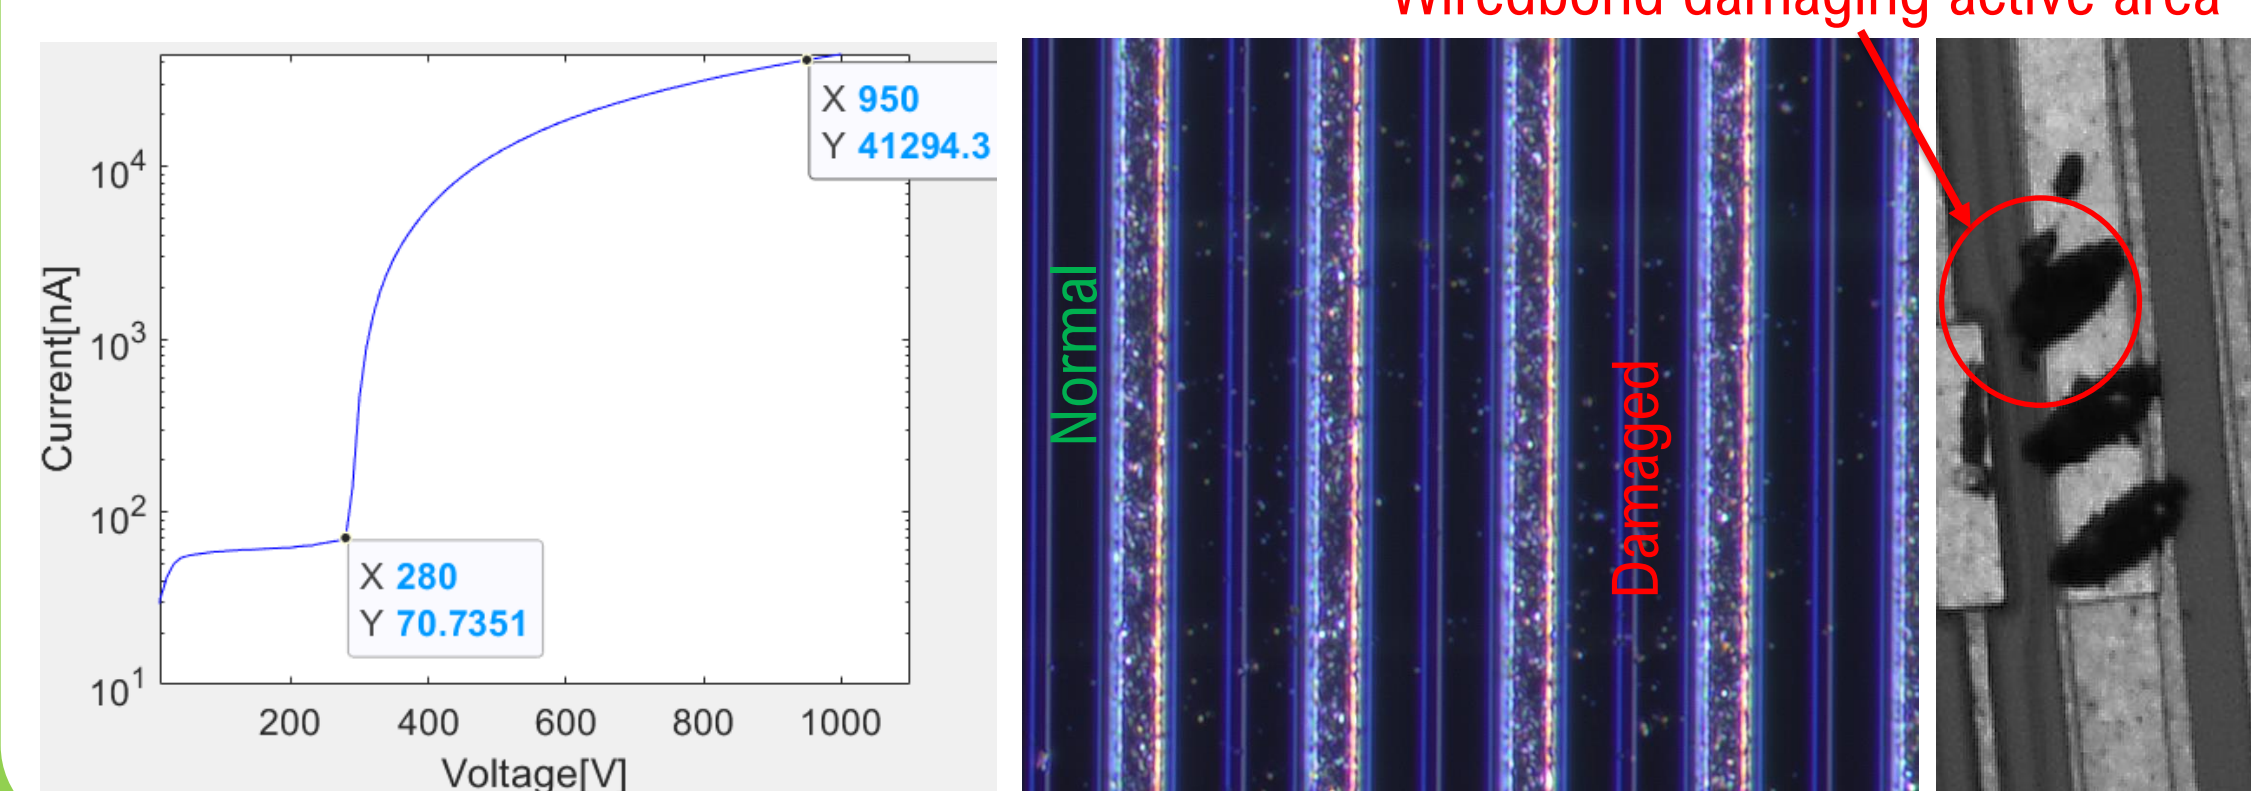
### ATLAS18 R1 Wafer 297

This sample had a very large breakdown area shown (Right) at 950V and 41 $\mu\text{A}$  of current. Microscope imaging (middle) of the area shows speckling in the damaged region which was later agreed to be the result of a wirebond damaging the active area.

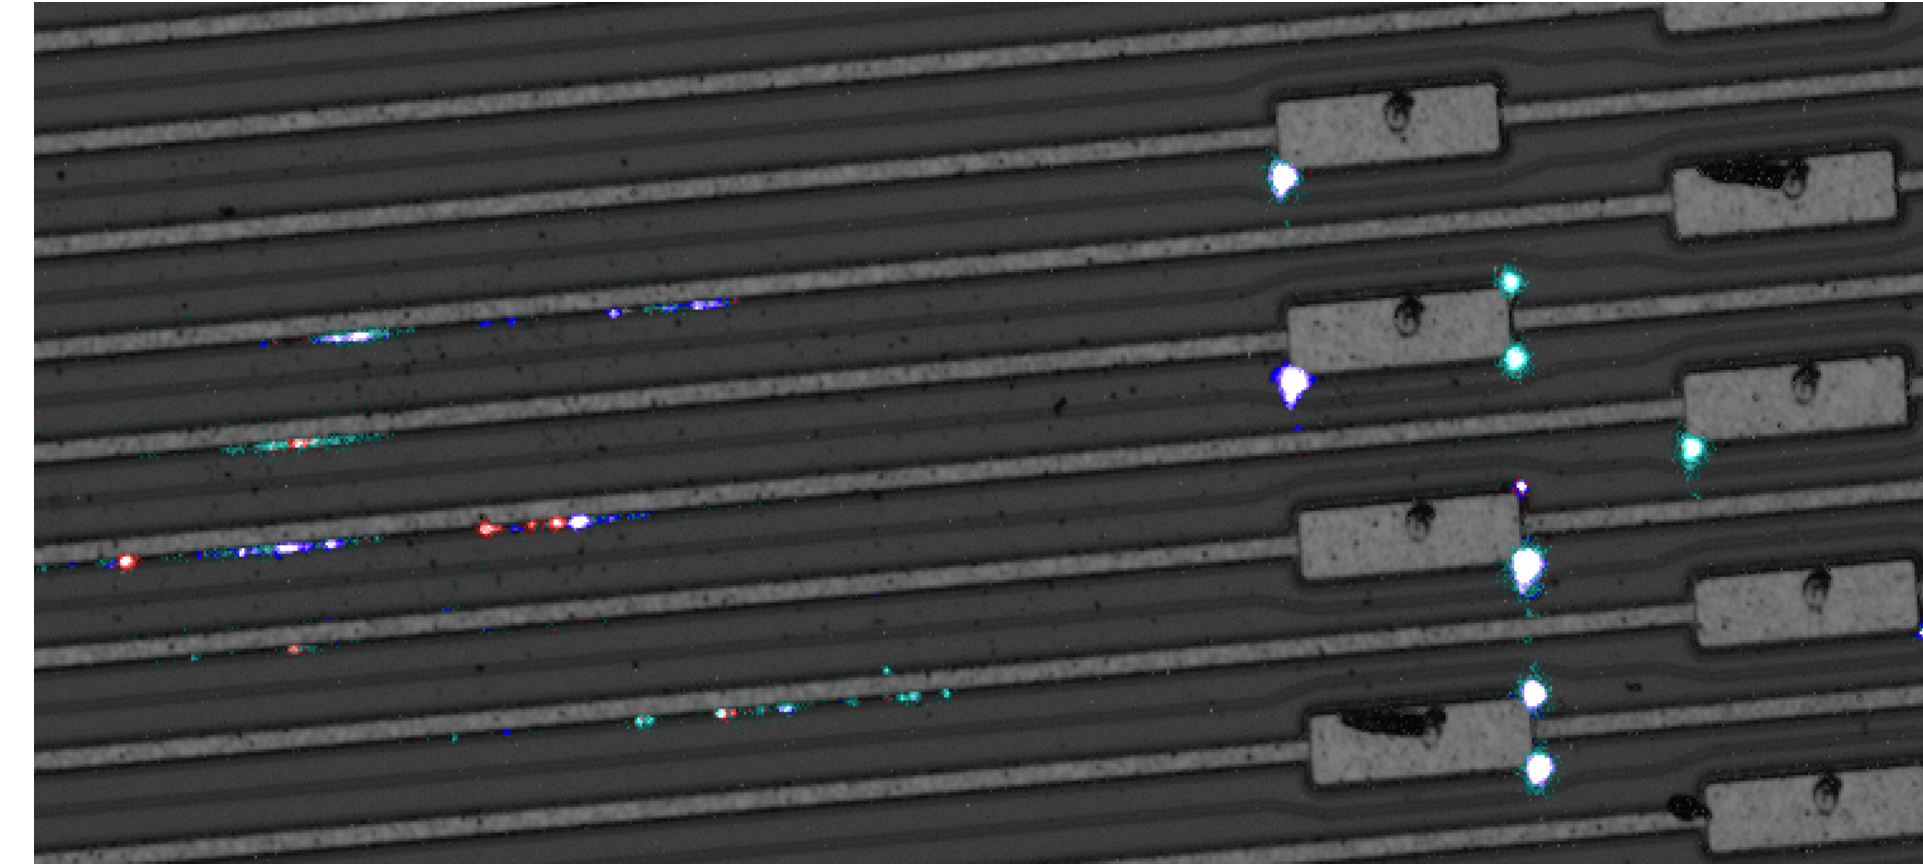
This newer composite image using the Retiga E7 shows 3 different captures about 10 minutes apart colored in Red, Blue and Purple. This demonstrates the non-static nature of the breakdown with breakdown distributed in different areas.

Wirebond damaging active area

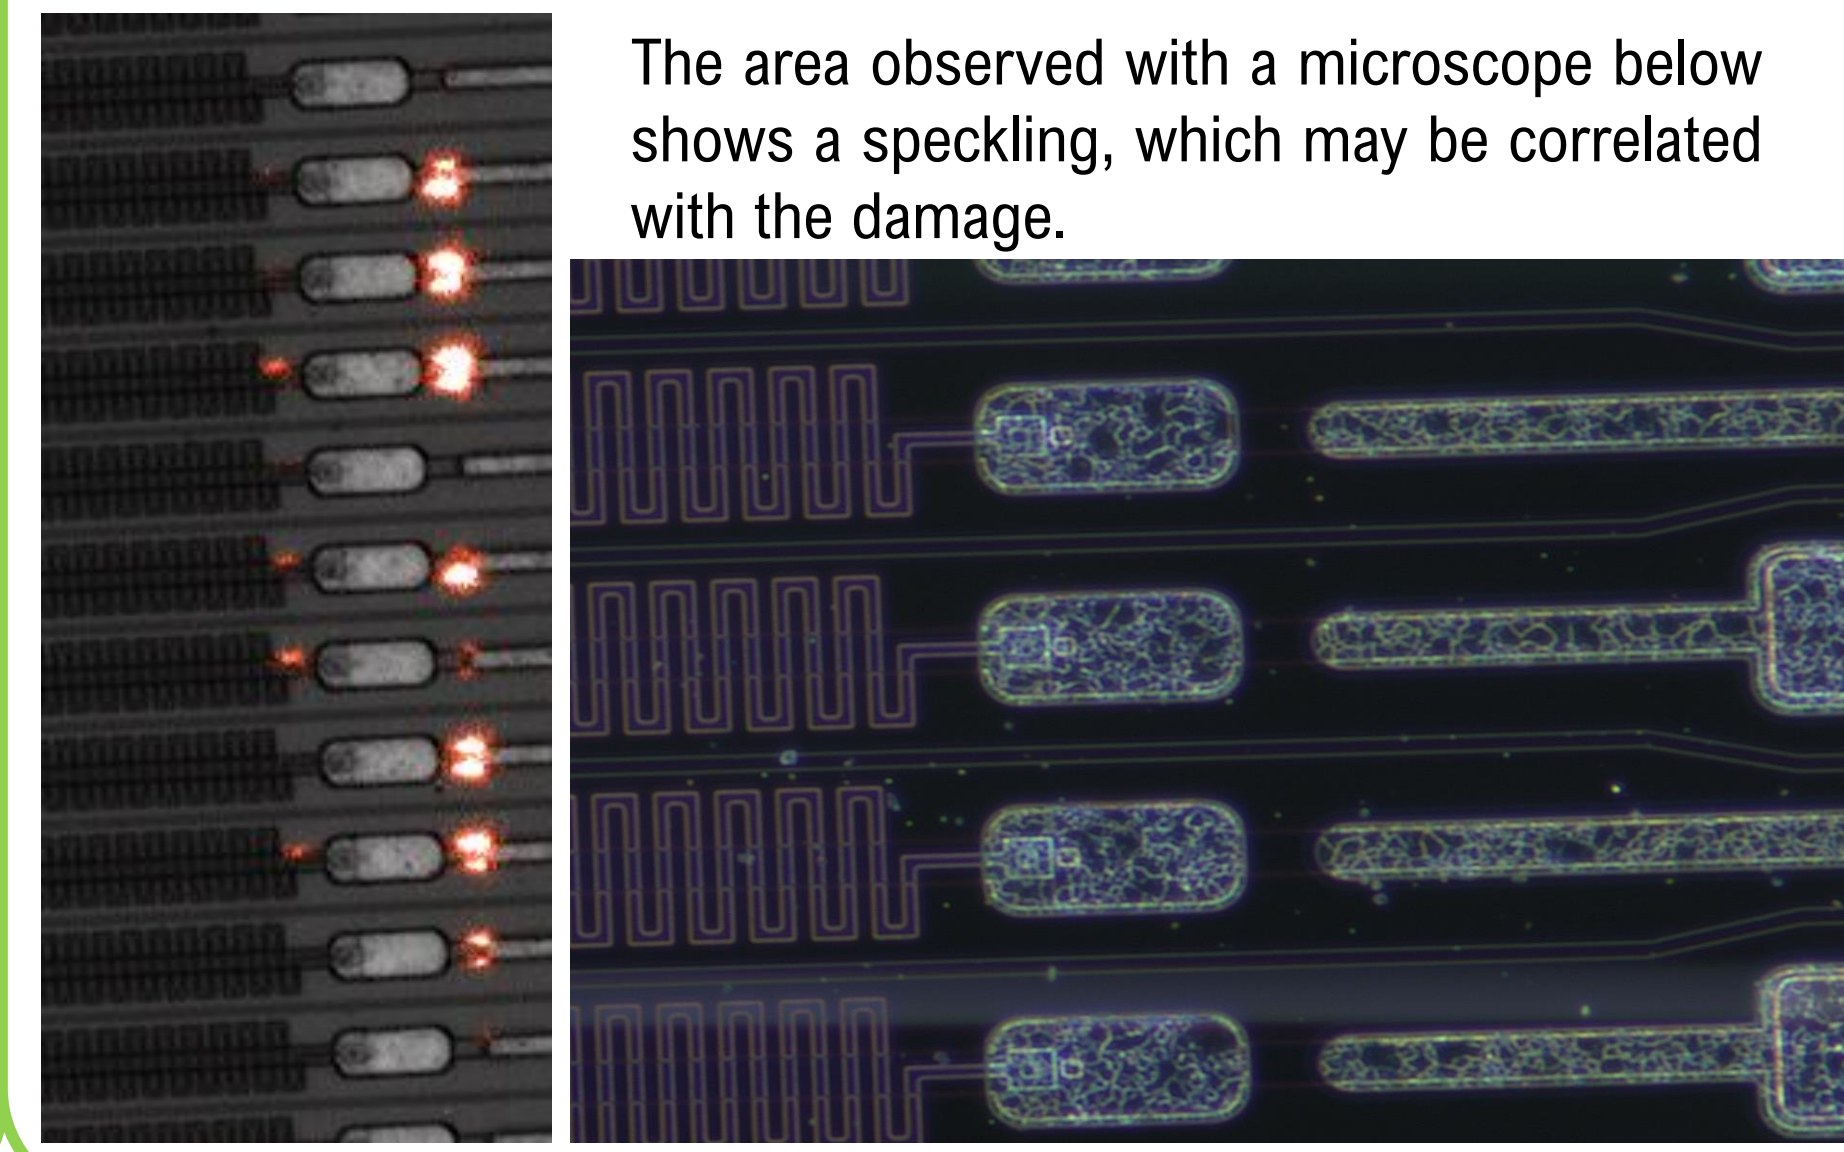
### ATLAS18 R4 Wafer 500

Breakdown was captured on the strip biasing resistors (bottom right), captured at 600V, 20 $\mu\text{A}$ . It seemed to be spread across a section about 700 $\mu\text{m}$  long.

The area observed with a microscope below shows a speckling, which may be correlated with the damage.

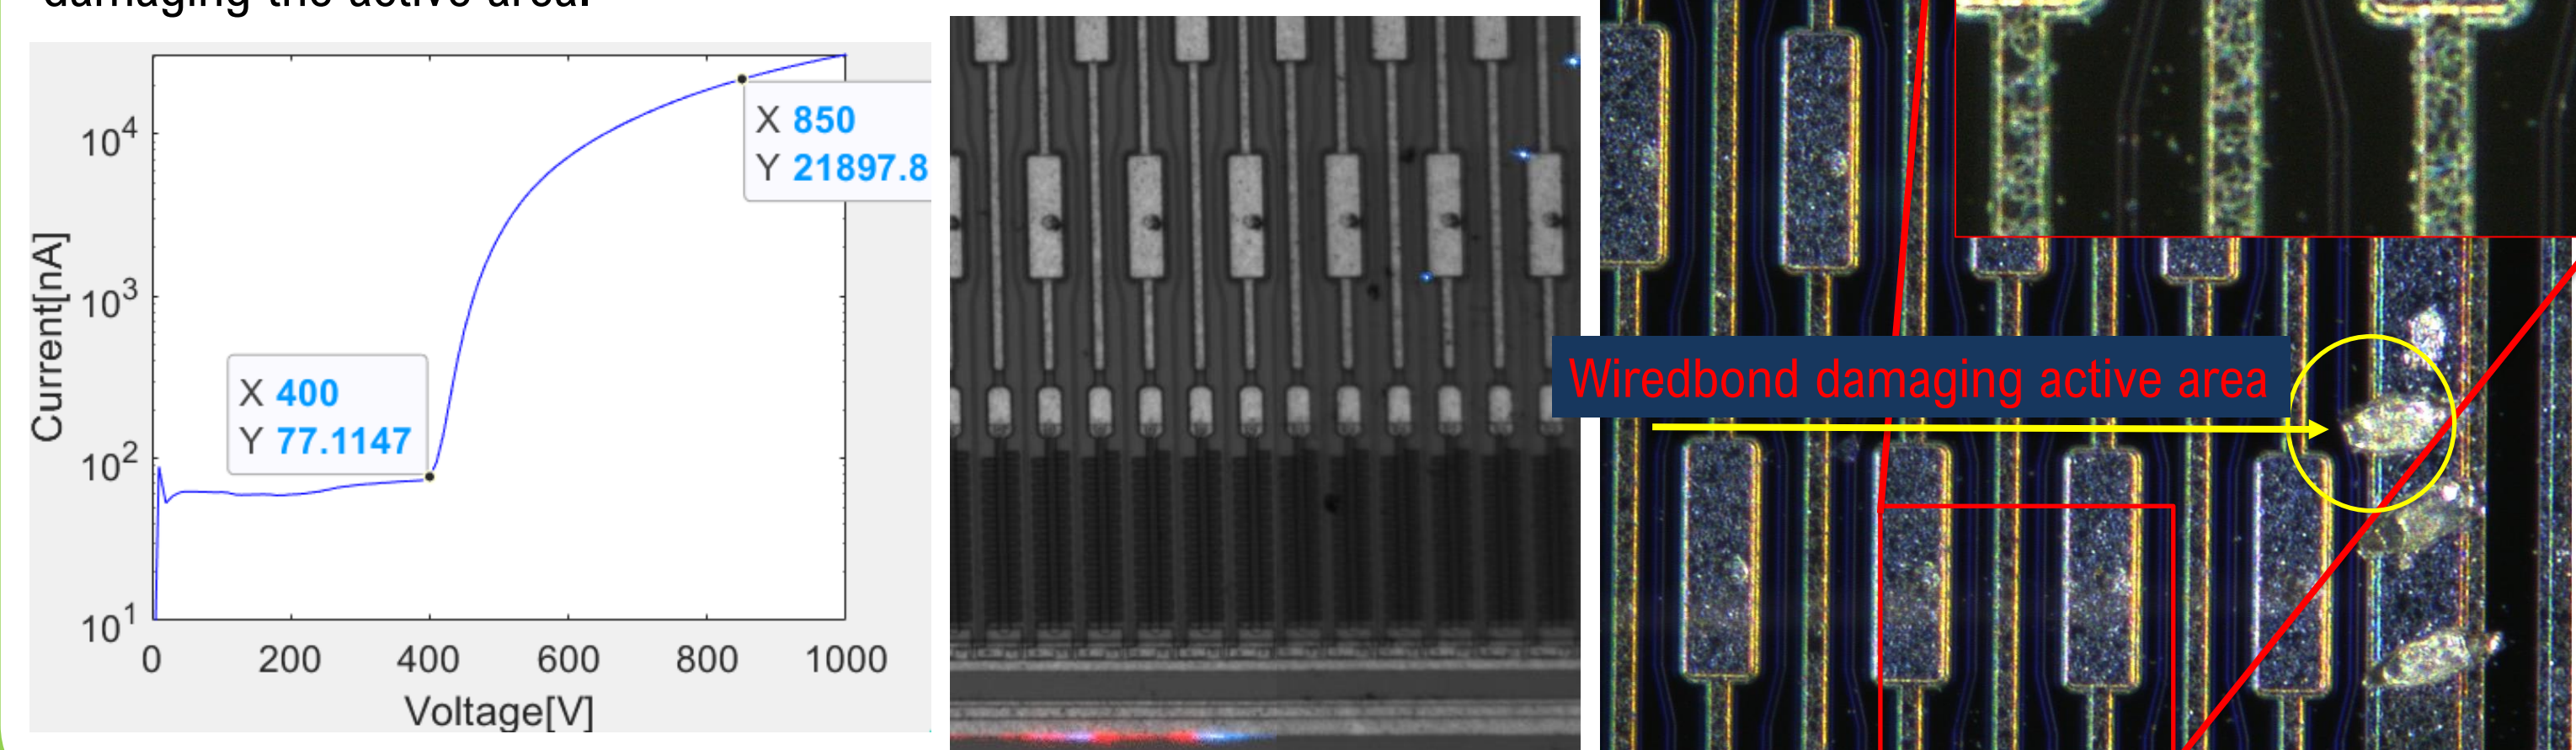
### ATLAS18 R1 Wafer 281

This sample has a breakdown region that changed over time, left biased at 850V, 22 $\mu\text{A}$ . Two captures were taken 2 minutes apart (Middle) shown in red and blue showing an evolution in the breakdown region. Microscope imaging (Right) shows a speckling in the damaged area which was later assumed to be the result of a wirebond damaging the active area.

Wirebond damaging active area

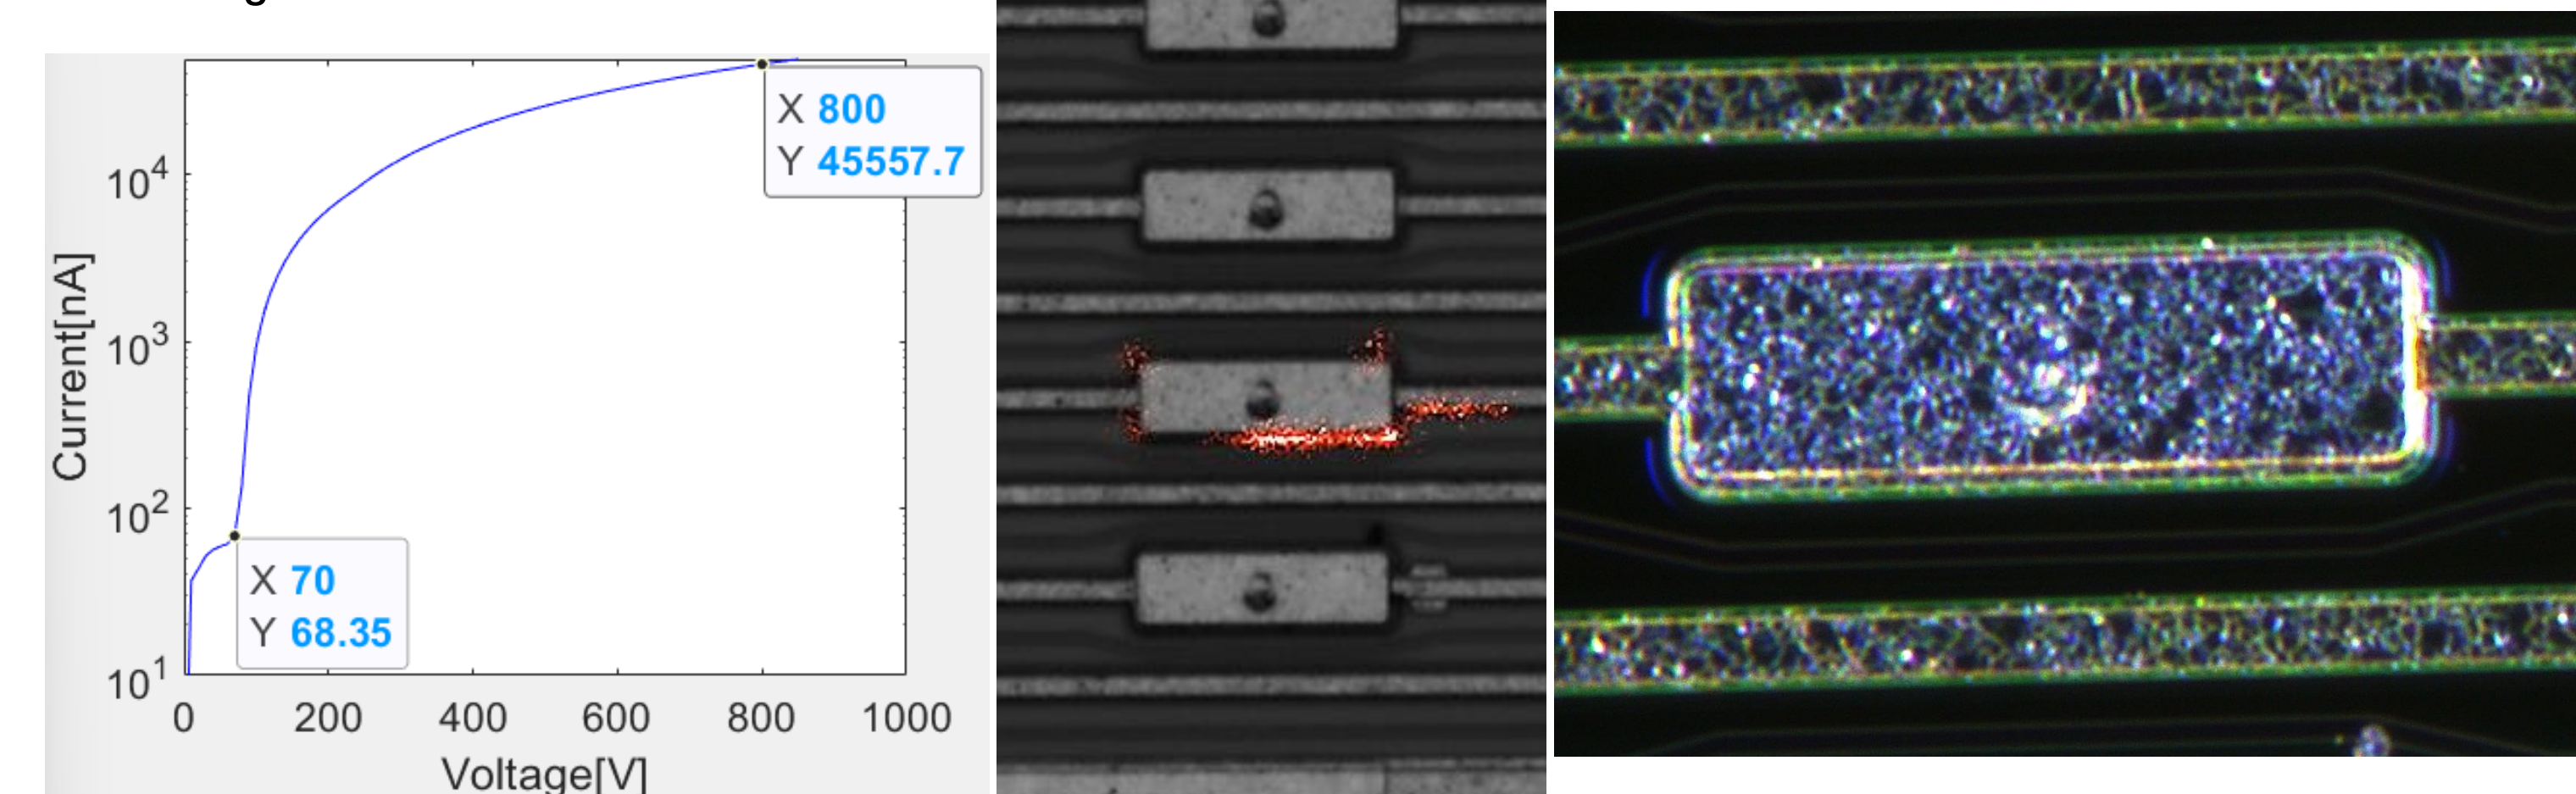
### ATLAS18 R4 Wafer 517

This sample has a breakdown area surrounding a pad in the active area (Middle) captured at 800V, 45 $\mu\text{A}$  but still requiring a long 3-minute exposure. Microscope imaging (Right) shows no obvious defects on the area. Therefore, it was concluded this damage is caused by trapped static charge. (1) 400nm UV light treatment successfully repaired the damage.

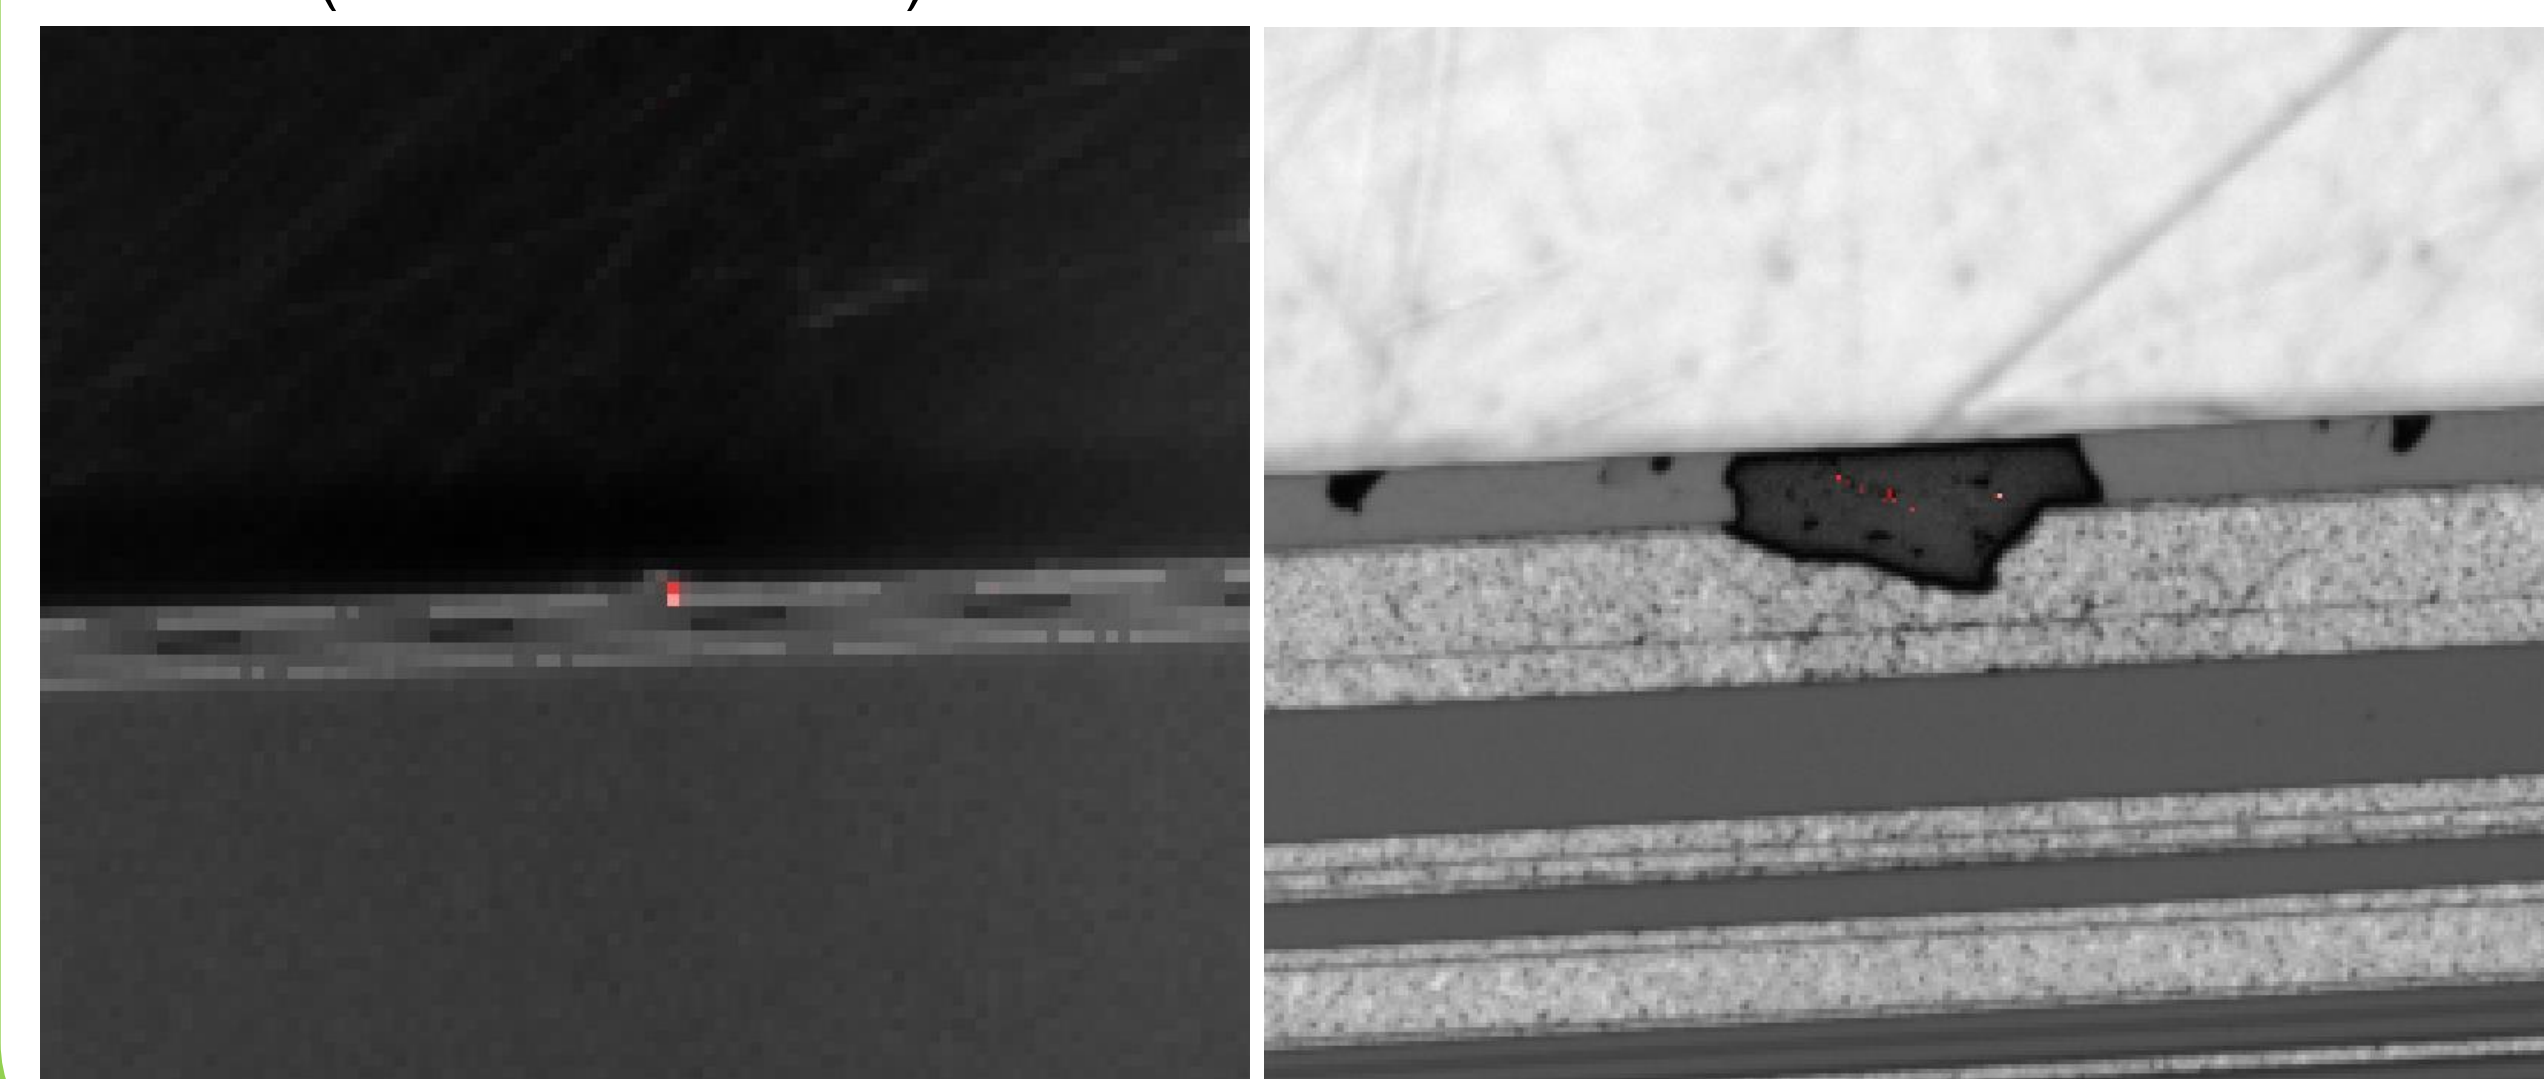
### ATLAS18 R5 Wafer 82

This sensor had instant breakdown conditions on reception for quality control. It underwent several procedures to attempt to repair it. Recently, the Retiga E7 was used to locate the damage. The wide-angle image (Left) showed an extremely dim illumination on the edge of the sensor, requiring several minutes of 2x2 binned exposure at 950V 24 $\mu\text{A}$ . Magnified imaging of the area (Right) shows a chip on the edge producing a faint glow, also requiring several minutes of exposure with 2x2 binning to capture. This sample proved extremely challenging imaging conditions (like instant breakdown) are still feasible!

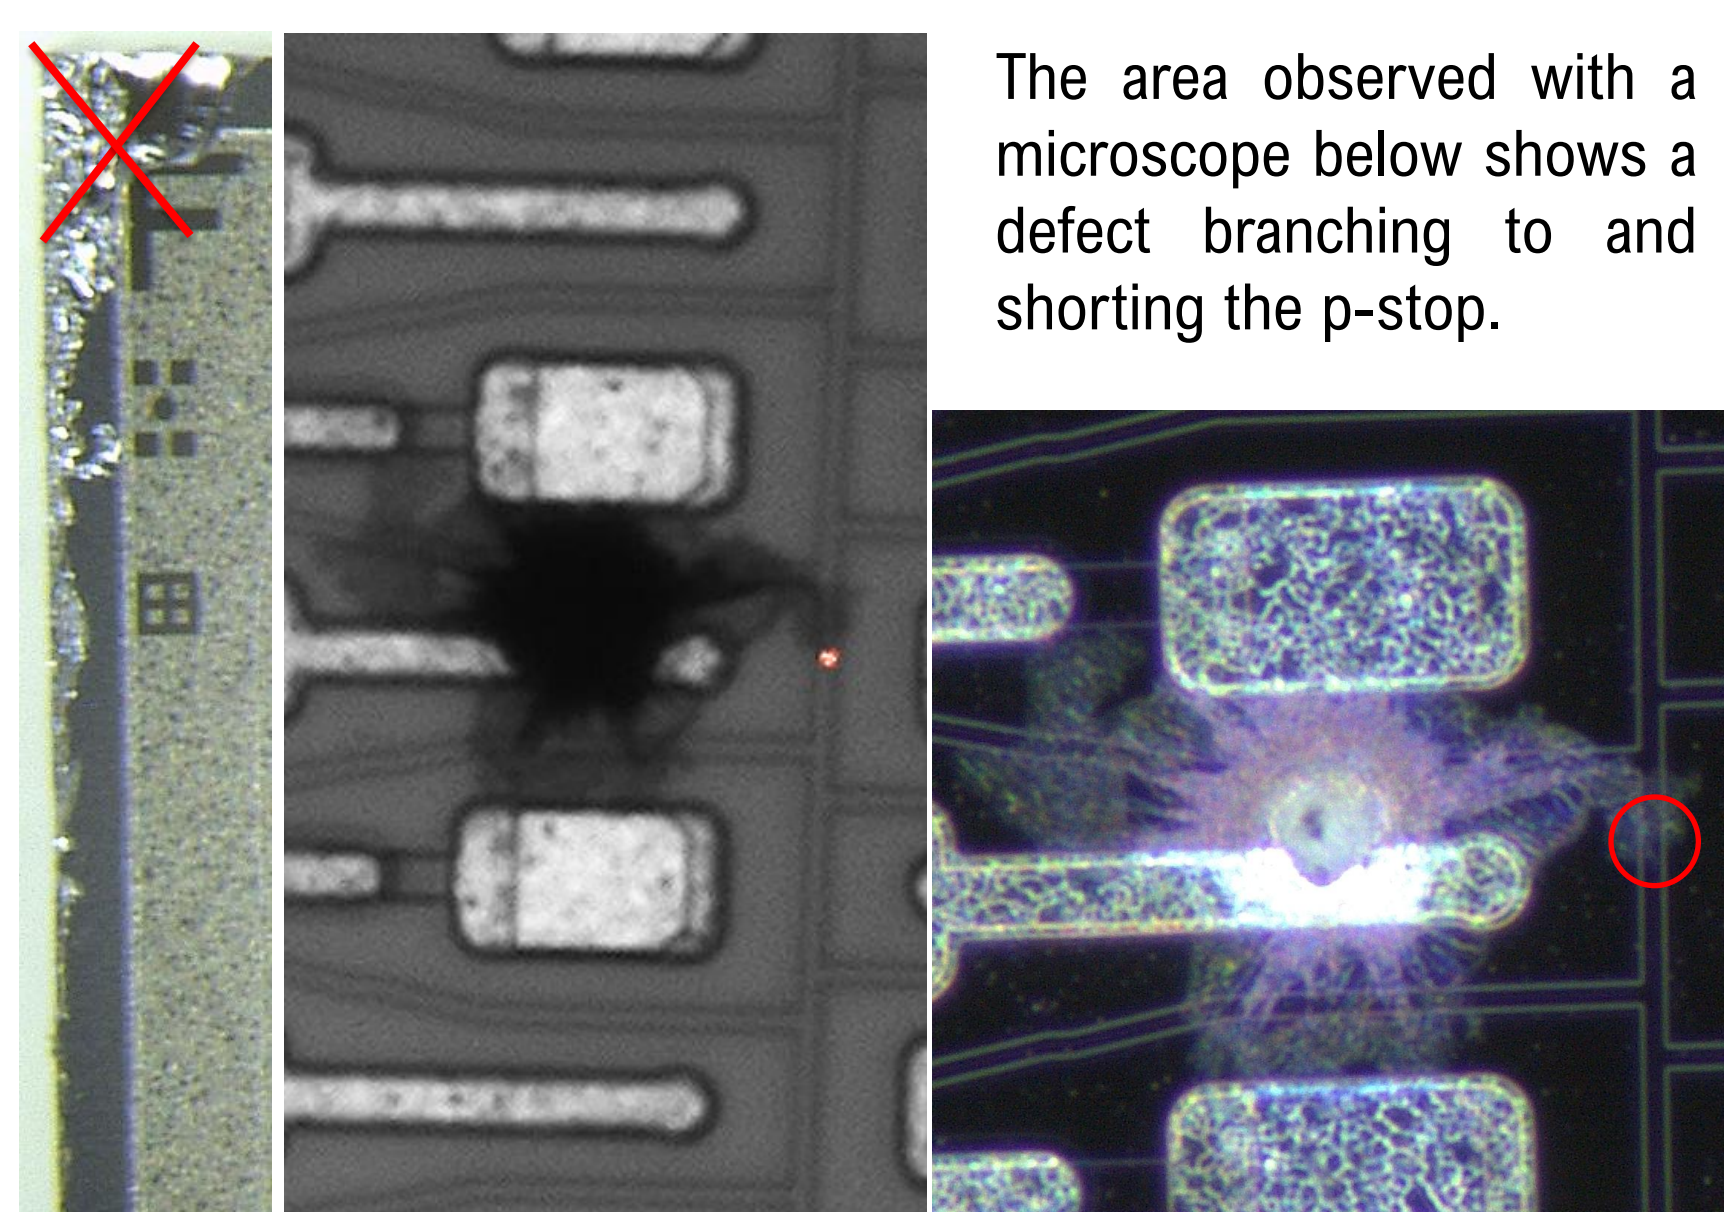
### ATLAS18 R1 Wafer 585

This sensor was chipped badly in one corner as shown bottom left. It was assumed the breakdown would occur in this region, but it was found that a manufacturing defect in the active area was more significant, captured at 800V 11 $\mu\text{A}$ .

The area observed with a microscope below shows a defect branching to and shorting the p-stop.

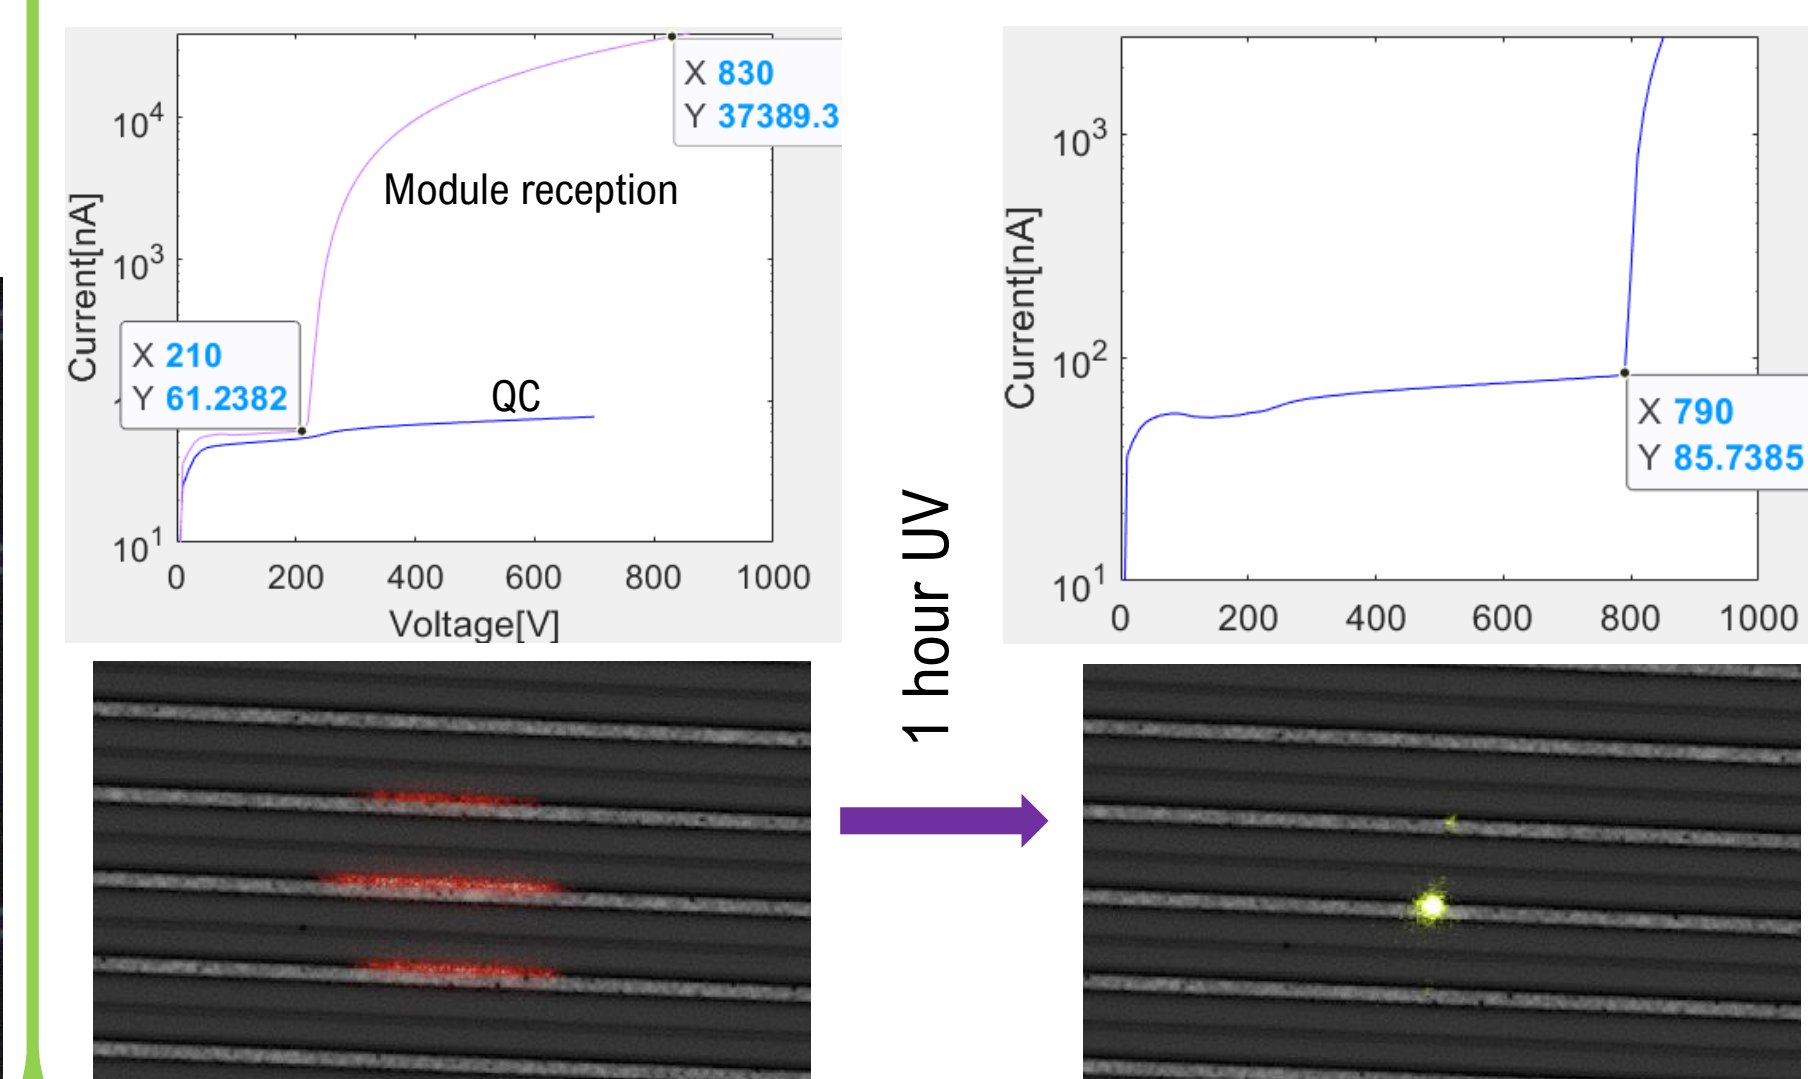
### ATLAS18 R4 Wafer 501

This sensor initially passed quality control but started breaking down after the sensor was shipped and received. Breaking down at 220V and imaged at 830V 37 $\mu\text{A}$ , emissions were found in the middle of the active area (Left) with no visible damage. Using a 1-hour 400nm UV light treatment (1), the breakdown no longer occurs until 790V and produces a much smaller breakdown region at the same location (Left) confirming this was static charge buildup.
