Analysis of the short-to-ground event in the LARP-AUP MQXFAP1 magnet, and its implication on the production and tests of the series magnets

Vittorio Marinozzi, Giorgio Ambrosio, Joseph Muratore, Piyush Joshi, Emmanuele Ravaioli, Stoyan Stoynev, Peter Wanderer

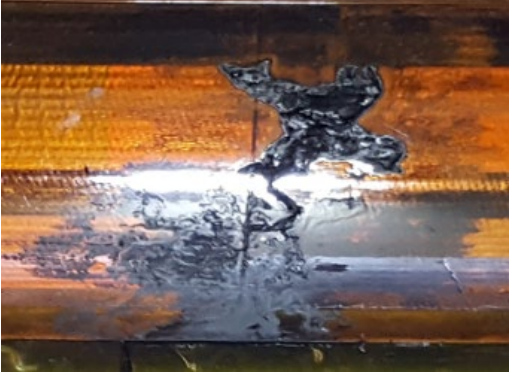
Figure 2: picture of MQXFAP1 short circuit location

Short circuit to-ground occurred in the coil QXFAP5, that was known to have a short circuit coil-to-heater, happened between quench 1 and quench 2 in the outer layer, low field region. Visual inspections confirmed that the short to-ground occurred in the region above the quench heater strip, where a clear burnt of the insulation can be observed (see Fig. 2).

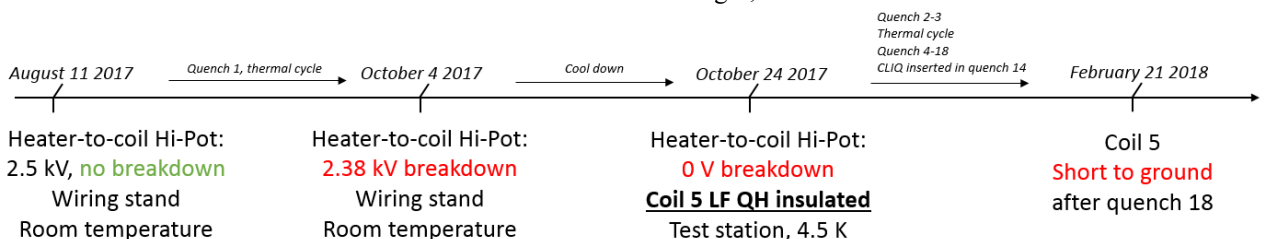
Figure 3: History of quench and hi-pot tests on the coil QXFAP5, low-field zone

Figure 3 shows the test procedure adopted for MQXFAP1 during the cold vertical test [2], together with the quench history, focusing on the Hi-Pot tests performed on the coil QXFAP5. The Hi-Pot tests were performed according to the procedures used for cold tests of MQXFS (short models) by LARP and CERN.

The first Hi-Pot test, at room temperature, showed that the heater-to-coil insulation was robust. However, after just one quench and one thermal cycle, the second room temperature Hi-Pot test showed a 2.38 kV breakdown, the first evidence of a heater-to-coil short. After cooling the magnet without any quench, the Hi-Pot showed a 0 V breakdown, clearly indicating a heater-to-coil short. The coil QXFAP5 outer layer low-field quench heater was therefore insulated. Then the magnet had quench 2 and 3, and a complete thermal cycle. After 14 more quenches, it showed a short-to-ground, and the test campaign was stopped.

It is evident that the heater-to-coil short occurred immediately after quench 1. We hypothesize that it was caused by the second hi-pot test at room temperature. Indeed, after the first quench and thermal cycle, cracks in the epoxy resin can occur due to thermal contractions and electromagnetic forces; superfluid helium can infiltrate into these cracks and become trapped within the resin.

We can conclude that performing hi-pot tests at room temperature, after the magnet has been in contact with superfluid helium, can pose a hazard. This procedure can cause a multiple heater-to-coil short, which, as we have seen, can pose risks to the safety of the magnet. After the magnet has been exposed to helium, the document “Electrical Design Criteria for the HL-LHC Inner Triplet Magnets” [9] (not available at the time of MQXFAP1 first

and second cooldown) recommends decreasing warm Hi-pot to 1/5 of the minimum design to withstand the voltage at nominal operating conditions. In the future, these guidelines will be strictly followed for short models and prototypes tests, and this issue will be avoided.

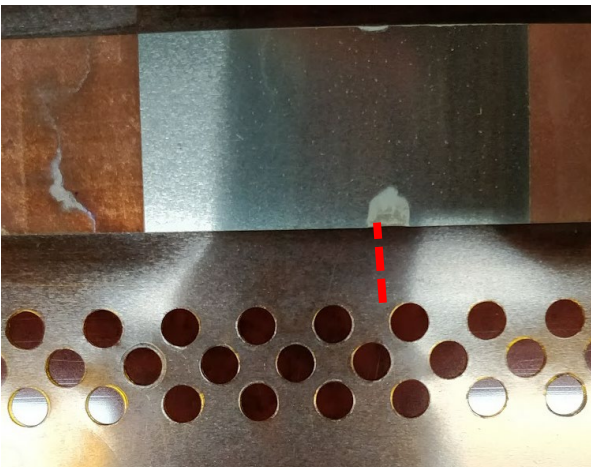
Figure 5: picture of the quench heater trace used for MQXFAP1.

Figure 5 shows the outer-layer quench heater trace. Since the quench heater trace contains holes that are about 5 mm away from the heater strips, it is possible to foresee a path from the coil to the quench heater through a crack in the epoxy filled with helium gas, and then through one of these holes. As a result, the electric arc can damage the polyimide insulation, creating a direct path from the coil to the quench heater that is just 200 μm long. This may explain the 0 V breakdown after the cool-down. It is not clear whether, in the specific case of coil QXFAP5, the heater-to-coil short had been in multiple turns since the beginning. It cannot be excluded, therefore that the insulation to-ground was exposed to heat deposition for 17 quenches.

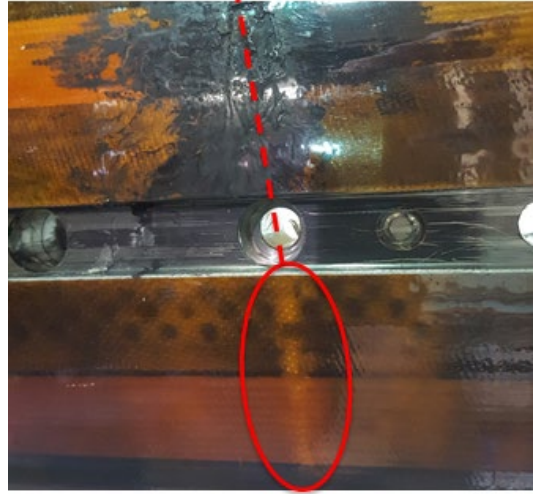
Figure 6: Evidence of poor impregnation (white zone) in the MQXFAP1 short location

In addition, figure 6 shows that the impregnation of the coil in the short zone was poor, increasing the chances of shorts. The sign of poor impregnation is the “white” area evidenced by a circle.
