# LESSONS LEARNED FROM HARDWARE FAILURE DURING HL-LHC AUP CABLING\*

E. M. Lee<sup>†</sup>, E. Buron, J.F. Croteau, A. Lin, T. Lipton, M. Naus,  
C. Perez, I. Pong (*IEEE Senior Member*), Lawrence Berkeley National Laboratory, Berkeley, USA  
A. Baskys, European Organization for Nuclear Research, Meyrin, Switzerland

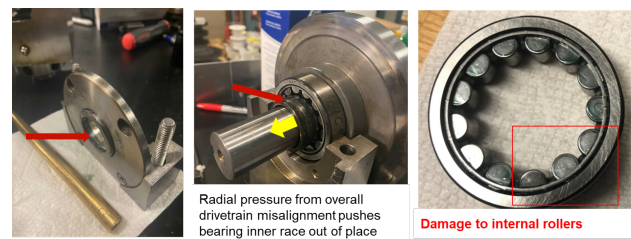
During the manufacture of Cable 1171, the operating team noticed that the cable mid-thickness had been increasing throughout the production run. The lead cabling machine operator made several attempts to stabilize the cable mid-thickness, but the keystone angle continued to decrease and the mid-thickness increased at an accelerated rate after each attempt. In the end, the cable was outside specification and rejected.

After the production run, disassembly of the drivetrain showed that the inner race of one of the drive rollers had been forced out of position by excessive journal pressure (Fig. 1). The roller assembly was therefore unable to hold its alignment in the vertical direction.

Figure 1: Roller bearing failure, Cable 1171.

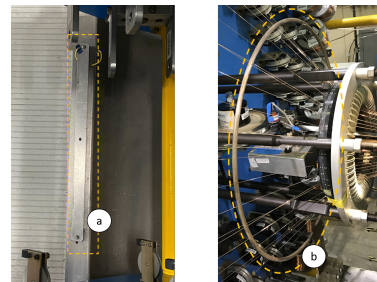
Figure 3: a) Floor switch and approximate trigger boundary b) Ring switch and approximate trigger boundary.

During sensor testing, the team observed uneven oxidation across the surface of the broken wire ring detector. Minor cleaning/oxidation removal with Scotch Brite abrasive did not improve the sensitivity of the broken wire detector, which continued to trigger inconsistently. A qualified electrical worker (QEW) and a former cabling technical lead were brought in to assess the broken wire sensor subsystem for defects that could cause a system fault. No electrical shorts or damaged components were found in the relay control circuit for the air brake. The team ultimately proceeded by shutting off the broken wire detector due to its inconsistent behavior, and the issue has not recurred.

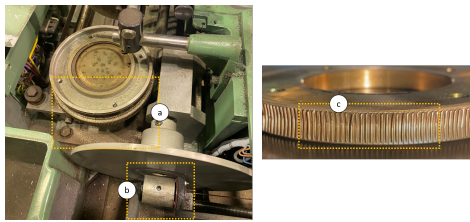
In November 2021, the respooling machine (respooler)'s main transmission broke down due to increased wear and tear during LARP/HL-LHC AUP. After drivetrain inspection, the team quickly identified that the worm gear assembly and the rubber transmission wheel were damaged beyond repair (Fig. 4) and required replacement.

Figure 4: a) Worm gear location and brass debris b) Worn friction transfer wheel c) Detail, gear tooth damage.

To put the machine back into service, the gear and mating worm from the transmission were sent to a specialty machine shop in Milwaukee, WI for reverse engineering and replacement fabrication. The shop determined the material of each component, measured the original mating geometry (pitch angle, etc.) and hobbled new gears. The LBNL main shop manufactured a new transmission wheel for the friction drive. Upon receipt of all parts and re-assembly, the technician team re-aligned all drivetrain components and identified areas for future preventive maintenance.
