ST-Note-2003-044

## **CONSOLIDATION ON CIVIL ENGINEERING AND TECHNICAL INFRASTRUCTURE**

P. Alves, M. Nonis, P. Pepinster, W. van Baaren

### **Abstract**

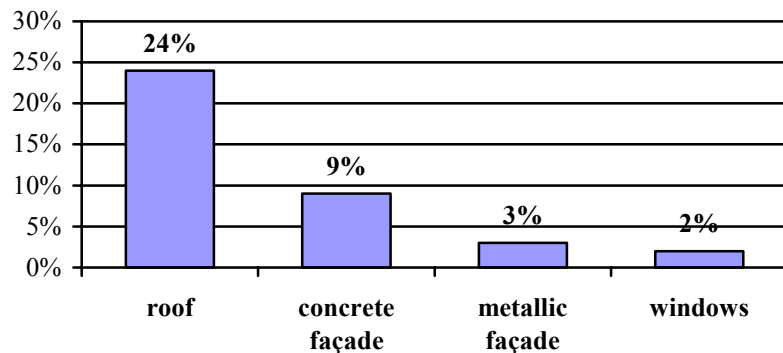
**Figure 2:** Percentage of buildings presenting the most frequent problems, divided by typology.

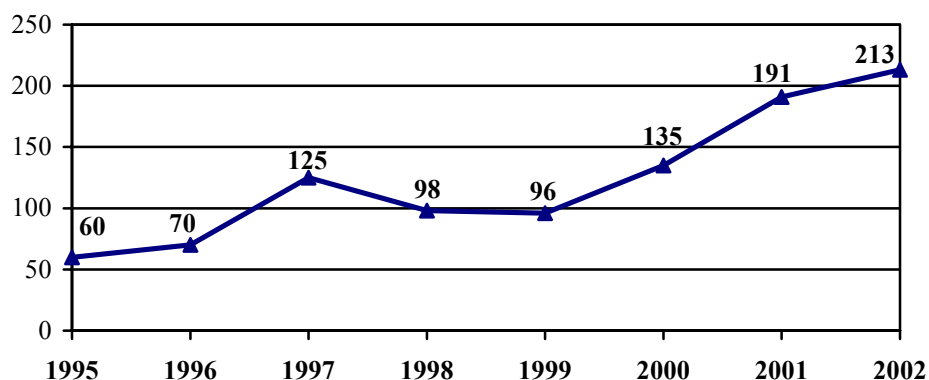
The most frequent and serious problem on civil engineering is represented by roof waterproofing: the number of roofs repairs per year has increased since 1995 (see figure 3) and is now more than the double with respect to 4 years ago.

**Figure 3:** Number of roofs interventions per year.

We consider that around 20 buildings need a short term repair for an area of 19'000 m<sup>2</sup> (over a total area 35'500 m<sup>2</sup>). The overall cost is 3 MCHF that need to be spent in the next 4 years at
