WHAT DID WE LEARN WITHOUT BEAM IN 2008?

R. Saban and M. Pojer, CERN, Geneva, Switzerland

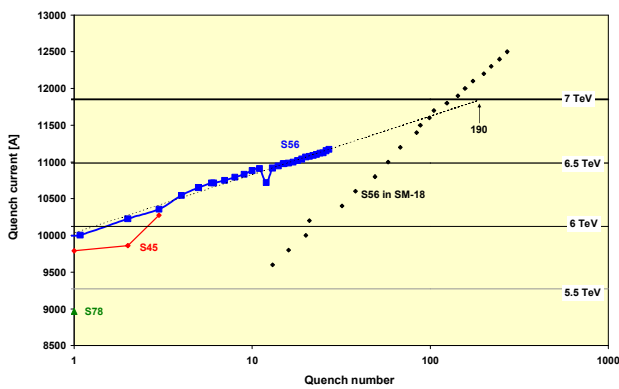
Chronologically, the first surprise was the assessment that the training of the dipoles was taking much more time than expected. The figure below shows the observations in Sector 56 where an extensive training campaign was carried out and interrupted at 6.6 TeV.

Figure 1: Training in the tunnel versus training at the test benches

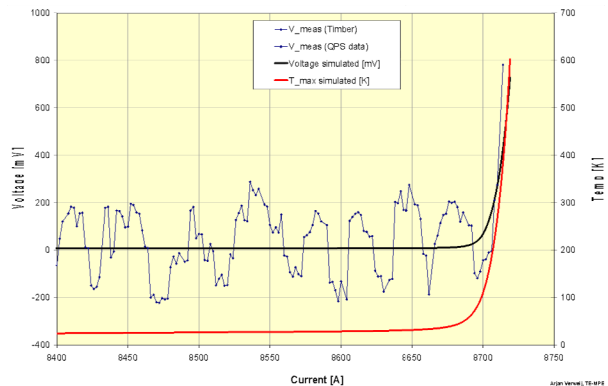
The task force established that the initial fault developed in an interconnect splice on the dipole circuit where both the longitudinal continuity of the copper stabilizer and the bonding of the superconducting cable to the stabilizer were missing. This assumption was confirmed by simulation.

Figure 2: Measured versus simulated incident with 220 nΩ joint and bad contact with U-profile and wedge

A study of how the energy stored in the magnets was dissipated at the time of the event where the circuit was energized with 8710 A showed that almost half of the energy (275 MJ) was used to create electrical arcs which punctured the helium vessel. This caused a helium discharge from the cold mass into the insulation vacuum with a flow that was calculated to be as high as 23 kg/s. This is well above the nominal design value of 2 kg/s for which two DN90 relief devices were installed on each insulation vacuum subsector. The pressure rise was responsible for the forces on SSS vacuum barrier, which displaced the cold masses and caused the collateral damage. Secondary arcs were also created in two different

The task force formulated recommendations on two axes: the first ones aim at the prevention of initial fault and the second ones aim the mitigation of consequences. They concern actions, hardware upgrades, improvements of test procedures as well as personnel access rules. Many of these are already implemented during the present shut down, others will be implemented during the commissioning and operation of the collider.

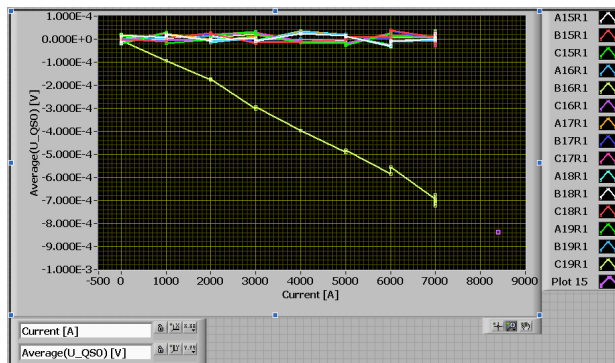
One of the first studies of the task force was the examination of data recorded during the tests to assess whether there were precursors to the September 19th incident that had gone undetected. This analysis revealed [4] that some sectors indeed had shown an anomalous increase of temperature during high current plateaux. Among them Sector 34 which exhibited a parabolic increase of 30 mK per hour during a one hour-long plateau. The observations however were done in unstable conditions because of the activity of the temperature control loops. A method was developed to repeat these measurements in normalized conditions; the method was validated by simulating the heat load of a faulty splice with a heater located inside the cold mass. Clearly these measurements will have to be repeated during the recommissioning. This method revealed two additional regions in the collider (Sector 12 and Sector 67) where abnormally high heat loads were measured during current ramps in the dipole circuit.

Figure 3: Confirmation of a 100 nΩ resistance measured inside a magnet cold mass (B16R1) spotted by calorimetric measurements

These suspect regions were equipped with voltmeters to measure, with an accuracy of a few μV, the voltage drop across the splices in the interconnects. These electrical measurements did not reveal any non-conformity and only confirmed very good quality splices. It was therefore decided to measure the resistance of the splices inside the magnets: the splices in the coils, the inter-pole and inter aperture splices. This measurement could be carried-out with existing quench detection electronics. They indeed revealed faulty splices with resistances compatible with

the calorimetric measurements. The data collected during the measurements at the test benches confirmed the findings.
