LHCb Silicon Tracker operations and performance with first data

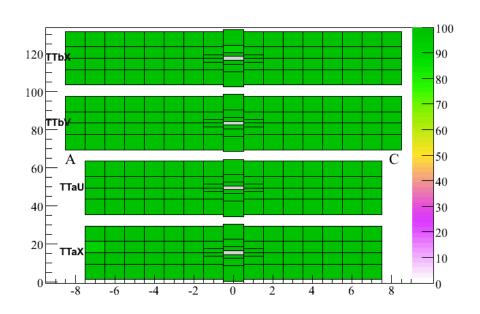
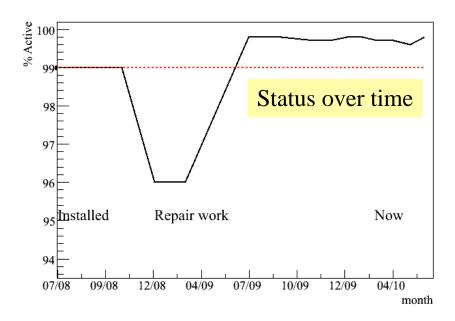
TT Status

99.8 % of the detector functional

- Repair work in 2009
 - Remove + replace module with HV problem [crack on readout hybrid]
 - Remove + replace modules with broken bonds

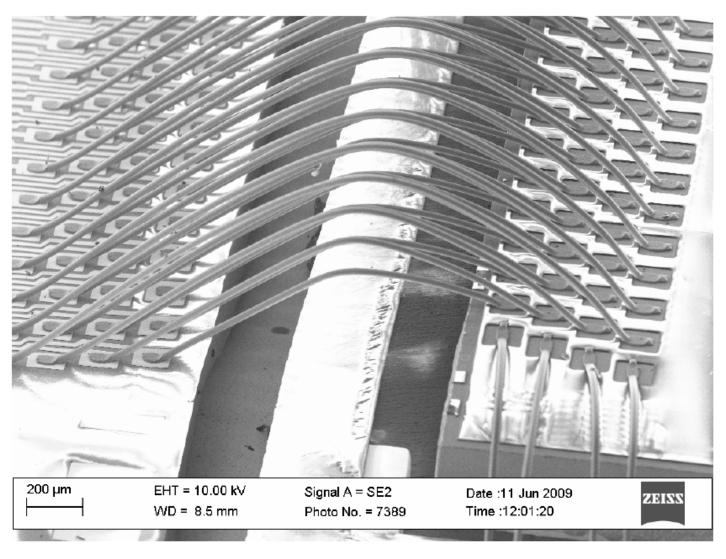
TT Broken Bonds

9 hybrids on 7 readout sectors effected

- Innermost bond row effected, mainly heel breaks
- Effect not reproduced in the lab despite extensive tests + thermal cycling
- Generally breaking (but not always) occurs on pitch adaptor side
- Majority of problems soon after installation, 2 developed in October 2008, one in June 2009

Possible causes of bad bonds:

- Initial cracks due to the bonding process, typically occur at first bonds
 - In this case would expect on Beetle side
- Loop height: should be > 25 % of the bond spacing
- Vibrations/Thermal cycling

bond row	distance between	bond loop height
	bond pads	above pitch adaptor
innermost	2 1.35 mm	0.48 mm
second	1.70 mm	$0.66 \mathrm{\ mm}$
third	2.05 mm	0.84 mm
outermost	2.40 mm	$1.02~\mathrm{mm}$

Bond heights for innermost bonds are tight, but if increased outermost bonds become too high

It was not possible to take a picture from a better angle because of collisions with the elektron gun. So I can't quantify the loop height of the bonds.

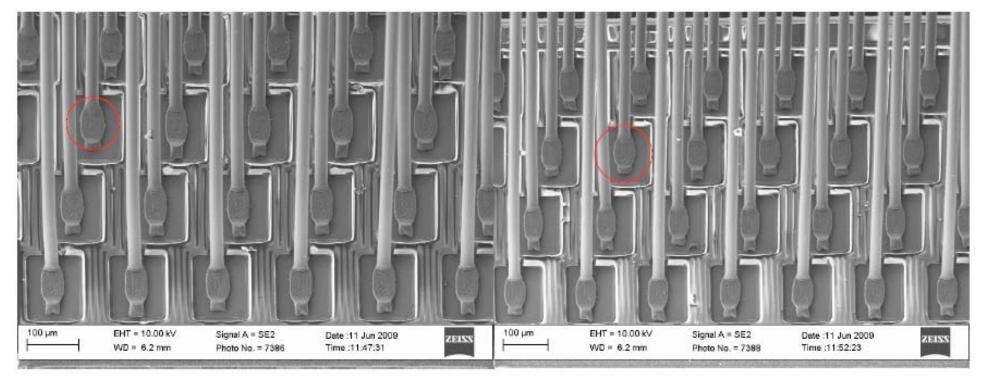
TT Broken Bonds

One of the problem hybrids is somewhat atypical

- Broken bonds on Beetle side (first bonds)
- SEM pictures shows presence of initial cracks from bonding
