# The LHCb Silicon Tracker: Running experience

**ABSTRACT:** The LHCb Silicon Tracker is part of the main tracking system of the LHCb detector at the LHC. It measures very precisely the particle trajectories coming from the interaction point in the region of high occupancies around the beam axis. It covers the full acceptance angle in front of the dipole magnet in the Tracker Turicensis station and the innermost part around the beam axis in the three Inner Tracker stations downstream of the magnet. The Silicon Tracker covers a sensitive area of 12 m<sup>2</sup> using silicon micro-strip sensors with very long readout strips. We report on running experience for the experiment. Focussing on electronic and hardware issues we describe some of the lessons learned and pitfalls encountered after three years of successful operation.

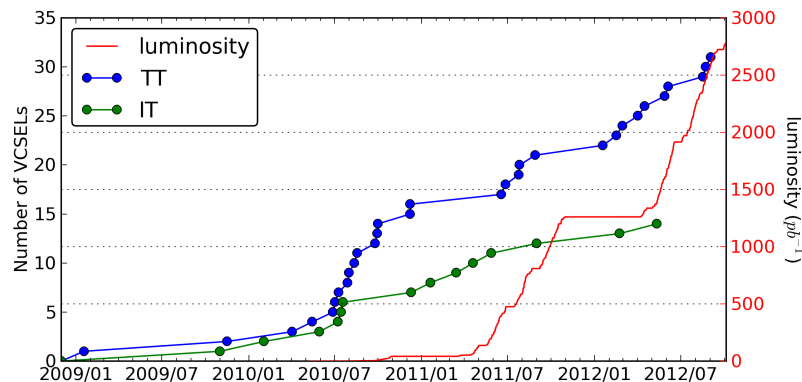
The silicon tracker uses VCSEL diodes in the readout system to transmit the data, from the detector to the TELL1 readout preprocessor boards, through optical fibers. In production, those VCSEL diodes were wave soldered to the digitizer boards. As a result, approximately 30% of the 2218 VCSEL diodes in the Silicon Tracker stations (1120 diodes in TT and 1098 diodes in IT), showed low output power. These were identified and replaced. [6]

**Figure 2.** Accumulated number of malfunctioning VCSEL for IT and TT, and accumulated integrated luminosity delivered to LHCb.

Since then some other VCSEL diodes had to be replaced due to ageing or malfunction (only 2%). The VCSEL diodes would stop transmitting and needed to be excluded from operation until

they could be replaced. A single broken VCSEL means the loss of the data of one Beetle readout chip over 1120 in TT or one over 1008 in IT. The effect in the performance is difficult to quantify as it depends on the location of the sensor and of the type of sensor itself, but the track reconstruction has not been affected by this problem. No significant correlation with temperature and humidity environmental conditions, peak luminosity or operation has been observed. The figure 2 shows the accumulated number of VCSELs replaced since the start of commissioning in 2009.

Due to technical constraints, the VCSEL diodes are not exchanged in situ. In practice the whole digitizer board [1, p. 22] is replaced. In the process, multiple cables need to be unplugged, sometimes including the optical fibre carrying the clock signal. The advantage of the easy access to TT digitizer boards played an important role, and the broken VCSEL diodes can be replaced in the technical stop periods, every two months. For IT, the broken VCSEL diodes can only be replaced during the long technical stop in Winter once a year, as the detector frames need to be open to access the digitizer boards. This exchange process is responsible for the clock synchronization problem which was observed since the start of operation but only understood this year, as explained in the next section.

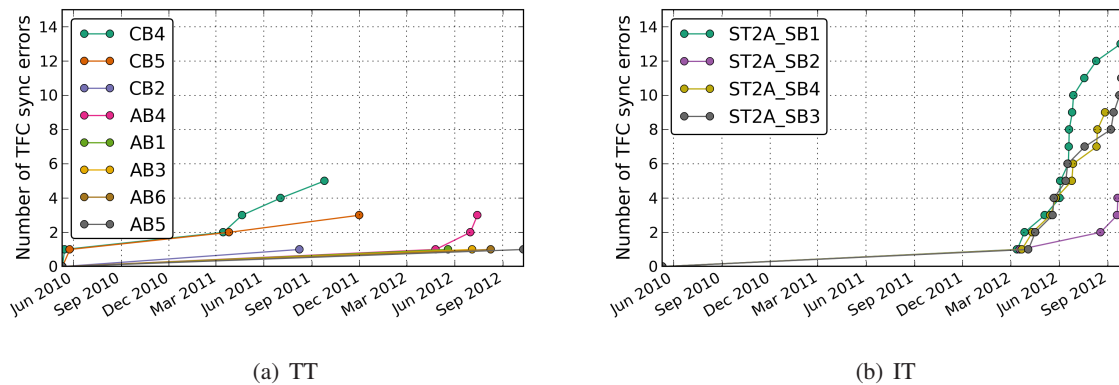
**Figure 3.** Accumulated number of synchronization problem for different control board IDs.

Since the start of operation in May 2010, the slow-control monitoring for TT presented unphysical readings for temperature sensors and low-voltage regulators connected to the SPECS[4] mezzanine DCU[7]. The communication server was able to access most of the hardware connected to the SPECS slave mezzanine, but not the DCU, giving back an error code and a wrong reading. This was always recovered after a power cycle of the Control Board [1, p. 63] done automatically by the control system safety tree [1, p. 228]. Figure 3(a) shows this in detail.

It was not possible to reproduce the problem at will. As the problem was believed to affect only the DCU, an automatic reset was implemented, but it did not solve the problem. In March 2012 the problem appeared also in the IT subdetector with a much higher rate, as shown in figure 3(b).

exchanged to replace some dead VCSELs. The connectors of the optical fibers were not properly protected during the intervention and some dirt accumulated in them causing from time to time synchronization errors.

Thanks to this, a relationship was established between the SPECS DCU problem and other alarms from devices connected through the SPECS as well as the occurrence of incomplete events (loss of data from the Beetle). The origin of the problem was traced back to the connection of the TFC fibers delivering the clock and the trigger commands to the Control Board.

Once understood, it was concluded the unphysical readings, and the incomplete events were all caused by a deficient connection of the TFC signal leading to synchronization errors.

An automatic recovery software workaround triggered by the SPECS DCU error code, was put in place on the 19th April 2012 to minimize the effect of the synchronization loss, as there is no easy access to the hardware until February 2013, when the connectors of the optical fibers will be carefully cleaned, hopefully fixing the problem.

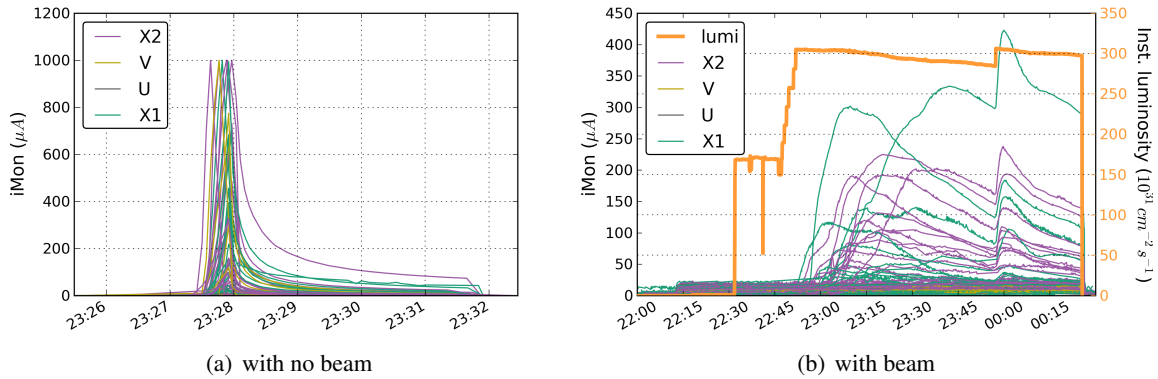
**Figure 4.** Ramp of HV current

Starting in October 2010, various TT detector biasing voltage channels had peaks in the current that sometimes reached 1 mA while taking data, and could reach 5 mA with no beam, leading several of these HV channels to trip.

When ramping the HV channels in the presence of beam, no current peak is observed until the instantaneous luminosity increases. A correlation effect can be observed in figure 4(b). The current increases moderately fast just after an increase in the instantaneous luminosity, and decreases slowly. This effect is observed mostly in layers X1(TTbX) and X2(TTbX), as shown in figure 5(a); those are the layers closest to the detector box walls.

When ramping the HV channels with no beam, as shown in figure 4(a), a slightly different effect is observed. Just as the HV channel is switched on, the current ramps up very fast and then decreases also fast at the beginning and more slowly after the first few seconds until it finally reaches its nominal value. The peaks observed are higher in this scenario. An improvement through training was observed sometimes, but was not conclusive. When ramping with no beam also some channels on U(TTaU) and V(TTbV) layers show similar behaviour.

Some attempts and tests have been performed in order to try to fix or palliate the problem. Lowering the biasing voltage from 350 V to 300 V reduced the maximum current while lowering the temperature of the sensors from 5 °C to -15 °C really made things worse. This last test confirmed that the current is not in the bulk of the silicon sensor. Relying on the correlation observed between the luminosity ramp, an attempt was made to ramp this luminosity in small steps, with a substantial reduction of the value of the peak currents.

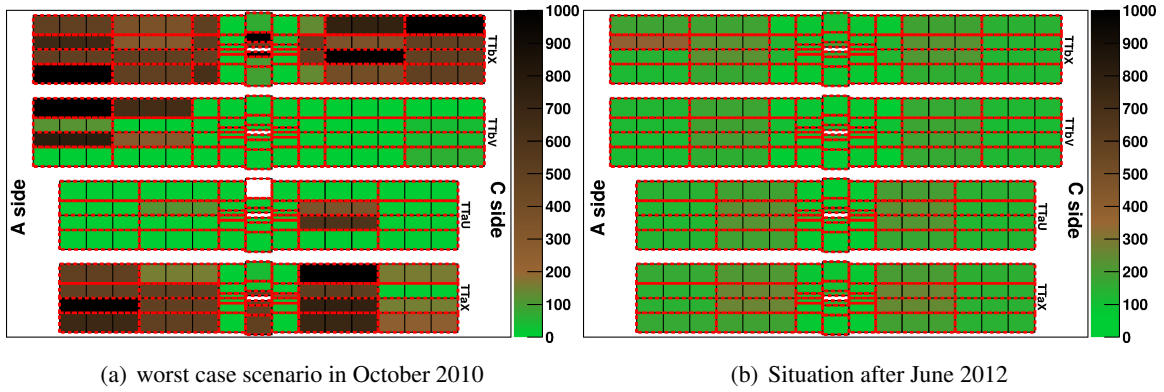
**Figure 5.** Maximum TT HV current (in  $\mu\text{A}$ ) geographic distribution.

The problem disappeared in mid June 2012 (figure 5(b)) after a change in the beam filling scheme and a change in the operation mode of the detector; whereas before the HV was switched off just after the beam was dumped, it now stays fully powered until the start of the next fill.

Some effort was put into shielding the sensors and the rails holding them. In a first stage, in May 2011, a kapton insulation was installed in the detector box front and back walls, confining the

problem only to the X layers. A second version of this electrostatic shield was installed in May 2012, adding a foil of aluminium and mylar to the existing kapton insulation. The Aluminium side was then also connected to high voltage.

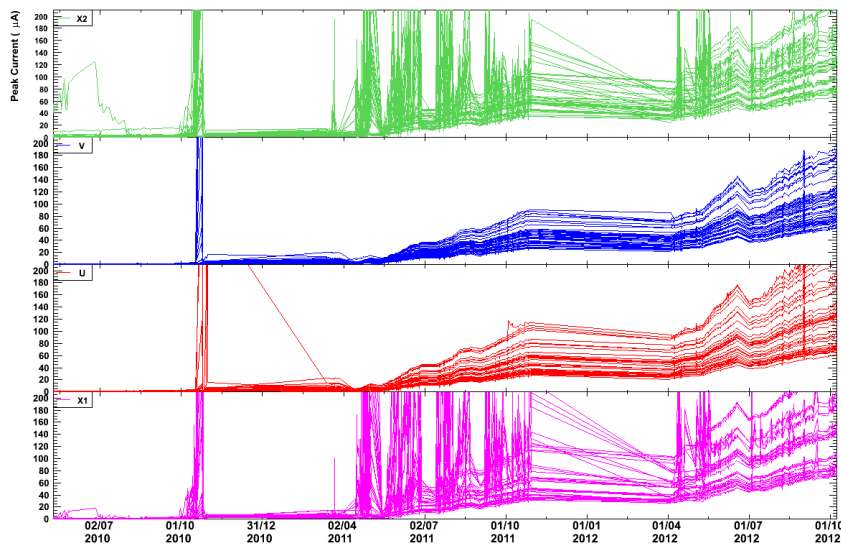
**Figure 6.** Evolution of HV maximum current measured each physics fill.

The effect of these various attempts to fix the issue are clearly visible when looking at the evolution of the maximum current measured in all the physics fills, as shown in figure 6.

Unfortunately the origin of this problem is not yet understood, peaks can still be observed when LHCb attempts to run above  $5 \times 10^{32} \text{cm}^{-2} \text{s}^{-1}$  instantaneous luminosity (the design luminosity for LHCb is  $2 \times 10^{32} \text{cm}^{-2} \text{s}^{-1}$ ), but more testing on the matter has been considered unnecessary as it would incur in loss of good physics data, and the detector is performing well.

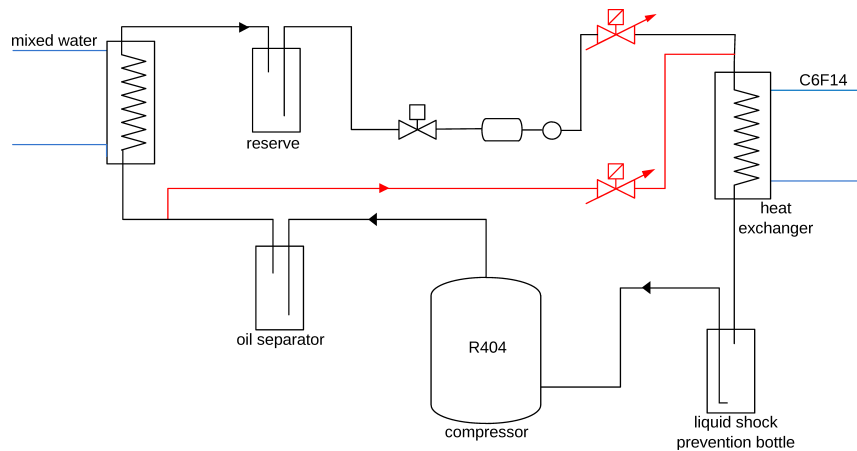
**Figure 7.** Diagram of the original design for the chiller used in IT and TT cooling systems and the modifications performed afterwards.

The first problem appeared very early in IT cooling plant and although several modifications have been introduced in the system, as shown in figure 7, the problem persisted and appeared also in TT a year ago. The oil present in the system, needed for the compressor, accumulates in the evaporation heat exchanger from R404A to C6F14. After some time, the concentration of oil is so high in the heat exchanger, that the C6F14 starts to warm up. To correct this behaviour, regularly, from twice a month up to 3 times a week, the cooling plant has to be stopped for several minutes

to let the oil sink out of the heat exchanger and be collected in the oil separator. During this short intervention, the C6F14 coolant still circulates on the detector side.
