**HIGH ENERGY BEAM IMPACT TESTS ON A LHC TERTIARY
COLLIMATOR AT CERN HIRADMAT FACILITY**

Presented at the International Particle Accelerator Conference (IPAC'13) –

Geneva, Switzerland, May 2013

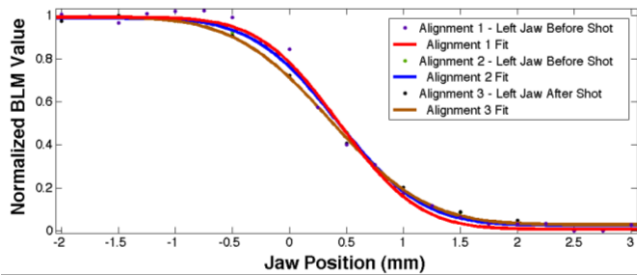
A beam-based setup was performed after Test 1 and Test 2 as an attempt to check the surface integrity of the jaws and the collimator mechanics following the beam shots. As can be observed from Fig. 4, there are no large variations between the beam positions before and after the shot, indicating that there is no critical damage of the jaw surface. It is however difficult to conclude on errors in the range of $100\mu\text{m}$.

Figure 4: Beam-based alignment of left jaw. Alignment 1 and Alignment 2 are performed before Test 1 while Alignment 3 represents the check after Test 1.

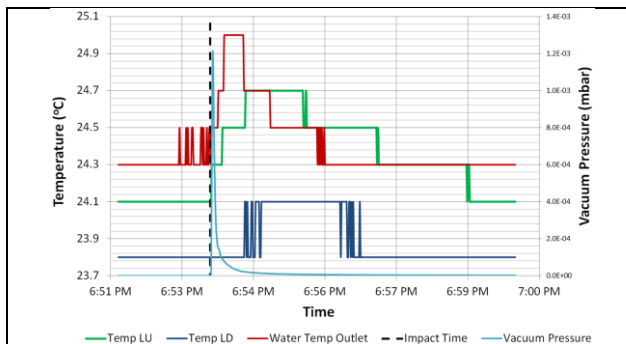
Figure 5: Test 1 temperature profiles captured by the upstream (LU) and downstream (LD) left jaw temperature sensors and by the water outlet temperature sensor. Also, vacuum pressure profile for Test 1. Impact at 6.53.51 PM.

The profiles in Fig. 5 show a temperature rise following the impact, which although small, is clearly observable. The temperature increases recorded are lower than expected and are not really compatible with post-mortem observations presented later. Thus these results have to be handled with care as there are potential issues under investigation. One of the reasons for these discrepancies might be the high thermal resistance (low contact pressure) between the temperature probe and the support to which it is attached, leading to an incorrect temperature recording. A peak in vacuum pressure for Test 1 is observed in Fig. 5 at the moment of impact.

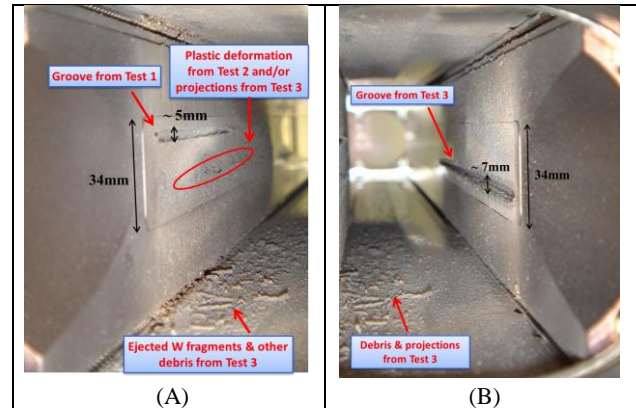
After the necessary cool-down of the irradiated collimator, a preliminary visual inspection (Fig. 6) was carried out to give a qualitative damage evaluation before further analysis. Grooves from Test 1 and Test 3 can clearly be identified, showing that there was a local temperature rise exceeding the melting point of the CuNi phase of the jaw insert material ($\sim 1343^{\circ}\text{C}$). Various fragments and projections of tungsten can be also observed between the jaws. Vaporisation deposit around the molten region is visible, indicating the extent of the damage caused by the beam impacts. The reason why the alignment checks in Fig. 4 did not indicate the presence of such grooves might be because the grooves do not cover

the full length of the jaw and the unperturbed part at the end of the jaw still determines the closest point to the beam that determines the alignment.

Figure 6: Preliminary visual inspection. (A) Damage on the left jaw caused mainly by Test 1 beam impact. (B) Damage on the right jaw caused by Test 3 beam impact.
