First results of an aging test of a full scale MWPC prototype for the LHCb muon system

Aging studies for a multi-wire proportional chamber of the LHCb muon system have been performed using the CERN Gamma Irradiation Facility. The irradiated four-gap chamber corresponds to a full size prototype with 1500 cm² sensitive area and has been operated with an Ar/CO₂/CF₄ (40:50:10) gas mixture. A linear charge of ~ 0.25 C/cm for 100 m wire length has been accumulated over a period of 6 months, which corresponds to the charge collected in 5 LHCb years. The aging influences observed do not prohibit the use of these chambers in the LHCb experiment.

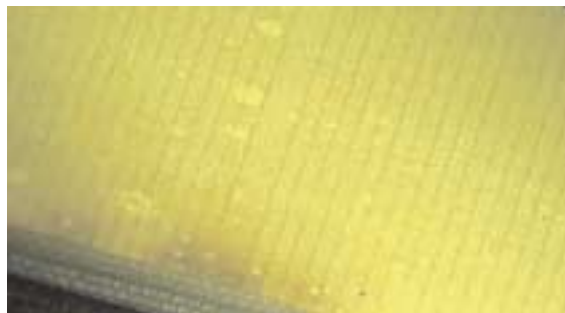
The test was concluded on the 27th of July 2001 after collecting a maximal charge equivalent to five LHCb years in gap B2. The reasons for interrupting the test were a broken wire in gap A2 close to the wire fixation bar on the 4th of June and a high voltage instability of the gap A1 on the 16th of July.

The chamber was opened to replace the broken wire and to investigate the current instability in gap A1. As the wire tension of only 60 g is far from the elasticity limit (140 g), the wire breakage is probably a random event.

The cathodes show some minor deposits after the irradiation. The deposits are often correlated with the wiring structure. Typically this deposit starts at a distance larger than 10 mm from the gap border. There are also two brownish spots located near the gap border on the wired planes. One spot is located in the A2 gap close to the broken wire, the other in the A1 gap where the HV instability occurred (Fig. 5).

Figure 5. The photo shows the position of the broken wire and some dark spots underneath, indicating some sparking at that position.

The wire planes do not show any strong aging effect. Two small groups of wires (~ 100 wires or 8% of the total amount) located over the two brownish cathode spots mentioned above have small black dots. However, the total area of this covering is less than 10^{-3} , hence will have negligible influence on the chamber.

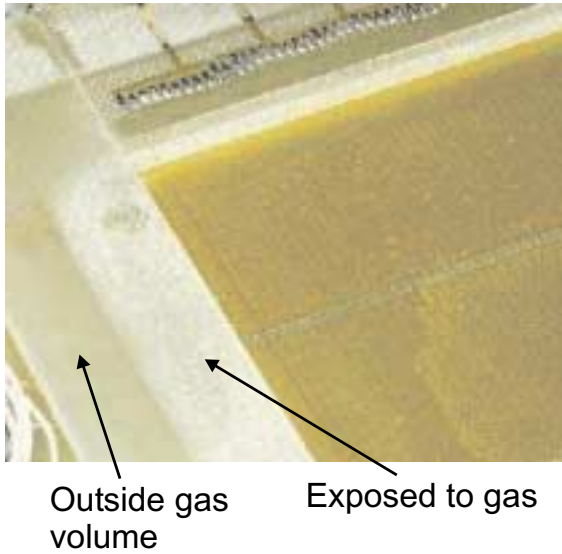
Some chemical activity of the gas in the irradiated gaps appears as etching on the surface of the FR-4 bars exposed to the gas. This effect is absent in the reference gap B1. It has not been observed before and needs additional investigation. Others have reported [5] about anode and cathode etching effects due to the fluorine in the gas mixture, which have been moderated by adding a few hundred ppm of water vapour to the gas

Figure 6. The FR-4 bars show clearly some change in surface colour due to etching

mixture. Similar solutions should be tried for our chambers.
