CERN-PS /90-62 (HI)

PERFORMANCE OF THE CERN HIGH-INTENSITY RFQ

E. Tanke, M. Vretenar and M. Weiss
PS Division, CERN, CH-1211 Geneva 23, Switzerland

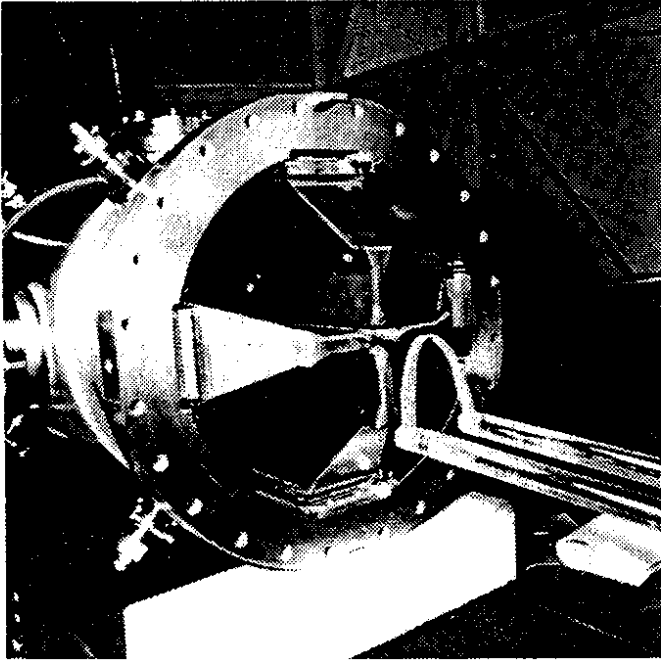
To clean such a complicated structure as the RFQ2, containing a lot of weldings and brazings, is far from obvious. The oil deposited on various surfaces could have been removed, but the cracked oil on the vane tips was the real problem. It rendered any normal operation impossible, in particular in view of the high fields which are required for the RFQ2 ($2.5 \times$ Kilpatrick limit). To remove the cracked oil, chemical or mechanical cleaning has to be employed. Chemical cleaning requires subsequent rinsing with distilled water, which is incompatible with the tank being made of mild steel. Therefore, mechanical cleaning making use of inorganic abrasive paper with aluminium-oxide grains deposited on a substrate was used. The danger is that, after the cleaning, the grains remain encrusted in the cleaned surface. Several papers were tried out and it was found that grains of at least $5 \mu\text{m}$ were necessary to remove the cracked oil. Before starting the cleaning, a sample of the vane material (Cu-Cr alloy) was gently cleaned with such a paper, rinsed with alcohol, and then analysed under a microscope: no encrusted grains were seen on the sample.

Figure 1: Mechanical cleaning of the vane tips

A strip of the abrasive paper was fixed on two Plexiglas rods, which permitted progressive cleaning of the vane tips, see Fig. 1. The progress of the cleaning was continually checked by an endoscope. A few hours were necessary to clean a vane. After all the vane tips were cleaned, the RFQ2 was placed in vertical position and rinsed with alcohol and freon, and then left to dry.

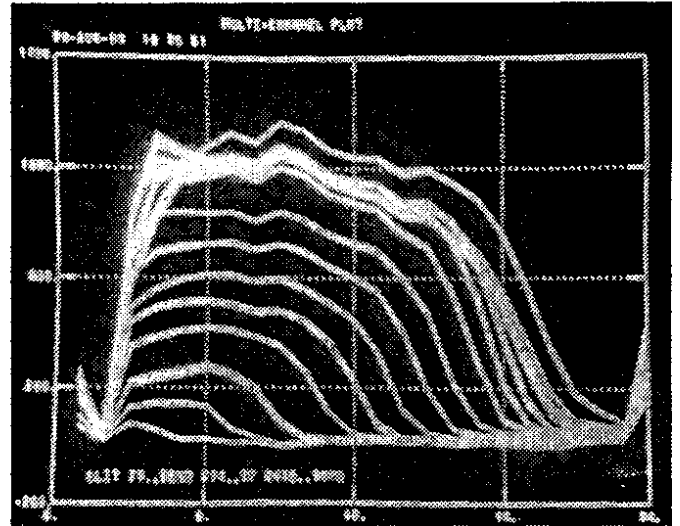
Figure 3: Energy spreads of the RFQ2 beam for different vane voltages. (Horiz. scale: 39 keV/div.)

Energy spread: about ± 70 keV was measured, for an output beam of 200 mA and a 5% higher vane voltage (note that the space charge increases the energy spread by a factor of about 3 between the RFQ2 and the measurement device). In Fig. 3 one sees the energy spreads for different vane voltages, ranging from 70 to 105% of the nominal value. There are practically no particles in the right energy range for voltages below 70%. The areas under the various curves are proportional to the accelerated beam.

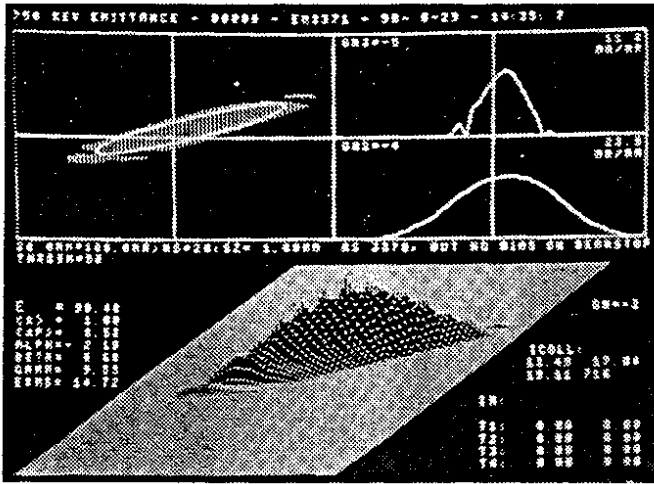
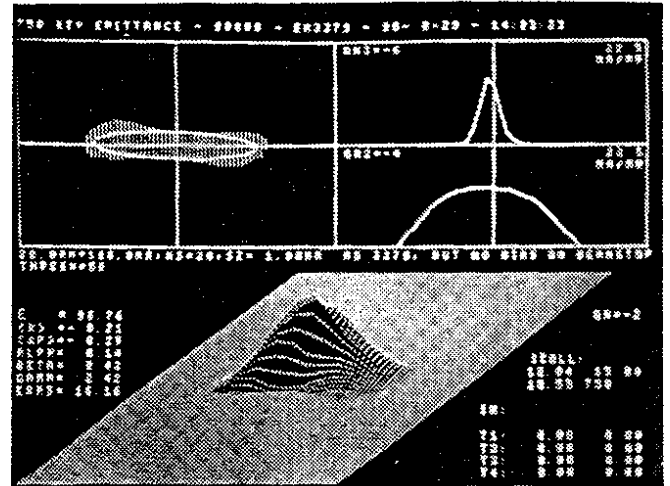
Output beam emittances: the measured output emittances are shown in Figs. 4 and 5. The normalized r.m.s. value, $\epsilon_{rms,n}$, is about 0.6π mm-mrad. For comparison, we also show emittances measured before the accident, see Figs. 6 and 7. Their $\epsilon_{rms,n}$ value is about 0.5π mm-mrad. The corresponding input emittance values are $\epsilon_{rms,n} \approx 0.4\pi$ mm-mrad.

It seems that the impaired field symmetry slightly reduces the output beam and increases the output emittances.

Figure 4: Horizontal output beam emittance

Figure 5: Vertical output beam emittance
