MECHANICAL CONSOLIDATION OF THE LHC INNER TRIPLET MAGNET SUPPORTING SYSTEM FOR REMOTE ALIGNMENT

Abstract

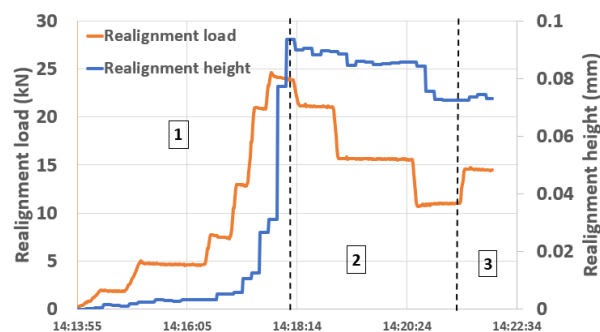
Figure 3: Realignment height vs load – 5R Jack Q2D.

The realignment system was slowly lifted with a progressive load transfer from the LHC jack onto the alignment system (Fig. 3 label 1). Noticeable cryostat lifting started at a realignment system load of 21 kN.

Since the final alignment height was overshoot, descent orders were sent to the realignment system (Fig. 3 label 2). The load on the realignment system then decreased to about 11 kN with no correlated cryostat movement.

The realignment load was down to around 11 kN, so the realignment sequence was aborted, and a lift order was sent to recover some load on the realignment system (Fig. 3 label 3).

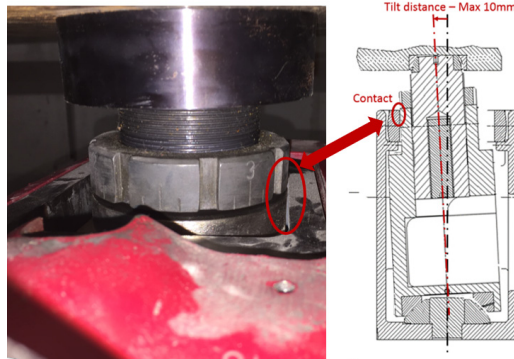
Subsequent tunnel inspections showed that the jack Q2D was tilted to a blocking position in the longitudinal direction (Fig. 4) and was in contact with its frame.

Figure 4: (left) Triplet 5R Jack Q2B in contact (right) schematic cross-section of the jack.

Further underground inspections showed that, six out of eight triplet strings had at least one realignment jack in contact with its frame on the Q1 magnet (similar to Fig. 4). This showed that the Q1 magnets were all subjected to a longitudinal movement greater than their allowable jack design capability of +/- 12 mm leading to an unwanted internal contact.

A longitudinal movement of the Q2 magnet was then manually carried out thanks to the interconnection tie-rods in order to recover some jack clearance. As a result, the jack recovered its alignment capabilities.

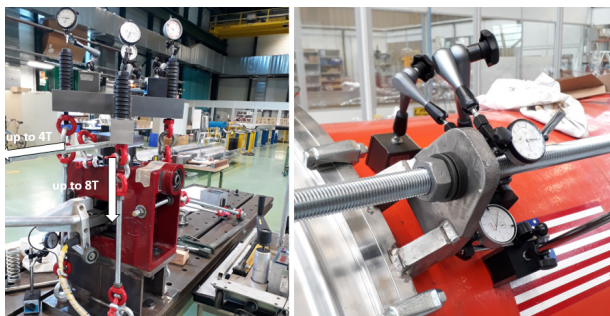
Figure 5: Dedicated testing of (left) standalone jack test (right) tie rod ear stiffness.

The jack was put in contact with its frame, similar to the situation witnessed in the tunnel and was progressively loaded transversely on a dedicated test bench (Fig. 5 left). It was then operated for a vertical realignment operation and the operating load was measured with a load cell. Early results showed that when loaded transversely, a large friction load was to be overcome to get a vertical jack motion [3]. However, no measurable stick slip was witnessed,

the jack movement remained smooth within a 0.01 mm resolution. These results were consistent with the pattern seen on Fig. 4.

Later, the tie rod ears of the spare triplet magnets were loaded up to 20 kN each to measure their respective longitudinal deflection in operation (see Fig. 5 right). The longitudinal deflection at the level of a single tie rod was in the order of 3.5 mm [4]. Cumulating the displacement due to the tie-rod ear deflections, the Q1 magnet longitudinal movement under vacuum was expected to be in the order of 17.5 mm before reaching a steady state situation. This is more than the 12 mm of jack design capacity.

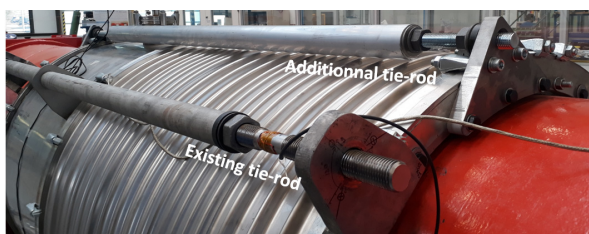
Figure 7: Prototype of additional tie-rod (autumn 2019).

Following the understanding of the alignment issue, a consolidation solution was devised to stiffen the triplet longitudinally and avoid making a major modification of the system kinematic. It was proposed to add additional tie rods at the level of the interconnection to increase the stiffness of the present tie-rods (and tie-rod ears in particular) which was confirmed to be insufficient.

With two additional tie-rods on each interconnection (see Fig. 7), the system longitudinal stiffness increased by 35%. This is expected to be sufficient to avoid bringing the tilting column in contact with the frame of the jacks, thus allowing realignment as designed originally.

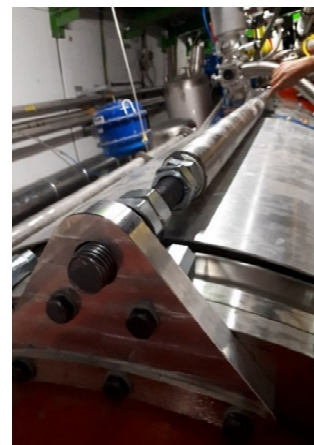
Figure 8: Additional tie-rod implementation in the LHC.

The additional tie-rods have been implemented on all LHC triplets during the long shutdown 2 in summer 2020 (see Fig. 8).

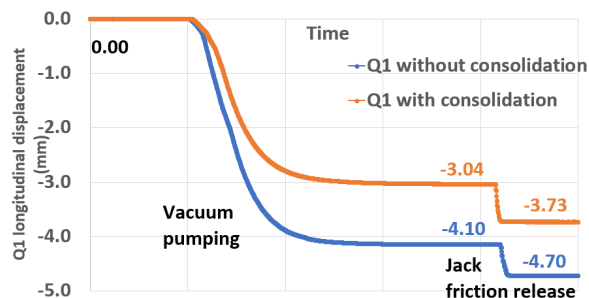
After cycling the insulation vacuum, the overall triplet longitudinal stiffness was found to have increased as expected (see Fig. 9).

Figure 9: Comparison of the longitudinal travel of Q1R5.
