## SYSTEM'S PERFORMANCES IN BI

V. Schramm, William Viganó, C. Zamantzas, CERN, Geneva, Switzerland

### Abstract

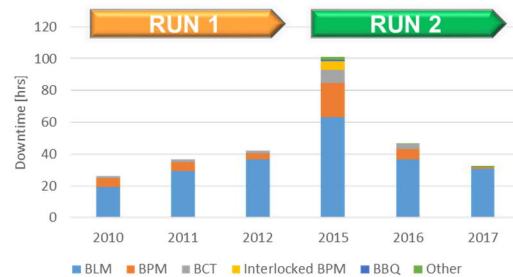
Figure 1: Raw Fault Time by System.

Observing this period only, the absolute yearly downtime of all BI systems significantly decreased year to year (see Fig. 1).

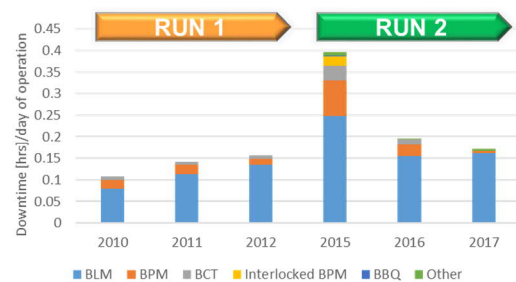
Figure 2: Normalized Raw Fault Time by System.

Nevertheless, when the data are normalised per day of operation, it can be seen the decrease of the downtime remains true but the step is smaller (see Fig. 2).

During 2017, the BLM system maintained the same availability level as in 2016. Because of the Extended Year-End Technical Stop, the LHC lacked 50 days of operation compared to 2016. An operational day is herein defined as a day where the storage ring was filled.

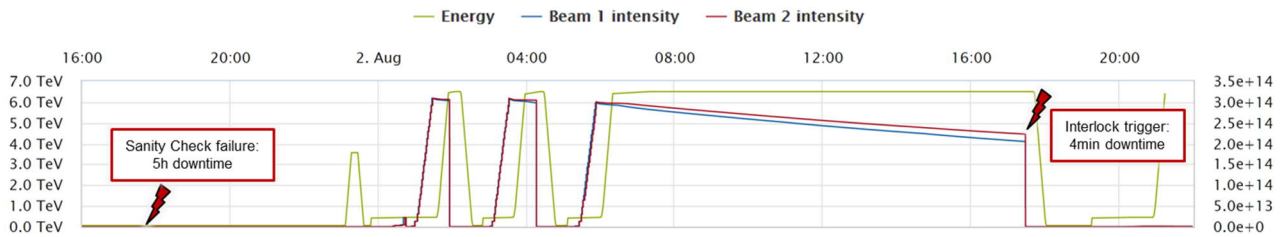
Figure 3: AFT extract of the 02.08.2017. Two distinct BLM failures with different availability and luminosity impact.

To illustrate the different impact Fig. 3 displays two BLM system faults within 30 hours of operation in August 2017. The first was a problem with the dump block SEMs and caused 5h of LHC downtime. The issue was discovered while performing the Sanity Checks before a new fill and prevented this fault to happen during physics operation and therefore avoided to unnecessarily fill the machine in a fault state. The second fault is an interlock, which triggered due to incorrect BLM system voltage values. It accounts for 4 minutes of downtime, but happened during the flat top and dumped the beam. For this example, this clear contradiction between availability loss and associated luminosity loss requires special attention when drawing conclusions for future improvements. It is hard to quantify precisely the lost luminosity related to a false beam dump because of many parameters, which vary depending on different operational scenarios. This can be the time of the dump at either injection or at a specific time on the flat top, the optimum fill length, the energy, degraded operation and many more to name only a few. Nevertheless, future efforts need to aim at reducing the amount of false dumps by reliably discovering fault states of the system before injecting the beams. This increases the luminosity production when furthermore the availability impact of these fault states is mitigated.
