## SYSTEMS PERFORMANCE: CIRCUITS

The performance of the LHC magnet circuits for the proton physics run in 2017 is evaluated. This contribution focuses on the availability of magnet powering (PC) and protection systems (QPS, EE, FMCM and Interlocks) and evaluates the impact of the new deployments, mainly the FGClite and RPADO power converters, on the overall performance of the machine. Finally, a comparison with 2016 availability is presented.

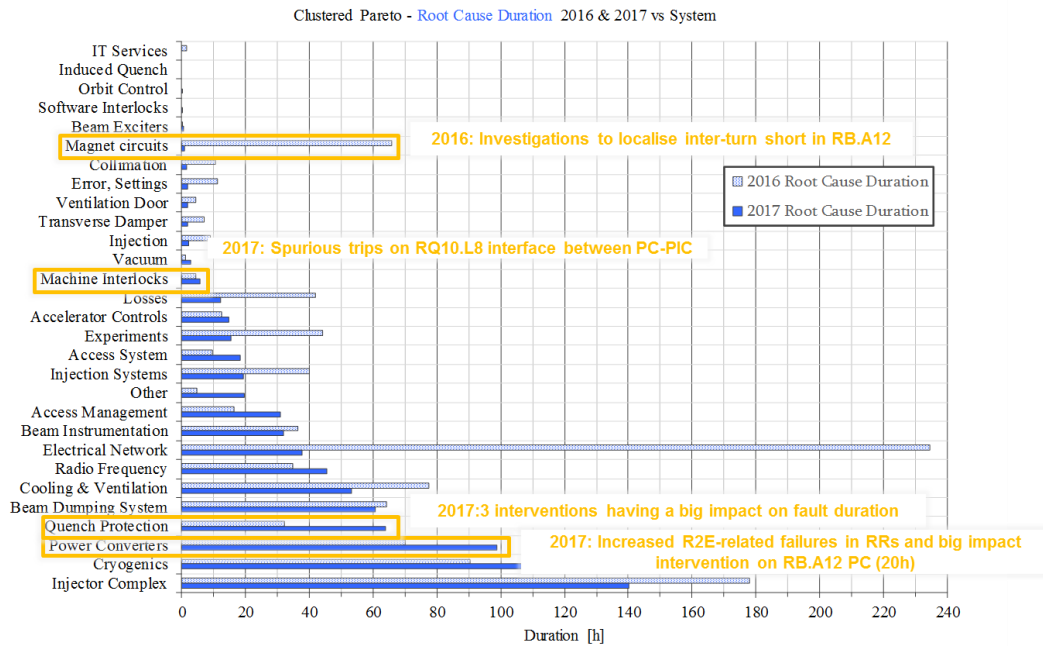
Operational statistics in 2017 show that 211 fills, out of a total of 762 fills, reached Stable Beams. About 20 % of the fills (i.e. 160 fills) were prematurely aborted by magnet powering and related protection systems, which contributed with 169.5 hours to the total downtime (out of a total of 800.7 hours). Figure 1 illustrates the distribution of fault duration in 2017 on the various root causes and provides a comparison with faults in 2016. Quench protection systems and power converters appear as one of the main contributors, while the impact on availability from magnet circuits and machine interlocks remains residual.

The increase on the power converter fault duration with respect to 2016 can be explained by an increment of the R2E suspected events in the RRs and several interventions on the RB.A12 power converter to fix a leak on the water-cooled busbars. The Quench Protection System was also penalized by lengthy interventions on the RQD.A12 Energy Extraction system and a main quadrupole acquisition system. The contribution from magnet circuits was drastically reduced as a lot of time was dedicated in 2016 to localise the inter-turn short in RB.A12.

Figure 1: Root cause duration per system as observed in 2017 vs 2016
