PS / PO / Note 2002-121 (Tech.)

**Second Inspection and Testing of BNL (AGS) Dipole Coils  
at Sigmaphi**

M. Hourican

Geneva, Switzerland  
08-07-2002

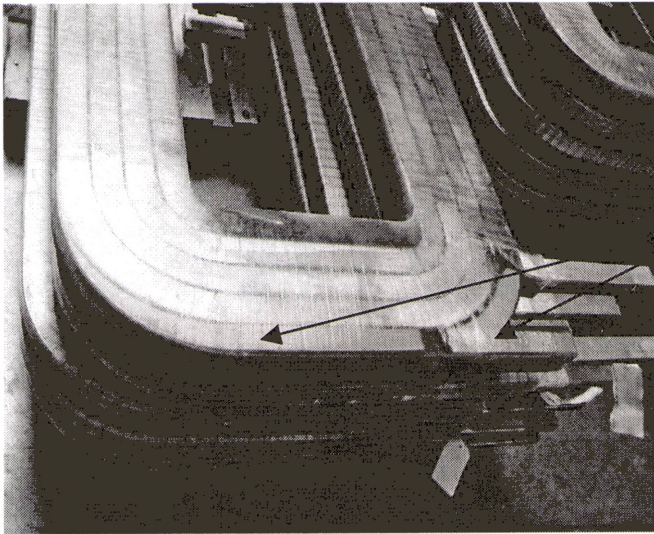
Coil No. 1

This coil was slowly ramped to 32kV and showed no signs of breakdown.  
(See photos below)

Filler blocks appear to have been machined in accordance with the BNL drawings.

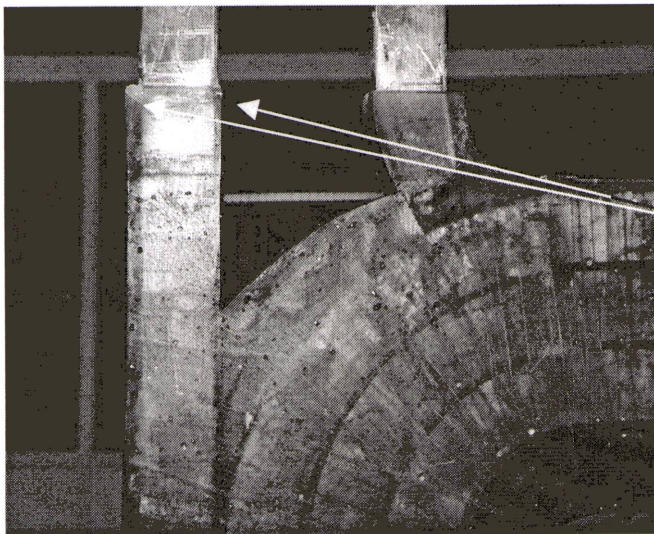
Coil No.1

Coil windings.  
The copper conductors were not correctly centered within the epoxy insulation layer and in one case (New coil No.2) the minimum thickness of the insulating layer was approximately 0.6mm.

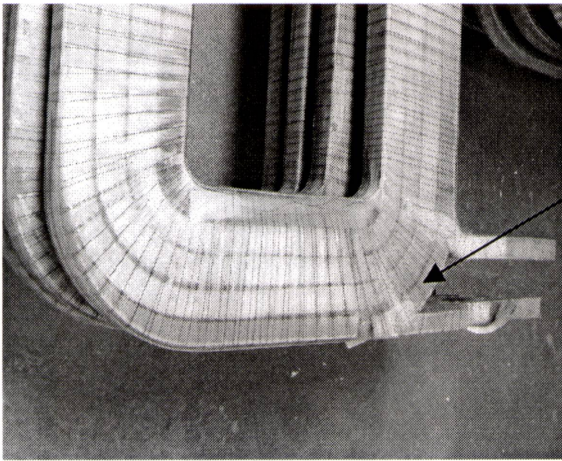
Coil No.2

The filler blocks appear to be in accordance with the drawings provided by BNL but I was not able to verify the exact geometry.

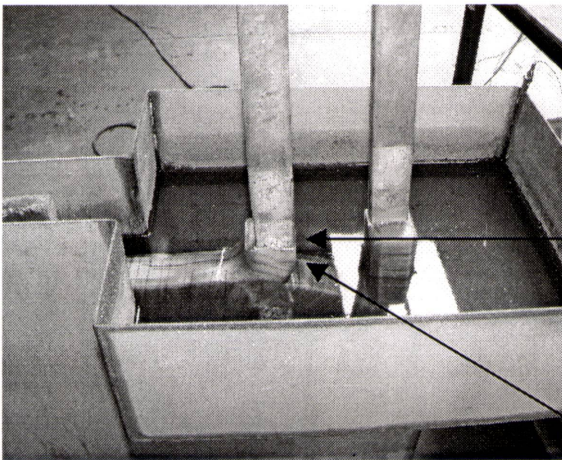
Coil No. 2

Voltage was ramped to 32 kV but during the 60 second test period there were four instances when the coil end connections flashed over to the water surface.  
(See photos below)

When a flashover occurs, it is generally in this area and the arcing takes place between the exposed copper conductor and the surface of the water.

The problem of arcing between the exposed copper end connections and the water surface was clearly in evidence. This could be eliminated, by increasing the length of the insulated part of the conductor, and ensuring there are no sharp surface asperities on the copper leading to increased field amplification effects and eventual flashovers.

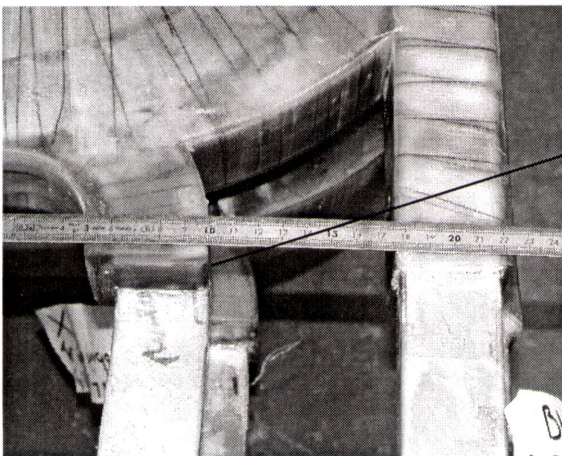
Coil No. 2

The thickness of the epoxy insulation on the inner surface of this conductor is approximately 0.6 mm which is not sufficient. This will be corrected by Sigmaphi and HV testing will be repeated.

During the testing of the new series of coils (i.e. remoulded coils), only coils 1 and 4 passed the HV test on the first attempt. Coils 3 and 5 had to be repaired and subsequently passed the test. Coil 2 failed as there was insufficient insulation in the region of the end connections, (0.6 mm). This coil has not been retested and will be repaired and retested by Sigmaphi.

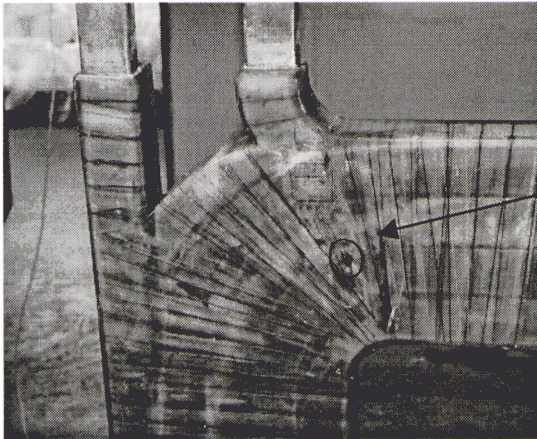
Coil 3 (Before repair)

The coil voltage was slowly ramped up but at 27 kV there was a flashover between the exposed copper conductor and the water surface. The test was stopped and the connections were cleaned up. During the second test the coil itself failed at 30kV between the coil body and ground. In the photo below we can see the location of the breakdown at 27 kV. The exact location of the breakdown was found using a dielectric tester at 3 kV which produced a leakage current in excess of 1mA.

HV breakdown at  
27 kV

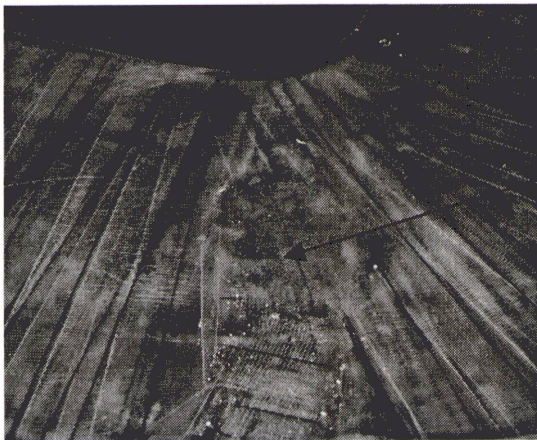
Coil No. 3 (After repair)

It was decided to attempt a repair on this coil and the following day (after the repair), a new HV test was performed on this coil. The coil was ramped to 32 kV, slowly, and held for 65 seconds without any breakdown. During the test an slight audible buzzing could be heard which was probably due to corona effects in the region of the end connections.

Repair site

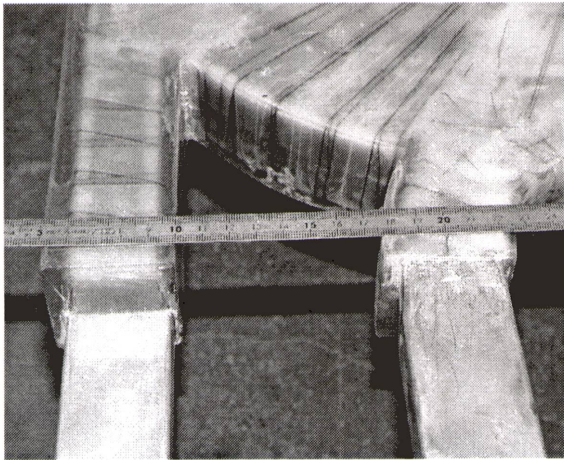
During the ramping up of the voltage, there was one flashover between the exposed copper end connections and the surface of the water but the coil held 32 kV for the required 60 seconds without any failures.

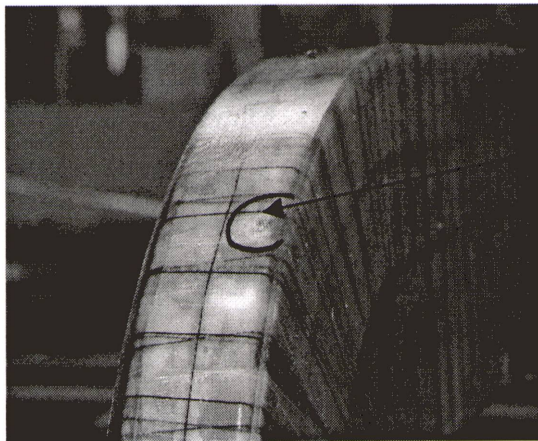
Coil No. 5, failure location.

This coil was ramped up to 32 kV and held for 45 seconds, after which there was a breakdown between the coil and ground. The failure location was localised using the dielectric tester and can be seen in the photo below,

HV breakdown at  
32 kV

It was decided to attempt a repair on this coil and perform another HV test the following day. The results of the repair were satisfactory and the coil held the required 32 kV for 60 seconds, although there was one flashover between the exposed copper end connections and the surface of the water during the voltage ramping stage. During the 60 seconds test period, the coil was stable.

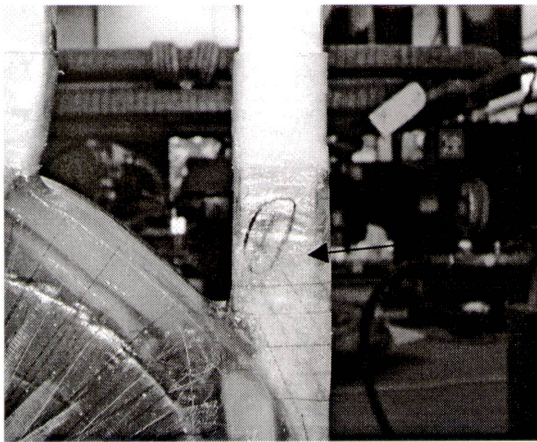
During the voltage ramping stage of the test, the coil failed in the region of the connections at 27 kV, and was repaired by Sigmaphi staff.

Breakdown site

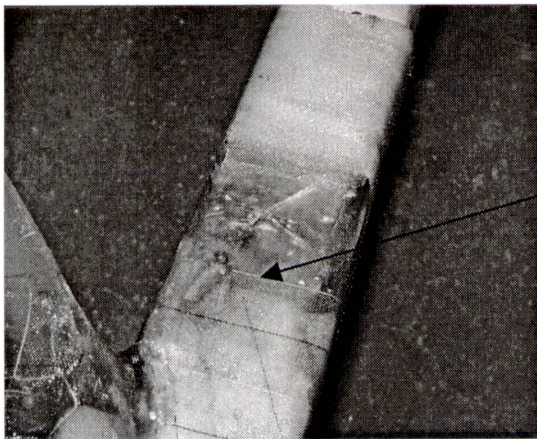
After repair

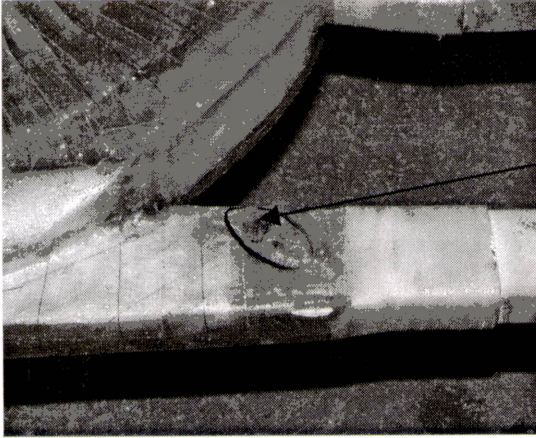
The repaired coil then underwent a second test when it failed again in the same location at between 4 kV and 5 kV.

Breakdown

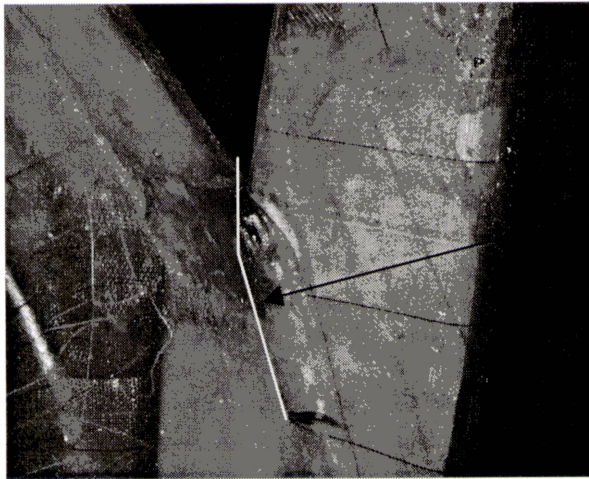
Following another repair the coil again failed the HV test at 10 kV where a leakage current caused visible arcing below the water surface in the test tank. The voltage was increased to 25 kV where the arc increased in intensity and eventually following another increase in voltage to 32 kV the coil failed. This failure was traced to the main connection / racetrack junction which was completely cracked from one side to the other, (See photo below)

The line in the photo is the approximate position of the crack.  
This crack in the insulation would be typical of a handling error as the crack has propagated from the front side in the photo to the rear side.

It is highly possible that the coil no. 3 end connections have received a mechanical shock causing the fracture in the end connection insulation. This causes an immediate short circuit during the testing and will have to be correctly repaired before any further testing can be carried out.

Further testing of this coil was considered to be pointless.

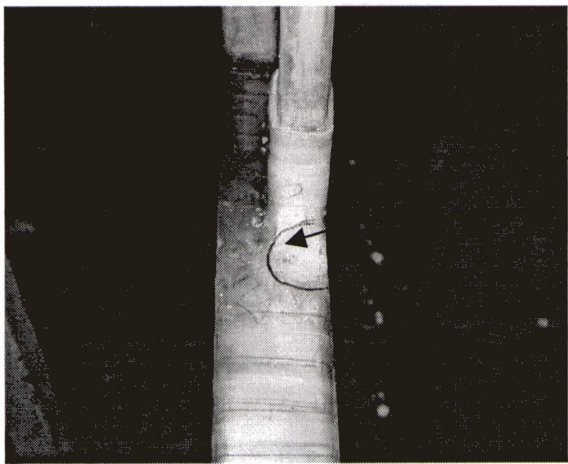
Coil 8 was ramped slowly up to 32 kV but after 30 seconds there was an insulation failure on the inner connection, outer edge of the racetrack assembly, see photo below for exact failure location.

HV Breakdown at  
32 kV

It was decided to repair this coil immediately and following the repairs the coil was again tested.

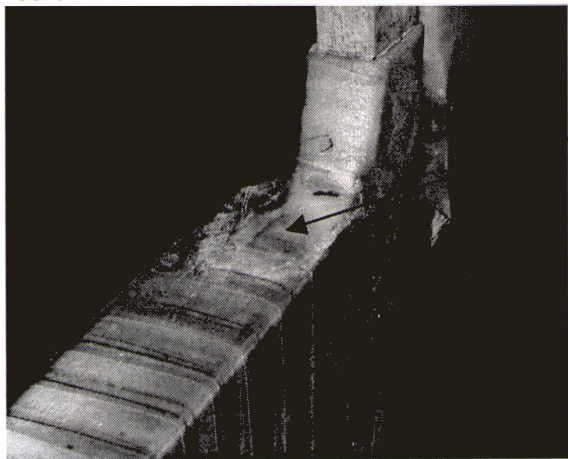
Repair completed

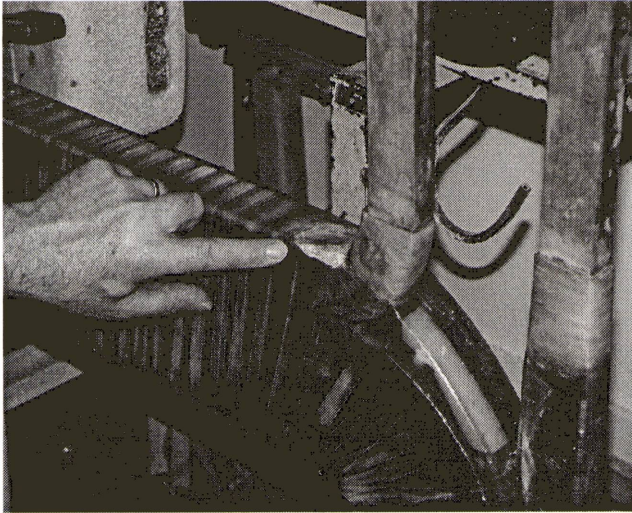
The voltage was applied slowly and at 28 kV there was another breakdown in the same location. This was again repaired in-situ and the test was repeated. Again the coil failed in same area but on the edge of the racetrack. This was then ground and completely re-insulated, see photo below.

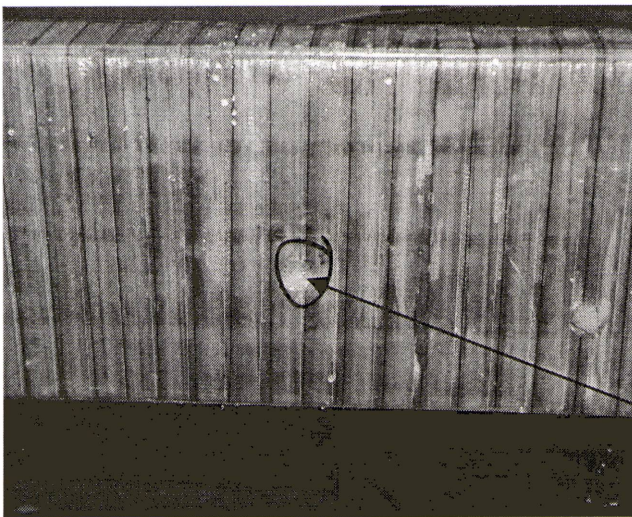
Last failure site on old coil 8

The test was then repeated but unfortunately failed again in a different location. The location was determined again using the dielectric tester and was found to be at the opposite end of the racetrack, in a previously repaired area of the coil, see photo below.

The testing of this coil was suspended as there was not enough time to implement repairs and repeat the test. Sigmaphi have agreed to repair this coil and perform the necessary testing at 32 kV.

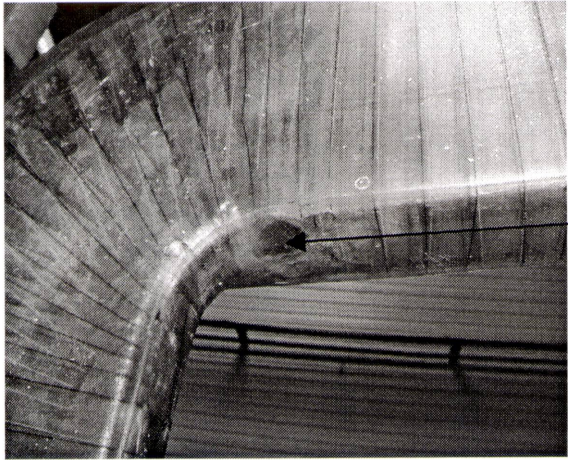
After ramping this coil to 32 kV the insulation held for 58 seconds and then failed on the inner edge of the racetrack assembly, at the connection end of the coil, see photo below.

Repair of the failure site

The coil was subsequently repaired and subjected to the standard voltage ramping up to 32 kV and it held for 60 seconds, with no audible or visual signs of breakdown.

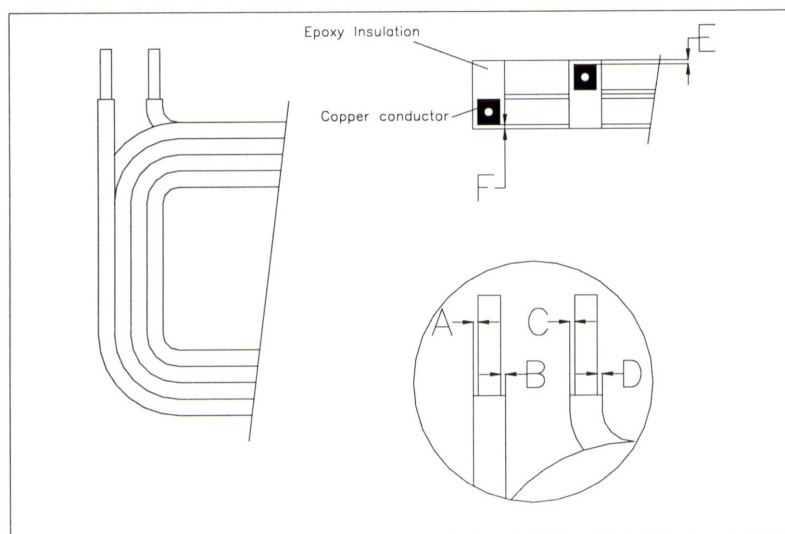
Some arcing occurred between the exposed copper of the connections and the surface of the water during voltage ramping, which could possibly be due to the fact that the insulation thickness is not sufficient in these regions. The coil terminals, in some cases, appear to have been poorly positioned, (i.e. not centered correctly), prior to moulding with the result that the thickness of the epoxy is as little as 0.6 mm in one instance, (New coil 2). For this reason I measured, approximately, the thickness of the insulation for the new coils and have tabulated measurements below. Refer to the drawing above for the measurement positions, A to F. (Dimensions are given in mm).

Coil No.	A	B	C	D	E	F
1	7	2	4	4	1.5	3
2	5	2	0.6 **	10	2	1
3	6	2	3	5	2	2
4	6	2	7	5	2	2
5	7	2	2	5	2	2

\*\*Coil No. 2 to be repaired.
