## Failure analysis of a heavy gauge fastener of the ITER toroidal field gravity support system

ITER toroidal field  
Gravity support  
Nickel base superalloys  
Delayed failure

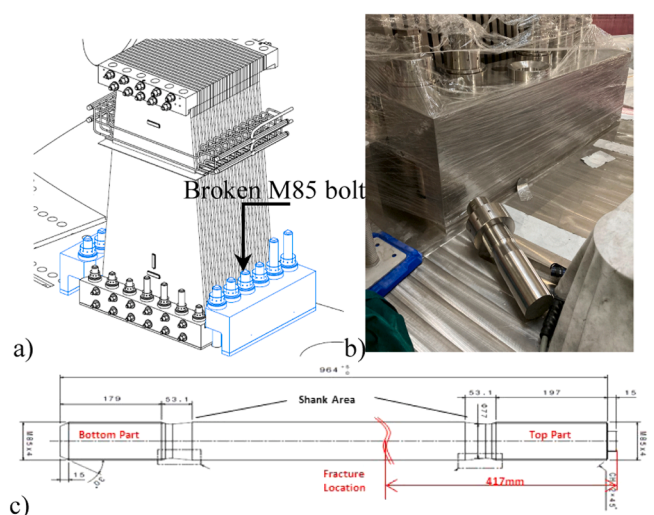
Despite the stringent requirements and the extensive quality controls applied to the forged prematerial and to the bolts, a complete break of one M85 bolt was discovered, that occurred about 40 days after its installation and preloading up to 2.65 MN (45.1% of  $R_{p0.2}$ ), prior to the application of any operating stress. The upper half of the part blew out from the bolthole and was found lying horizontally on the Cryostat Base near the TFGS (Fig. 1) while the lower half part shot downward and lied in the confined space of Cryostat Base. The present paper reports the results of the comprehensive failure analysis carried out following the incident.

Fig. 1. a) Complete GS, including M60 and M85 bolts. b) Top part of the broken bolt that blew out from the bolthole. The delayed catastrophic failure occurred near the bottom of an L - shape clamp of the TFGS18, visible on the back. c) Rupture occurred in a full section of the stud, outside the reduced diameter shank areas.

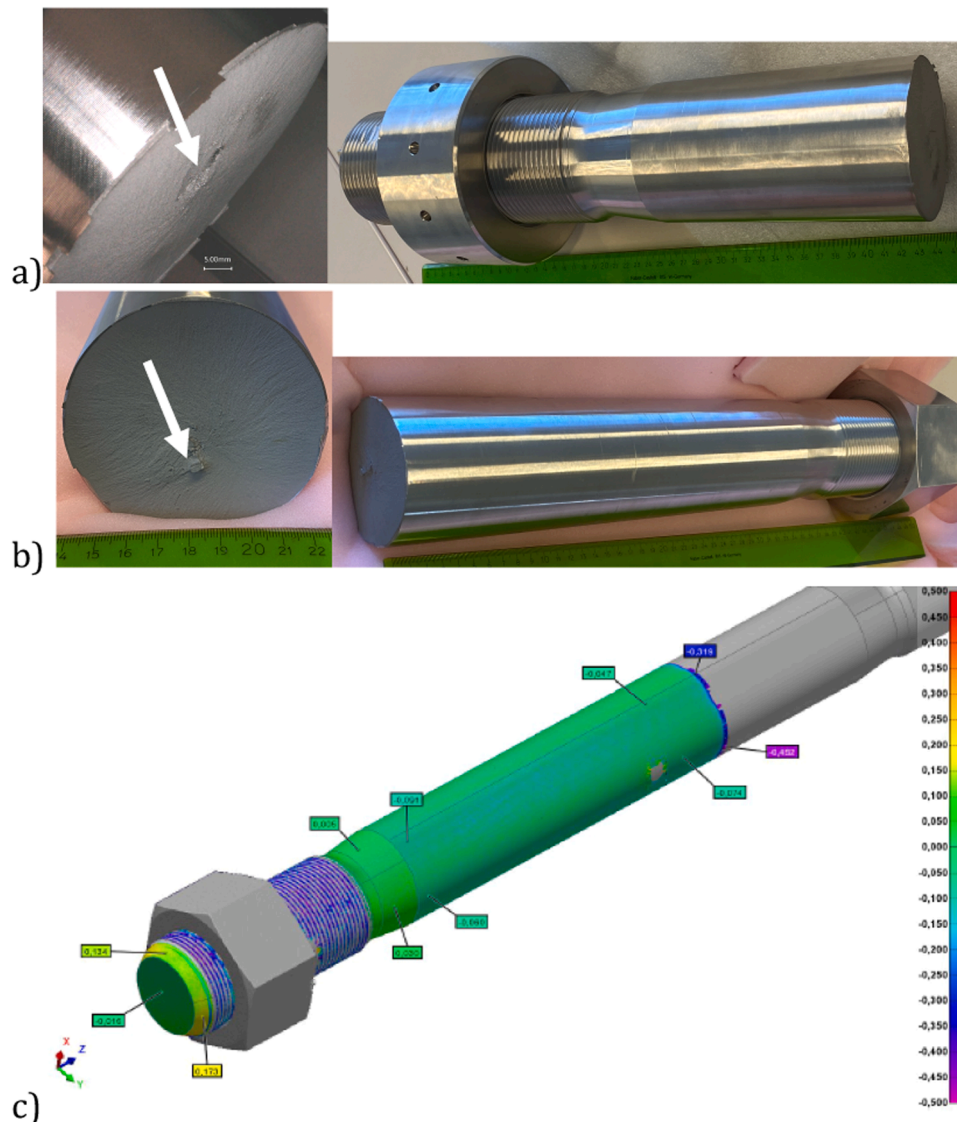
**Fig. 2.** Fracture surfaces of the broken stud (the initiation site is identified by a white arrow). a) top portion; b) bottom portion; c) dimensional metrology (top portion shown) concludes on almost total absence of necking.

Fig. 2 illustrates the appearance of the two fracture surfaces of the broken stud. The macroscopic observations confirm a very flat fracture and almost total absence of shear lips.

This is distinctive of limited ductility and is unexpected for this alloy, usually featuring cup-and-cone ductile fracture when broken by tensile overload [5]. Dimensional metrology (Fig. 2c) confirms absence of significant necking ( $< 1$  mm diametric reduction, corresponding to  $Z < 2\%$ , far below the minimum specified value of 15%). The initiation site is easily identified in the bulk, where all the river patterns converge. It spans over several tens of  $\text{mm}^2$ . It is slightly eccentric from the axis and far from the free surface, hence excluding a bending moment that would have occurred in operation due to misalignment or off-axis loading. Curved radial lines emanate from the eccentric initiation site and eventually propagate in a radial manner. SEM observations of the fracture surfaces (Fig. 3a) show a generalized quasicleavage, intergranular secondary cracks and interconnected networks of fractured precipitates. They reveal smooth surfaces and surface terraces, evidencing a pre-existing local lack of cohesion. Some surfaces at the initiation site show a solidification structure, pointing to cavities not closed by the forging reduction. Similar cavities were identified in the vicinity of the fracture surface by immersion UT and confirmed by CT and metallographic observations. In particular, some 10 mm upstream of the top fracture surface, a cavity was identified in the bulk at a radial distance of  $\sim 8$  mm from the axis, in a matching position with respect to the one of the initiation site (Fig. 4).

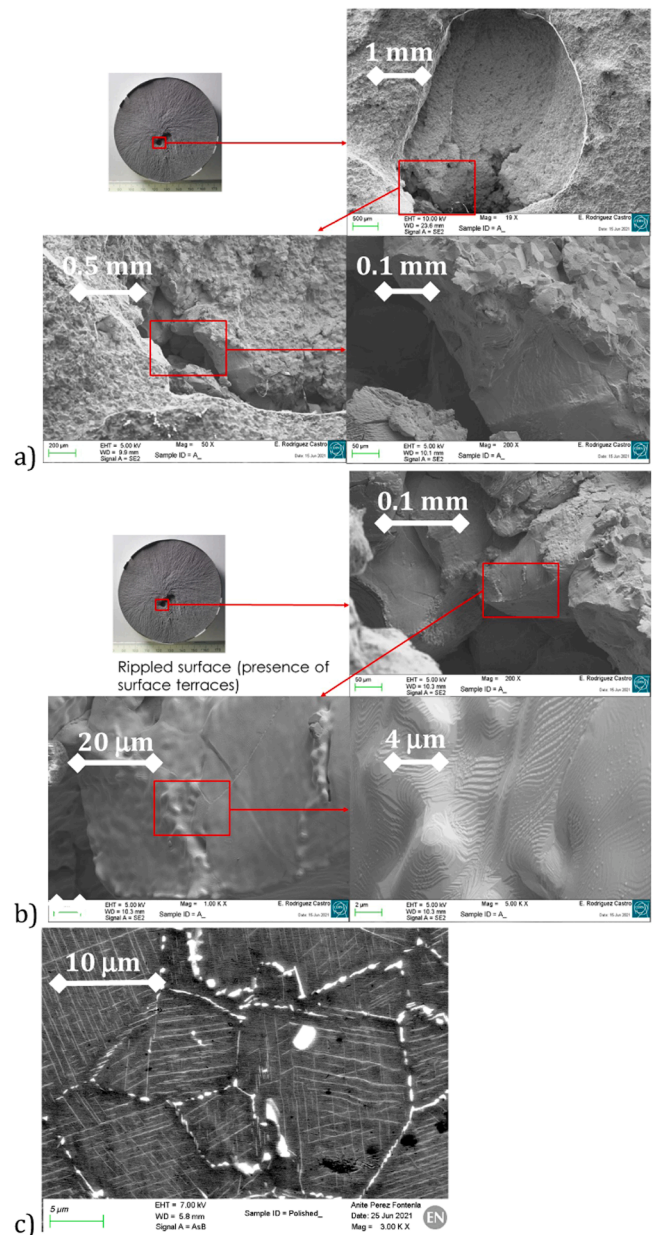
Grain structure is fine and equiaxed, with  $G$  spanning from 7 in the centre to 9 at the periphery of the stud, within the specified limits. However, GB decoration is widely observed (Fig. 3c), under the form of continuous networks of secondary phases along GB. The aspect of these precipitates is compatible with intermixed acicular  $\delta$ -phase and Laves' phase (platelets). EDS analyses and XRD confirm  $\delta$ -phase ( $\text{Ni}_3\text{Nb}$ ) and presence of Laves ( $\text{Fe}_2\text{Nb}$  crystal structure, enriched in Mo), whose composition assessed by EDS (30.6Ni14.3Fe13.1Cr-12.2Mo14.3Nb) is compatible with the predicted one [6]. Isolated carbides ( $\text{NbC}$ ) are also observed. The excessive presence of  $\delta$ -phase at the GB is understood as due to the high Nb content of the alloy (over 5.3%), towards the high bound allowed by standards in force (5.50%), promoting GB precipitation when submitted to the standard ASTM A1014 heat treatment.

Fig. 3. SEM observations of the initiation site. a,b) A system of cavities in the continuity of the initiation event showing rippled surfaces is observed in the bulk of the stud; c) The Grain Boundaries (GB) are affected by an extensive precipitation of secondary phases.

The broken stud featured an extensive network of cavities at the fracture surface and in the adjacent volumes on top and bottom sides of the fracture, identified by UT and further confirmed by metallographic observations. These cavities were located mainly towards the inner diameter where also the initiation was identified. In the volume of the broken stud close to the rupture, results of tensile tests confirmed that the certified tensile properties were not fulfilled for any of the specimens. In particular, the specimens extracted from the inner position featured a very limited ductility. When observing the initiation site of their fragile tensile breakdown reproducing at a local scale the rupture of the stud featuring almost total absence of ductility, this coincides with a cavity or network of cavities. Based on the investigations performed, the delayed rupture of the stud is compatible with a failure under sustained tensile stress, initiating from a central position featuring very poor ductility, moreover severely weakened by the presence of a large network of cavities not closed by the forging operations. After an initiation time, the subsequent fast propagation through the extensive continuous network of intergranular  $\delta$  and Laves phases resulted in an overall brittle rupture with almost absent local necking. Even under a preloading stress lower than nominal, after a delay time the product was not forgiving due to the combined effect of an improper steel remelting, resulting in ingots affected by cavities that an insufficient forging reduction did not allow to close, and a non-optimised combination of composition and applied thermal treatment. This resulted in a

continuous network of secondary phases embrittling the GB and inducing a local lack of ductility, poor tensile strength and impact toughness. In order to exclude the simultaneous occurrence of cavities and embrittling phases, UT procedures were developed to confirm that the remaining bolts, including the installed ones, are free of cavities using sufficiently conservative criteria [4]. In particular, in-situ axial inspections allowed installed bolts that could contain relevant imperfections to be identified and replaced. Fatigue crack propagation behaviour is suggested to be considered for future work.

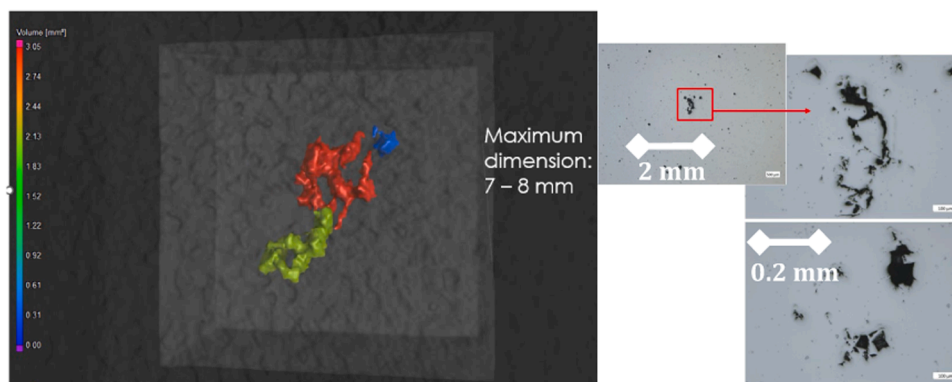
Fig. 4. Typical cavities as confirmed by CT (left) and microoptical observation (right) in the volume of material surrounding the breakdown.
