Review of the modulator MDK13 faults that occurred during Run 2.

G. Coudert, G. McMonagle, P. Pearce, G. Rentier

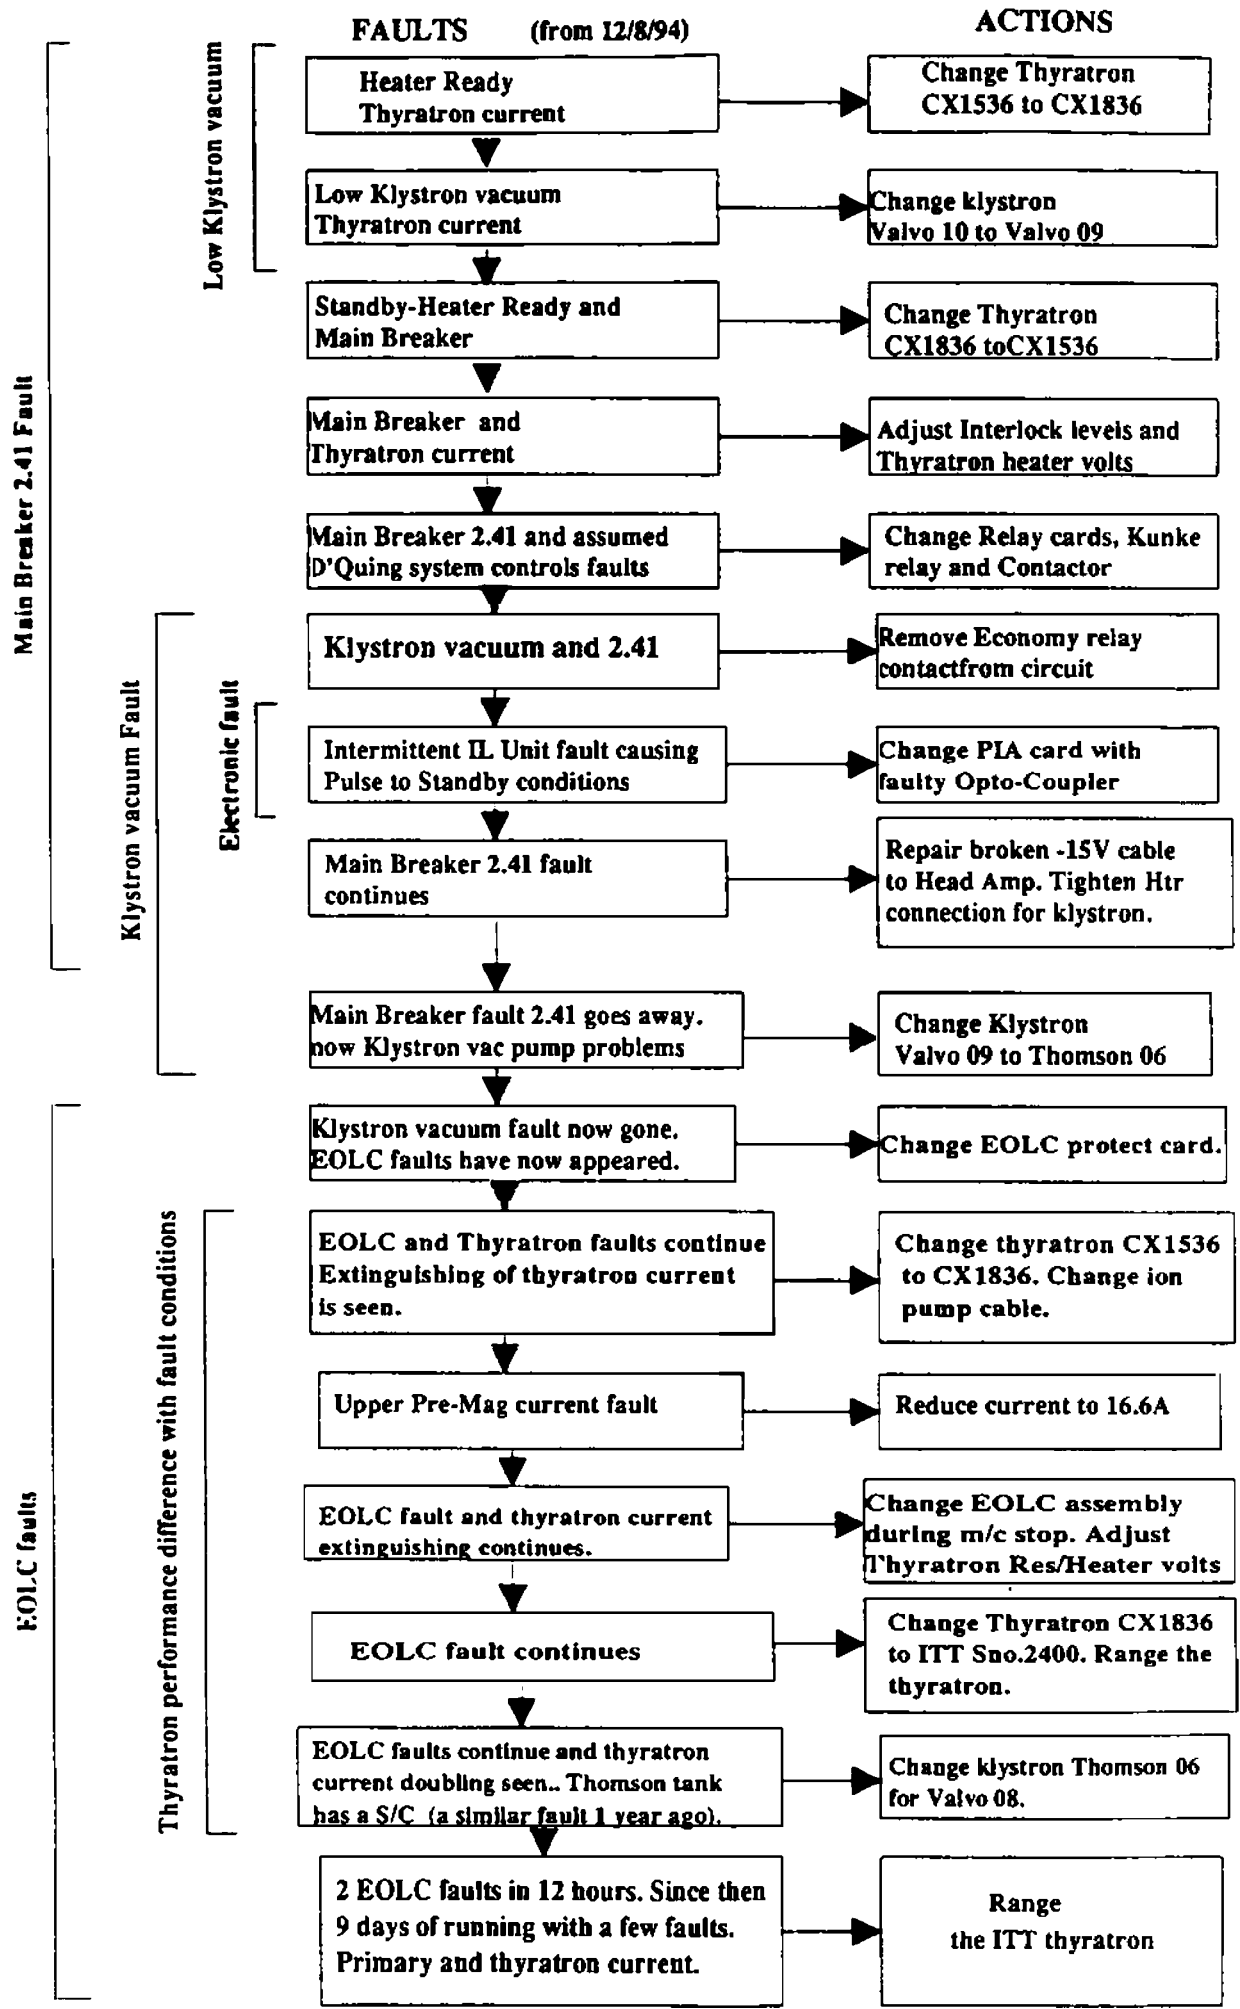
FIG 1

The fault scenario shown in Figure 1 indicates that there were two main problem areas associated with the modulator. The first, called the Main Breaker 2.41 fault went from the 12/8/94 until 2/10/94. The second principal fault area was the EOLC or end-of-line circuit faults that appeared from the 3/10/94 until the 12/10/94.

Under the Main Breaker fault was an intermittent klystron vacuum fault that appeared on two different klystrons that were operational in this position. The first klystron that showed vacuum problems was replaced with a second (the hot spare) that also gave similar symptoms. But overlaying these "secondary" problems was the highly intermittent Main Breaker fault. This fault caused the main breaker to the modulator to be opened with apparently no actual fault being recorded, and also with no command from the control system to put MDK13 into the standby state being given.

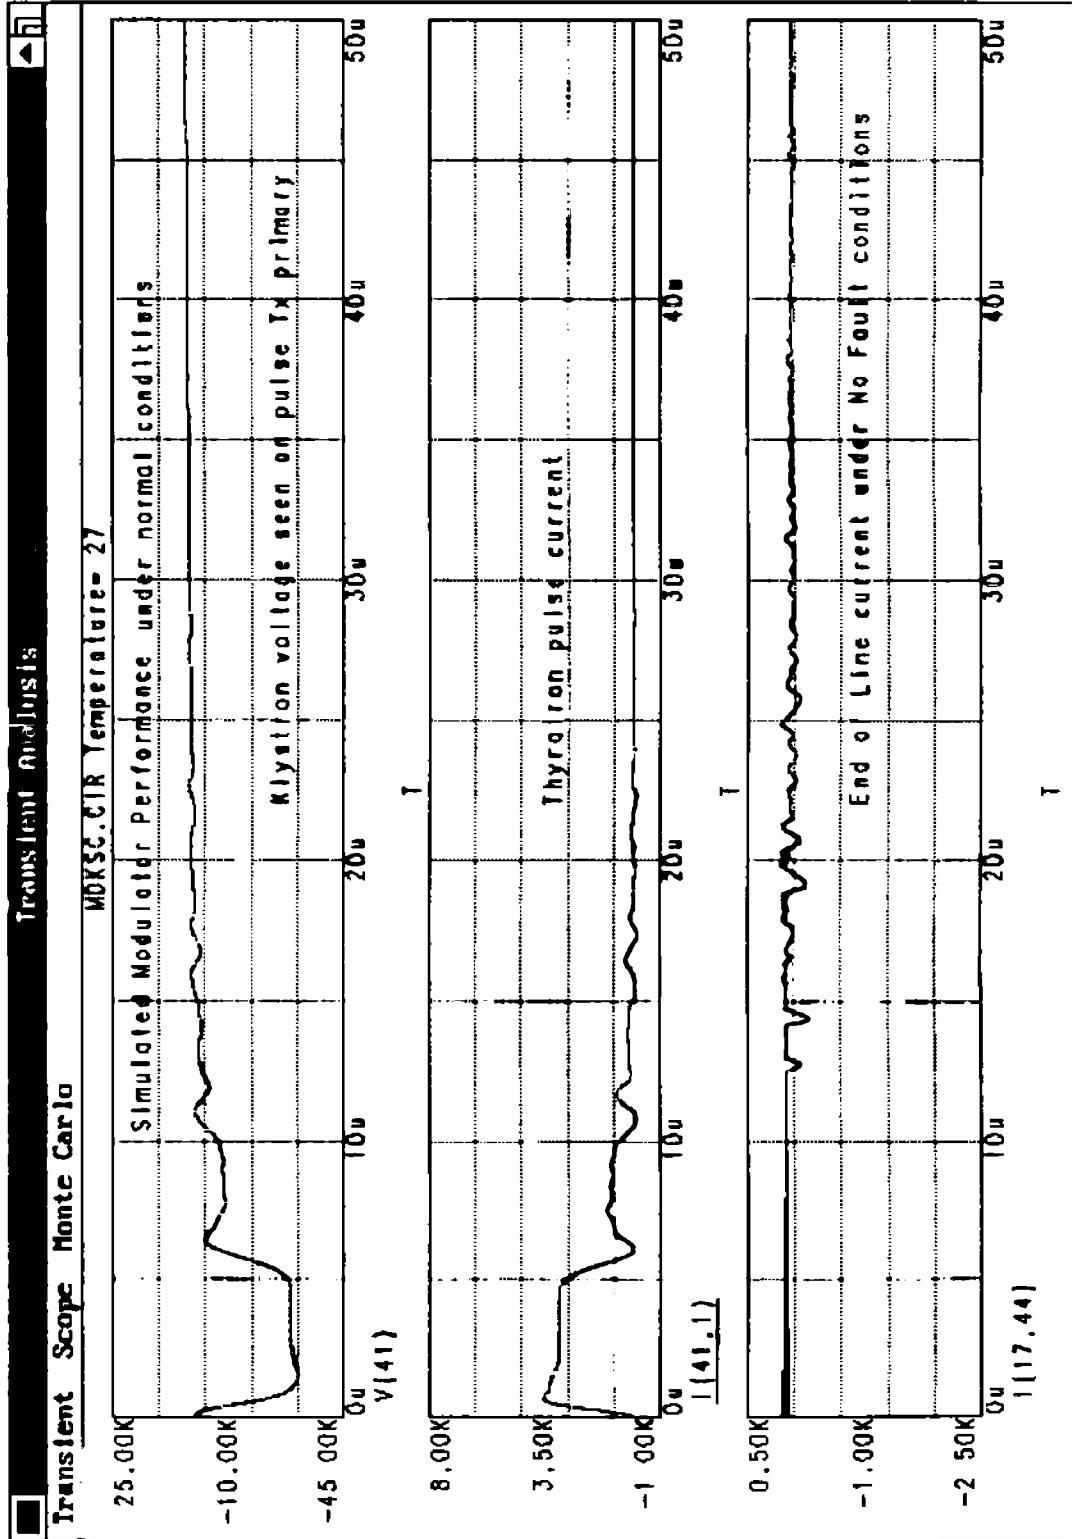
Fig 3

- Figure 3. The normal waveforms that are observed in an operational modulator. The klystron voltage waveform can be compared to the top photo in Figure 6.

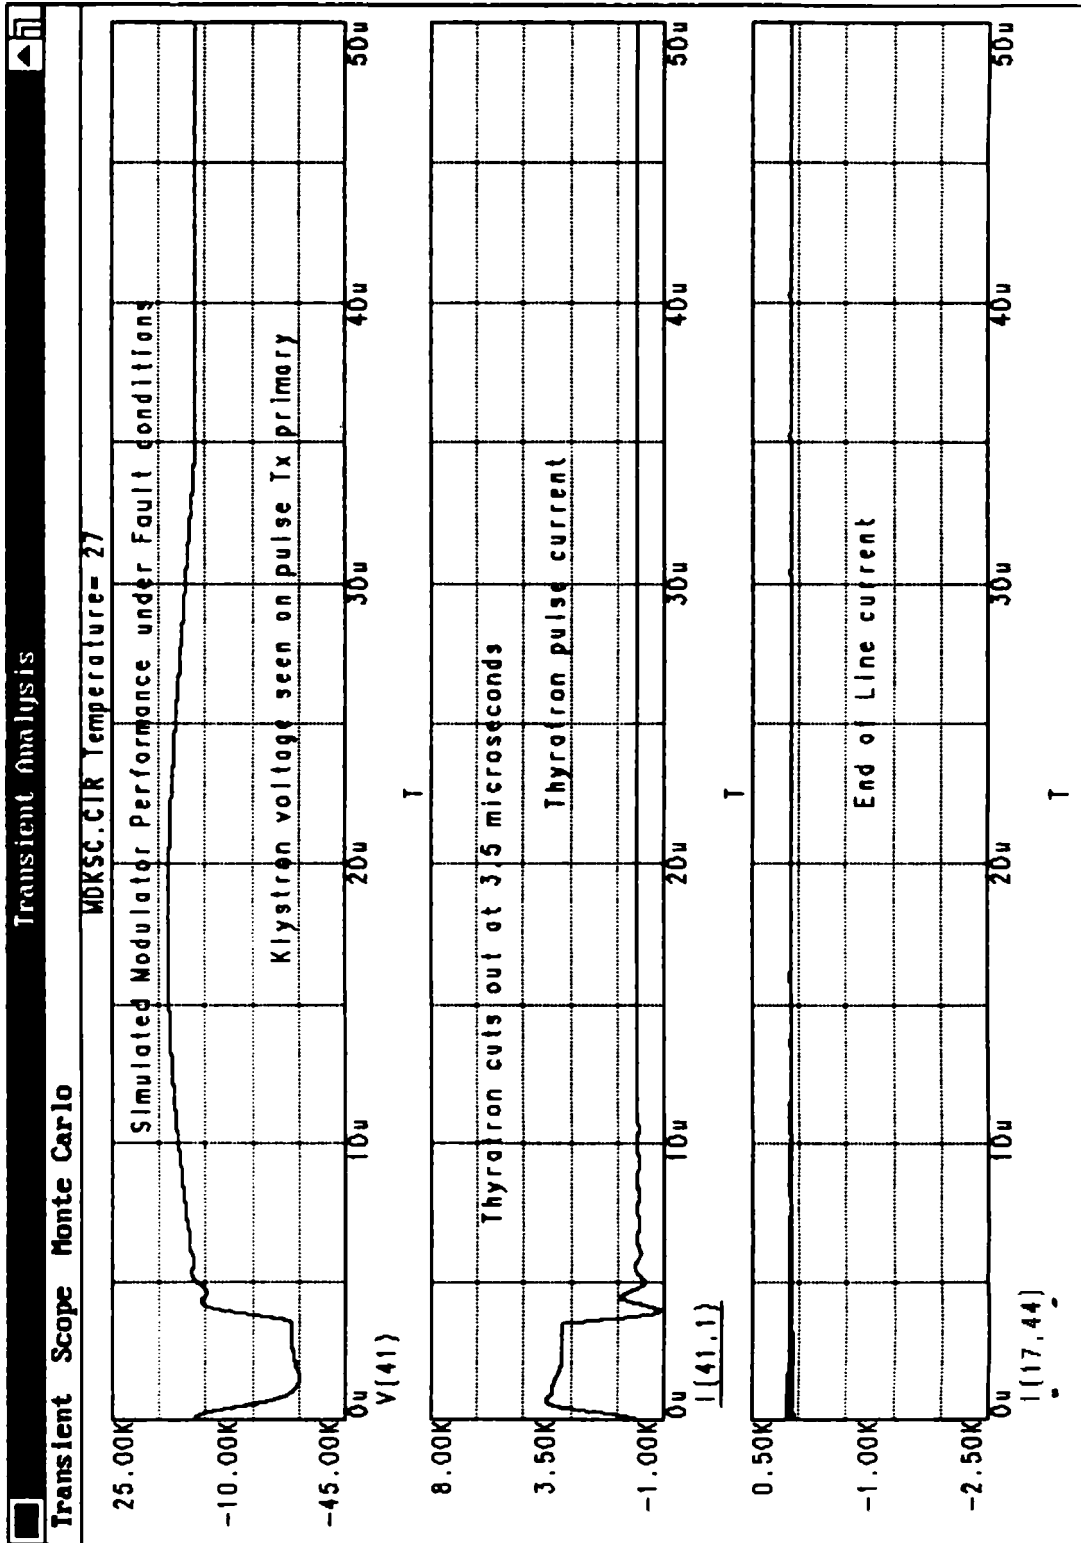
FIG 4.

- Figure 4. The thyatron switching off during the current pulse and the subsequent effect of a positive voltage bump (Kly. Voltage 3) at the klystron cathode. This effect was produced by the EEV pulsed keep-alive thyatron due probably to insufficient gas plasma density in the tube. This can be compared to the bottom photo (klystron pulse voltage) in Figure 6 and the top photo (thyatron current) of Figure 7. This effect is also produced when an IIT thyatron runs out of gas pressure and can no longer support the current during the whole pulse width. It then requires that the reservoir voltage be ranged to correct this.

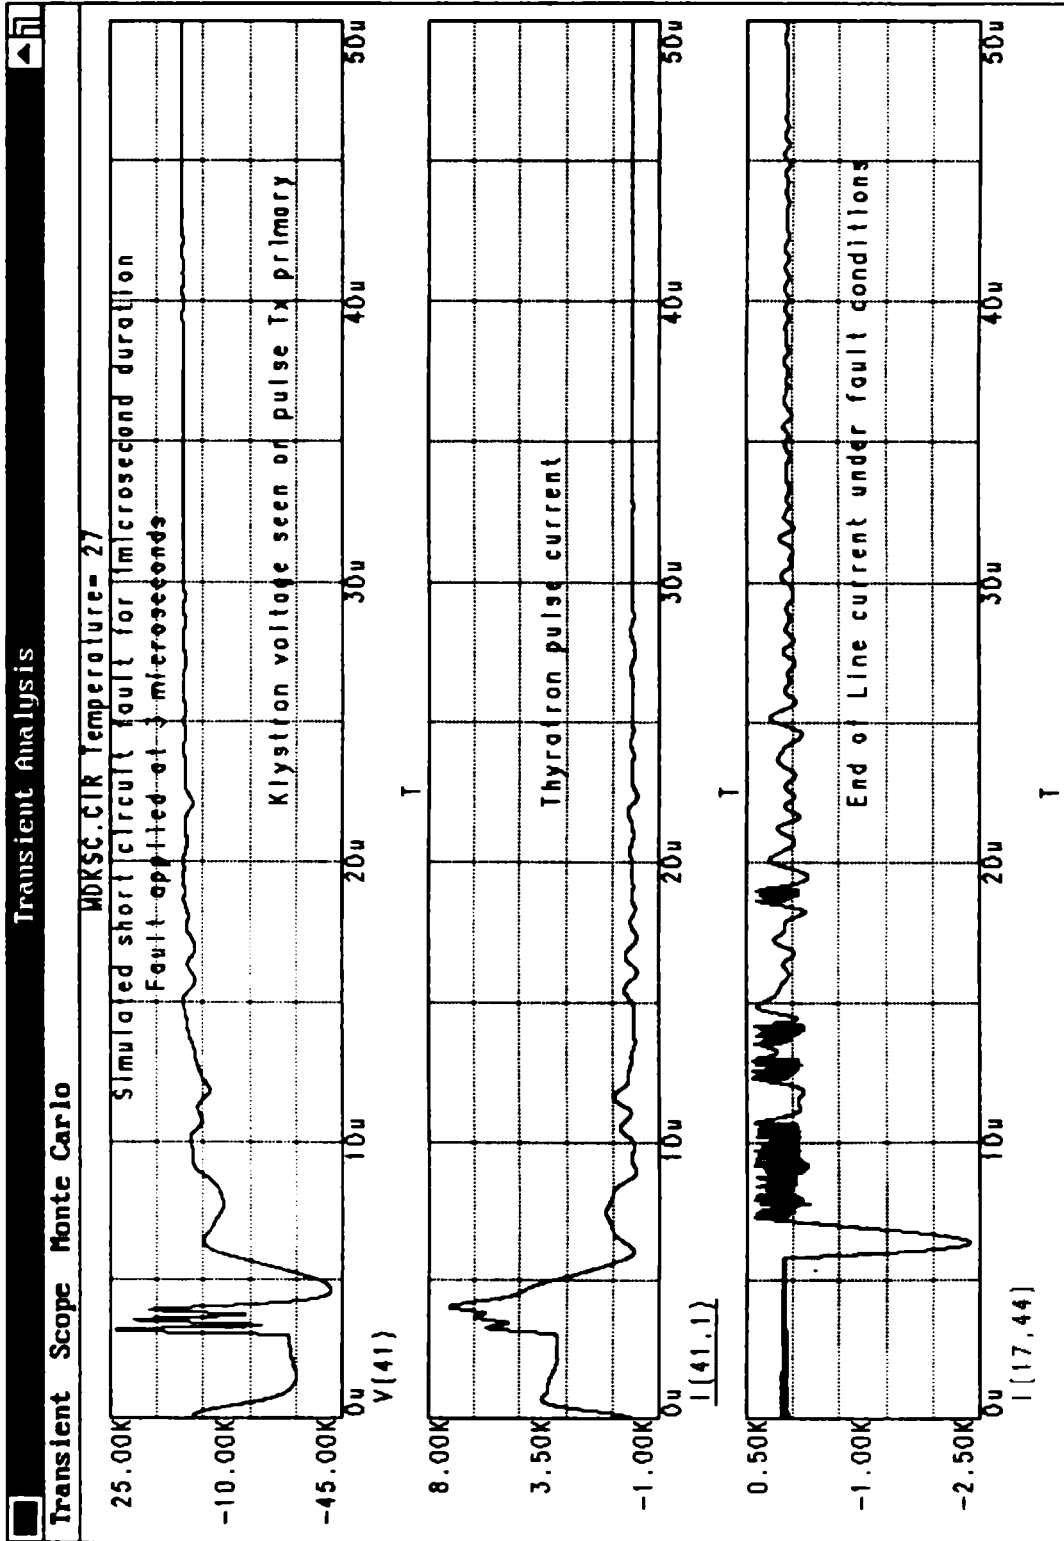
Fig 5.

- Figure 5. This shows the effect of a short circuit on the high voltage side being applied for 1 μ s at a point 3 μ s into the voltage pulse. The effect of current doubling due to the short circuit, and the appearance of a large negative EOLC signal are also seen in the bottom photo of Figure 7.

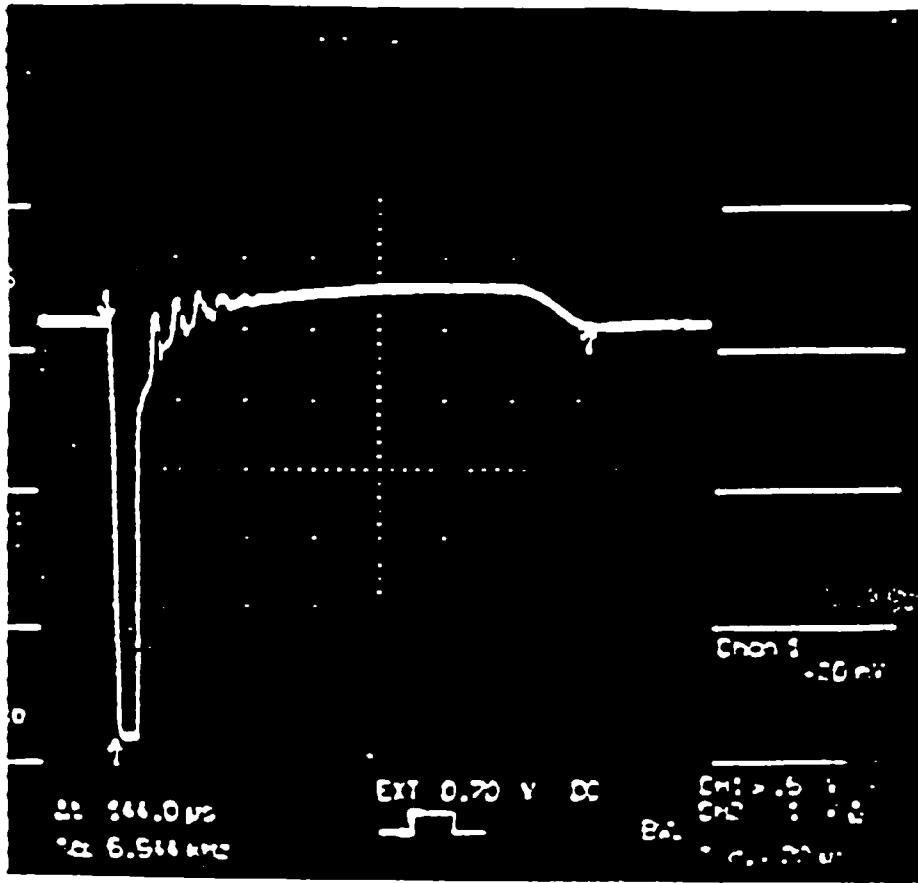
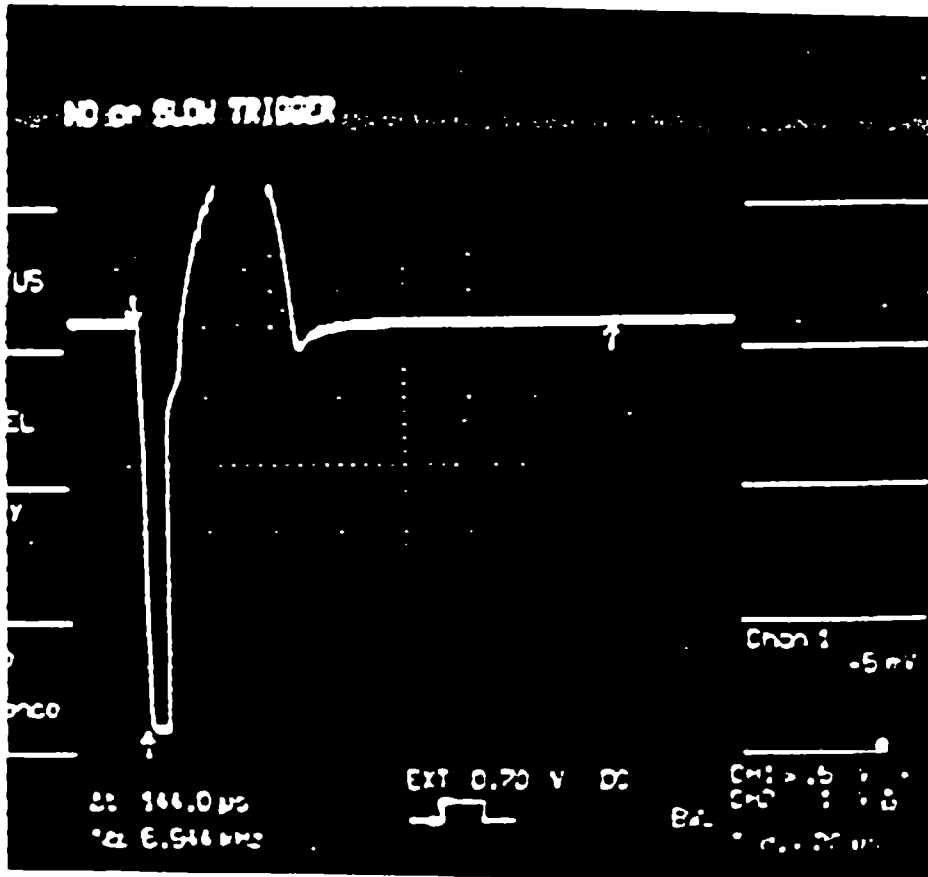
Fig 6.

KLYSTRON
VOLTAGE
(NORMAL)

KLYSTRON
VOLTAGE
(THYRATRON
OPEN CKT)

Thomson tank/Klystron SN^o 06 (EEV CX1836 Thyatron)

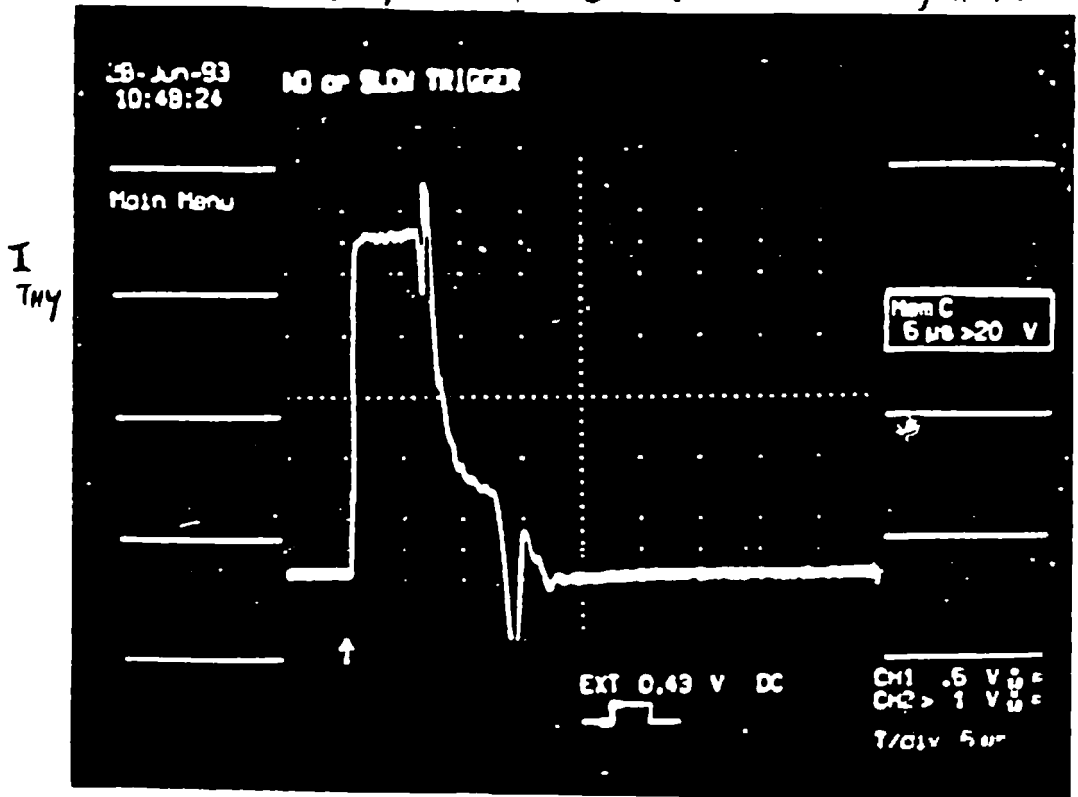
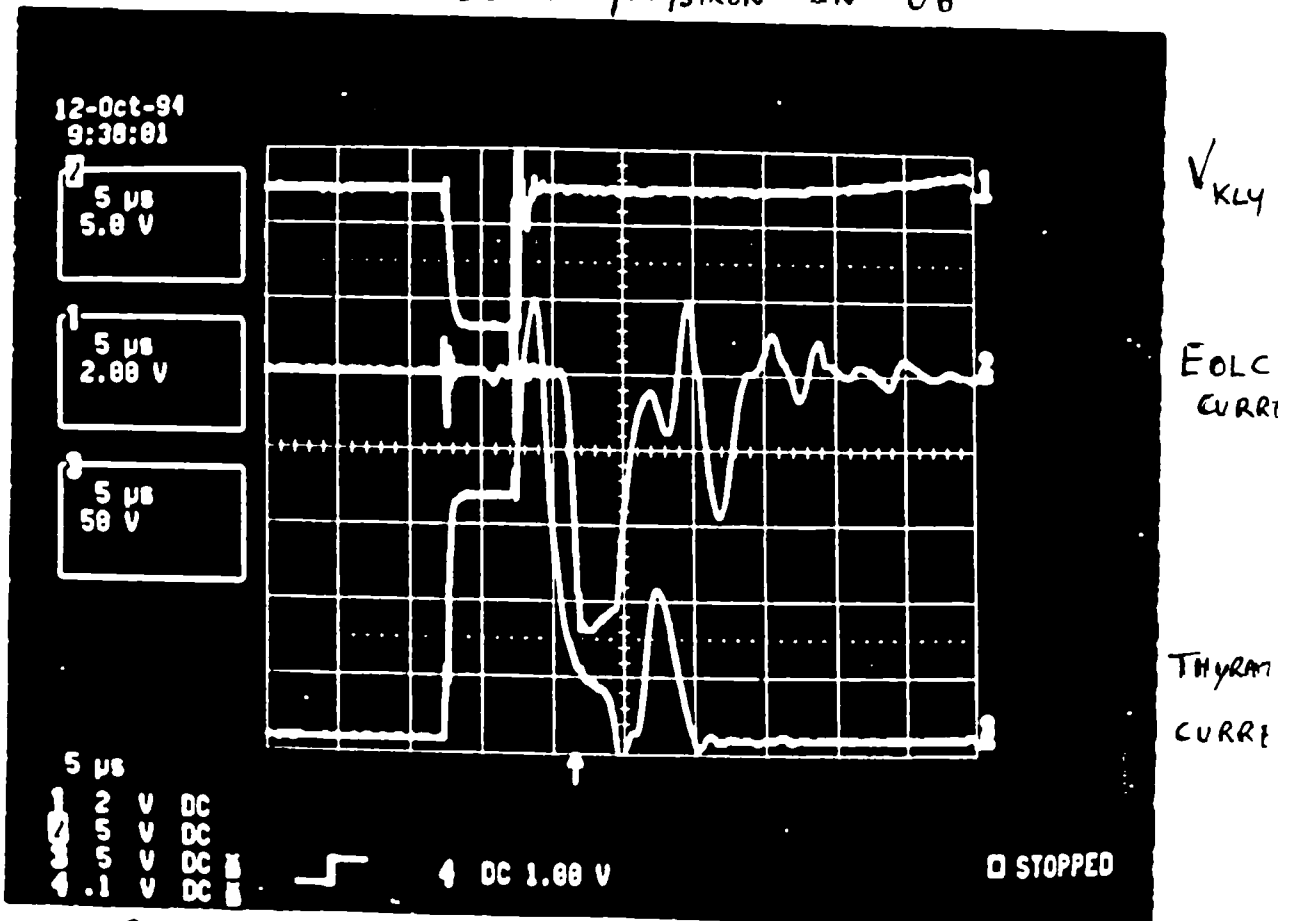
FIG 7

The EOLC fault situation, which turned out to be a short circuit at the klystron tank level, showed up the different recovery performance characteristics of both EEV and ITT thyratrons, with the different keep-alive conditions. For the EOLC fault observed the ITT tube with dc keep-alive allows reverse current to flow for a longer time than does the EEV tube with pulsed keep-alive. In fact the EEV tube acts as a better diode under these conditions and switches off and so prevents excessive voltage spikes appearing on the klystron cathode. From the fault finding view point this made the fault appear as a short circuit with the ITT tube (which was correct) and a lack of gas pressure in the EEV tube, because it was switching off during the pulse at the moment of the fault occurring.

MDK13 with THOMSON tank/KLYSTRON SN^o 06

SHORT CIRCUIT CONDITION IN TANK (ITT THYRATRON)

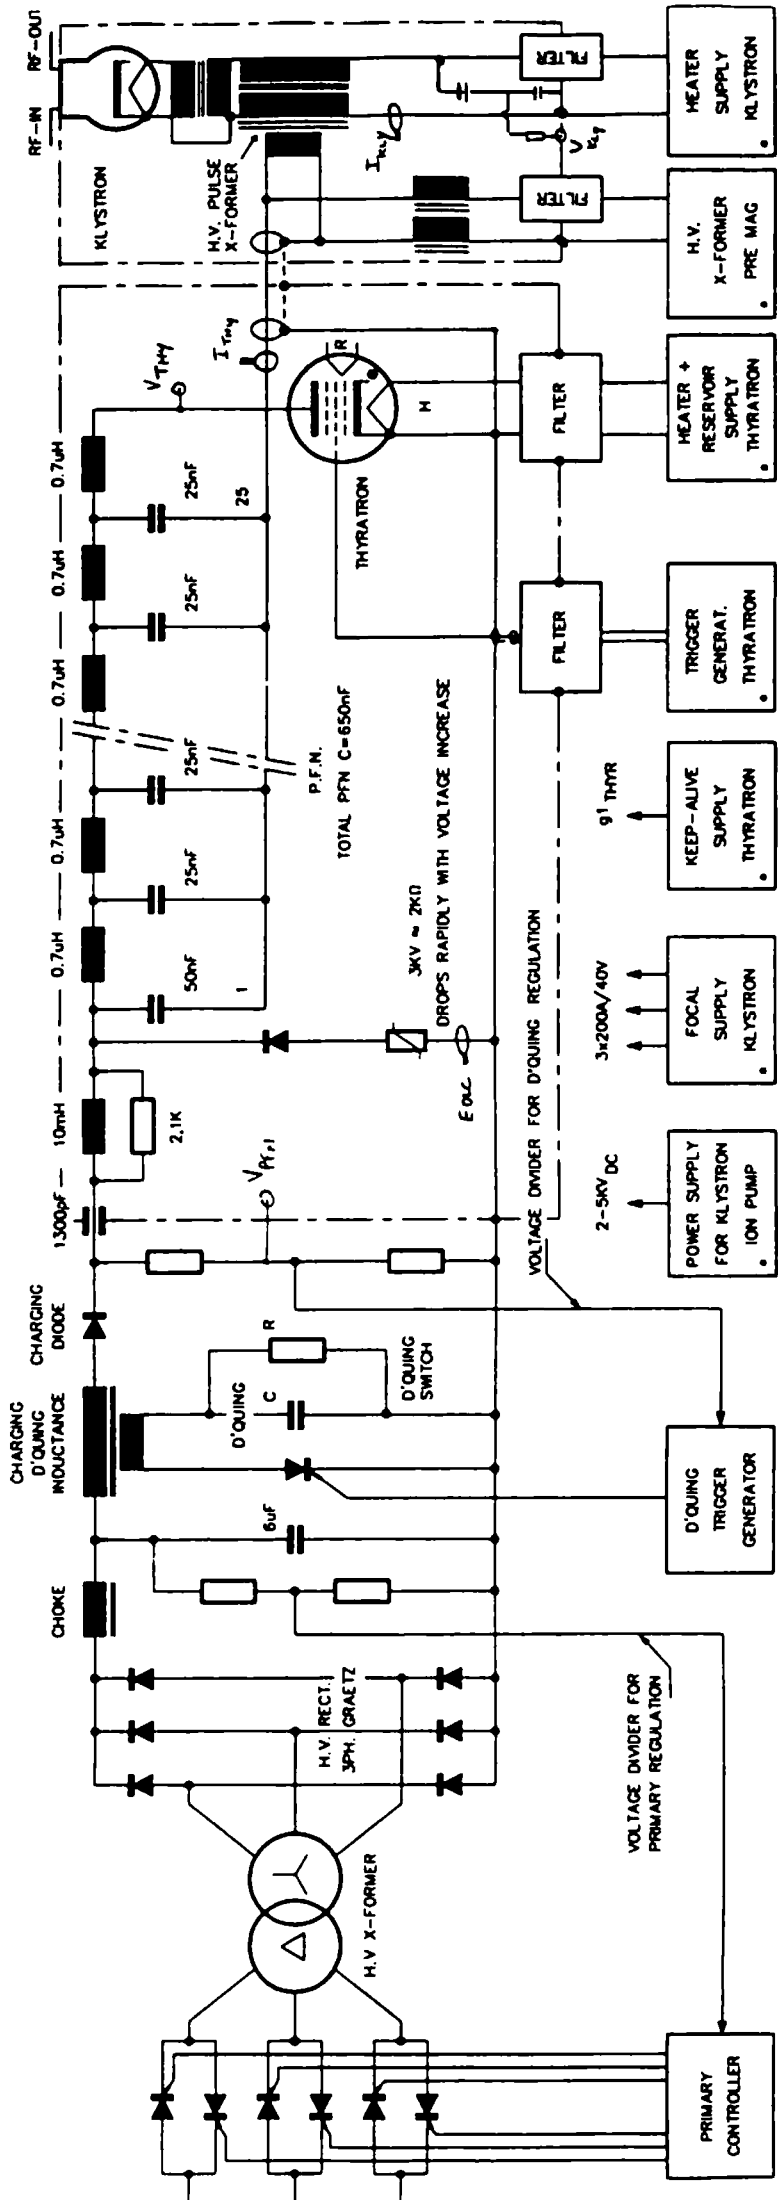
FIG 8.

Always when difficult situations arise the maximum of information is required to solve the problem. This fault situation was no different from any others, and particularly when equipment responsibilities are shared over different groups the need for a common picture of the system is required. *The general modulator schematic of Figure 8 that was used was found not sufficient and lacked important fault finding information.* A better schematic that will show the principal power, timing, control and interlock interconnections between equipment as well as signal viewing points is being made.

- 7. Block diagram.** A block diagram showing all the major units in the modulator, their primary inter-connections and all signal test points is to be made.
