Gamma irradiation of ATLAS18 ITk strip sensors affected by static charge

Specific Issues observed in QC testing

Sensors affected by static charge in real experiment

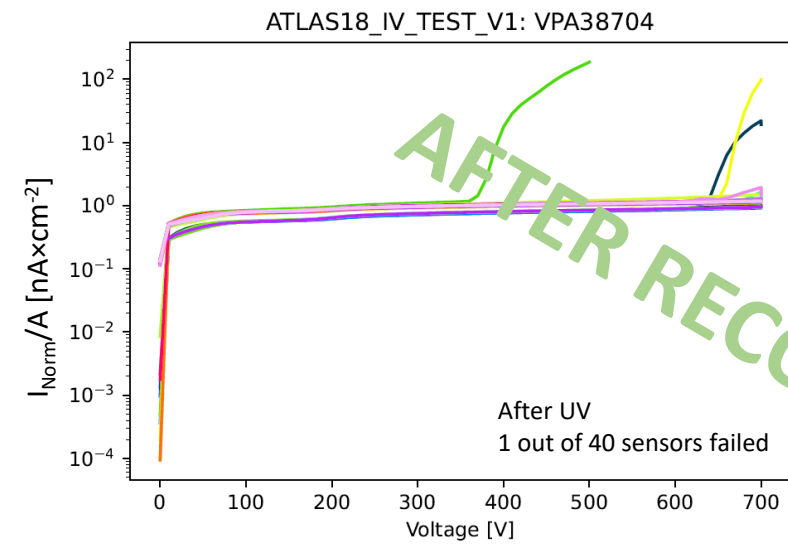
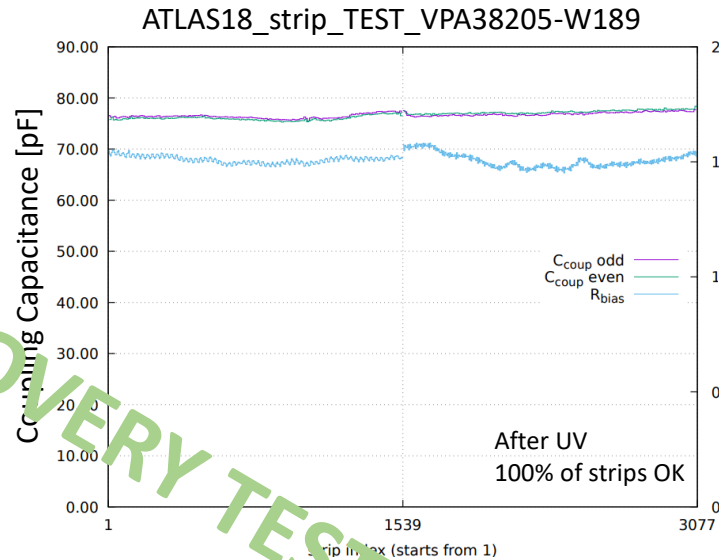
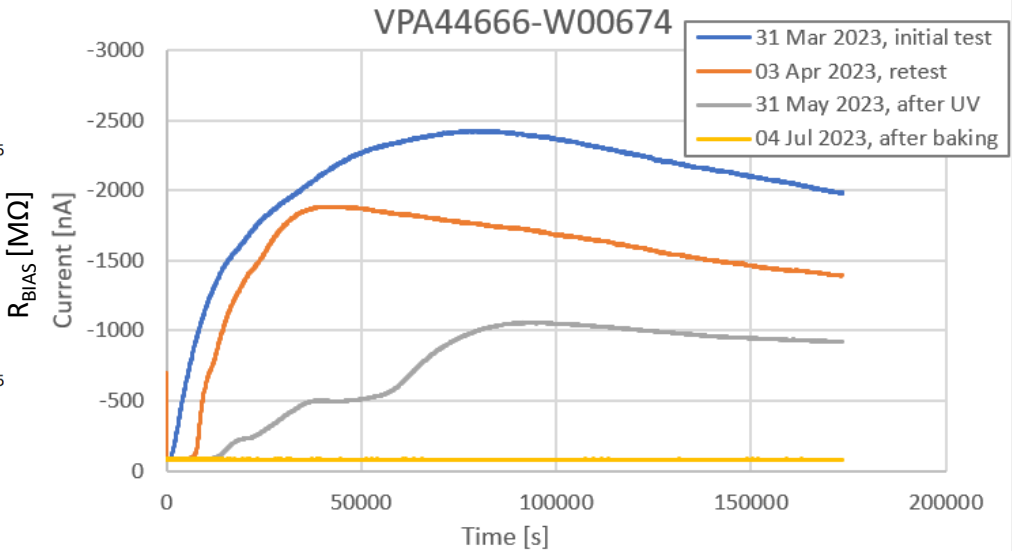
static charge measurement

- Strong correlation between observed electrical failures and high electrostatic charge (up to ~ 100's V/inch)
- Electrostatic charge accumulated on the surface of the sensor
 - in the strip area can lead to the loss of interstrip isolation
 - close to the edge and bias ring can cause instability of current or low breakdown voltage

- Introduced sensor recovery techniques:
 1. irradiation of the sensor surface with **UV-A** and **UV-C** light
 2. application of the intensive flow of ionized gas
 3. subject the sensors to high-temperature exposure
 4. dry storage over days / weeks

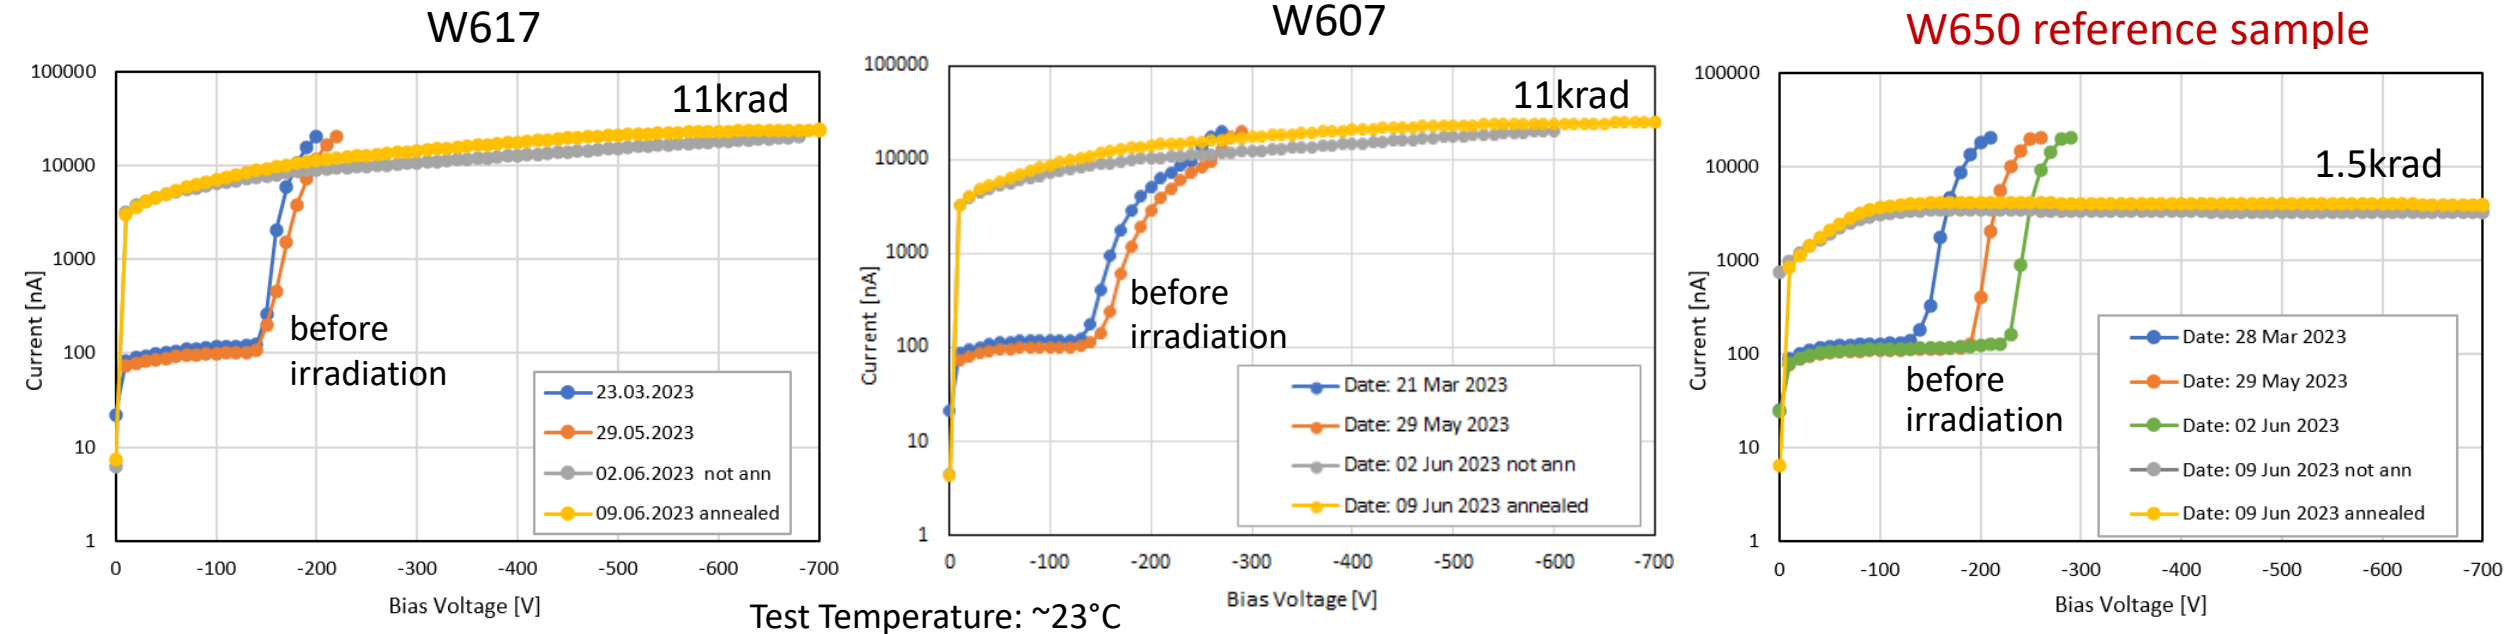
IV before and after gamma irradiation

- Early BD of sensors W617 and W607 disappeared after gamma irradiation to 11krad.
- Early BD of reference sample W650 was not resolved (green line). W650 was transported and handled alongside W617 and W607 but not subjected to irradiation.
- After later gamma irradiation of the reference sample W650 to 1.5 krad the early BD disappeared too.
- Leakage current is $\sim 100\times$ higher after 11krad gamma irradiation, $\sim 35\times$ higher after 1.5krad.
- Annealing at 60°C for 80 minutes does not decrease the current.

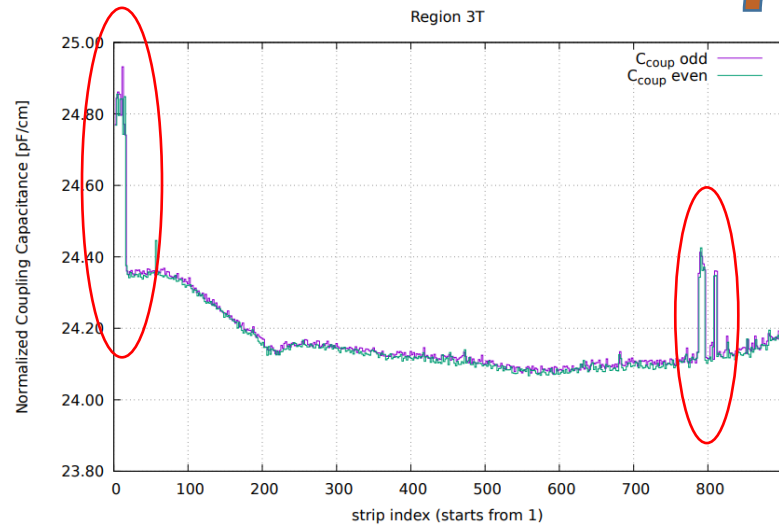
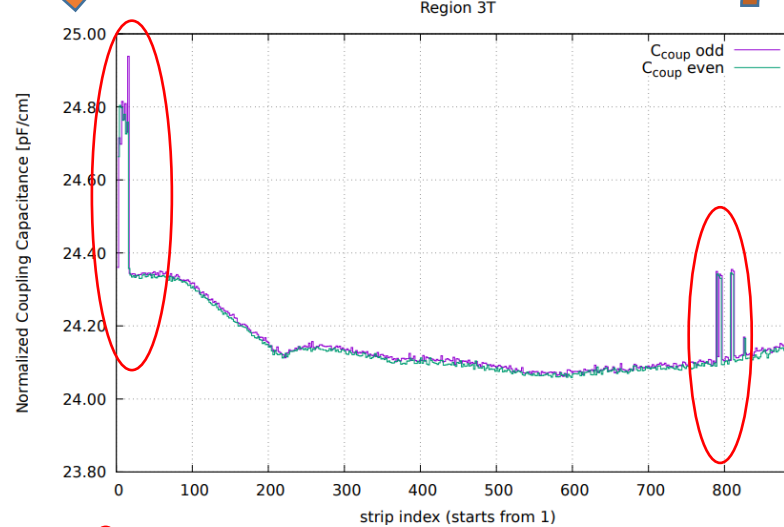
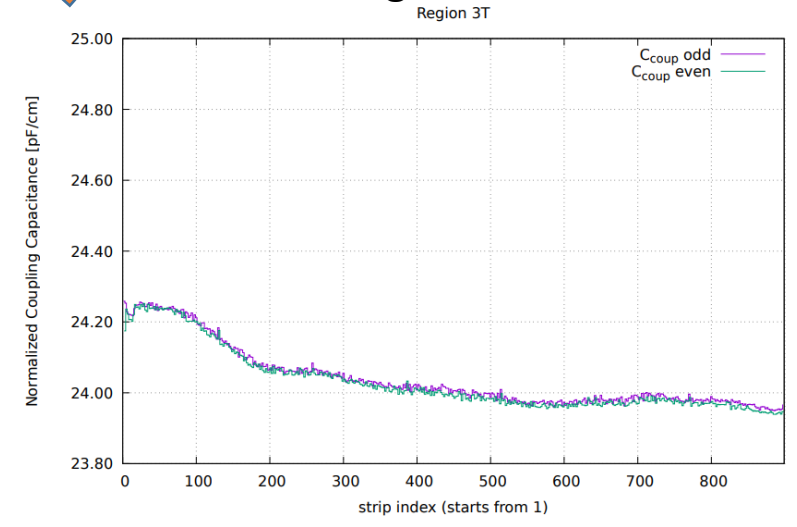
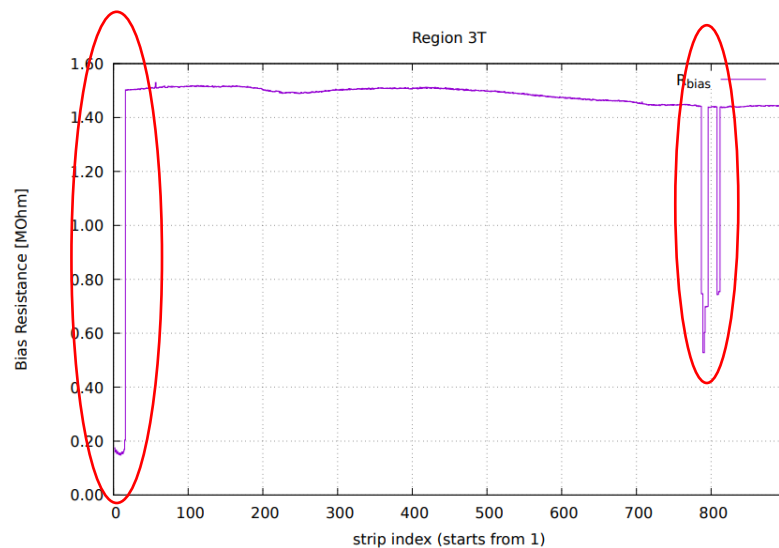
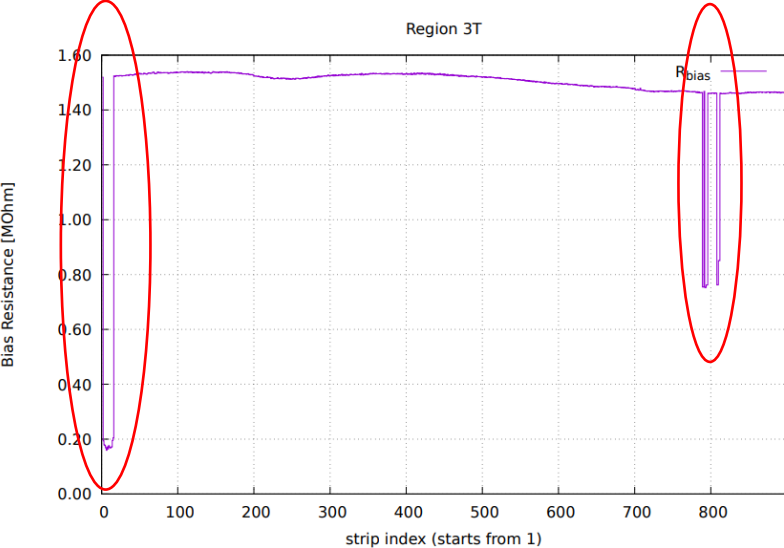
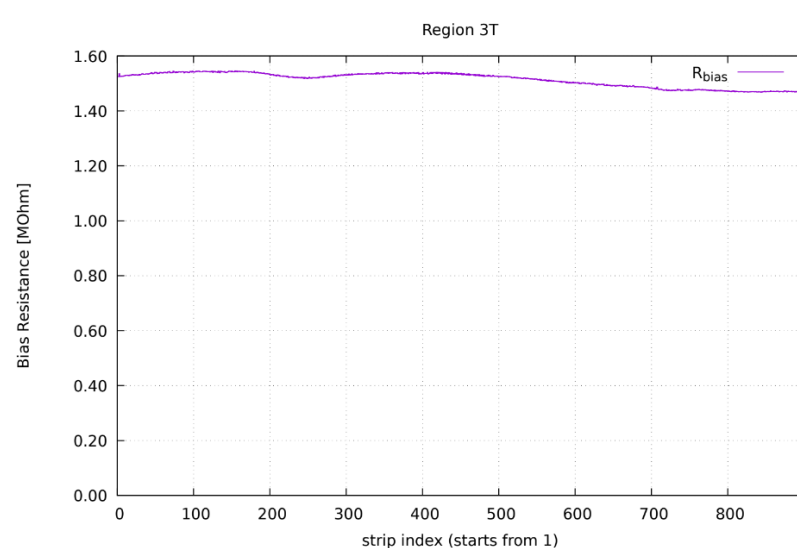
R3-W1014: Full Strip Tests

Full strip test before irradiation: # of bad strips	Full strip test after irradiation: # of bad strips
R1-W635	40	0
R1-W620	18	18
R3-W1014	24	0

- Gamma irradiated sensors **cured**: BDV increased and low interstrip isolation areas disappeared
- Reference sensor (transported and handled alongside the other sensors, not subjected to irradiation) **not recovered**.
- Gamma irradiation resolved issues successfully during initial planned step of irradiation with 11 krad (~1 week in the real experiment) => further irradiations to higher TIDs were not needed
- Instead, the reference samples were irradiated to an even lower TID of 1.5 krad (~1 day in the real experiment).
