Identification and Recovery of ATLAS18 Strip Sensors with High Surface Static Charge

Abstract

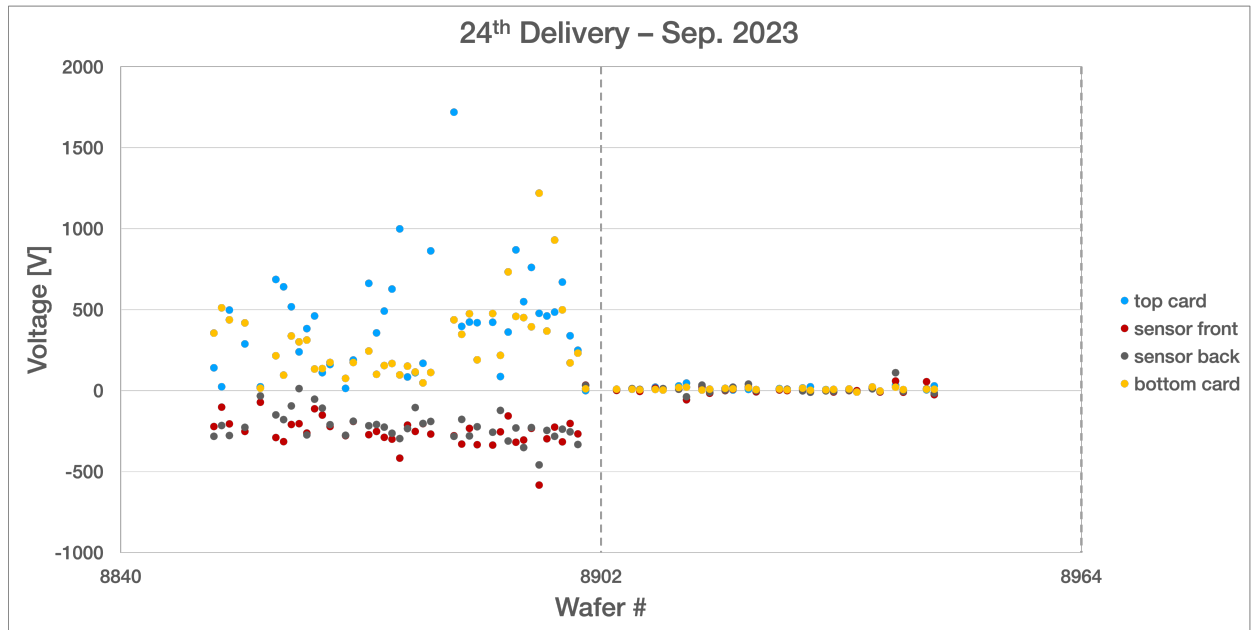
Figure 1: Surface static charge measured on two batches of sensors from the same delivery. The first batch, left of the hashed line, have high static charge on the sensors and sheets. In the second batch, right of the hashed line, the static charge is drastically lower.

A dependence of surface static charge on the sensor’s packaging material has been observed. Figure 1 demonstrates the effect of the packaging cards. In a single delivery two back-to-back batches of sensors are packaged with the two kinds of packaging cards. In the batch packaged with “old style” cards (left of hashed line) the static charge measured on the sensor and cards is on the order of many hundreds of volts and in extreme cases >1000 V. However, the second batch, packaged in the “new style” cards (right of hashed line), shows very little static charge, typically <100 V.

1. **Static charge measurement:** The surface static charge of the sensor and packaging cards is measured by an electrostatic field meter upon sensor reception and unpacking. This was not originally part of the QC procedures but has been adopted as part of QC initial reception. Sensors with high static charge may be specially selected to undergo LTS or strip testing.
2. **Electrical grounding:** Grounding mats and bracelets are used in laboratories of QC sites in order to prevent the build up of static charge while handling sensors.
3. **“Matte-matte” orientation:** Sensors are packaged in paper envelopes and sheathed between two stiff protective cards. The cards have two distinct sides: shiny and matte. When sensors are stored in a particular orientation, with both matte sides of their packaging cards facing towards the sensor, the build up of static charge is reduced.

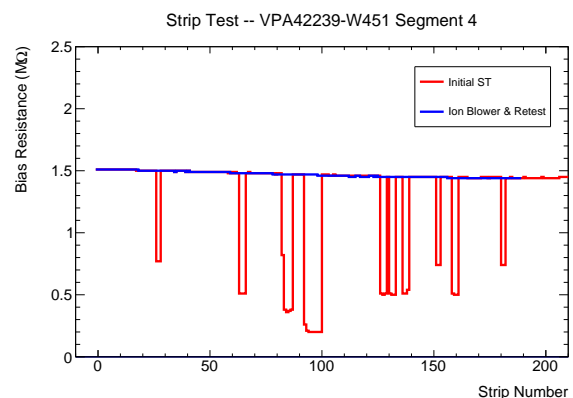
Figure 2: Bias resistance of the first ~200 strips of the topmost segment of a sensor as measured in the strip test. The initial measurement is shown in red and re-test after ion-blower treatment shown in blue.

An example of a strip test recovery is demonstrated in figure 2. Shown here is a sample of the strip test in the first ~200 strips of the topmost segment of a sensor. After the initial test (shown by the red curve) many regions each comprised of a couple to nearly a dozen strips have apparent low bias resistance. As previously explained, this is an indication of poor inter-strip isolation, most clearly seen in doublets and triplets of strips whose measured bias resistance is reduced by a factor of 2 or 3 compared to the nominal value of

1.5M Ω . Localized surface static charge may be high enough to invert the surface just below the SiO₂ interface. With strong enough inversion, a conducting channel will form between strips interfering with the p-stop isolation structures and effectively eliminating inter-strip isolation. After the ion blower treatment (shown by the blue curve) it is apparent that this localized static charge has been eliminated and the inter-strip isolation is recovered in all regions where it had previously been compromised. Analogous examples of such recoveries for both IV and strip test failures using the UV-A and ion blower treatment are in [6].

1. **Ion-blower treatment:** Sensors may be treated for short periods of time, on the order of minutes, with

streams of ionized gas even before any QC failures take place especially if their measured static charge is greater than 100 V. This treatment is also used as a recovery technique on sensors which fail either the IV or the strip test.

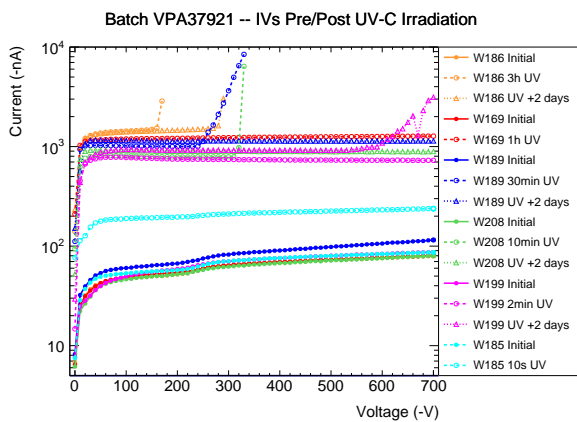
Figure 3: The effect on IV from UV-C exposure.

As a recovery technique, exposure to a UV-C light source is reserved for challenging cases of low inter-strip isolation which cannot be recovered in any other way. While very effective at restoring inter-strip isolation, the treatment has the undesirable side-effect of greatly increased leakage current by up to a factor of 20. The effect of UV-C exposure on sensor leakage current was tested using the lamp from a SAMCO UV-1 bench-top UV-Ozone cleaning system (other features of the system such as heating and gas flow were disabled). The results of this testing are shown in figure 3. Various wafers from a single batch with poor strip isolation were selected for UV-C treatments of various exposure times ranging from as little as 10 seconds up to 3 hours. In the shortest exposure time (10 s) the sensor leakage current increased by about a factor of 2. After a few minutes of exposure, the leakage current appears to saturate with relatively minimal increases for greater exposures. Additionally, it can be seen that prolonged exposures to UV-C light will not only increase the total leakage current, but also induce an early onset of breakdown. For this reason, the UV-C light exposure should be extremely short, that is, less than a few minutes.

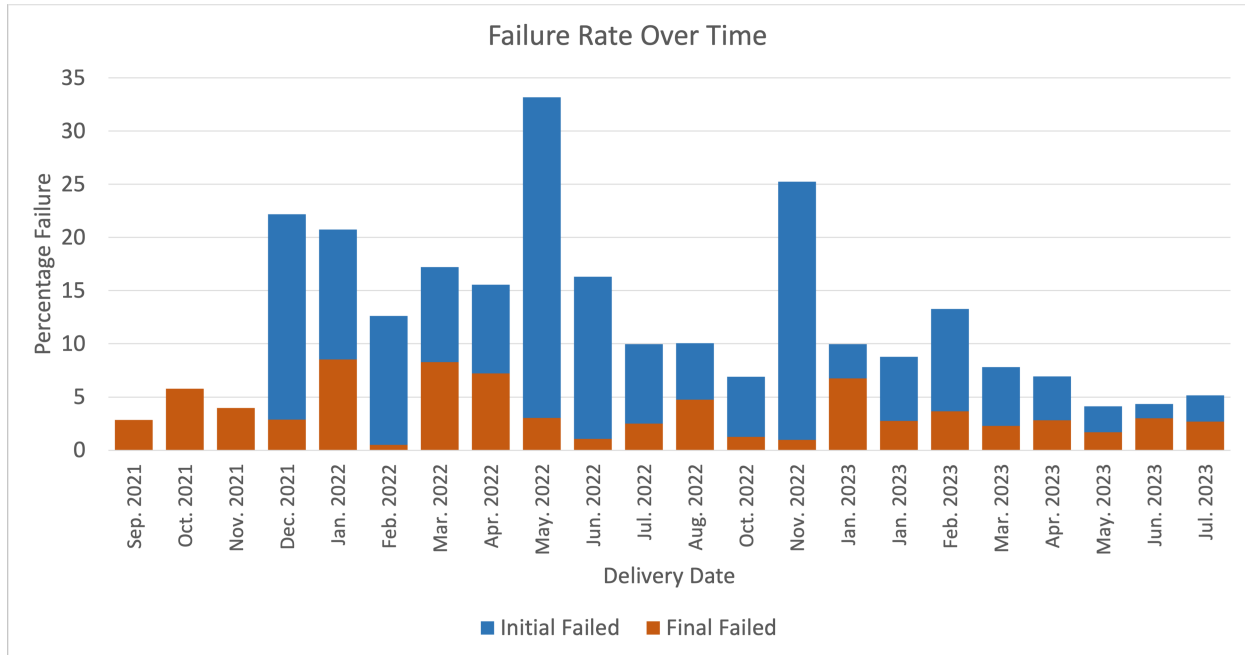
Recovery of sensors has greatly decreased the total failure rate as shown in figure 4. Initial failure rate is the rate of sensors failing any QC tests before any recovery techniques are attempted whereas the final failure rate is the rate of failures after recovery. Following the third delivery, the initial failure rate drastically increased and the need for recovery became apparent. Hence, there were no recovery efforts throughout the first three deliveries. The figure demonstrates that the recovery efforts of the QC sites have been effective at keeping failure rates below 10% in every single delivery and below 5% in all but 4 deliveries¹. More generally, the overall trend is a reduction of the fraction of sensors with issues toward the end of the time period shown.

Figure 4: A summary of sensor failure rate over time for the first 22 deliveries. The “Final Failed” rates are much lower than the “Initial Failed” rates and reflect the recovery efforts implemented by QC sites.

Strategies for mitigating and treatments for recovering sensors with high static charge have been implemented by the QC sites. These, along with site specific setups are detailed in [6]. The summary of the QC site efforts is that sensors failing IV and strip test can be typically recovered in two dominant ways, particularly when the root cause appears to be high static charge accumulation. Exposure of sensors to a constant stream of ionized gas for short periods of time (on the order of minutes) or to a UV-A light source for longer exposures (>8 hours) often leads to improvement of the sensor performance.
