Gamma irradiation of ITk silicon strip modules with early breakdown

LHCP 2024: 12th Edition of the Large Hadron Collider Physics Conference
Boston, Massachusetts — 3-7 June 2024

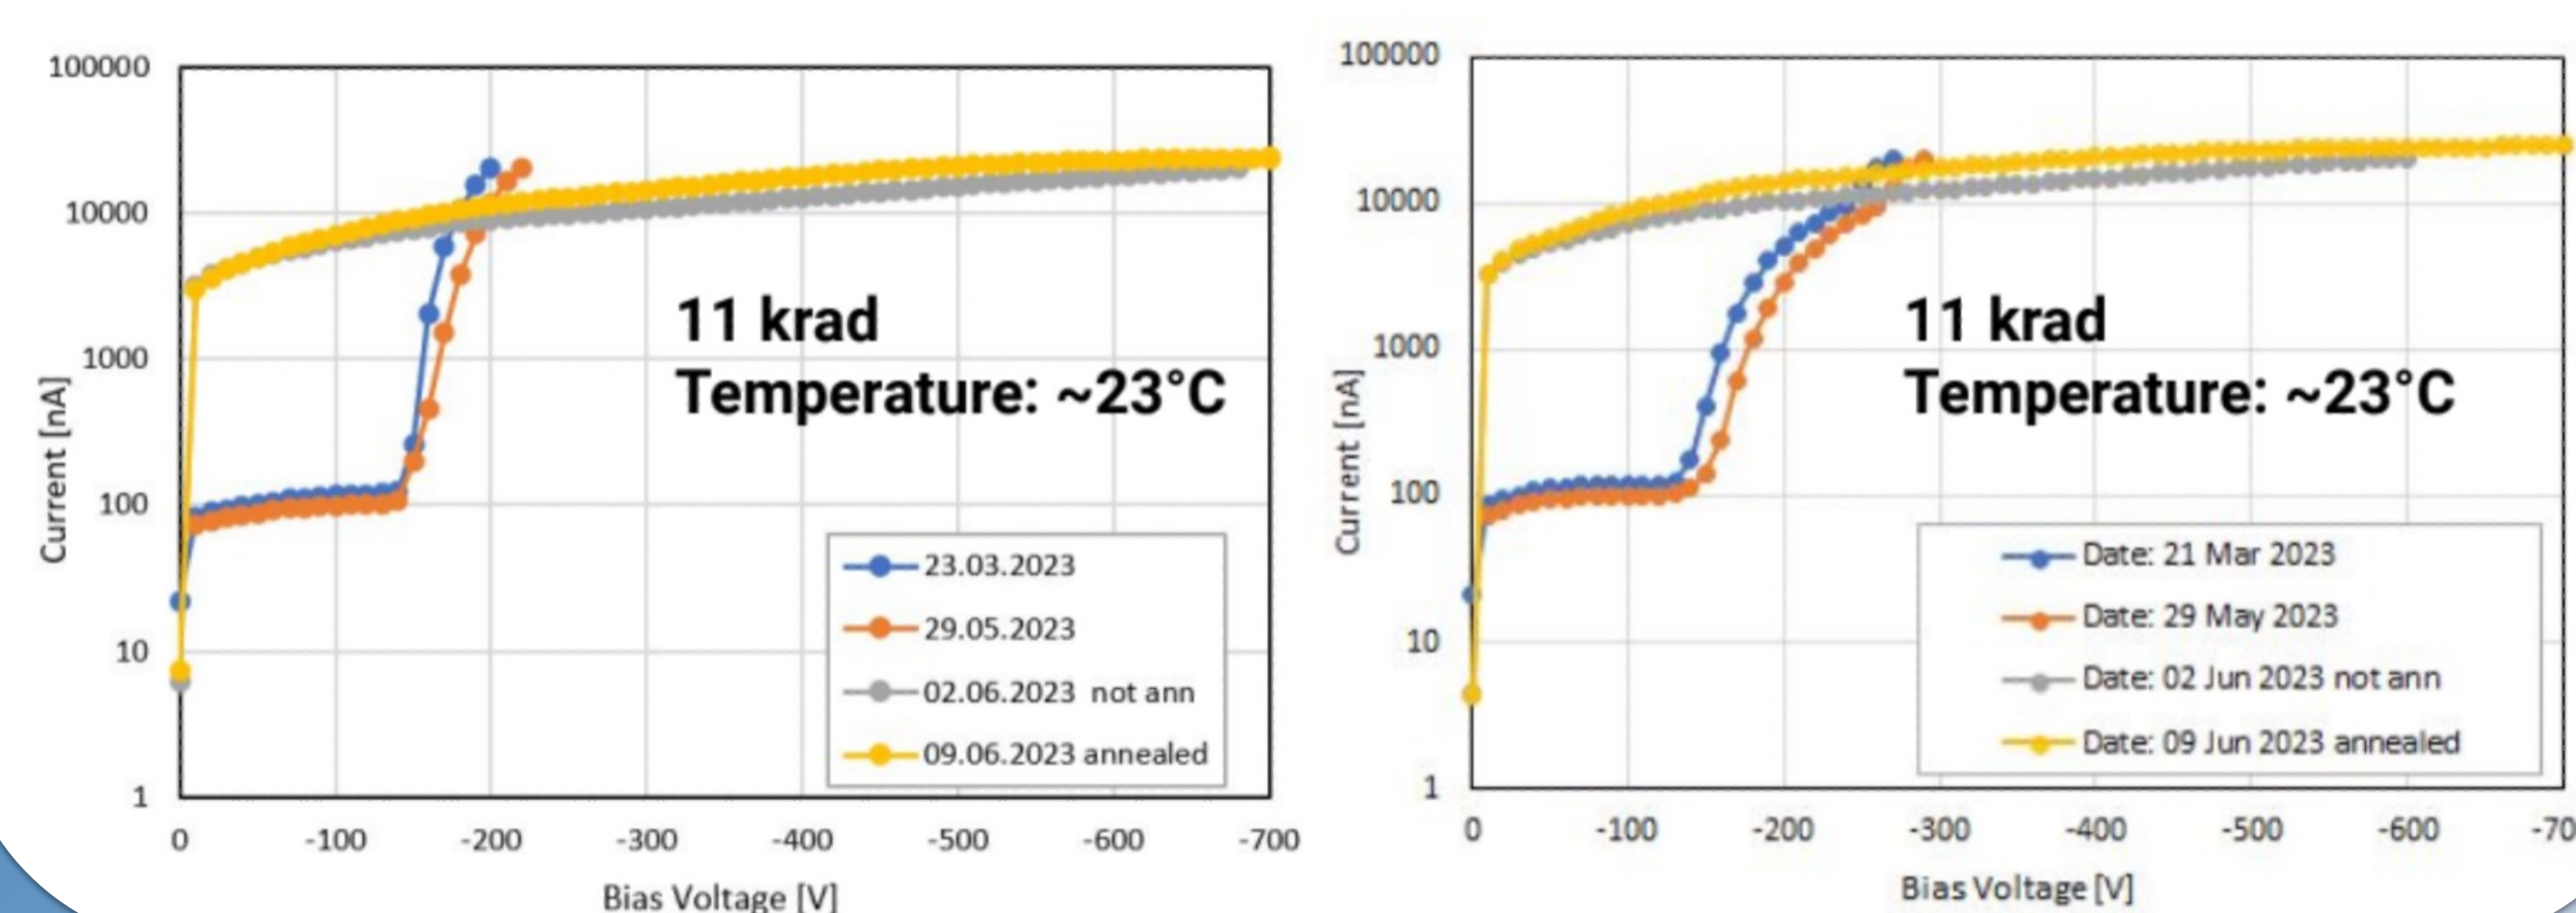
Results on bare sensors from Prague
W617 W607

- Sensors irradiated by Prague group showed early breakdown cured by 11 krad of gamma radiation [3]
 - Will we get the same effect after gluing?
- Similar ionizing irradiation can be performed at BNL gamma facility with ^{60}Co source
- We irradiated modules with 11 krad of ionizing radiation at BNL, equivalent to 1 week in HL-LHC

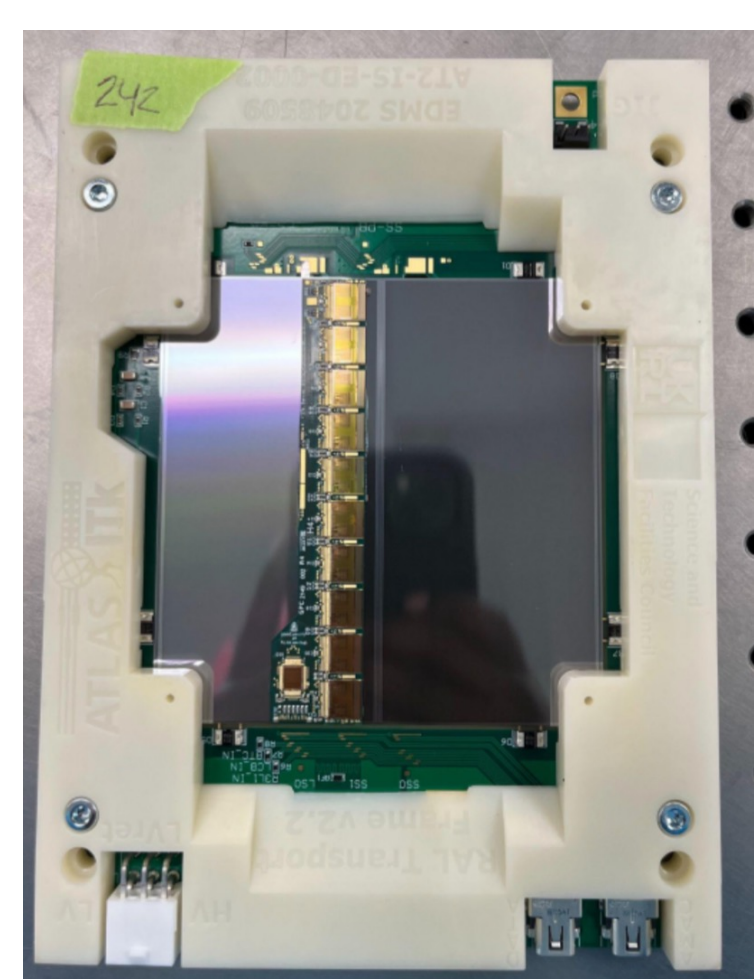
Irradiated module	Special characteristics
BNL-PPB2-MLS-242	Breakdown ~520V, unbonded
BNL-PPB2-MLS-243	Breakdown ~450V, unbonded
BNL-PPB2-MLS-213	Breakdown ~500V, glue on the guard ring

- Two **unbonded** modules developed early breakdown after gluing the hybrid onto the sensor
 - Irradiated before continuing assembly
- One module with **glue on the guard ring** irradiated (known cause of early breakdown [2])

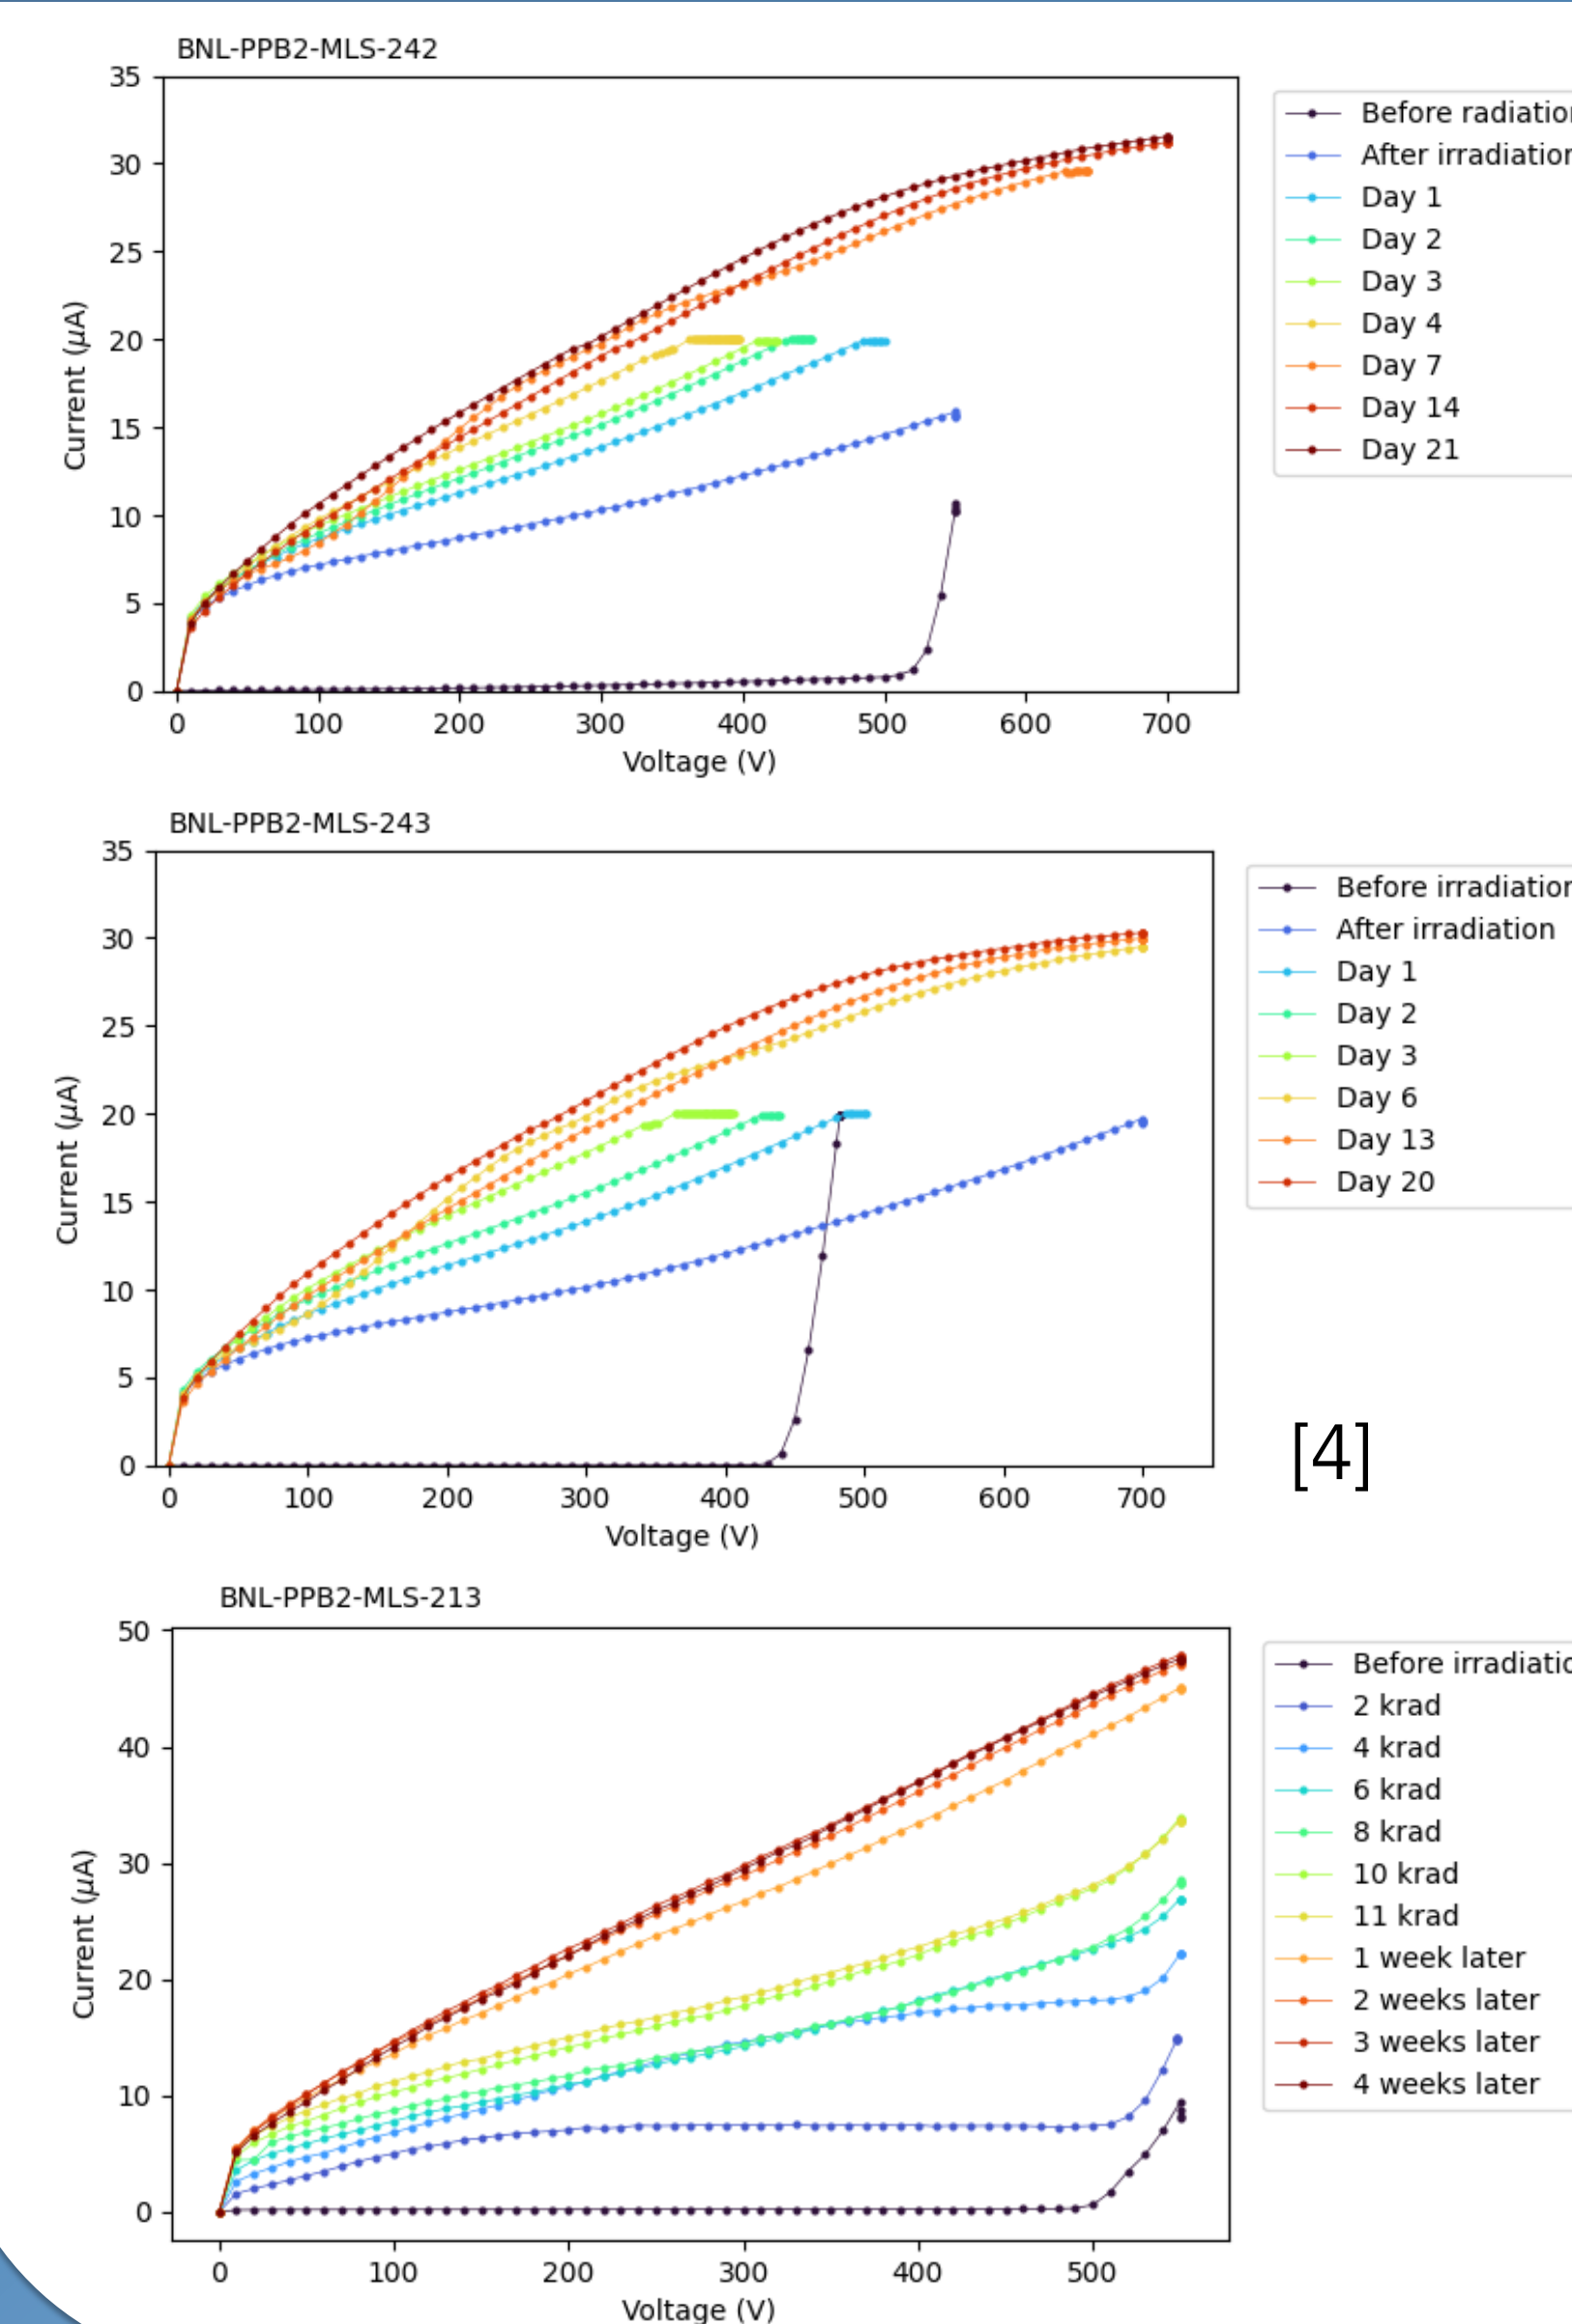
- Because of module electronics, BNL-PPB2-MLS-213 could only be biased up to 550V
- After irradiation, we see higher leakage current due to surface currents
- Sensors appear to self-anneal over time before current stabilizes
- In all cases, **breakdown voltage improves**

- 11 krad of ionizing radiation cured early breakdown in 3 modules, 1 with glue on the guard ring
 - Modules will experience this dose in just 1 week of HL-LHC
- BNL plans to irradiate more modules with early breakdown as they are discovered, particularly modules with glue on the guard ring
- These results mark a significant step towards establishing a reliable pattern of component recovery during detector operation
