# MICROBIOLOGICALLY INFLUENCED CORROSION IN THE FERMILAB MAIN INJECTOR MAGNET LOW CONDUCTIVITY WATER SYSTEM\*

P. G. Hurh<sup>#</sup>, N. Kubantseva, M. P. May, FNAL, Batavia, IL

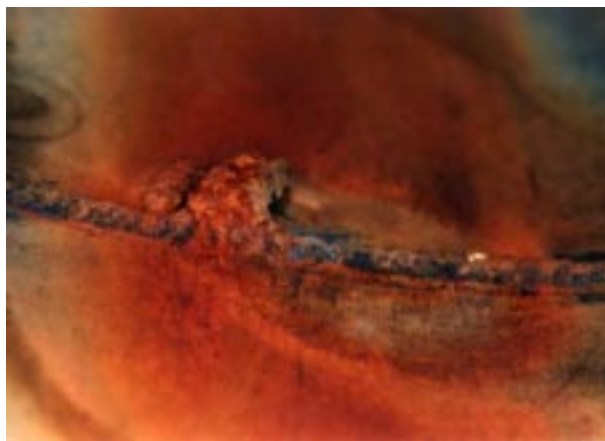
Figure 1: Typical corrosion site on MI LCW pipe weld.

The internal visual inspection revealed that almost every weld in the piping exhibited signs of advanced corrosion. Most welds had orange colored streaks flaring

out from tack welds that had not been consumed by the final weld pass. A majority of welds had a build up of corrosion byproduct (and MIC nodules) in several places on each weld. Some of the nodules were crumbled and/or knocked off by the passage of the camera device. The worst damage was usually at the bottom of the pipe.

The most widely used repair method was to remove the crown of the old, defective weld and then overlay with a new weld (316L stainless steel filler material). In this manner, the existing weld metal was re-fused and a new crown layer was added. In addition, the entire weld area was exposed to high temperature during welding which helped sterilize any remnant bacteria.

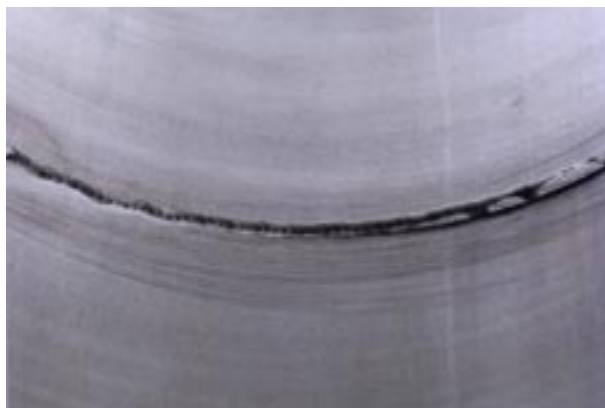
Figure 2: Mechanically cleaned SS pipe weld.

These devices all utilized spinning sets of abrasive pads (silicon carbide) driven by air motors. One device consisted of a spinning abrasive disk and an air motor mounted on spring-loaded wheels. This device was designed to be pulled through the pipes and buff the entire pipe inner surface including welds. A more sophisticated device design utilized a digital video camera to allow the operator to locate the cleaning pads on the dirty welds.

These devices eliminated all discoloration, both from heat tint and MIC deposits, on the pipe inner surface. In order to ensure that our techniques were adequate to protect against future corrosion, a microbiologist and a metallurgist reviewed the mechanical cleaning method and approved of its use.
