Study of Bump Bonding Technology[#]

S. Cihangir, J. Andresen, J. A. Appel, G. Cardoso, D. C. Christian, C. Kendziora, S. Kwan, M. Marinelli, M. Ruschman, M. Turqueti, M. L. Wong, S. Zimmermann

Fermi National Accelerator Laboratory*
P. O. Box 500 Batavia, IL 60510, USA
selcuk@fnal.gov

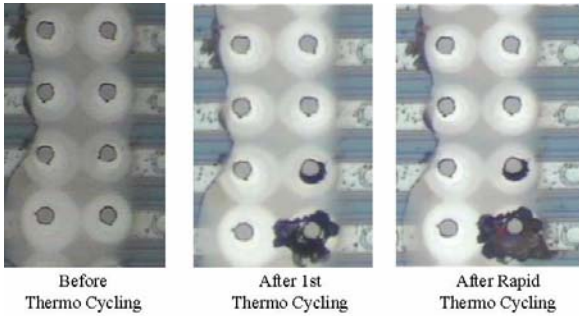
Figure 2: Degeneration at indium bumps

We observed that the indium at some of the bumps degenerated during thermo cycling. Figure 2 shows two such bumps before and after each of two thermal cycling. Degeneration progresses in one bump from one cycling to another. Some bumps had this degeneration before any thermo cycling. Table 1 lists the count of such degenerated bumps before and after each cycling. This effect might cause a change in capacitance of the corresponding electronics channel resulting a noisy readout.

Existed Before T-Cycling	Created During 1 st T-Cycling	Created During Rapid T-Cycling
AIT 1	225 (0.96%)	23	95
AIT 2	255 (1.1%)	28	69

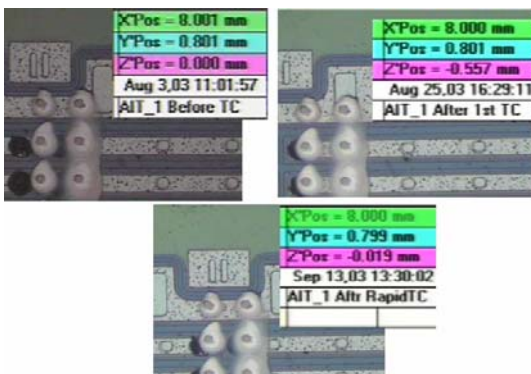
Figure 3: Location of one corner of a chip

We also observed that the glass chips shifted around during thermo cycling. In Figure 3 we show one corner of the first chip on AIT_1. The inset in each picture indicates the procedure for which the image is taken. Locations of the bumps relative to the structure on the sensors clearly indicate the shift. By studying the other corners of this chip, we concluded that it was originally misaligned during bump bonding. It then moved sideways about 50 μm and rotated counter clockwise during the first thermo cycling. During the second thermo cycling it shifted back to almost its original position with a slight clockwise rotation.

The glass chips on the other module, which was glued to TPG before the second thermo cycling did not shift at all, indicating that the CTE mismatch between the TPG and the silicon did not matter in this case.

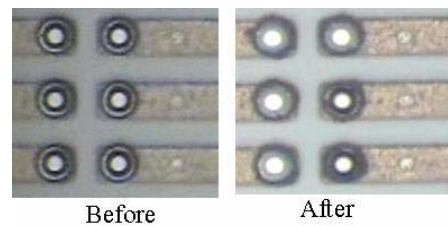
Figure 5: Colour blending of first dark ring

We observed in some of these bumps that the first dark ring changed colour to blend into the bright circle at the centre. Figure 5 illustrates this colour blending. It occurred originally on ~2% of the bumps, mostly on the edges of the chips. The new occurrences appeared with the second thermo cycling and the irradiation. One of them disappeared during the rapid thermo cycling. Table 2 shows the counts of new occurrences after each process. The module MCNC_1 is excluded because it was damaged during bump bonding procedure.

MCNC Module	After 1 st Cycling	After Radiation	After 2 nd Cycling	After 3 rd Cycling	After Rapid Cycling
2	0	124	N/A	0	7
3	0	N/A	93	16	99
4	0	N/A	0	3	-1

A possible explanation to this is that, the BCB is lifting off on the walls of the via (with or without cold) and partially reflecting the light causing the colour blending. In one case, the BCB shrinks back to re-create the dark ring. This phenomenon should not cause any problem to the electrical characteristics of the bump.

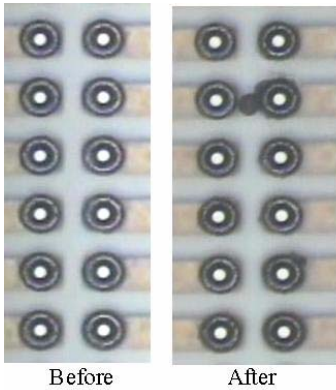
Figure 6: Extrusion developing at solder bumps

We also observed in some of the bumps, development of dark extrusions as shown in Figure 6. These also begin to appear during the second thermo cycling and the irradiation at a rate of ~ 50 per module. They seem to be on the surface (glass side) and mostly on the edge bumps. The vendor suggested they might be due ionic contamination (BCB originated), not completely removed during final cleaning.

We are still investigating with the vendors on the causes of these observed changes. While the bonds seem to remain intact despite these changes, we will do a pull test to study these bumps.

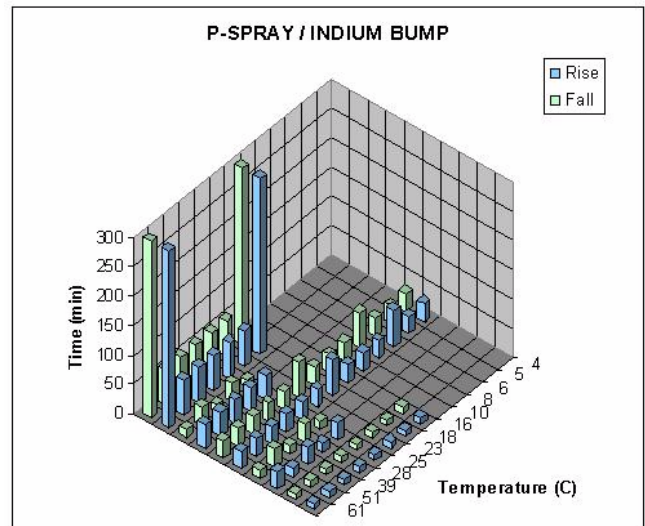
Figure 8: Temperature scan for indium bump detector

% of channels	at 7°C	at 69°C
Working	96.25	61.88
Not Responding	3.20	32.81
Very Noisy	0.55	5.31

% of channels	at 7°C	at 69°C
Working	96.02	61.95
Not Responding	3.28	32.27
Very Noisy	0.70	5.78

The indium bump detector shows a slightly bigger permanent effect of the thermo cycles compared to the solder bump detector. As we have seen in the cooled glass-silicon modules, the temperature cycling might be damaging the indium bump causing a change in the capacitance of the channel. This in turn results the non-response and/or noisiness we observe on the channels albeit at a very low level (<1%).

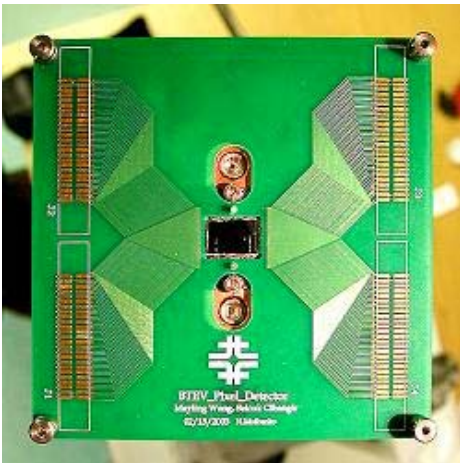
Figure 9: PCB-hybrid assembly for the cryo test

We had two cycles of exposing this PCB-hybrid assembly to LN₂ temperatures and all of 15 channels and their wire-bonds survived with no damage. We have built another PCB-hybrid assembly with 40 channels and will build a few more to extend this study with higher statistics.
