CERN/AT 2006-6 (MEL)

CONSOLIDATION OF THE 45-YEAR OLD PS MAIN MAGNET SYSTEM

Th. Zickler, D. Bodart, W. Kalbreier, K.H. Meß, A. Newborough

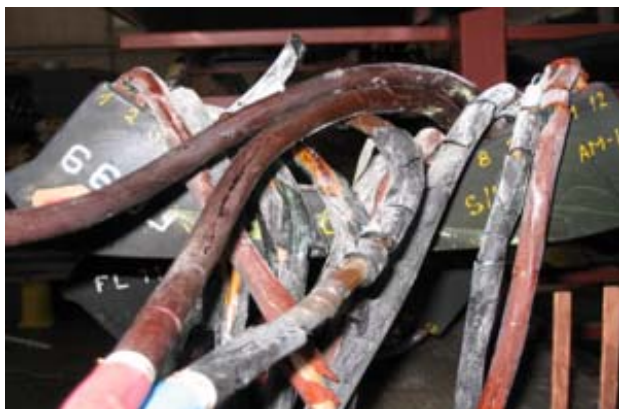
The polyurethane insulation of the PFW cables gave, at first glance, the impression to be generally in good condition. However, after an inspection it turned out that the insulation is falling apart when touched (see Figure 1). This damage results from a combined effect of degradation of the organic material submitted to high irradiation and its poor resistance against microbes.

Figure 1: Destroyed PFW cable insulation.

Once a PFW cable has been moved - accidentally or on purpose during an intervention - the insulation is completely damaged and the entire PFW has to be replaced. Since almost all PFW cables are suffering from this degradation the risk of a breakdown is considerably high. A PFW could be replaced in situ, but the vacuum chamber has to be removed, which requires a displacement of the magnet unit from its position.

The 240 PFW were produced by SIGMAPHI/ France. The main concern, in addition to the tight production schedule and the complex PFW design, was to find highly flexible and radiation resistance connection cables. A series of radiation tests led to the choice of ULTEM® (Polyetherimid) used as cable insulation material.

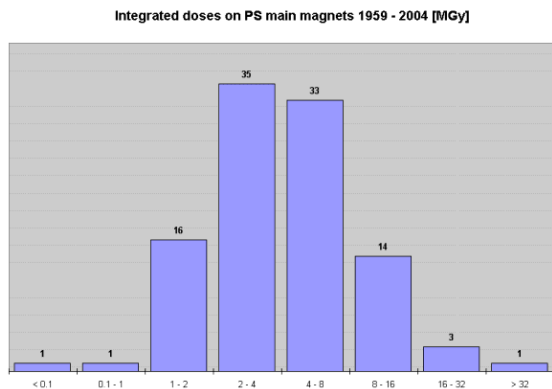
- Detailed visual inspection: Significant degradation of the main coil insulation, corrosion of aluminium conductor, damaged gold plating, disintegrated rubber pads, damaged PFW cable insulation, etc...
- The total integrated dose received between 1959 and 2004: Magnets close or beyond the "lethal" dose limit were given highest priority. 18 magnets were found to have received more than 8 MGy (Figure 2).
- The actual radioactivity: To profit from the exceptional long cooling down time, magnets with high radiation levels were given priority.

Figure 2: Histogram of integrated doses.
