# JTA Skyway 2017 Routine Inspection of Bridge Structures

Prepared For:  
Jacksonville Transportation Authority

Prepared By:  
RS&H, Inc. with/  
FIT Engineering, LLC

Final Draft Report

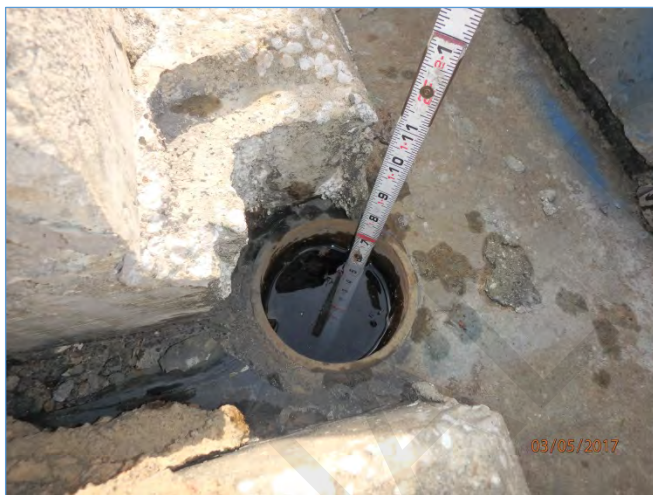
Missing Cap and Clogged Pipe at Pier 12, LT Guideway

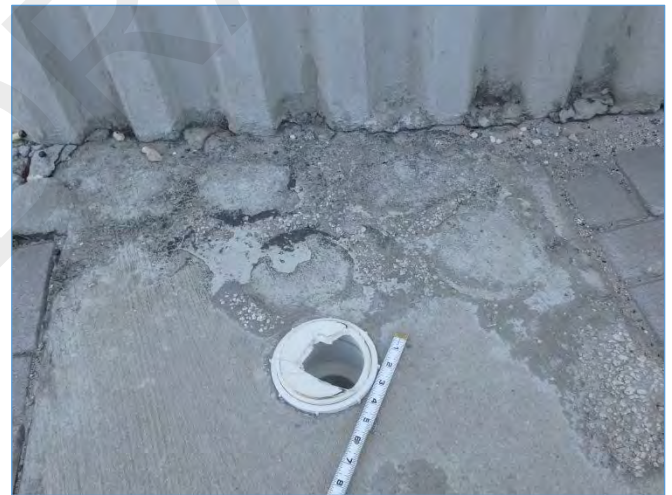
Broken Riser Pipe Cap at Pier 256L

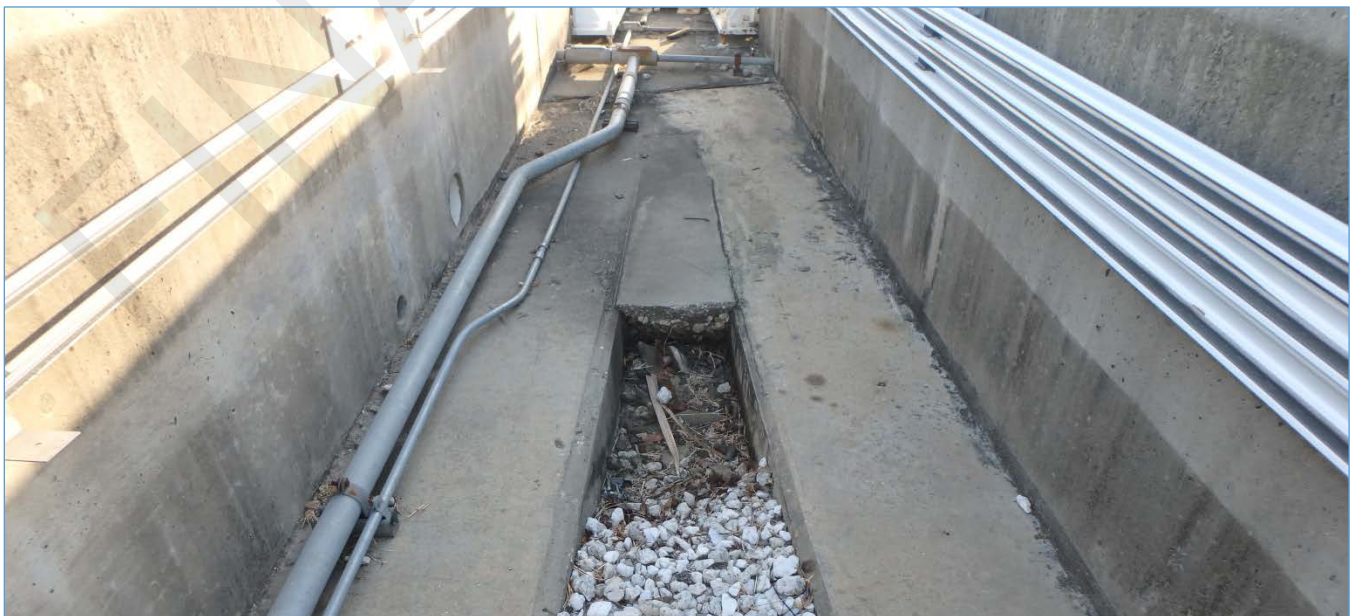
Shown in the photo below is an area of erosion between two slab-on-grade finger spans at the O&M Facility. Concrete was poured between the slabs in an effort to stop the erosion, but that just moved the affected area further back. This area is between M1B3 and M1B4 and measures 3.5' L x 14" W x 9" D. A similar area of erosion is present between M1B2 and M1B3.

Erosion Between Slab-on-Grade Spans M1B3 and M1B4 at the O&M Center

- Remove the soil and debris from the top of the deck, especially at the scupper locations. This should be done on a regular basis.
- Repair/replace the deck drain grates at the following locations: Pier 8 (N), Pier 12 (N&S), Pier 24N, Pier 24S, Pier 65R, Pier 66R, Span 253 (RT), Pier 255 (RT), Pier 406L, Pier 204L.
- Repair/replace the riser pipes and/or caps at ground level at the following piers: 214, 228, 230, 256L, 258R.
- Clean out clogged drain pipes at the following locations: Pier 12 (N&S), Span 253 (RT), Pier 255 (RT).
- Repair the eroded areas between the slab-on-grade spans at the O&M facility. Provide a means to convey the stormwater and prevent further erosion.

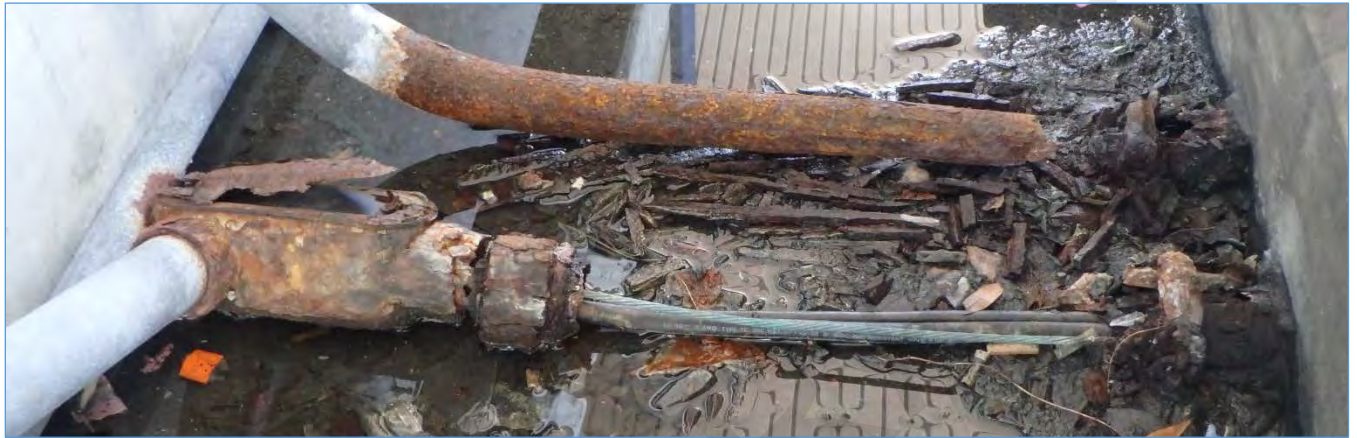
Many of the electrical conduits that run transversely across the deck have moderate to severe corrosion and section loss due to standing water and debris accumulation on the deck. Conduits at San Marco Station have the most significant deterioration, with 100% section loss and exposed wires as shown in the photo below.

Span 238L – 100% Section Loss of Transverse Conduits, Exposing Wires

- Remove soil and debris that has accumulated at transverse conduits on the deck.
- Replace conduit with 100% section loss and exposed wires at the San Marco Station.

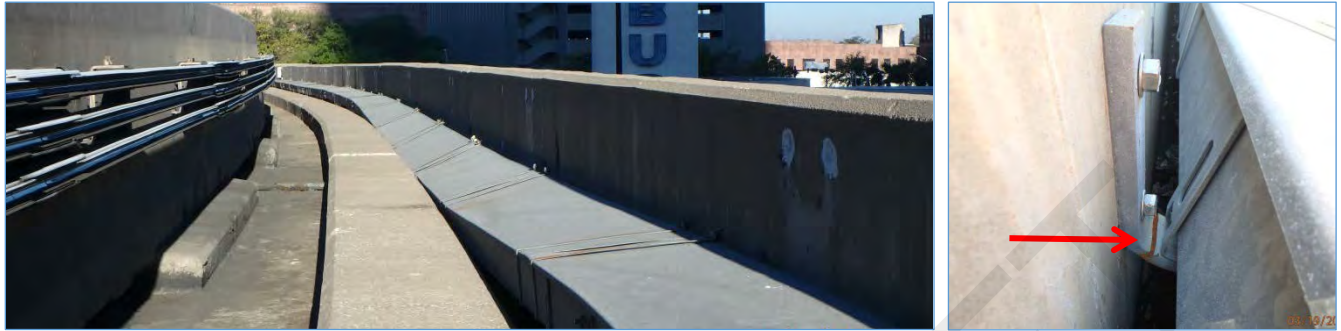
The cable trays that are attached to the inside faces of the sidewalls have isolated areas in need of repair. For instance, in Span 55L, there are three broken attachment brackets which are causing 30' of the tray to lean downward. See the photos below.

Span 55L Cable Tray with Three Broken Attachment Brackets

- Repair electrical cable tray defects at the following locations: Span 55L, Span 200R, Span 232R, and Span 239L.
- Clean and spot paint areas of corrosion on the electrical control cabinets located throughout the system.

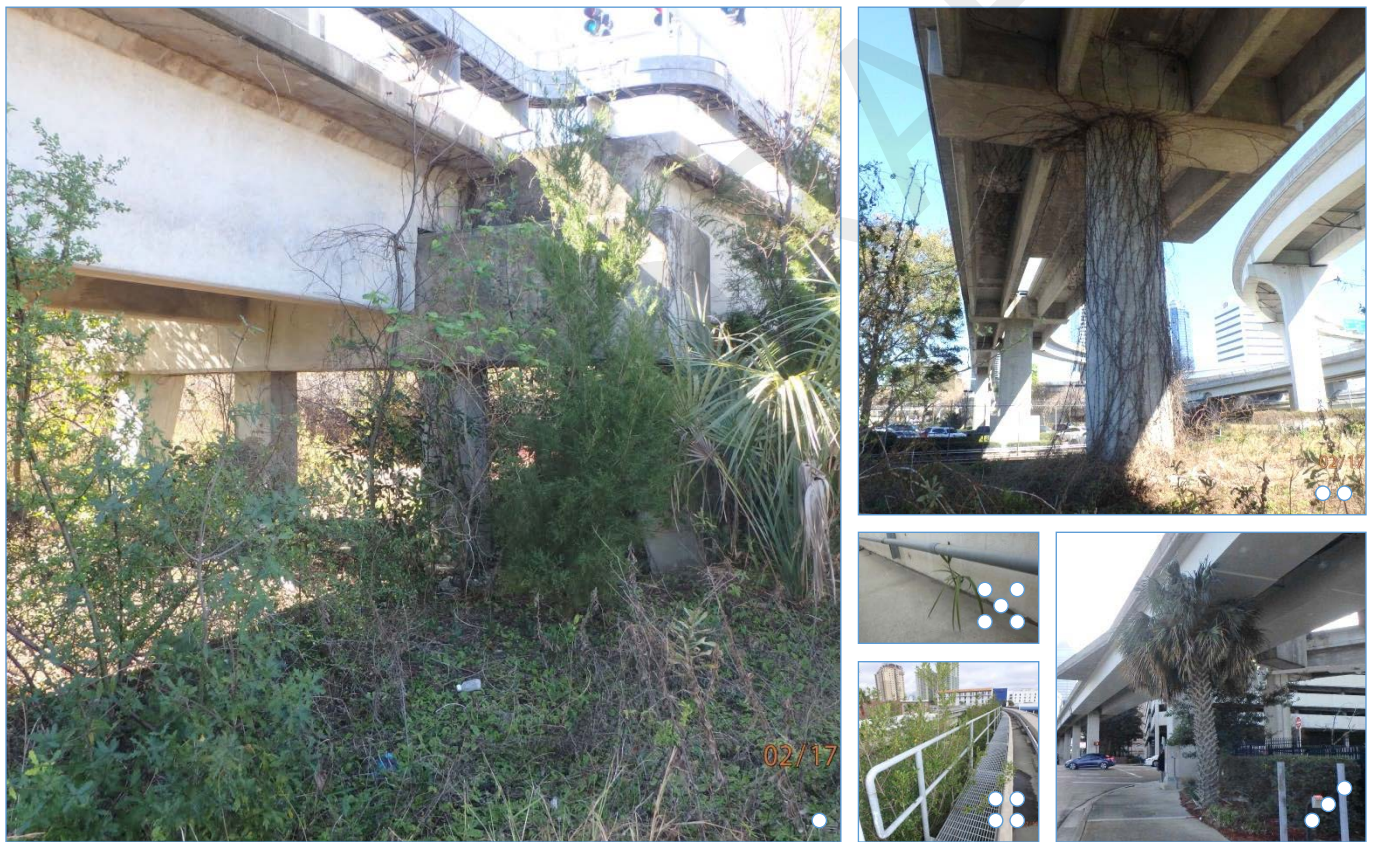
Small palm plants are growing through the joint between the sidewalls and deck at isolated locations throughout the Acosta Bridge spans. See Photo 5 in the collage below.

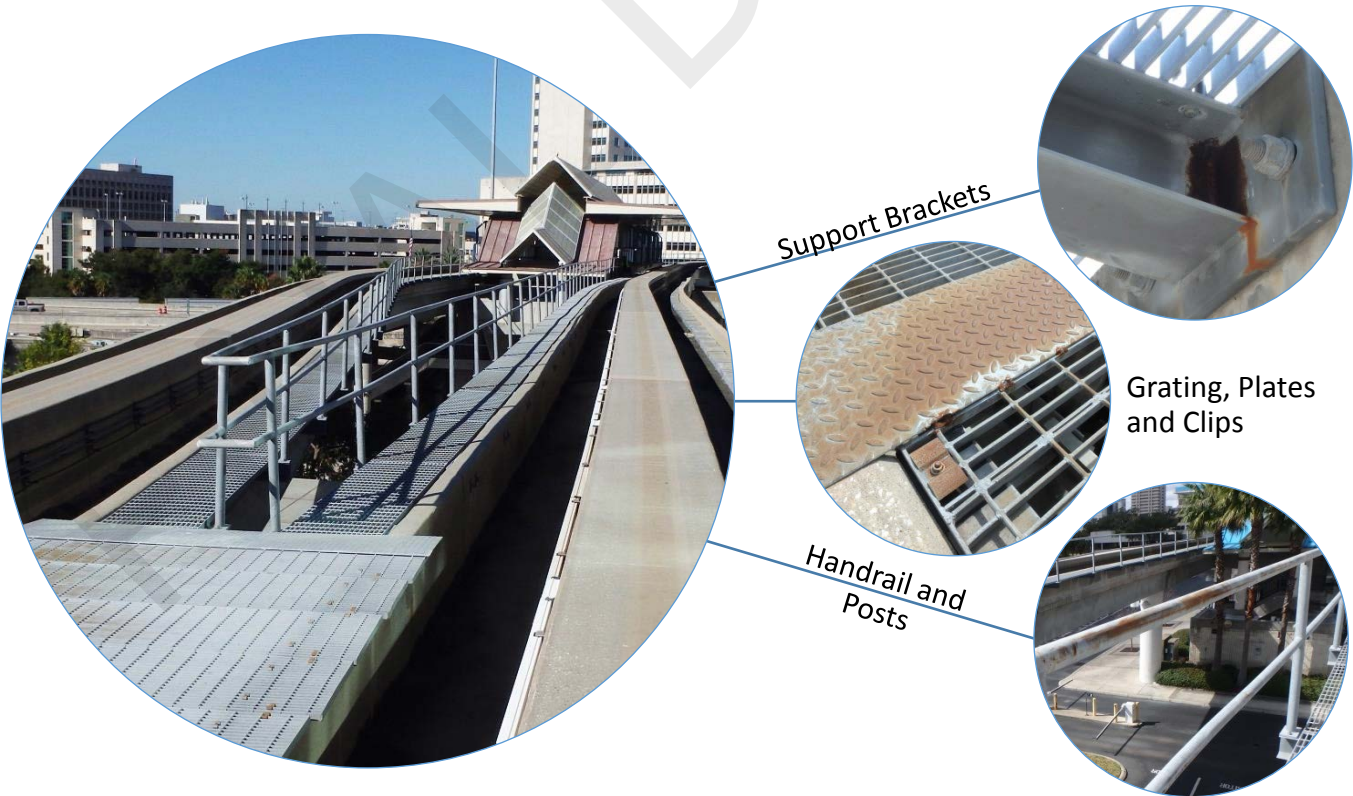
There is light to moderate surface corrosion on the emergency walkway grating, grating clips, and railings at various locations throughout the system, indicating a breakdown of the galvanization. While a number of these have been painted, many remain untreated. Numerous brackets supporting the cantilevered type walkways have moderate to severe surface corrosion at the connection to the sidewalls. See Figure 6 below.

Figure 6. Typical Emergency Walkway Surface Corrosion Locations

- Install new (wider) cover plates at the four Acosta Bridge expansion joints located at Piers R-1 and R-6.
- Apply a corrosion inhibitor such as *Clearco Products High Performance Zinc Spray* to the grating, grating clips, bolts and railing with moderate surface browning and surface corrosion.
- At the cantilevered walkway support brackets with moderate to heavy surface corrosion, clean the brackets with a wire brush and apply a corrosion inhibitor such as *Clearco Products High Performance Zinc Spray*.

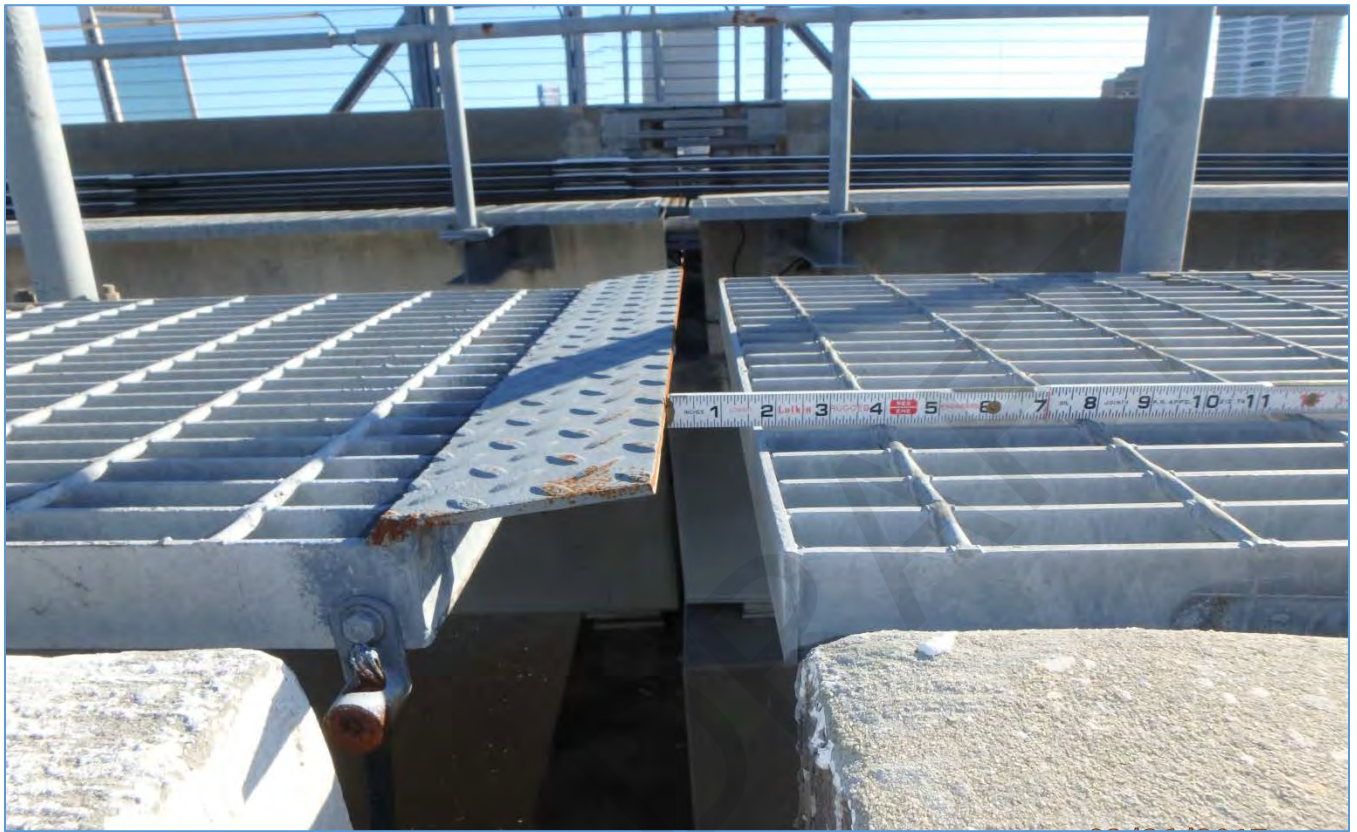
At the Acosta Bridge Piers R-1 and R-6, the grating cover plates are not wide enough to fully cover the expansion joint gaps produced by the bridge deck contraction. See the photo below.

Pier R-1 LT, Emergency Walkway Joint Expanded Beyond Expansion Plate

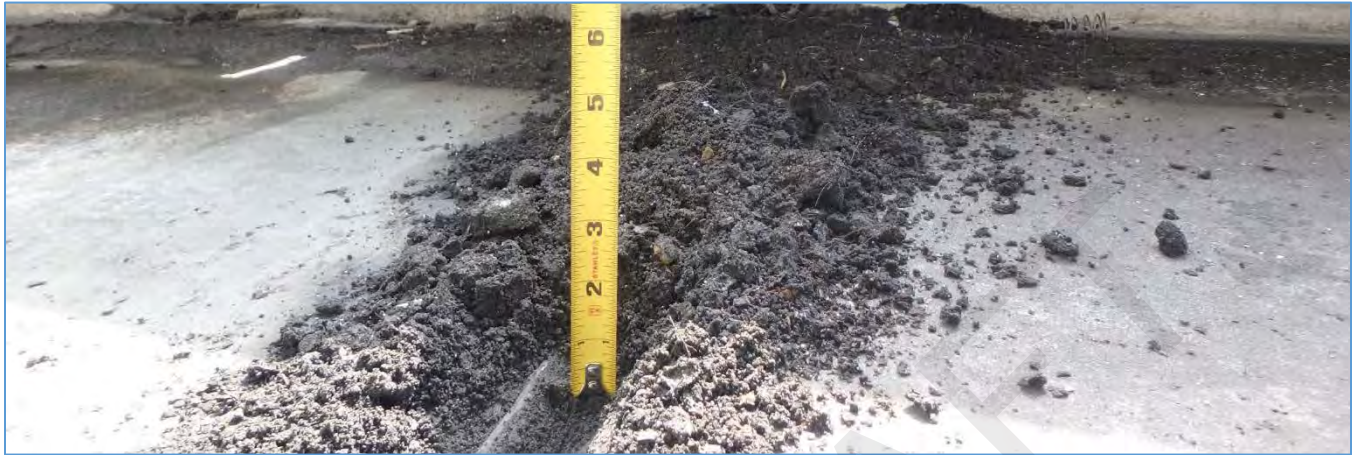
Many deck joints throughout the system are filled with soil and debris. See the photo below.

Pier 223L: 1-1/4" Joint filled with soil and debris.

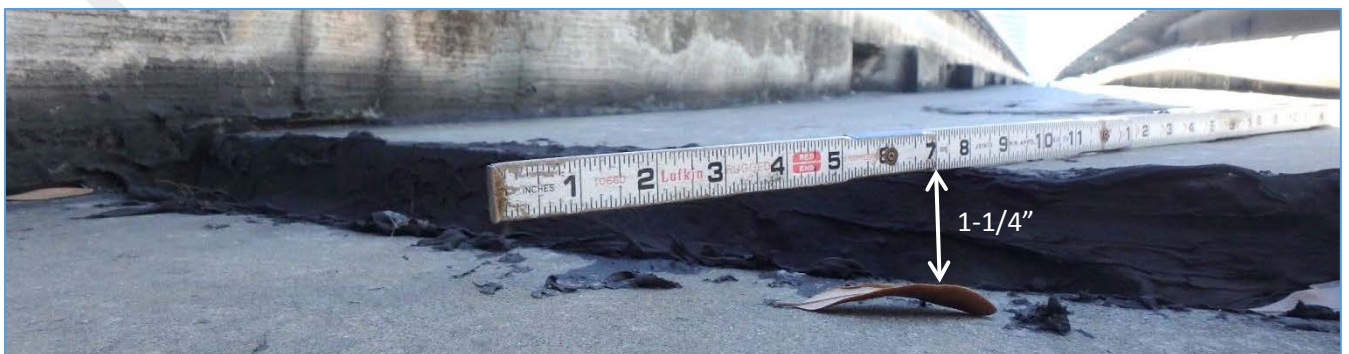
The top of pier cap and top of deck elevations were designed to be even. However, there are locations in which there is a vertical offset between the two. The worst case was noted at Pier 228R. See the photo below.

Pier 228R: 1-1/4" Elevation Difference Between Top of Deck and Top of Pier Cap

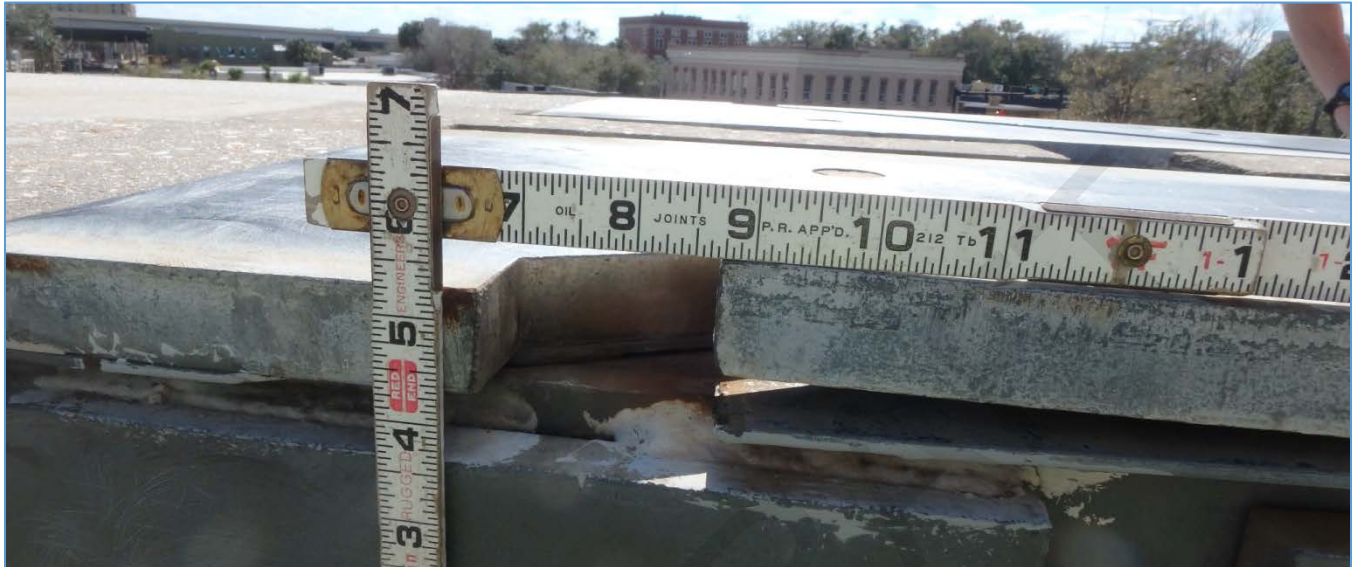
Vertical offsets of the sliding plates were noted at a few locations. The largest elevation difference was found at Pier 210L. See the photo below.

Pier 210L: 1/2" Elevation Difference Between Guidebeam Sliding Plates

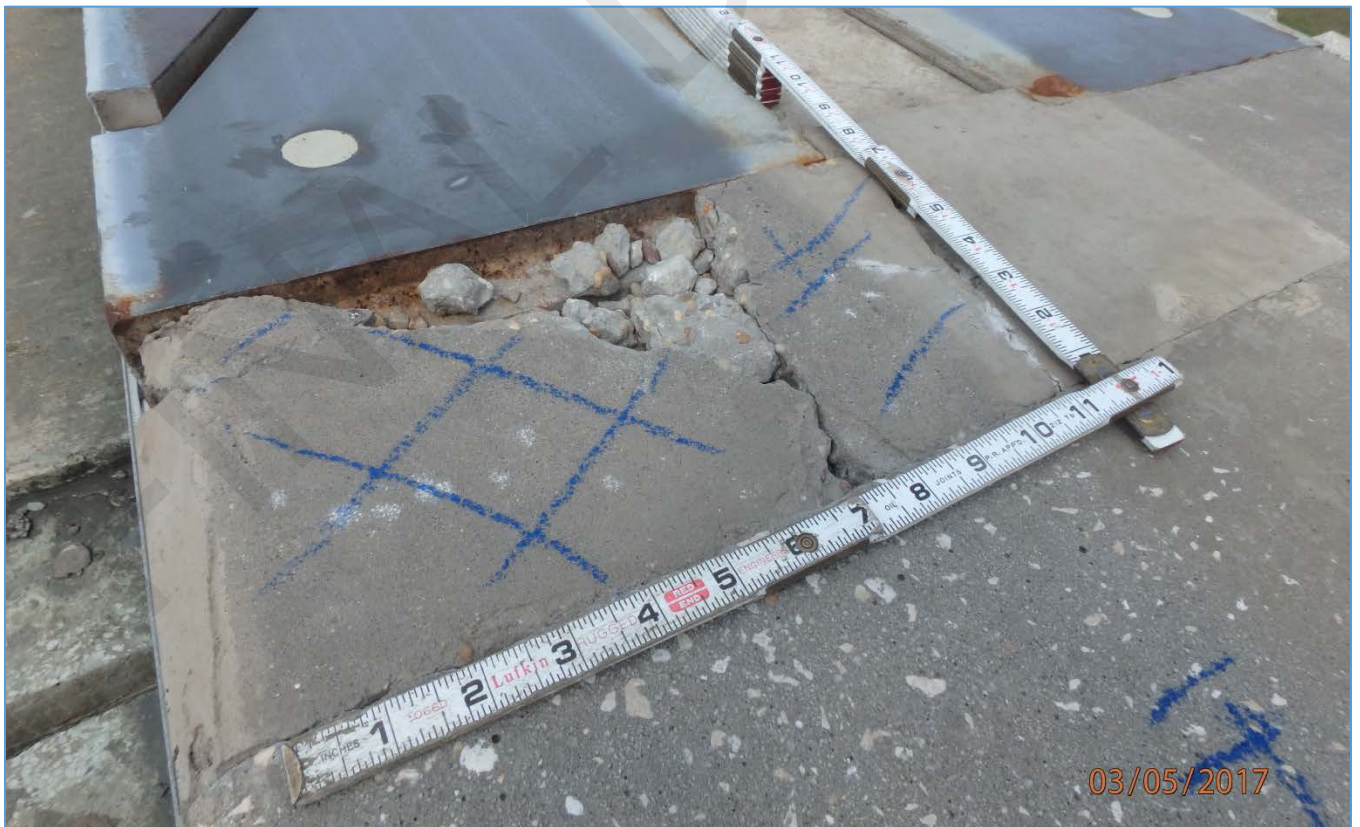
There are multiple locations in which the concrete closure pours (pourbacks), to which studs for the expansion components are embedded, have spalling, delaminations, patches or cracking. See the photo below.

Pier 29N: Spalling and Delaminations on Forward Pourbacks

- Reinstall the retrofit expansion extension plates at Pier R-6.
- Patch the spalls in the concrete pourbacks; locations are listed in Appendix D-5.
- Apply a corrosion inhibitor such as *Clearco Products High Performance Zinc Spray* to areas on the steel plates and fingers with surface corrosion that do not come in contact with the train tires.
- In the long term if the guidebeam is to remain, an engineered solution to retrofit the joints should be investigated due to the deterioration of the pedestals (see the Guidebeam section of this report). Perhaps this could involve replacing the single joint with two that coincide with the deck joints. Another option would be to retrofit the current configuration by replacing the bond breakers with thin sliding plate bearings.

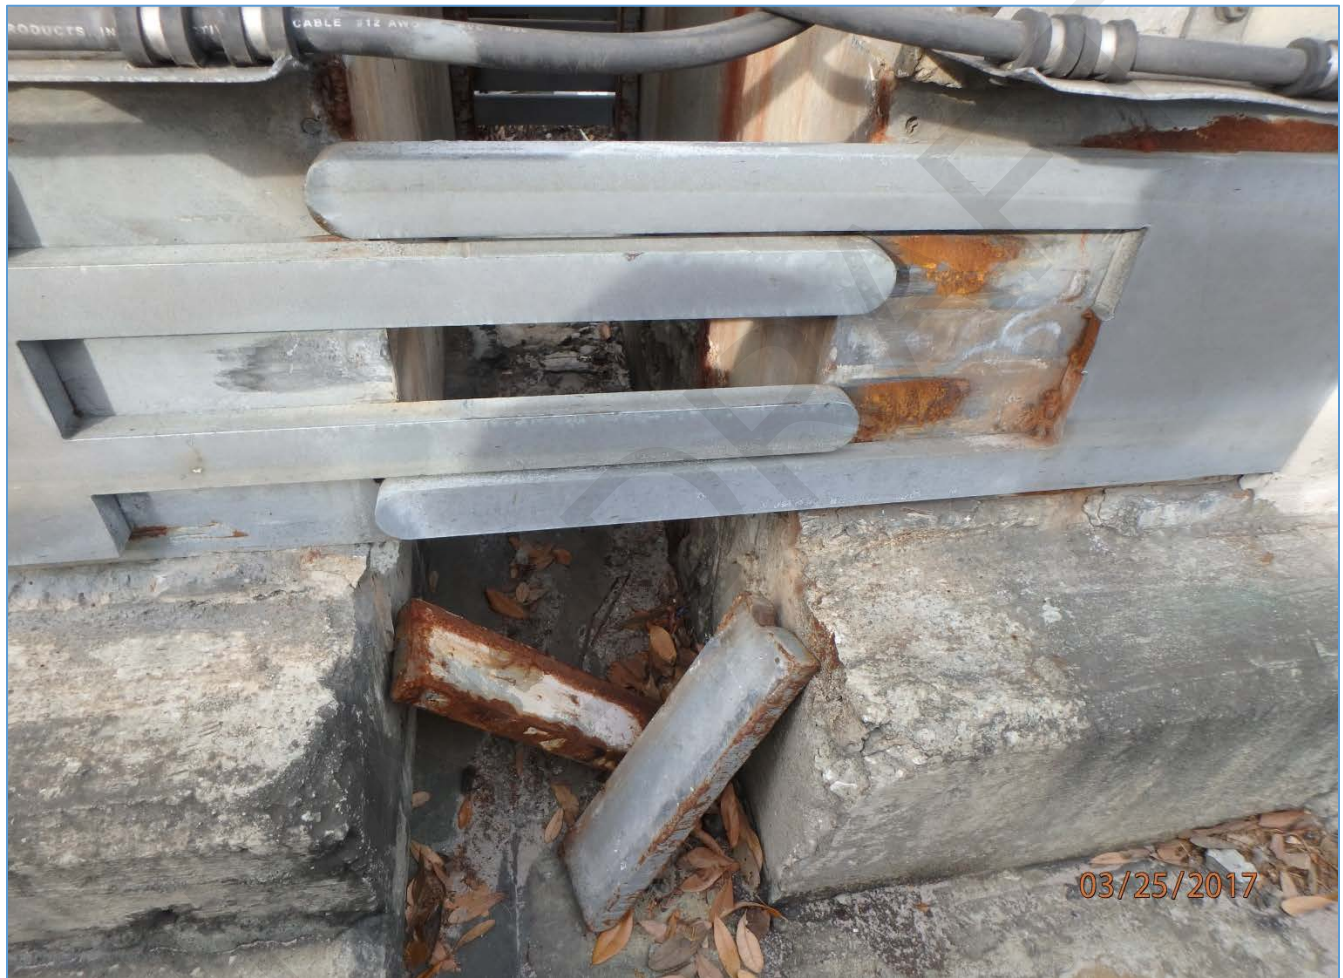
See the photo below showing the fallen retrofit extension plates, the 7/8" available embedded plate for finger expansion, and one of five broken fingers.

Pier R-6L, Guidebeam Expansion Joint, Right Side

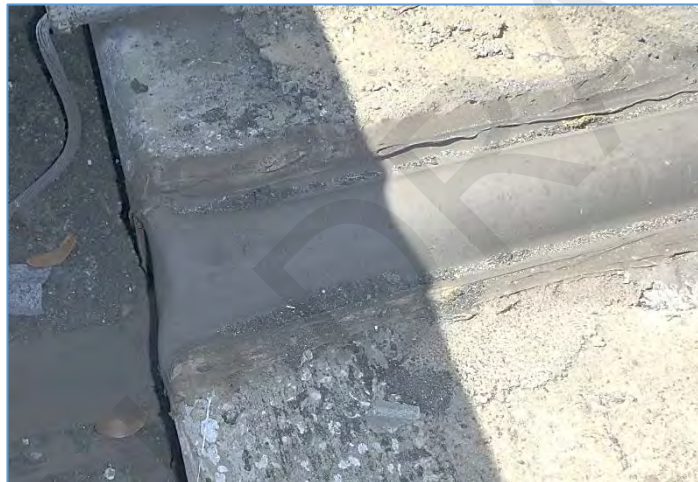
Pier 62L: Joint Covered With Neoprene Seal

If the guidebeam is intended to remain and there will be no vehicle contact with the joints, then the most economical solution will be to apply a neoprene seal over the existing failed joints. This has already been done at Piers 62 and 66; see the photo below. This solution is not feasible though, if the future design calls for a vehicle to run directly on top of the deck. If that becomes the case, then the existing compression seals should be removed and replaced once the guidebeam, pedestals, and second pours are removed.

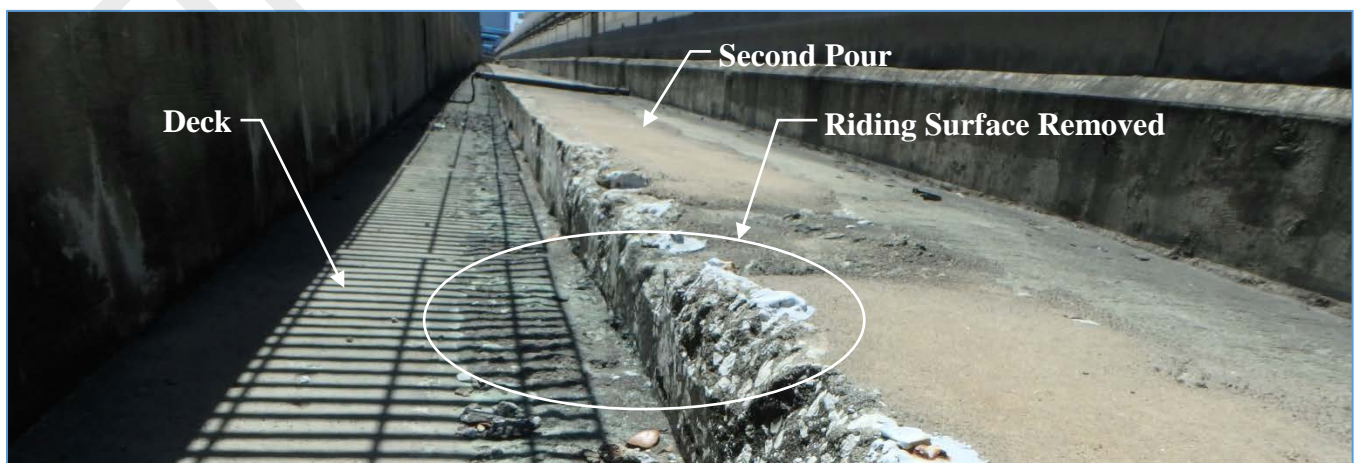
Typical Deck Top in the Starter and North Lines Showing Removal of Relic Riding Surface

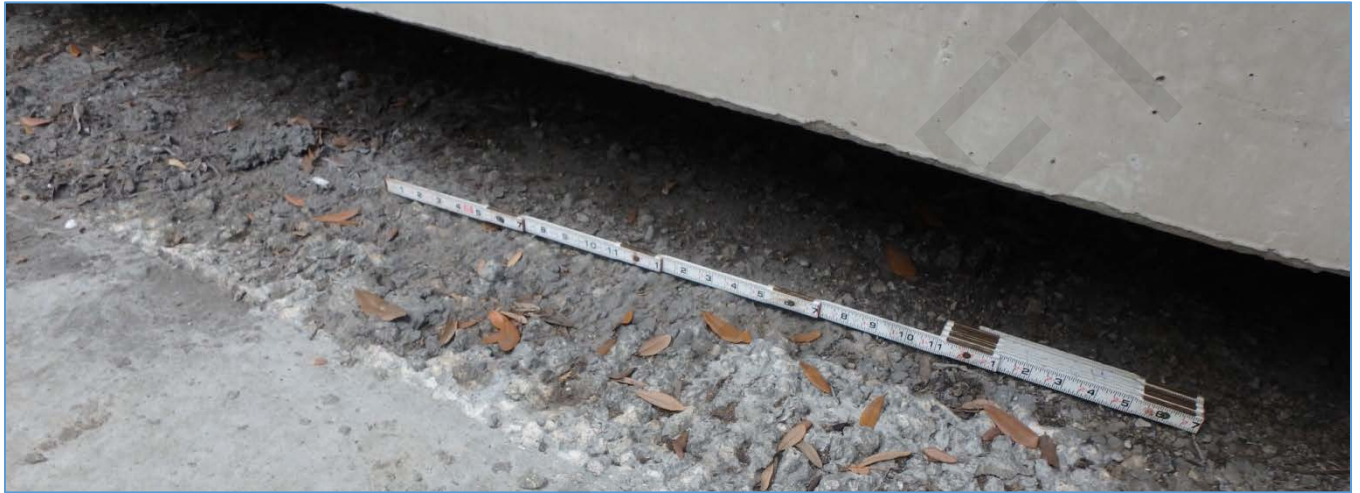
Typical Roughened Deck Top in the South Line Due to Intermittent Removal of Guidebeam Pedestal

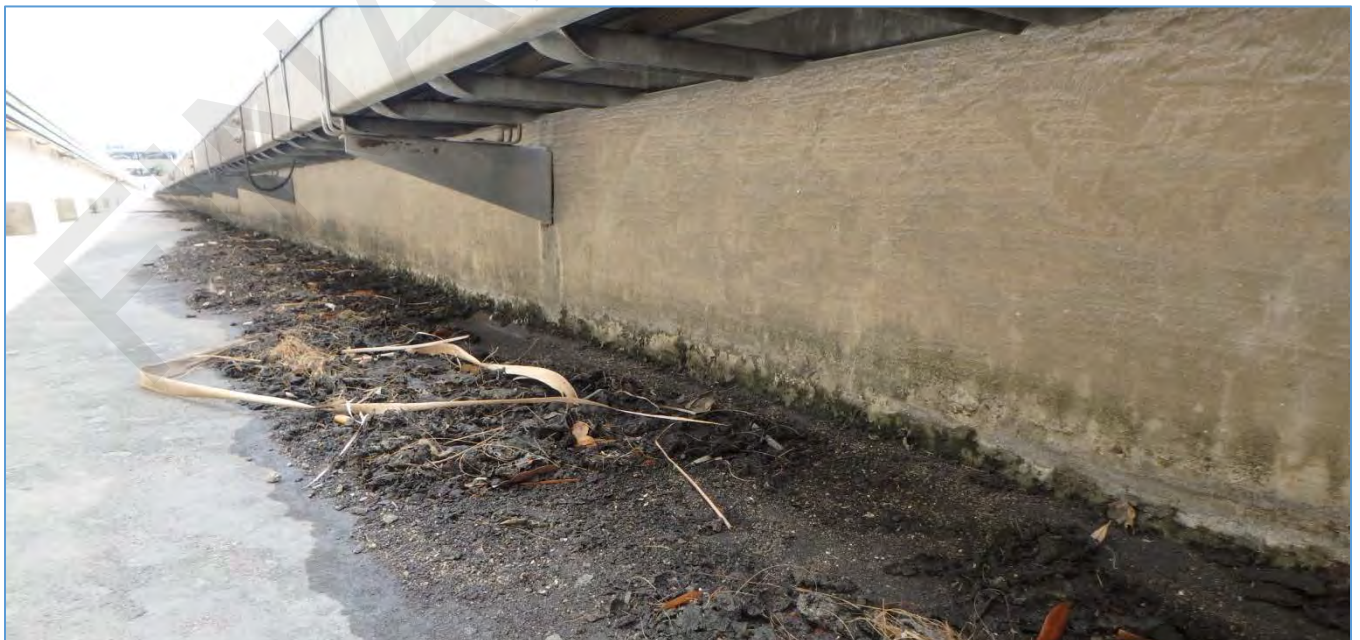
There is soil and debris build-up on top of the deck surface throughout the system; see the photo below. This debris traps moisture and results in drainage problems and corroded steel conduits. More information on these issues was presented in the Drainage and Electrical sections of this report.

Span 213L: Wet Debris for 20' over Pier 214

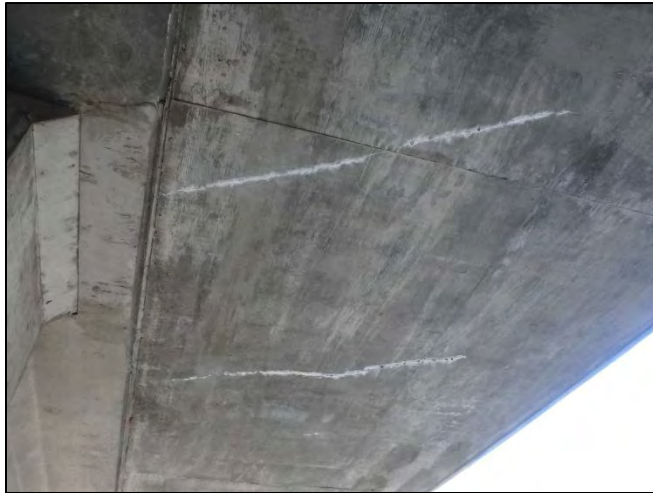
Span 75R: Transverse Cracking on the CIP Deck Underside

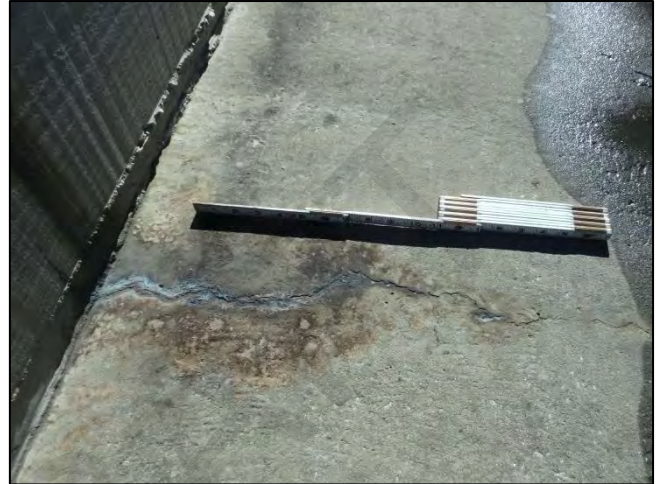
Span 241: Transverse Cracking on Deck Top Surface

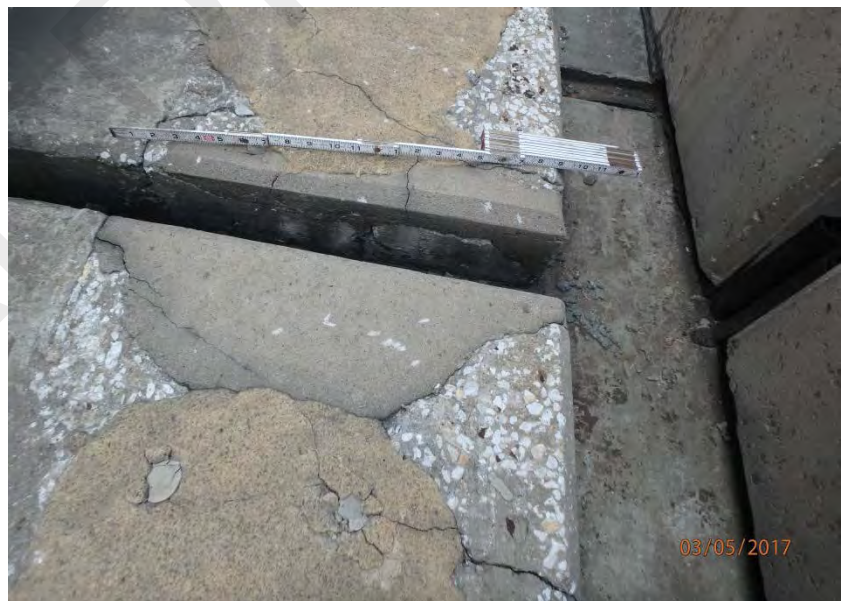
Concrete spalling and delaminations are present throughout the deck area. Most of the deterioration on the Starter and North Lines is of the old second pour, and often at a pier location. See the photo to the right.

Second Pour Delaminations Above Pier 38

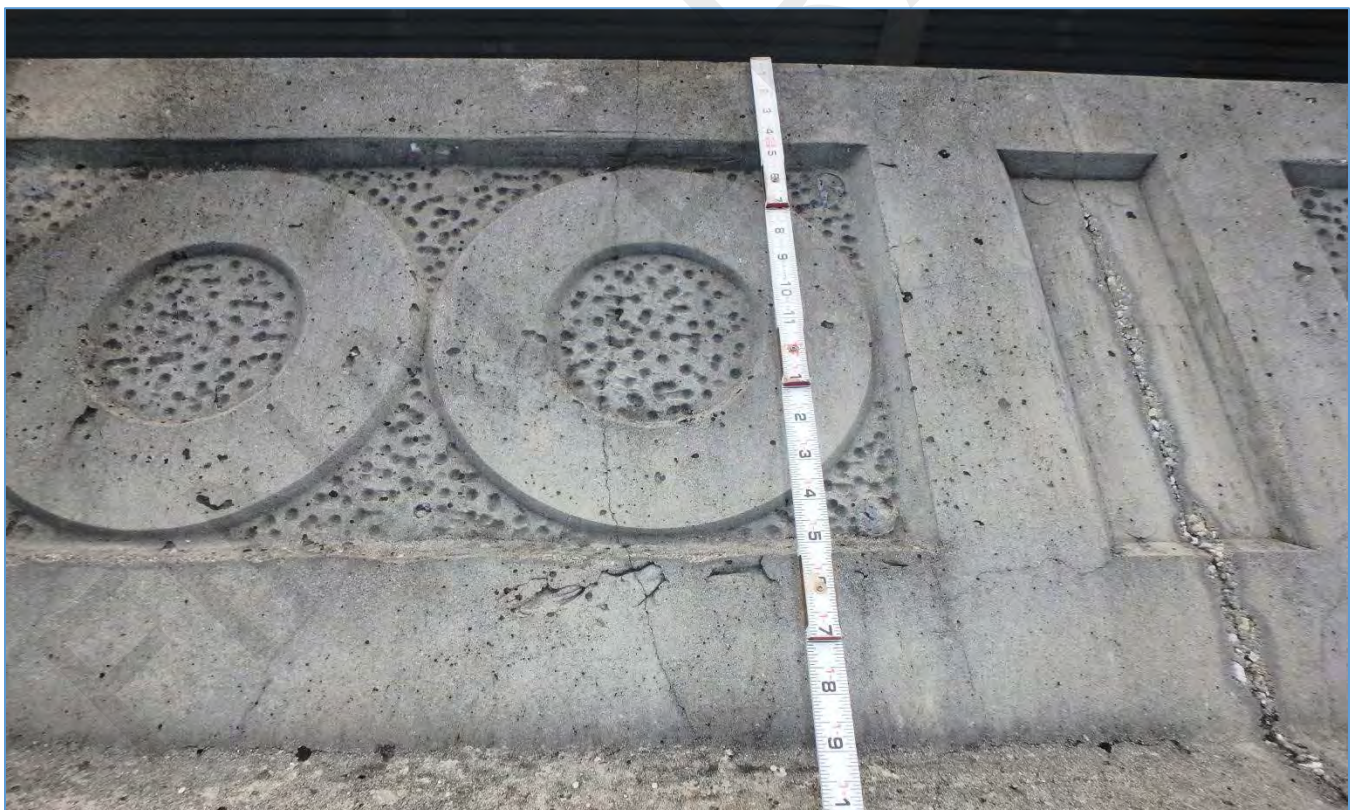
Typical Condition State 2 Cracking in the Sidewalls of the North Line

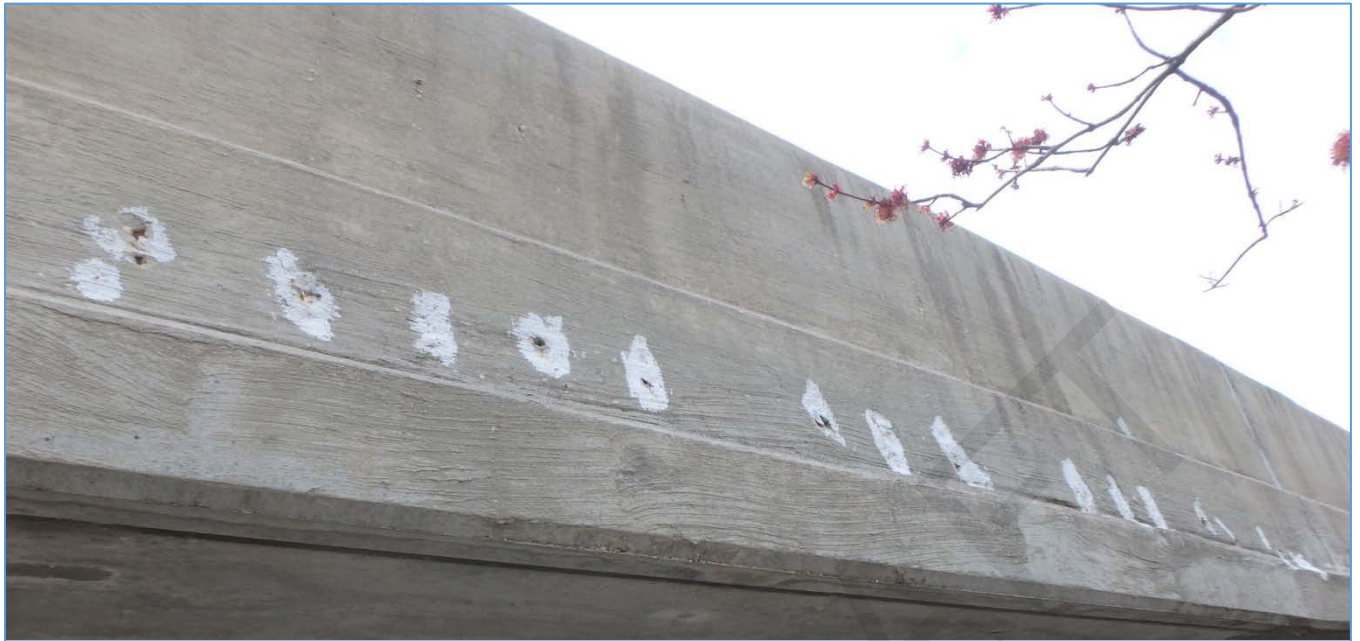
Another typical deficiency in the sidewalls is spalling, often the result of insufficient cover with exposed and corroded reinforcement. There are seven spans noted with between 10 and 40 shallow spalls, all along the same face of one sidewall; all seven spans are in the South Line. Many of the spalls with exposed reinforcement have been painted, but in some cases, the corrosion is reactivating. See the Photo below.

Shallow Spalls Due to Insufficient Cover in the Exterior Face of the Right Sidewall in Span 210R

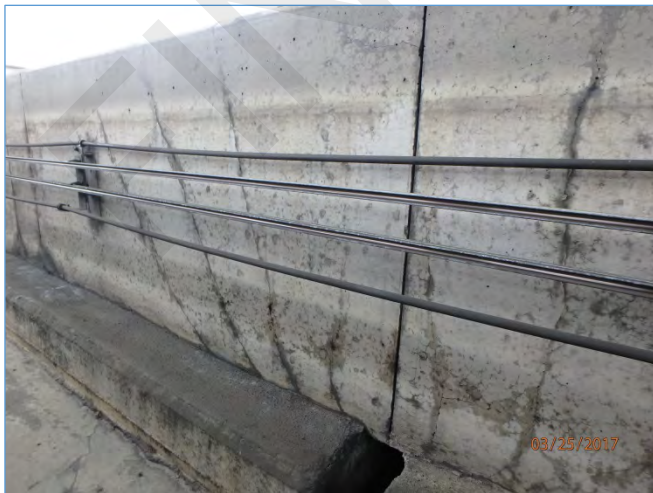
Span 253: Vertical Cracking in Guidebeam

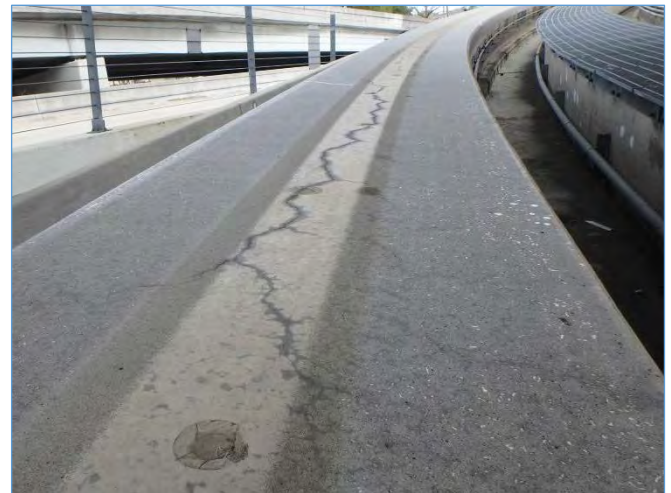
Span 253: Longitudinal Cracking in Guidebeam

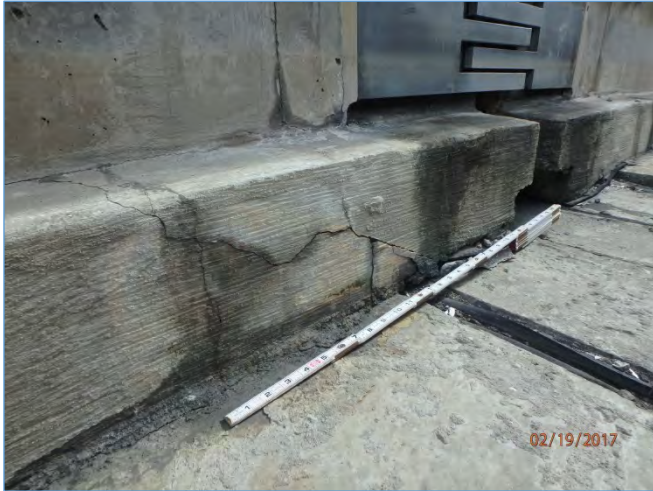
Pier 207: Guidebeam Pedestal Cracking

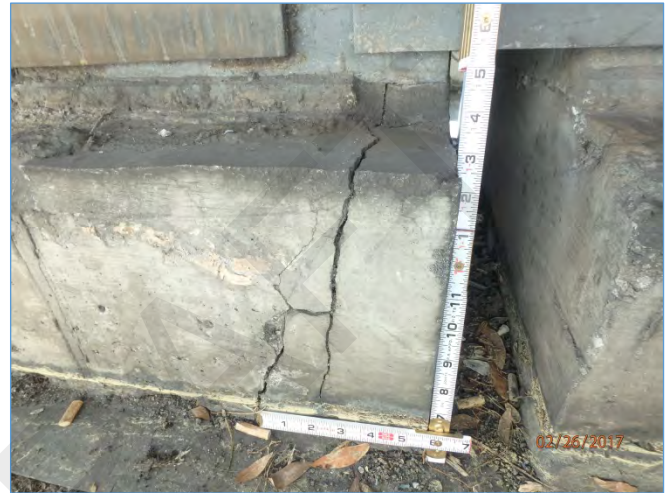
Pier 237: Guidebeam Pedestal Delamination

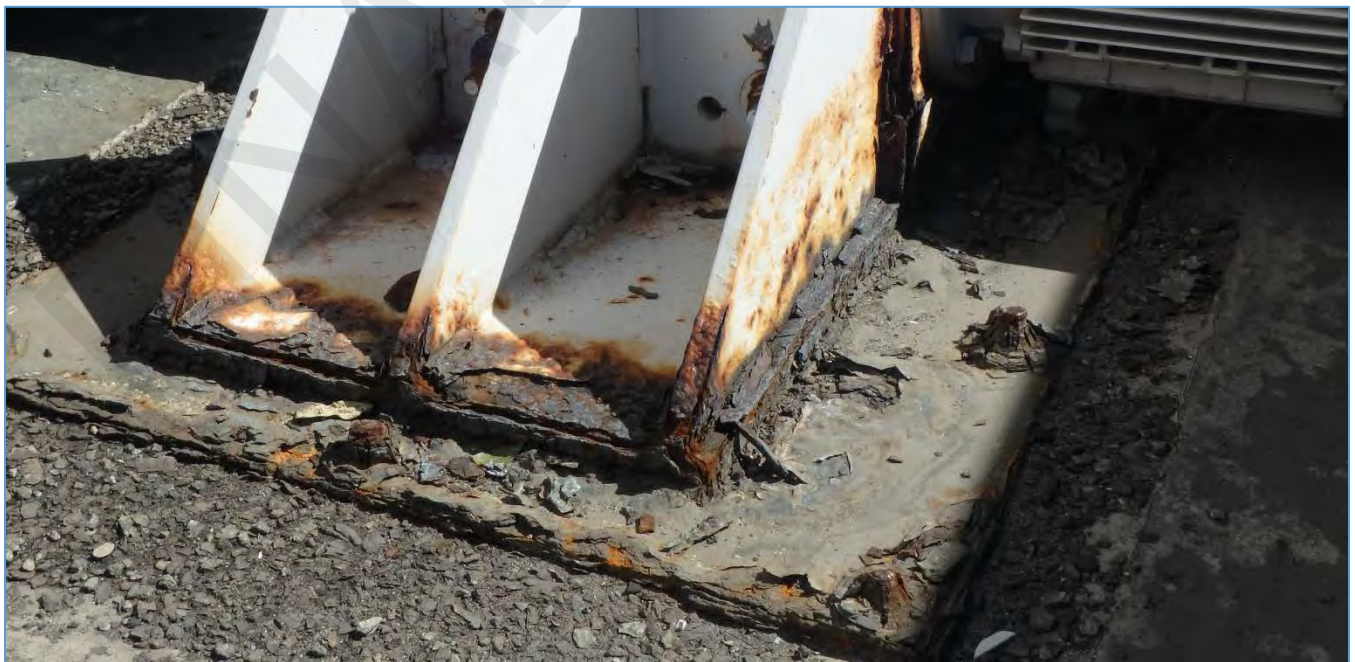
The paint on the steel guidebeams and switchbeams is in poor condition. The paint is very chalky, which is accelerated by direct UV degradation. There is surface corrosion on many of the switchbeam mechanism support brackets, plate and hardware. Spot painting is evident, but there are locations where corrosion is active and causing significant section loss. See the photo below.

Span 213L: Surface Corrosion and Section Loss on Switchbeam Machinery Support Brackets

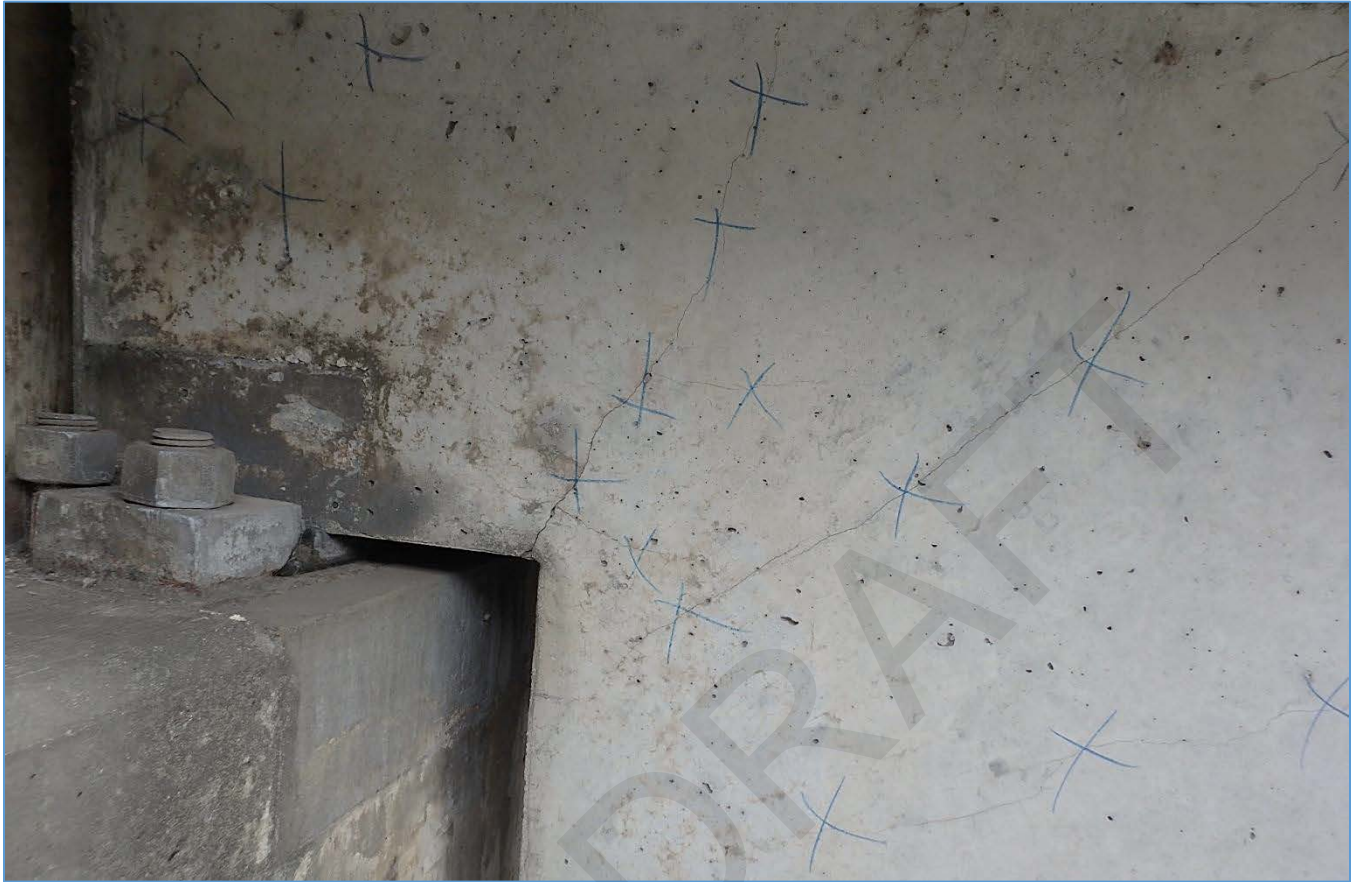
Based on the crack widths measured during the 2017 routine inspection, approximately 75% of the cracks are considered moderate and 25% are considered wide. The two beams with stems up to 0.03 inches wide may be considered “severe”. See the photos below.

Span 18N: Shear Cracking up to 0.02" Wide on Right Stem End at Pier 18N.

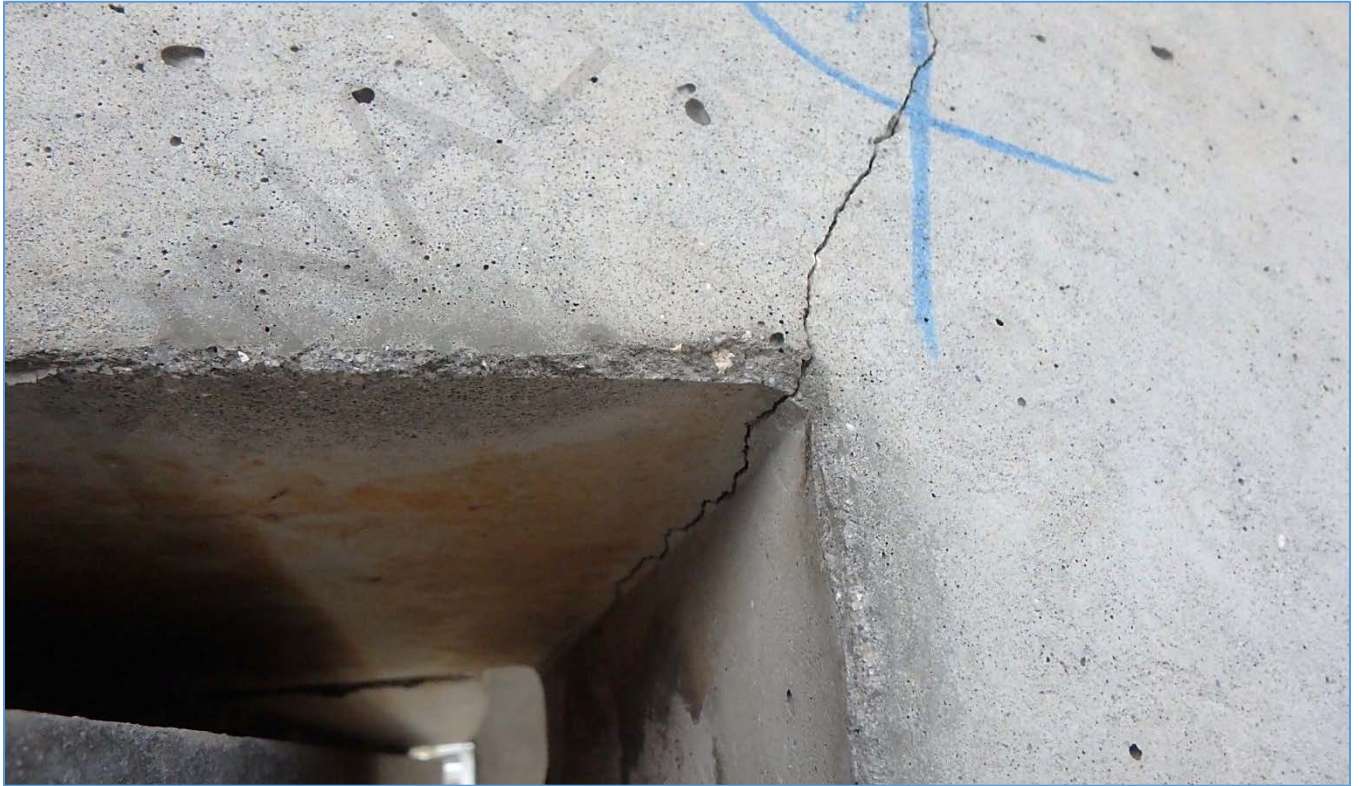
Span 24S: Full Depth Shear Cracking up to 0.03" Wide on Left Stem End at Pier 25S.
