# JTA Skyway 2017 Routine Inspection of Bridge Structures

Prepared For:  
Jacksonville Transportation Authority

Prepared By:  
RS&H, Inc. with/  
FIT Engineering, LLC

Final Draft Report

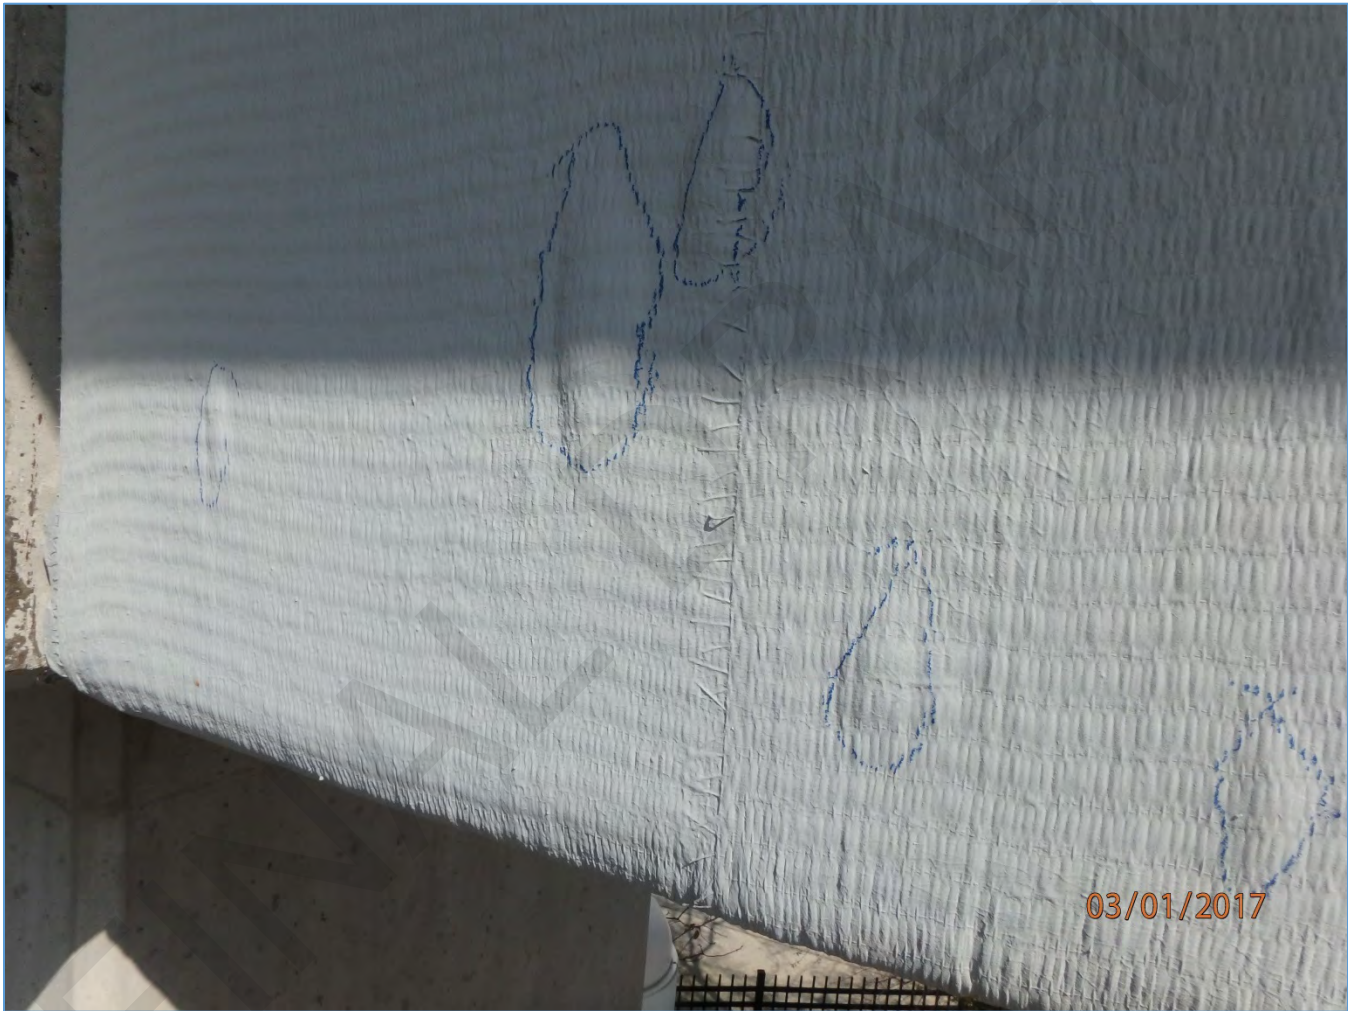
Nearly all of the CFRP wraps have small bulges at isolated locations. These bulges are mostly solid and are likely filled with hardened resin. There are a few locations in the system in which the bulges are delaminated and feel soft, spongy or hollow. The beam with the most delaminations is Span 47R with 24 delaminated blisters, up to 5" x 2". This is a new wrap which was added since the previous inspection. See the photo below.

Span 47R: Delaminated Blisters on CFRP Wrap, Right Stem at Pier 47R

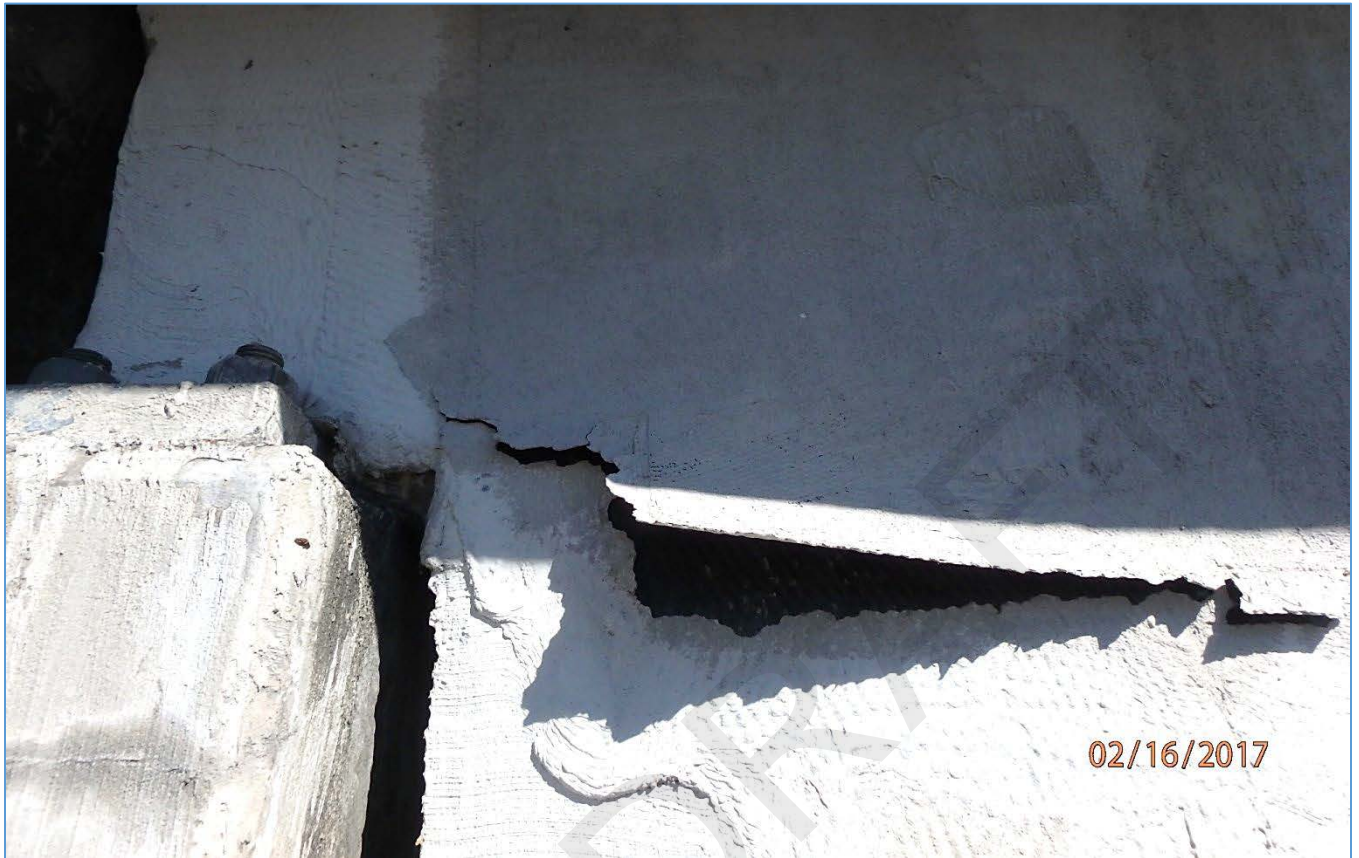
There is one location in which the wrap is failing altogether (material failure) and that is at Span 227L. The CFRP on the exterior face of the left stem is cracked and popping off 2'-6" L x 9" H, 18 feet from Pier 228 and 8" L, 10 feet from Pier 228. Also the wrap is delaminated nearly completely over the last 6 feet with peeled and cracked areas. There are numerous delaminations on both left and right stems. Attempts to repair these locations with epoxy injection have been ineffective. See the photo below.

Span 227L: CFRP Failure in at Pier 228

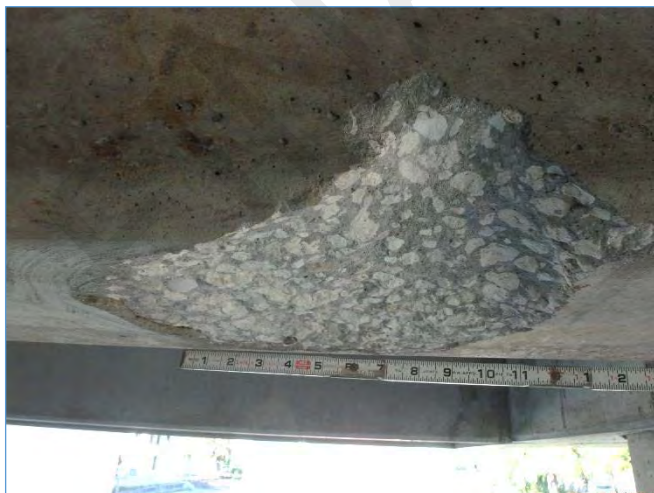
Span 75R: 10-1/2"x9"x1-1/2" Spall,  
Left Stem Near Pier 76R

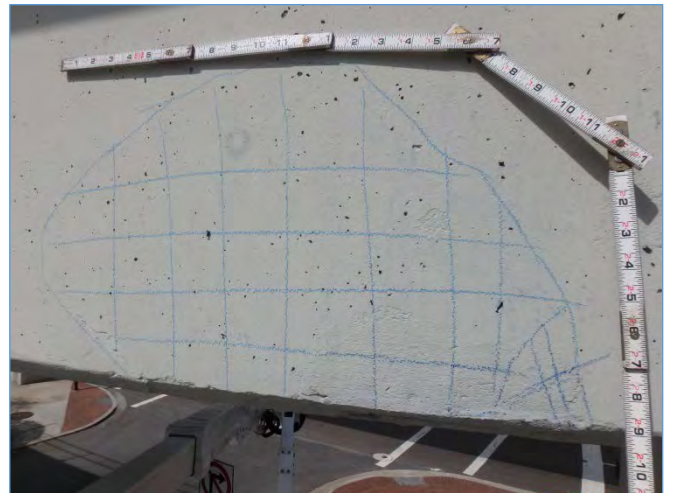
Span 47R: 24" x 14" Delamination,  
Right Stem Near Pier 48R

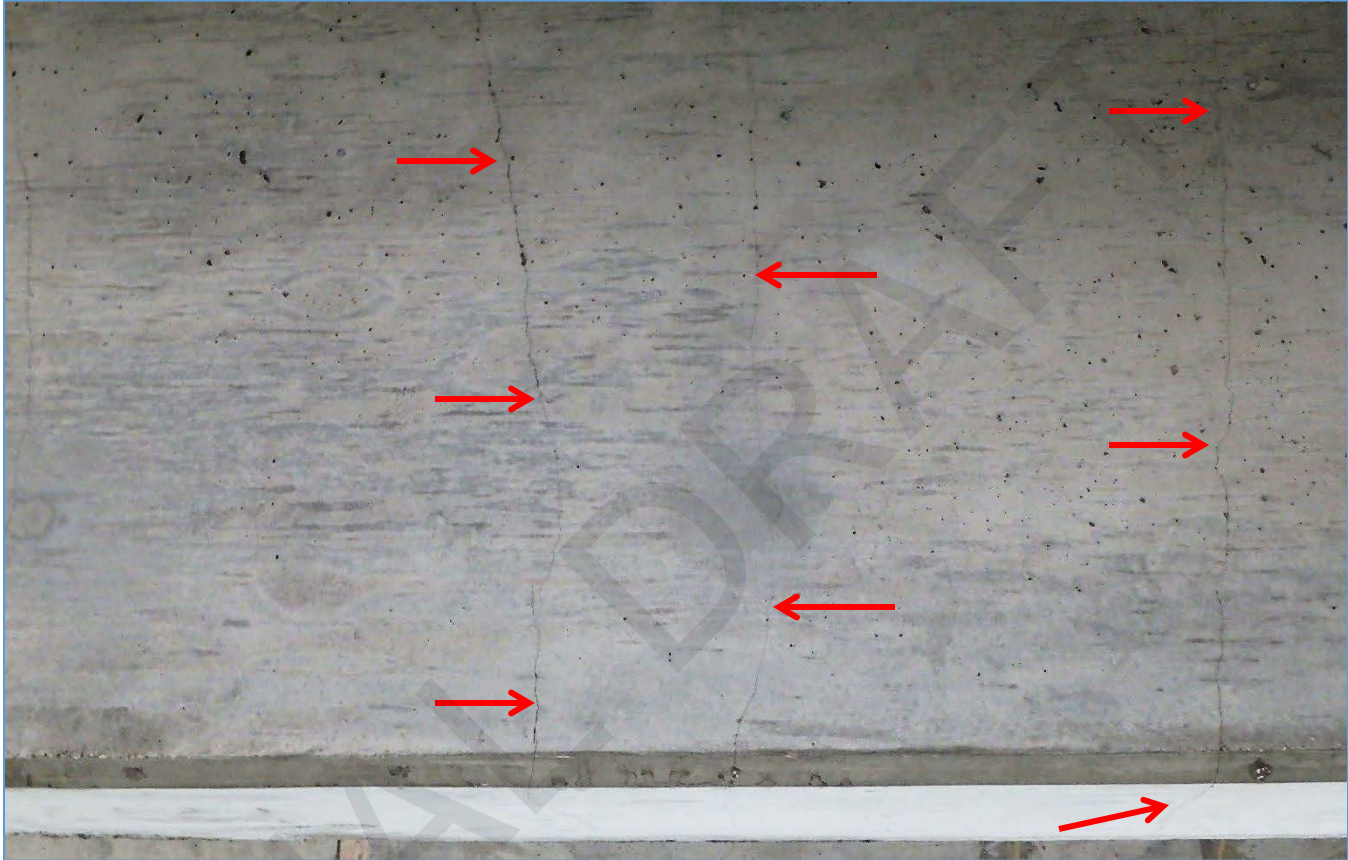
Span 42S – Cross: Typical Unsealed Flexural Cracking in Beam Stems

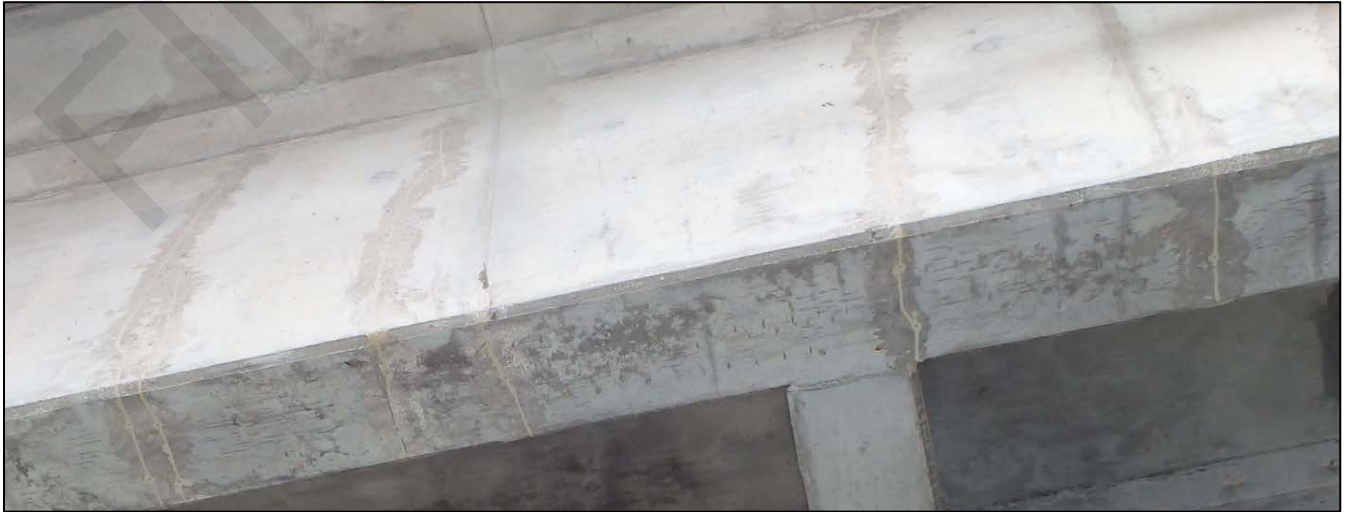
Span 42S – Cross: Typical Sealed Flexural Cracking in Beam Stems

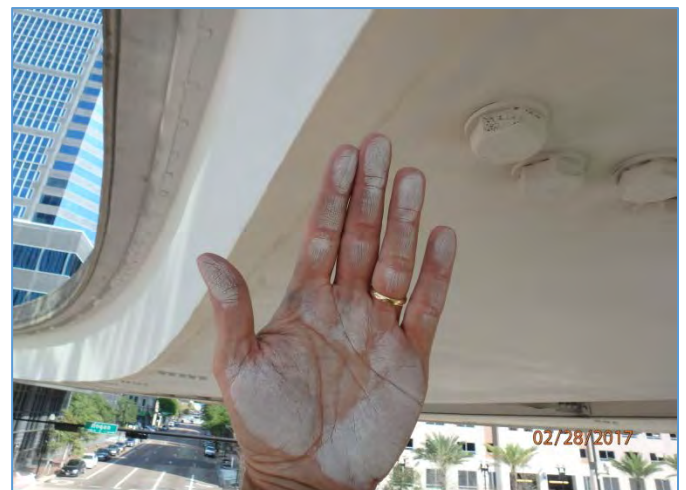
Very Chalky Paint Exterior – Typical Throughout

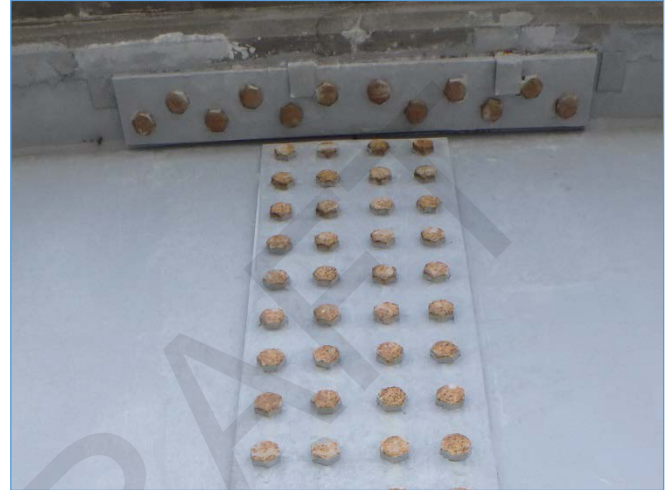
Span 405R: Surface Corrosion on Exterior Splice Bolts

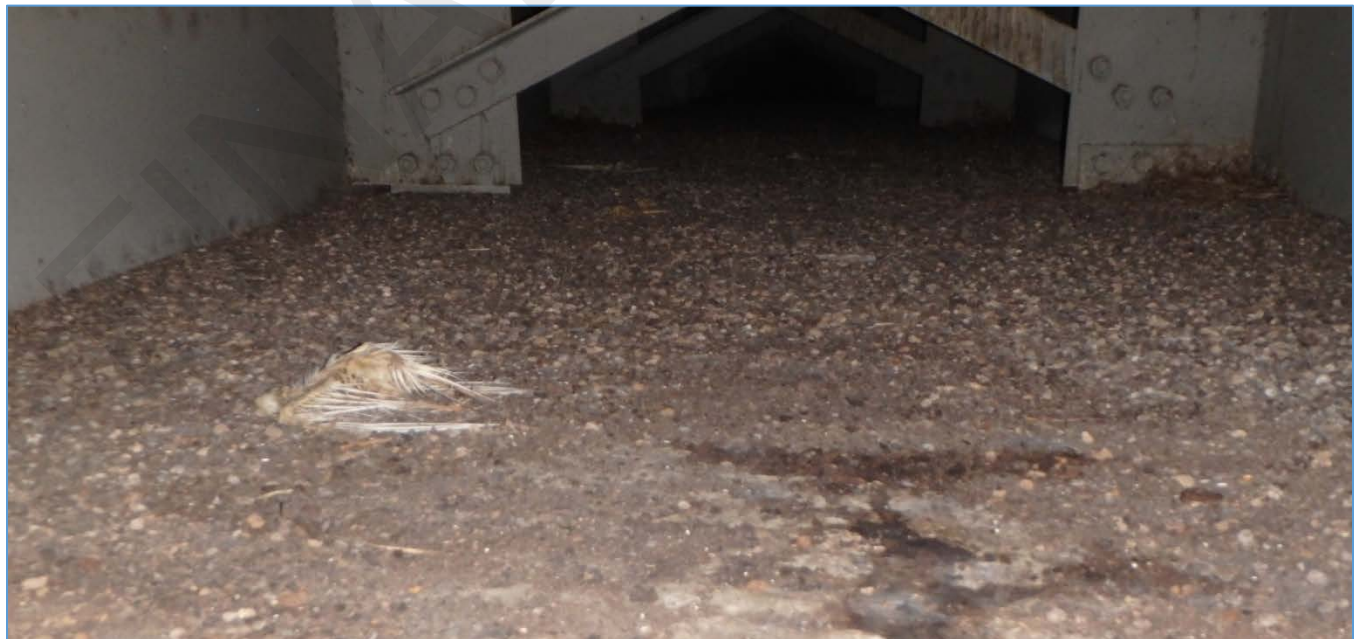
Span R-6 LT: Organic Debris up to 2" Deep

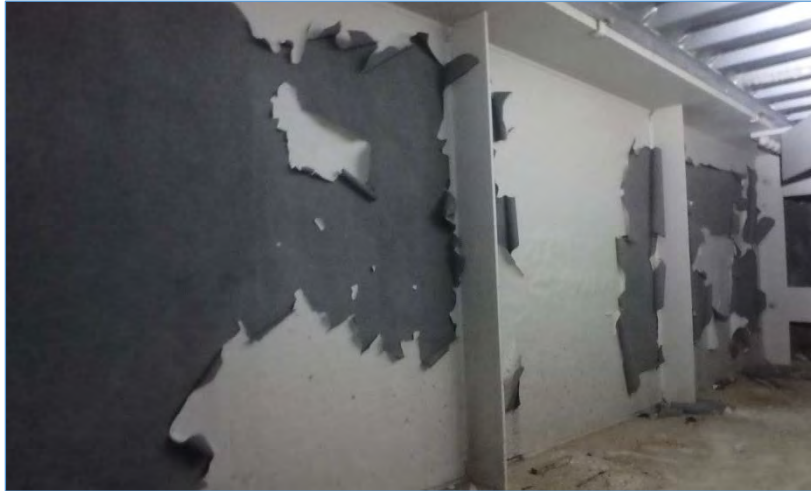
Span 9N: Peeling Paint Exposing Primer

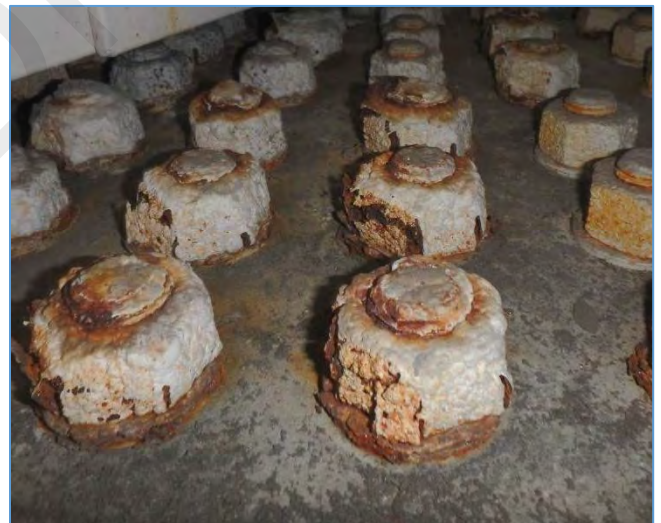
Span 52A LT, Bay 1 Splice (Up to 15% Loss on Nuts)

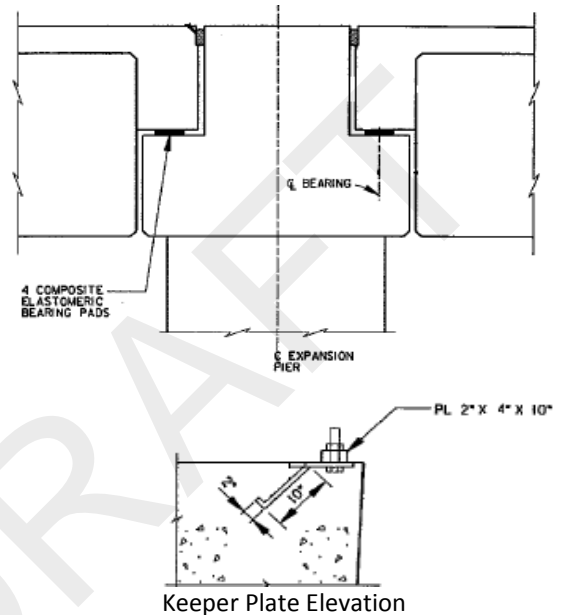
Keeper Plate Nut Missing Washer

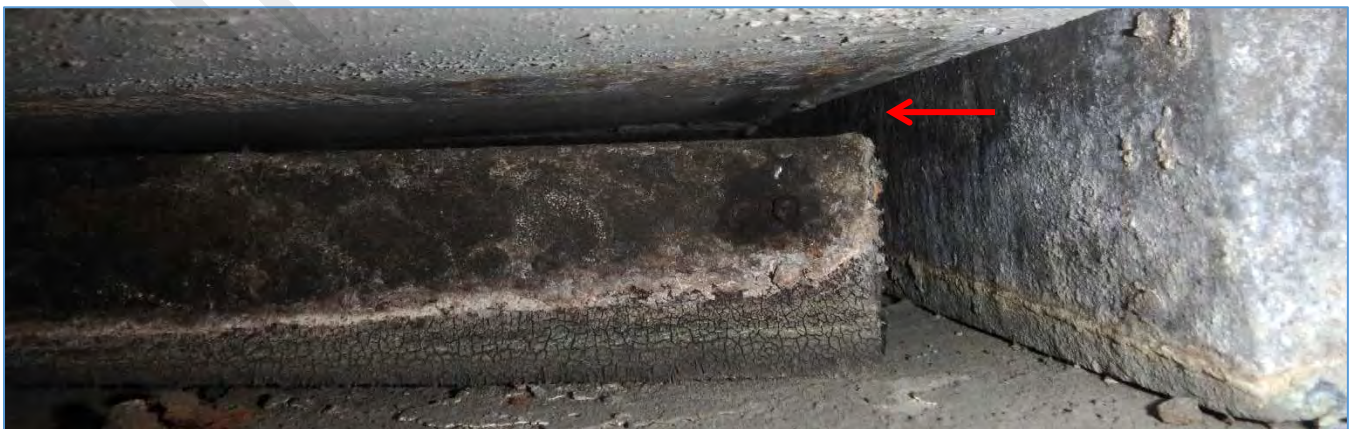
Span 202R: 1/4" Gap Between Left Stem and Bearing Pad at Pier 202R

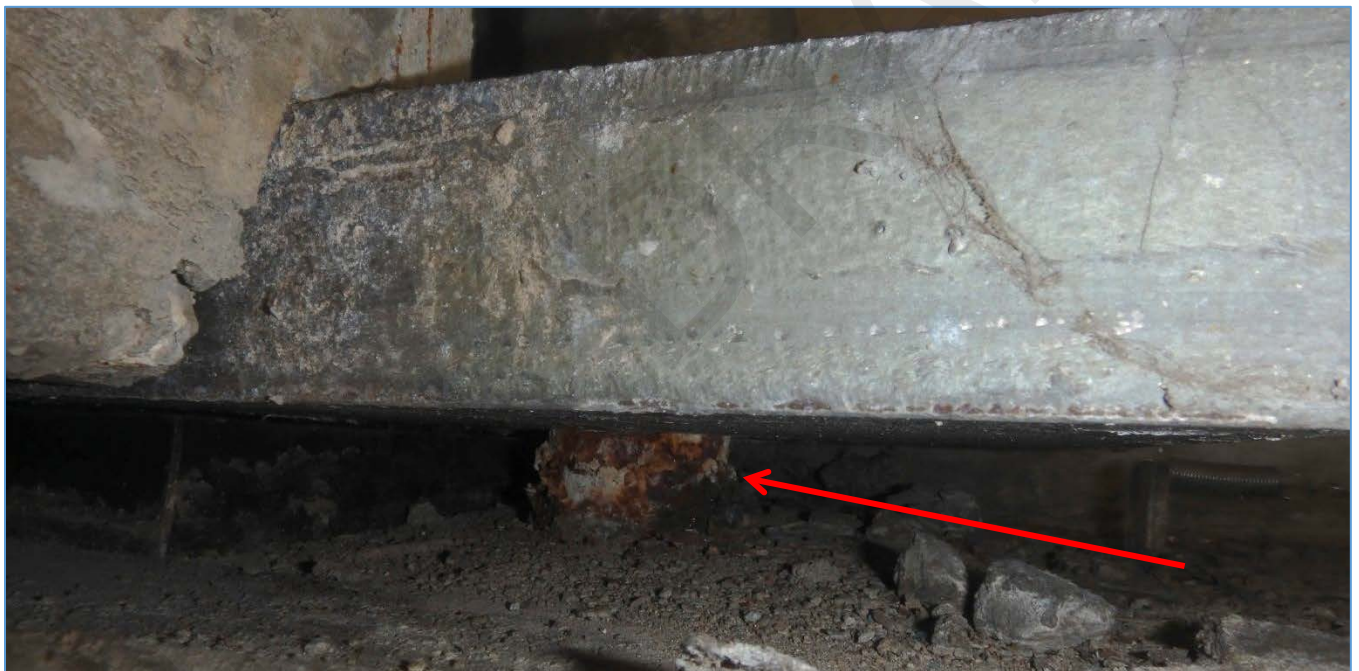
Span 239L at Pier 240L: Surface Corrosion on Bearing Plate Anchor Bolt

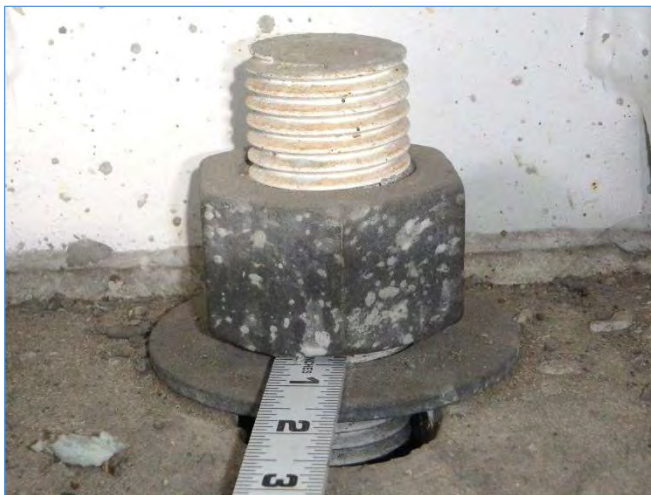
Span 205L at Pier 205L: Anchor Bolt Nuts Not Flush With Washers. Missing Jam Nuts.

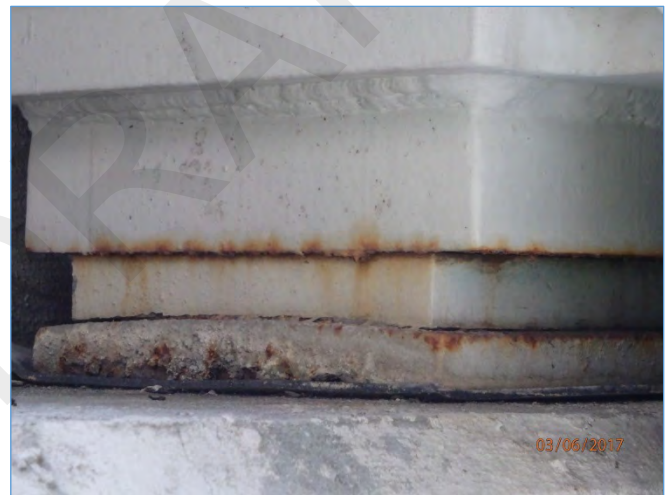
Span 206L at Pier 207L: Surface corrosion on Sole Plate and Masonry Plate

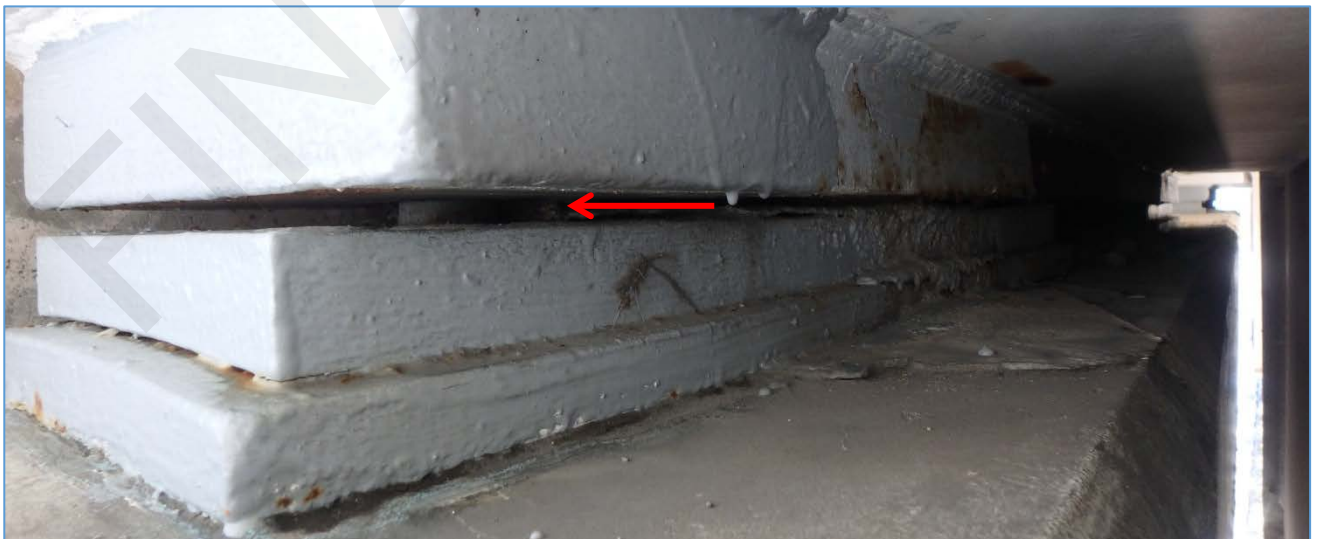
Span 52A Left at Pier 52A: 1/4" Gap Between Sole Plate and Bronze Plate

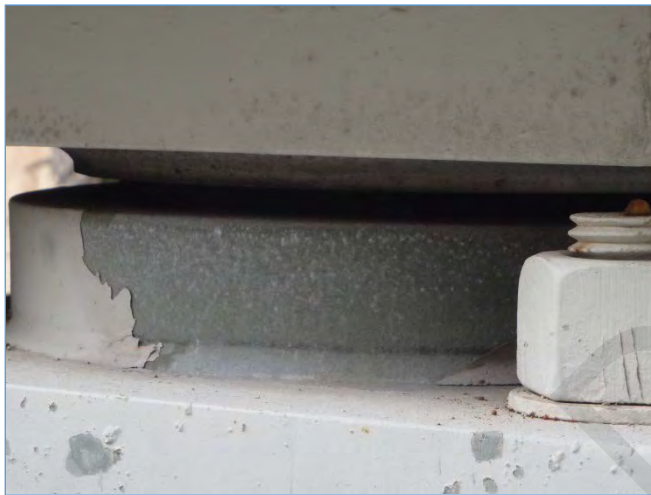
Pier 206L: Peeling Paint on Pot Bearing Cylinder

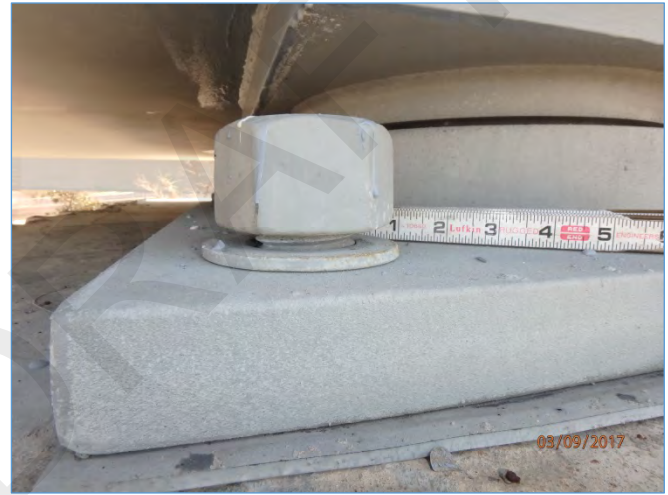
Pier 409L: Loose Bearing Anchor Bolt Nuts

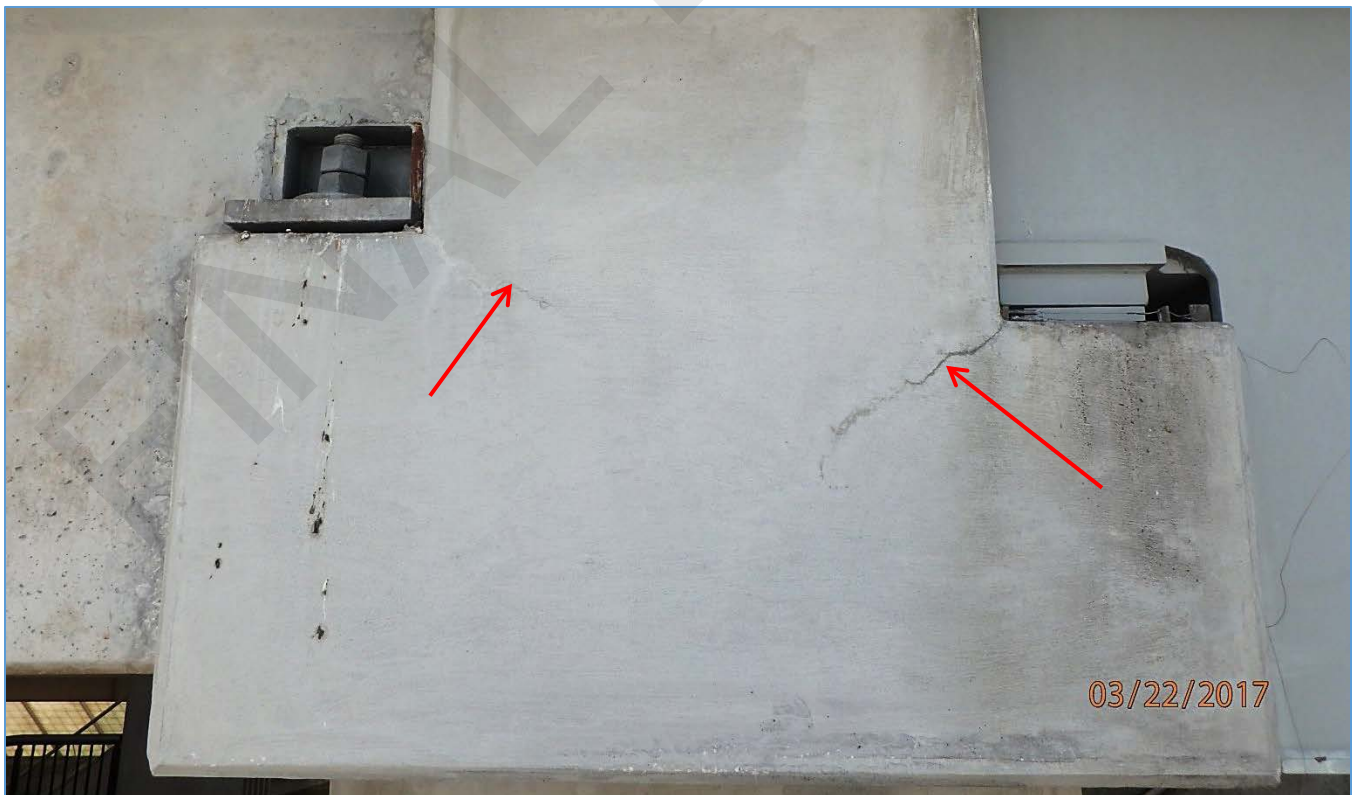
Pier 240, Right Face of Cap: Typical Beam Seat Corner Cracks

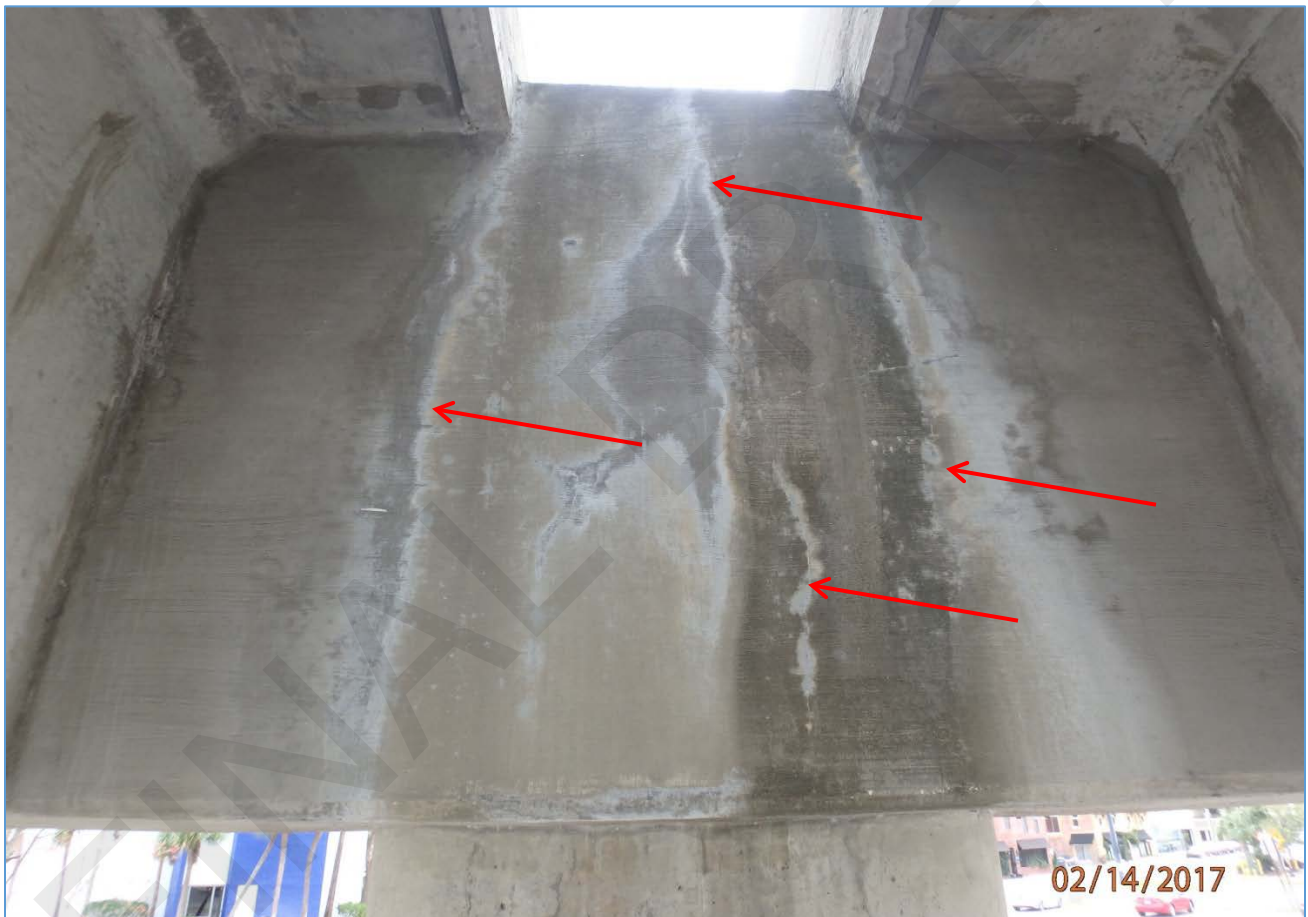
Typical Negative Moment Crack, Full Depth of Cap, Front Face of Pier 212

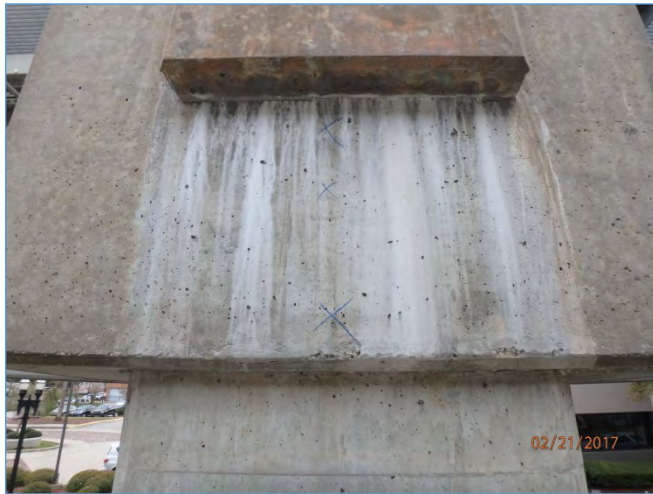
Pier 19N: Efflorescence Leaching from PT Cover

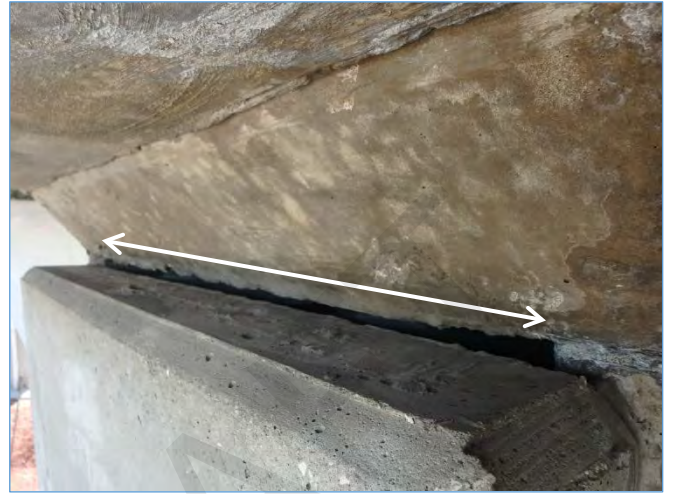
Pier 40N: 1/2" Gap at Top of PT Cover and Failed Caulk

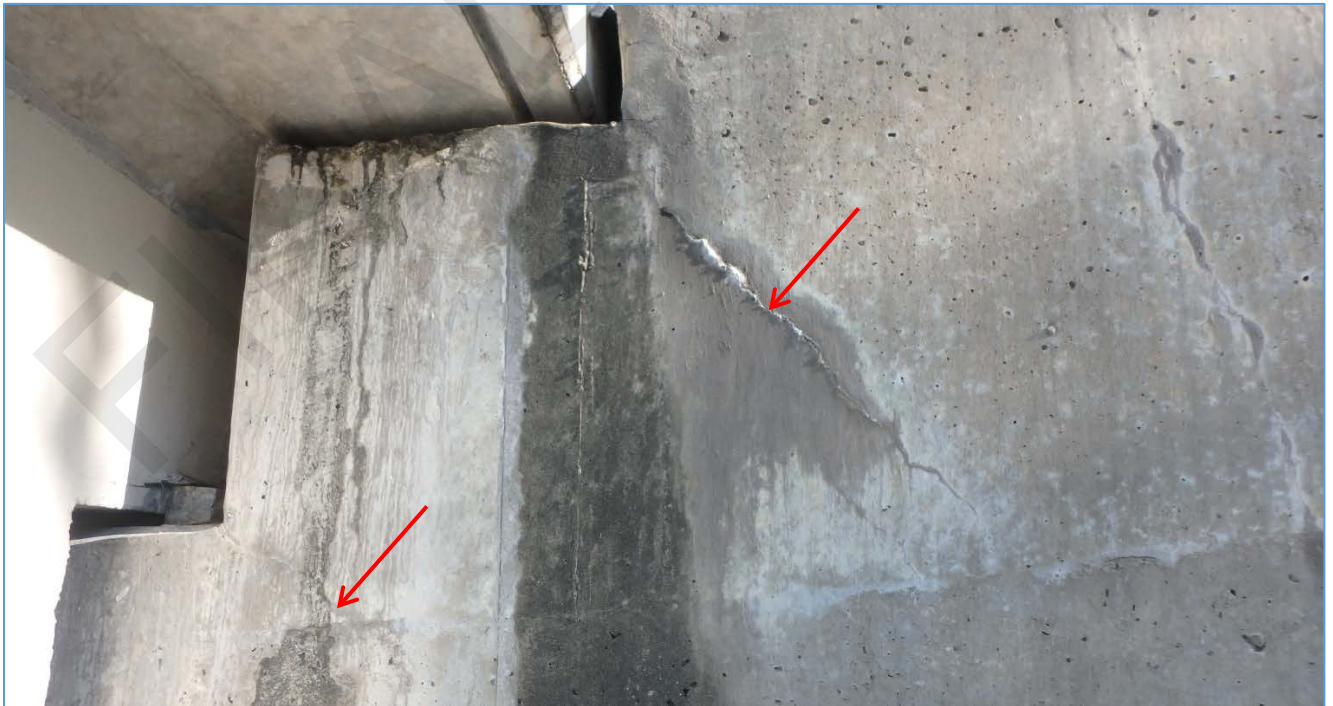
Pier 62: Diagonal cracks extending downward from the left beam seat corner and the top flange notch.

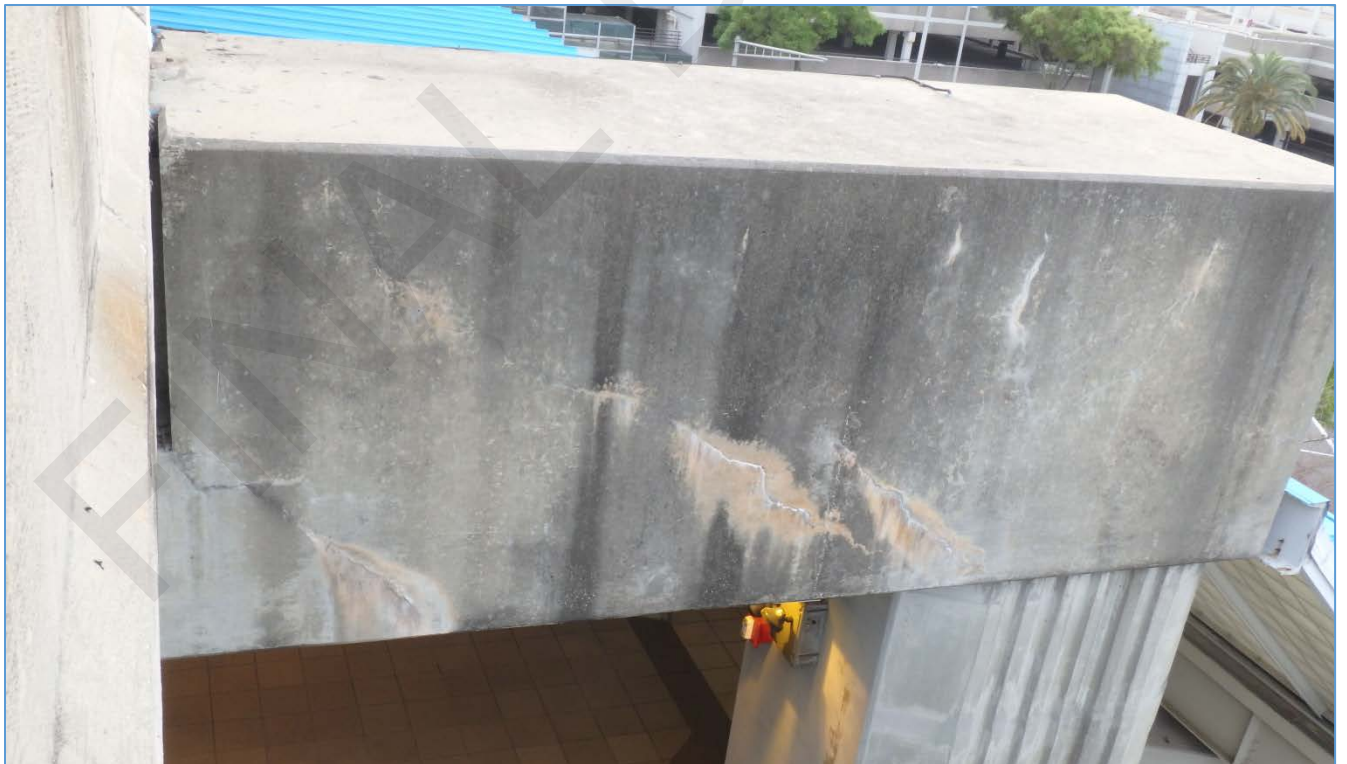
Pier 240: Diagonal Shear Cracks on the Front Face near the LT Column

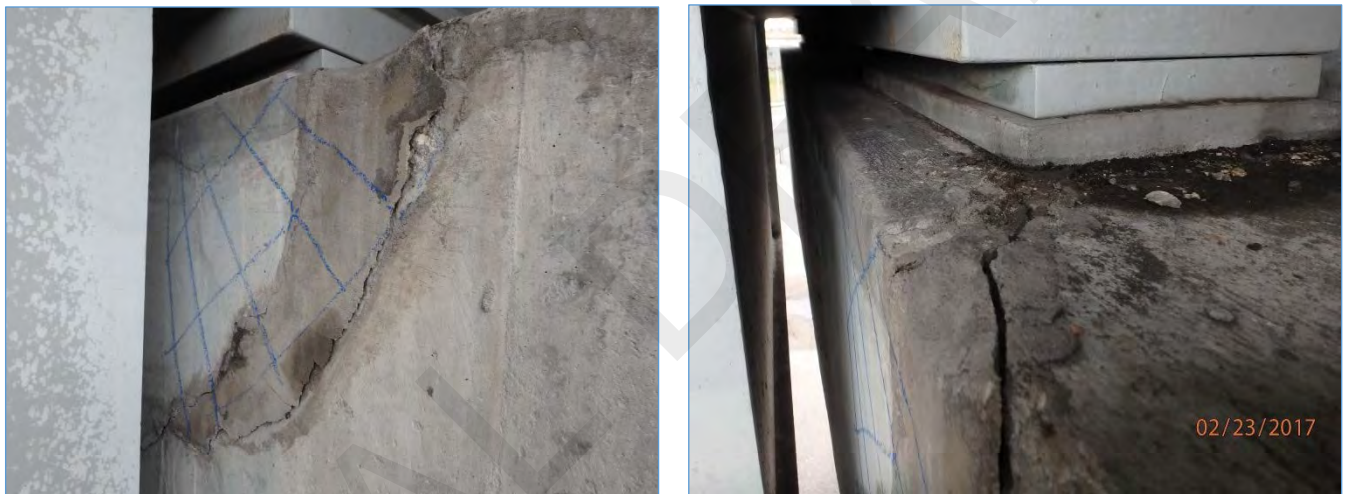
Pier 258R: Large Delamination Below the Right Bearing, Rear Face

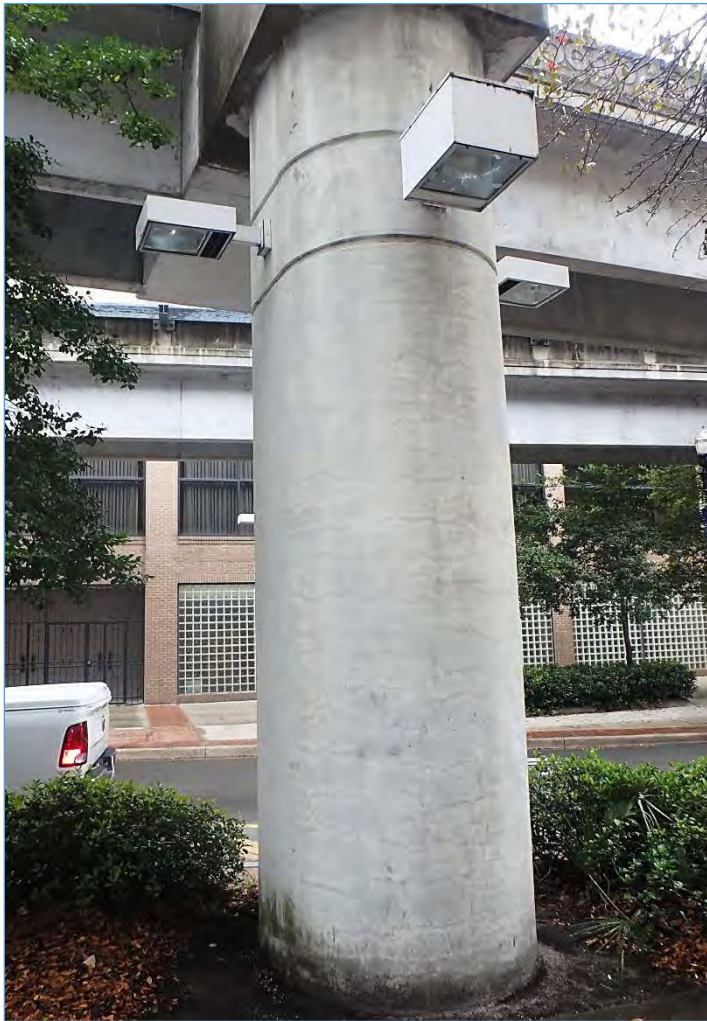
Pier 79R: Flexure Cracking in Column With Cantilever Cap

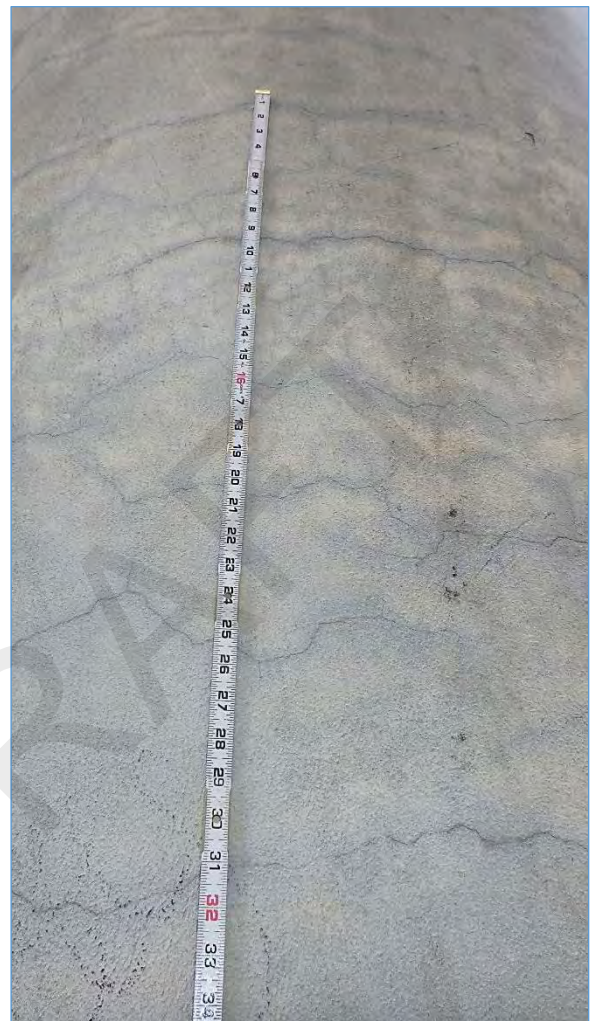
Close-up of Cracks

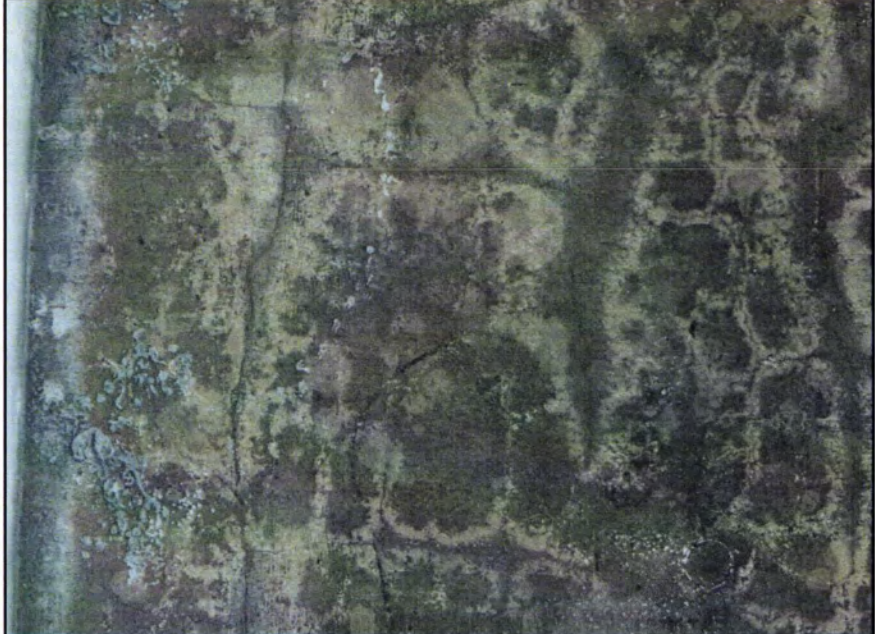
PHOTO 23 – ELEMENT 220  
TYPICAL VIEW OF THE INSIGNIFICANT SIZE LONGITUDINAL, TRANSVERSE AND DIAGONAL CRACKS IN THE TOP OF FOOTINGS

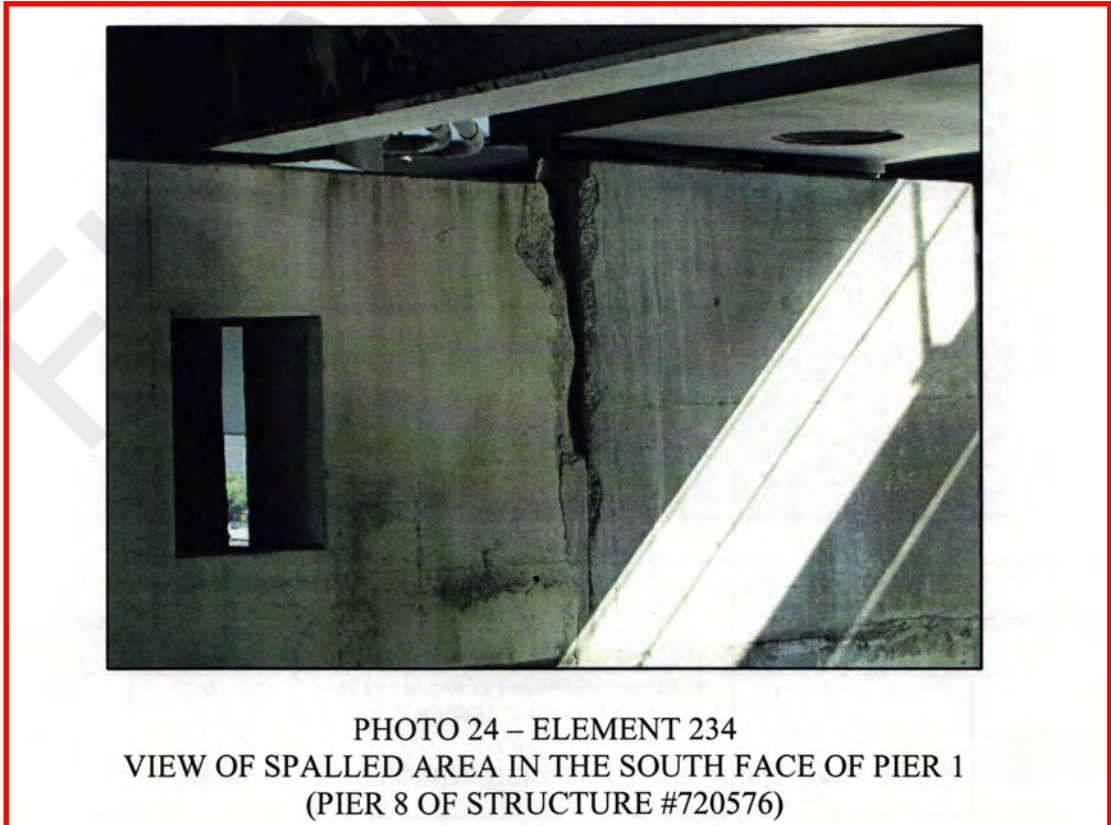
PHOTO 24 – ELEMENT 234  
VIEW OF SPALLED AREA IN THE SOUTH FACE OF PIER 1  
(PIER 8 OF STRUCTURE #720576)

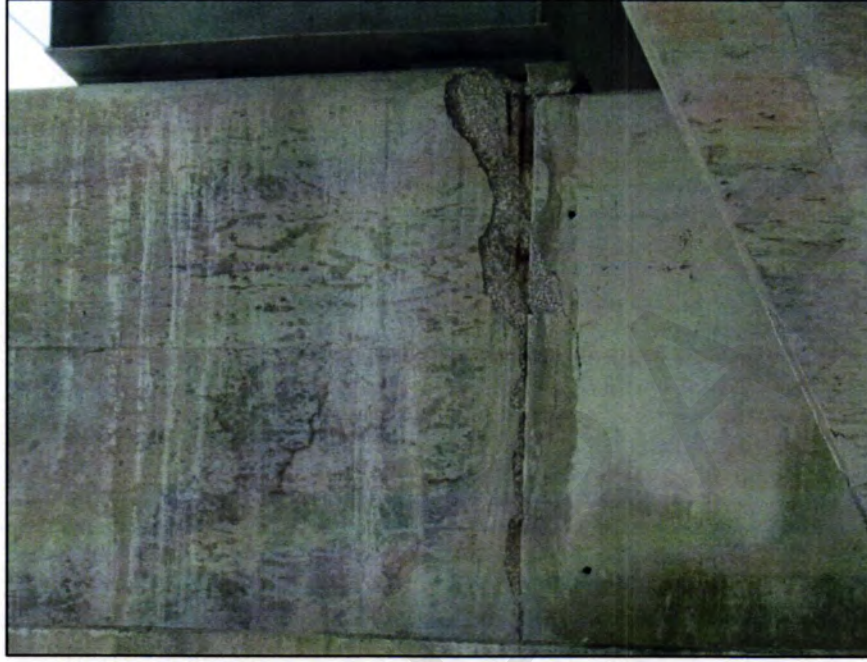
PHOTO 25 – ELEMENT 234  
 VIEW OF SPALLED AREA IN THE NORTH FACE OF PIER 1,  
 UNDER THE PEOPLE MOVER

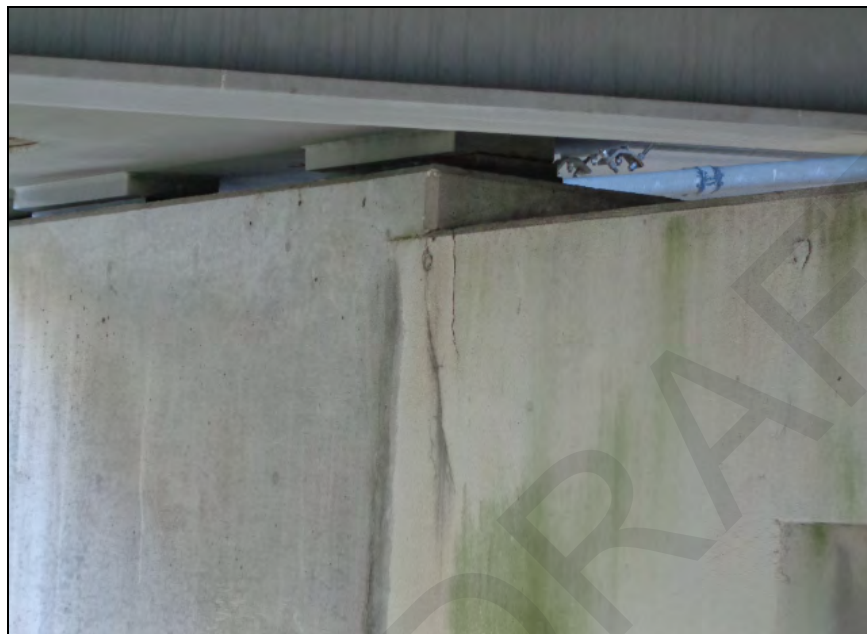
PHOTO 21 – ELEMENT 234  
 VIEW OF 16 IN. VERTICAL CRACK, SOUTH FACE OF PIER CAP 1,  
 ADJACENT TO PEOPLE MOVER EXTENSION

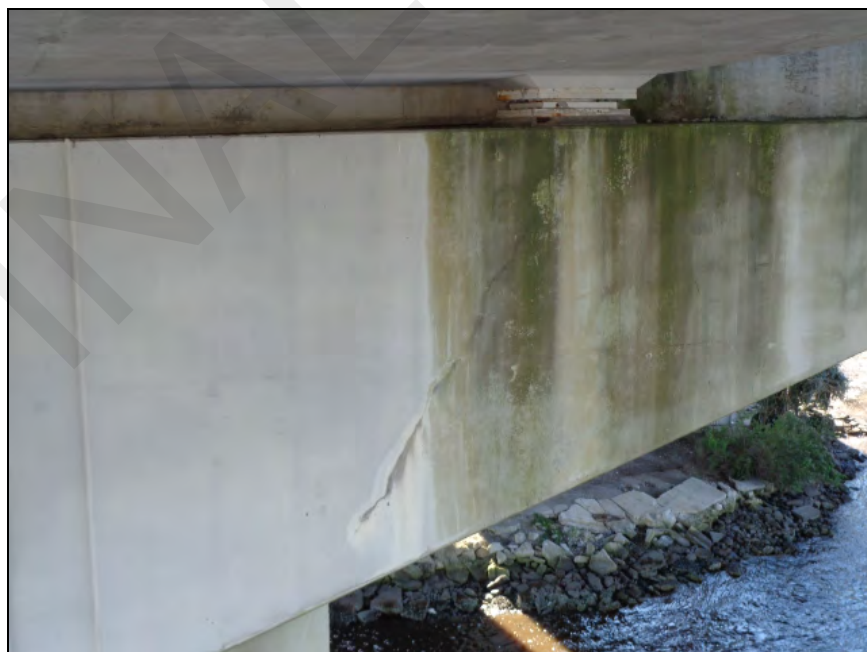
PHOTO 22 – ELEMENT 234  
 VIEW OF NORTH FACE OF PIER 1 CAP WHICH HAS INSIGNIFICANT  
 HORIZONTAL AND DIAGONAL CRACKS WITH EFFLORESCENCE  
 BELOW BEARING 1-1
