JTA Skyway 2019 Routine Inspection of Bridge Structures

Jacksonville Transportation Authority

RS&H, Inc. / FIT Engineering, LLC

Final Report

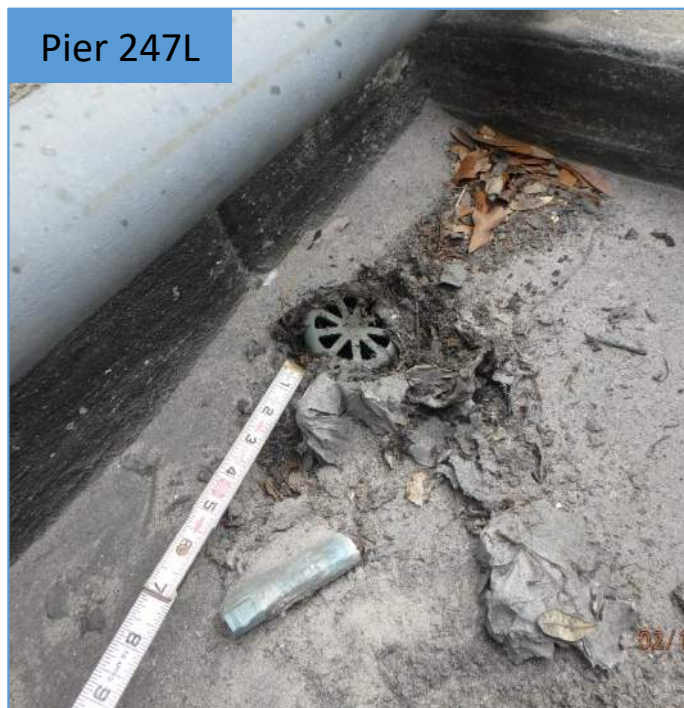
The lack of rain water drainage is a significant problem throughout the Skyway system, and for the most part this is a result of inadequate maintenance. It was evident during the 2019 inspection that some maintenance has been performed, but the number of drainage related issues has increased since the last inspection. Since thorough cleaning is not occurring regularly, debris and soil accumulate around the scupper atrium grates which protrude up from the deck and that prevents water from draining. See the Pier 247L and Span 6N photos below. The few floor drain grates in the system are located underneath the guidebeams within transverse tunnels cut into in the pedestals. These tunnels are filled with up to 4 inches of sand and debris; see the Pier 236R photo below.

- Thoroughly remove the soil and debris from the top of the deck, especially at the scupper locations. This should be done on a regular basis.
- Repair/replace the deck drain grates listed in Appendix D-1 that are broken, inverted or missing. Consider replacing with grates that are flush with the deck to make cleaning around the drains easier.

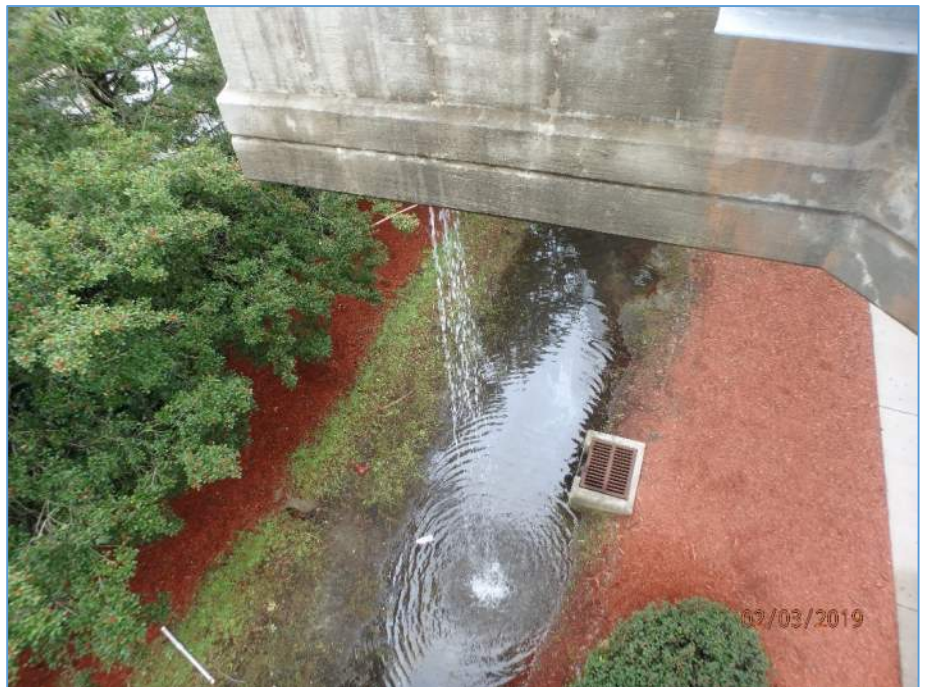
As previously noted, there are numerous locations around the system in which water ponds on the deck surface. This is primarily due to the accumulation of soil and debris around the deck drains and transverse pipes, preventing the normal flow of water. During the inspection, inspectors used hand tools to clear around many of the drains and watched the water gush through, only to see it stop as debris quickly clogged up the grate again. As an example, a thru-deck drain with an inverted atrium grate in the right deck overhang of Span 205L (near the Kings Avenue Station) was filled with debris and not conveying water. Inspectors removed the debris and the water drained immediately. The photo above shows the water draining after debris removal (it was not raining at the time).

Span 205L: Water Draining from Deck after Debris Removal

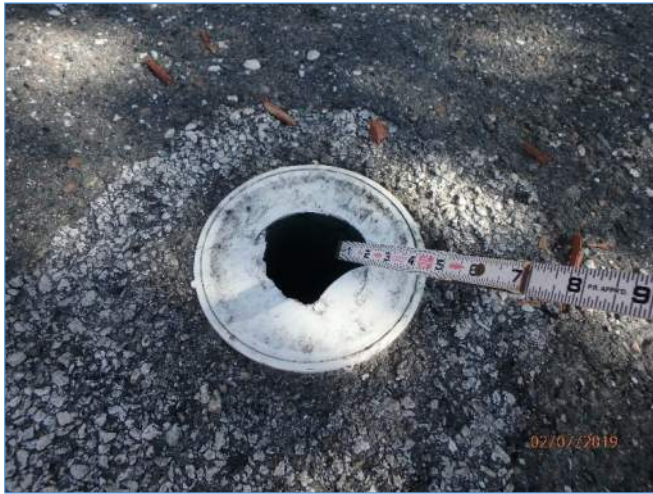
Pier 261R: Broken Riser Pipe Cap

- Repair/replace the damaged riser pipes and/or caps at ground level in the South and River lines listed in Appendix D-1.
- Clean out clogged drain pipes listed in Appendix D-1.

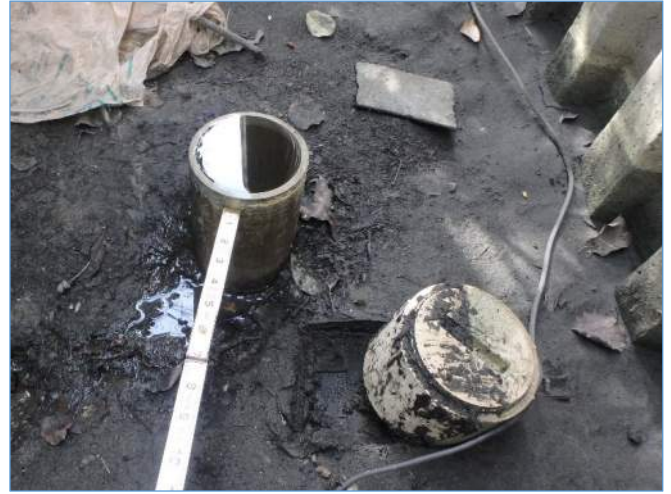
Span 253R: Riser Pipe Filled with Water

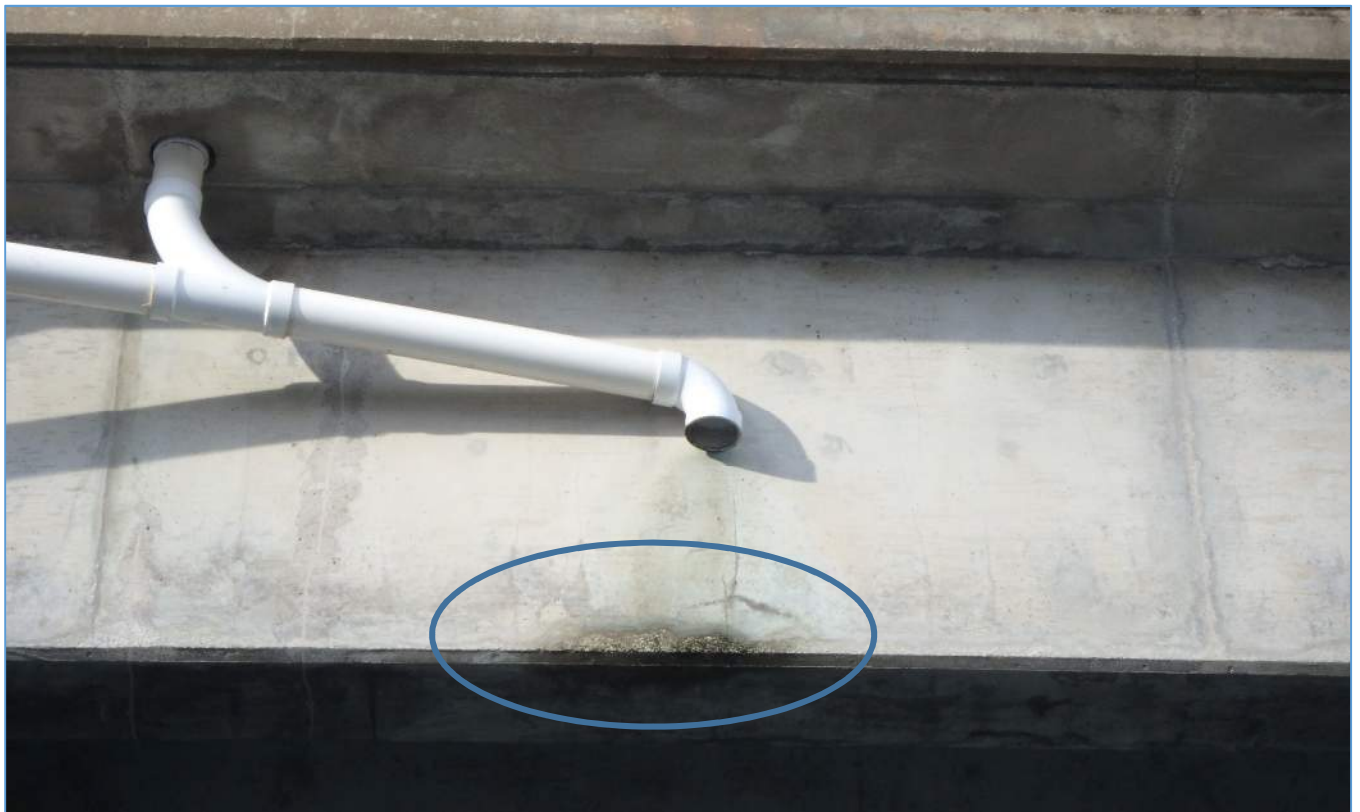
In the crossover span just before Central Station, the drain pipe beneath the left overhang is dripping water onto the beam stem. The water is infiltrating cracks and causing minor abrasion. See the photo below.

Span 42S Cross: Drain in Need of a Downspout

- Drain the water from inside the guidebeam in Span 2N.
- Install a downspout at the end of the drain pipe in Span 42S Cross.
- Investigate and repair the water dripping from the right overhang of Span 409R onto Water Street (EB) from the first deck downspout past Pier 409R.

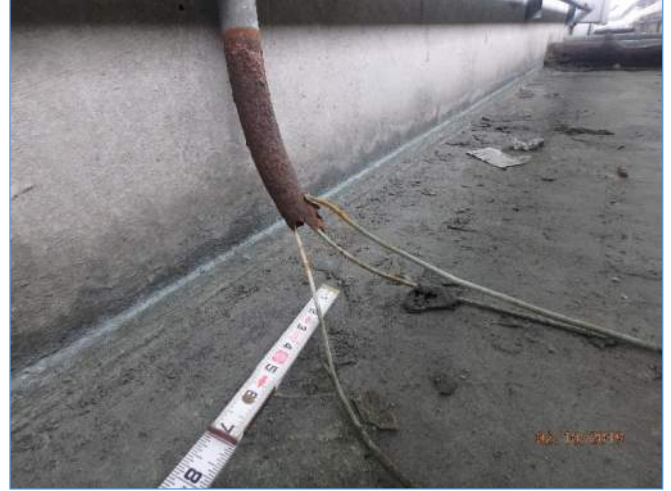
Span 238L: Conduit with 100% Loss Exposing Wires

- Remove soil and debris accumulation at transverse conduits on the deck.
- Replace conduit, brackets and straps on top of the deck with severe section loss.

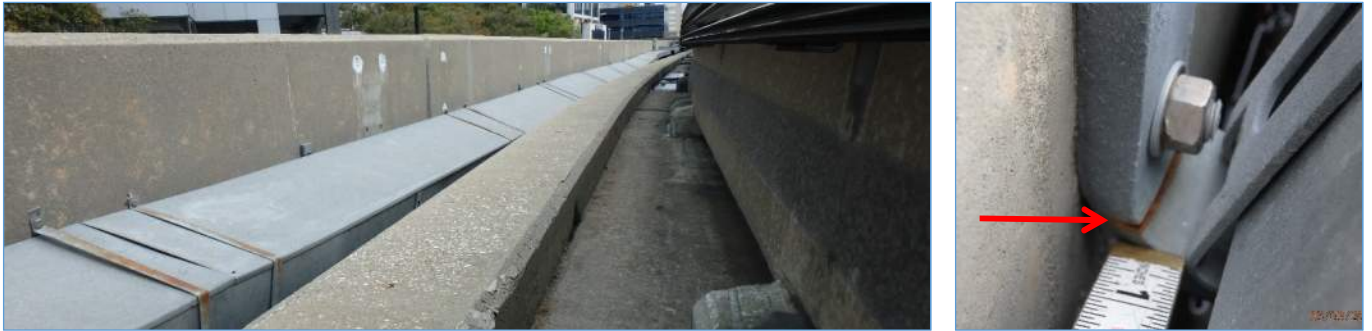
The cable trays that are attached to the inside faces of the sidewalls have isolated areas in need of repair. For instance, in Span 43N, there are four (previously 3) broken attachment brackets which are causing 45' (previously 30') of the tray to sag downward. See the photos below. There are also locations with missing straps and covers.

Span 43N Cable Tray with Four Broken Attachment Brackets

- Repair electrical cable tray defects listed in Appendix D-2 including missing straps, missing covers and broken or missing sidewall brackets.
- Investigate and mitigate the cause of the water leaking from the electrical outlet and light connections on the column of Pier 76.

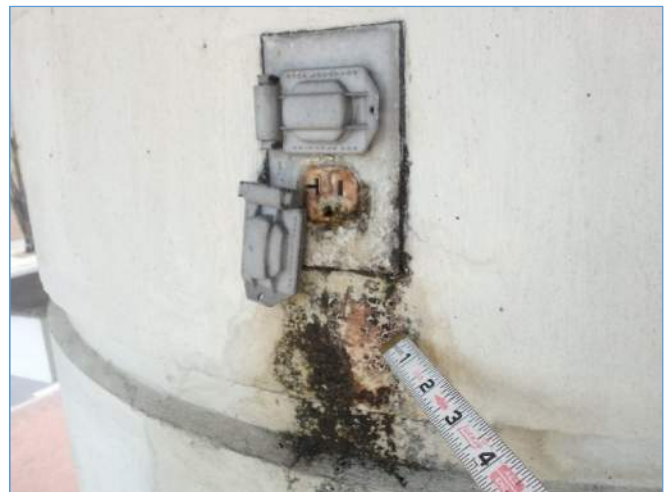
Many of the piers in the North Line have electrical outlets attached to the columns that are missing one or both of the hinged weather covers. There is an outlet cutout on Pier 52 that is missing cover plate. There is active water dripping from the light connections and the electrical outlet attached to the column at Pier 76. See the photos below.

Pier 76: Close-up of Water Leakage from Electrical Outlet

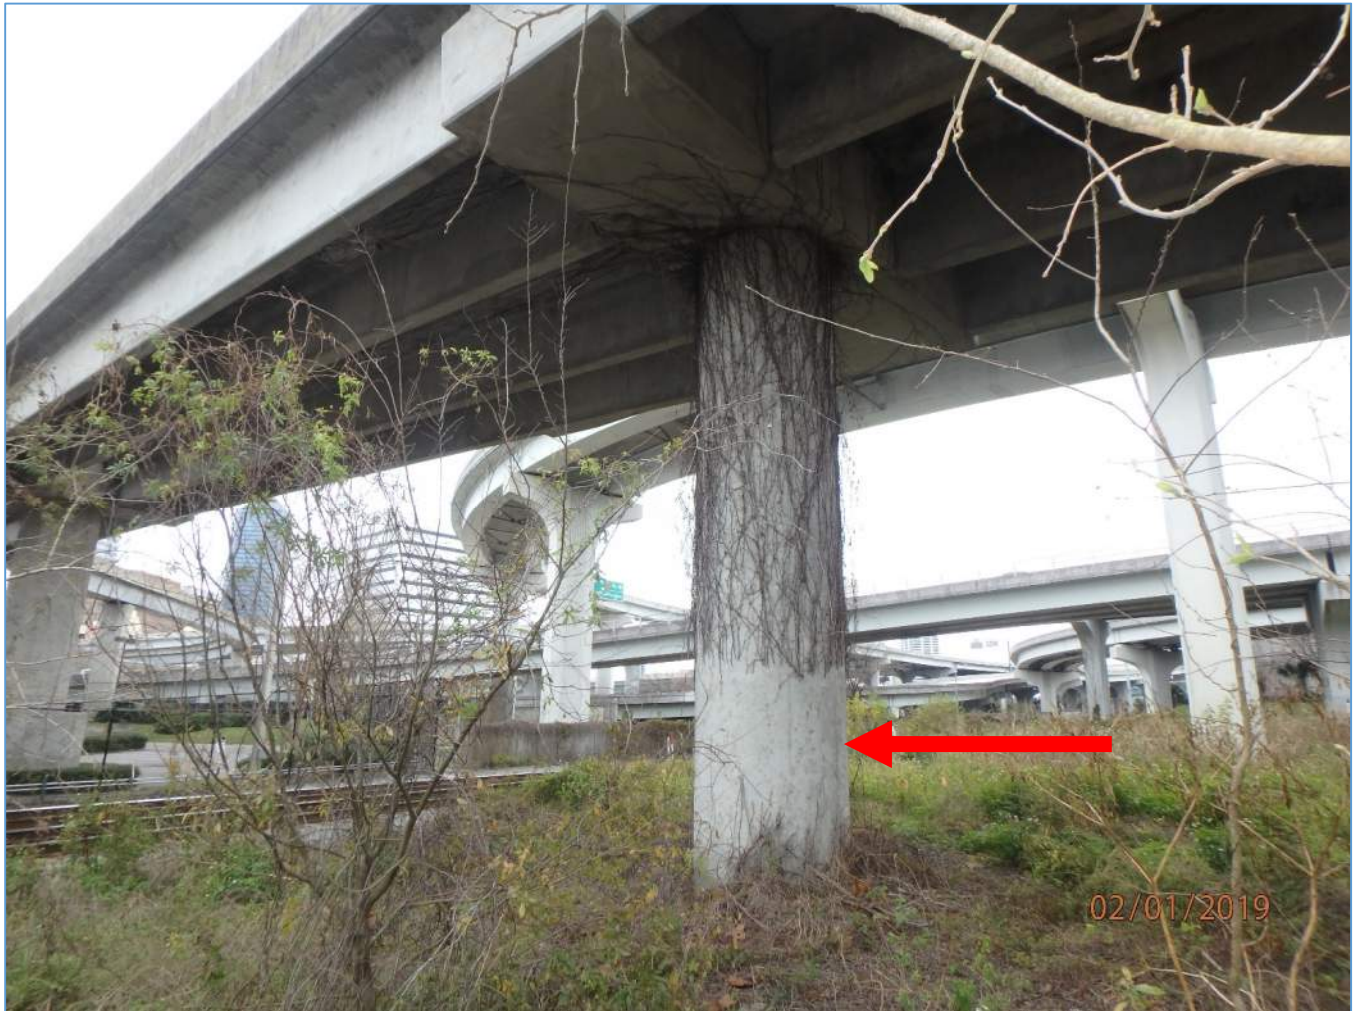
Pier 403: Cut Vines Growing on the Column

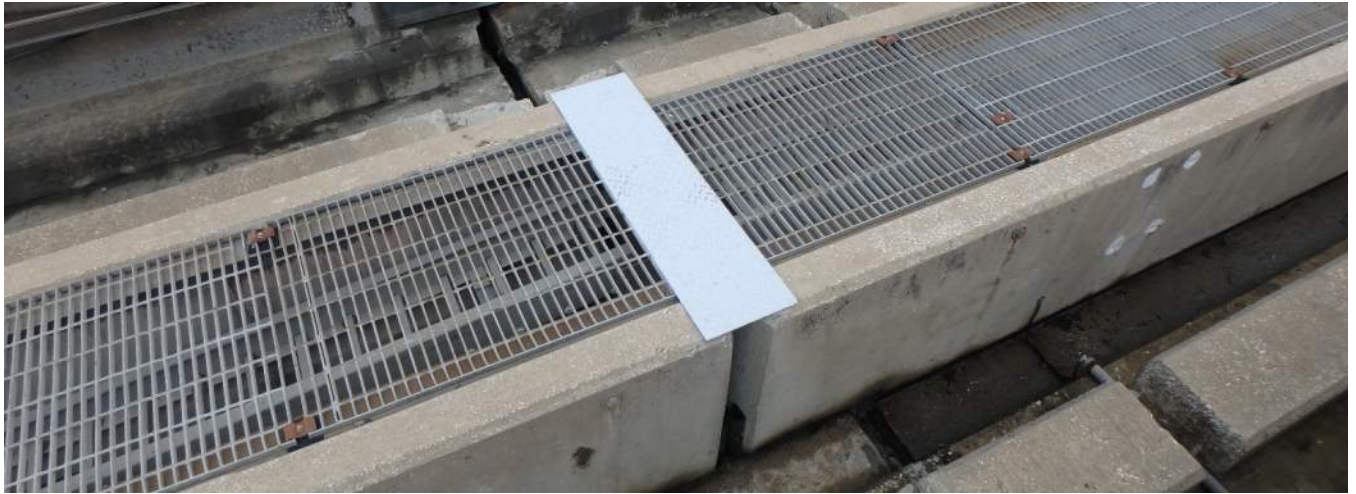
Coated Emergency Walkway Grating Expansion Cover Plate at Pier 32

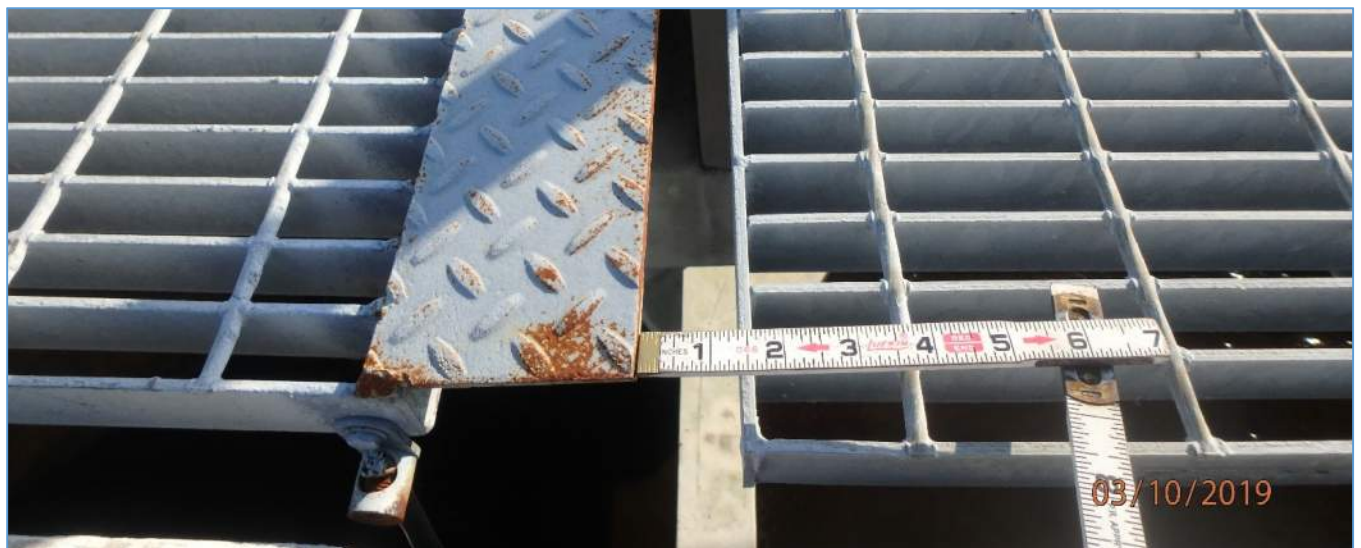
At the Acosta Bridge Piers R-1 and R-6, the grating cover plates are not wide enough to fully cover the expansion joint gaps produced by the bridge deck contraction. See the photo below.

Pier R-1 LT, Emergency Walkway Joint Expanded Beyond Expansion Plate

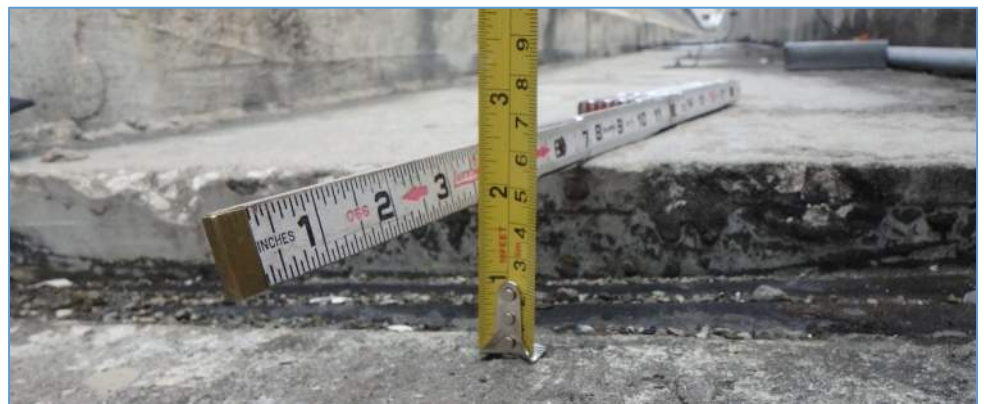
The top of pier cap and top of deck elevations were designed to be even, but at 29 joint locations, there is an elevation difference, noted between 1/4" to 2-1/4". In nearly all cases, the top of cap is lower than the top of adjacent deck. See the photo to the right.

Pier 258L: 1-1/4" Elevation Difference Between Top of Deck and Top of Pier

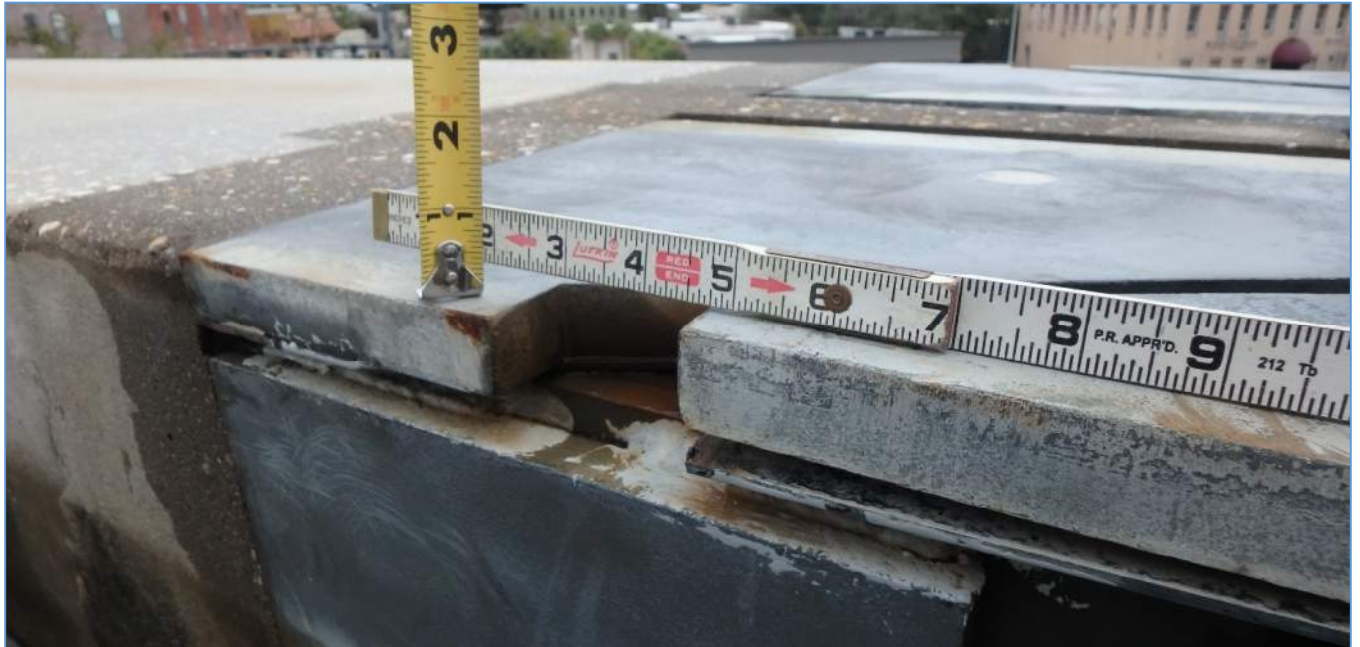
There are 99 guidebeam expansion joints in the system. These joints are in fair condition overall with no significant changes from the previous inspection. Vertical offsets of the top sliding plates were noted at fourteen locations. The largest elevation difference was found at Pier 210L. See the photo below.

Pier 210L: 1/2" Elevation Difference Between Guidebeam Sliding Plates

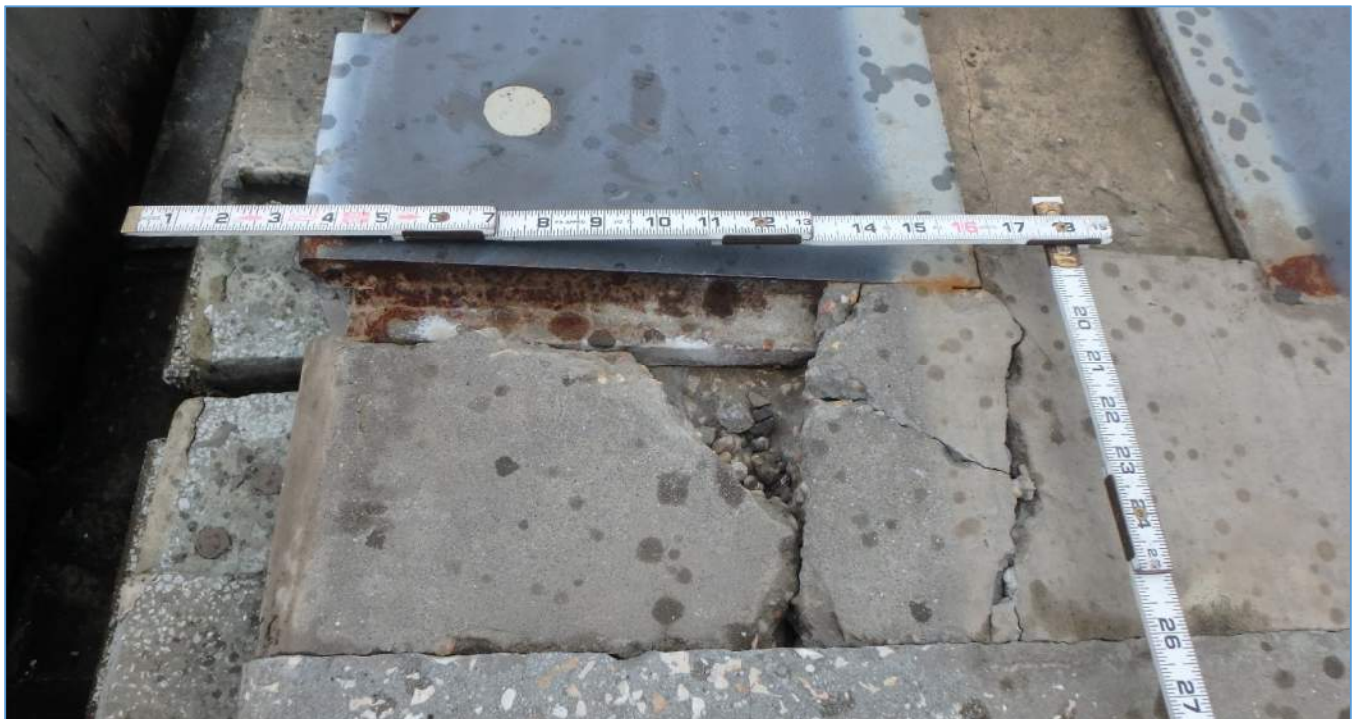
There are multiple locations in which the concrete closure pours (pourbacks) on either side of the joints, have spalling, delaminations, patches or cracking. Delaminations and spalls were noted at 48 of the 99 joints. See the photo below.

Pier 29N: Spalling and Delaminations on Forward Pourback

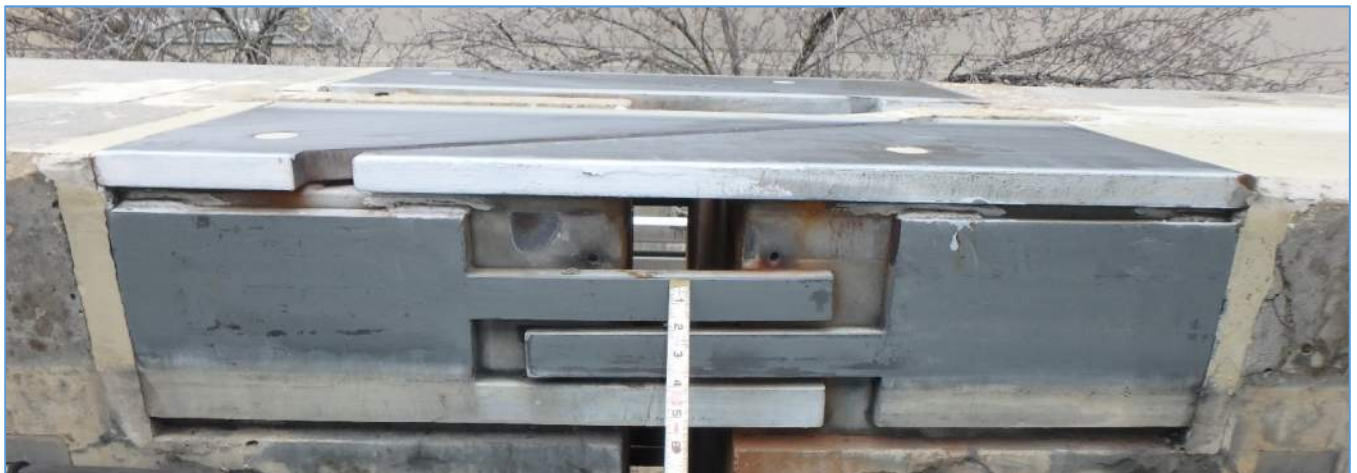
Pier 78L: Missing Finger on the Right Side of the Guidebeam

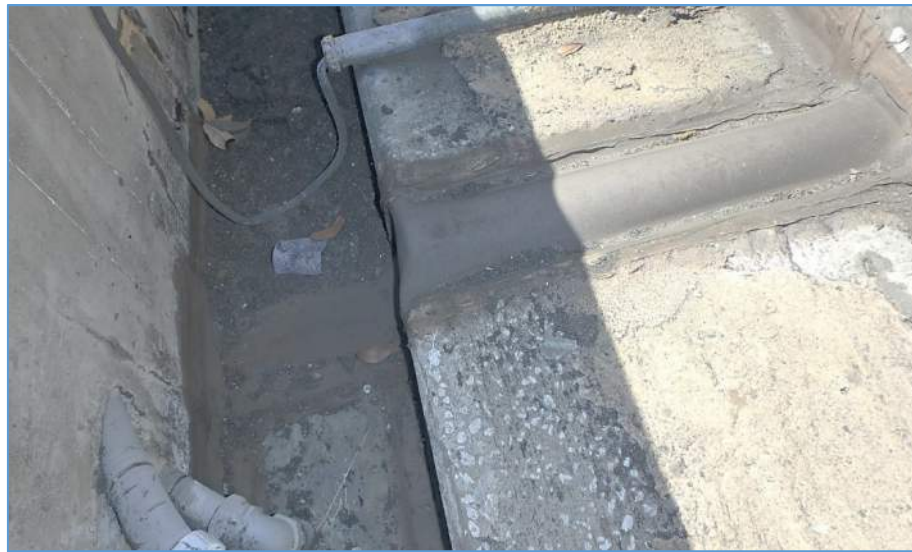
Pier 62L: Joint Covered With Neoprene Seal (Photo from 2017)

If the guidebeam is intended to remain and there will be no vehicle contact with the joints, then the most economical solution will be to apply a neoprene seal over the existing failed joints. This has already been done at piers near Hemming Plaza Station; See the photo below.

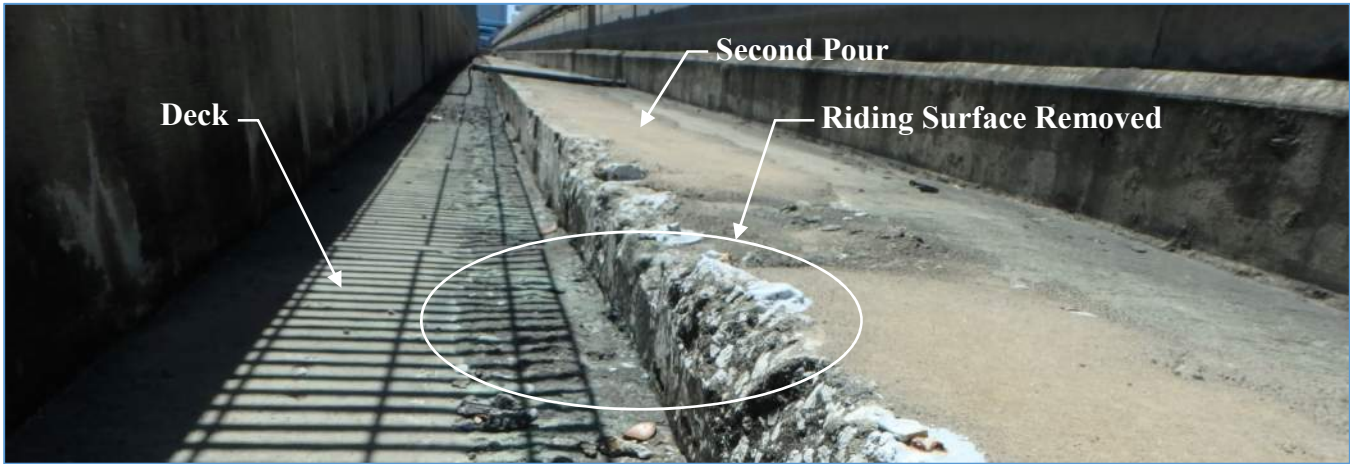
Typical Deck Top in the Starter and North Lines Showing Removal of Relic Riding Surface (Photo from 2017)

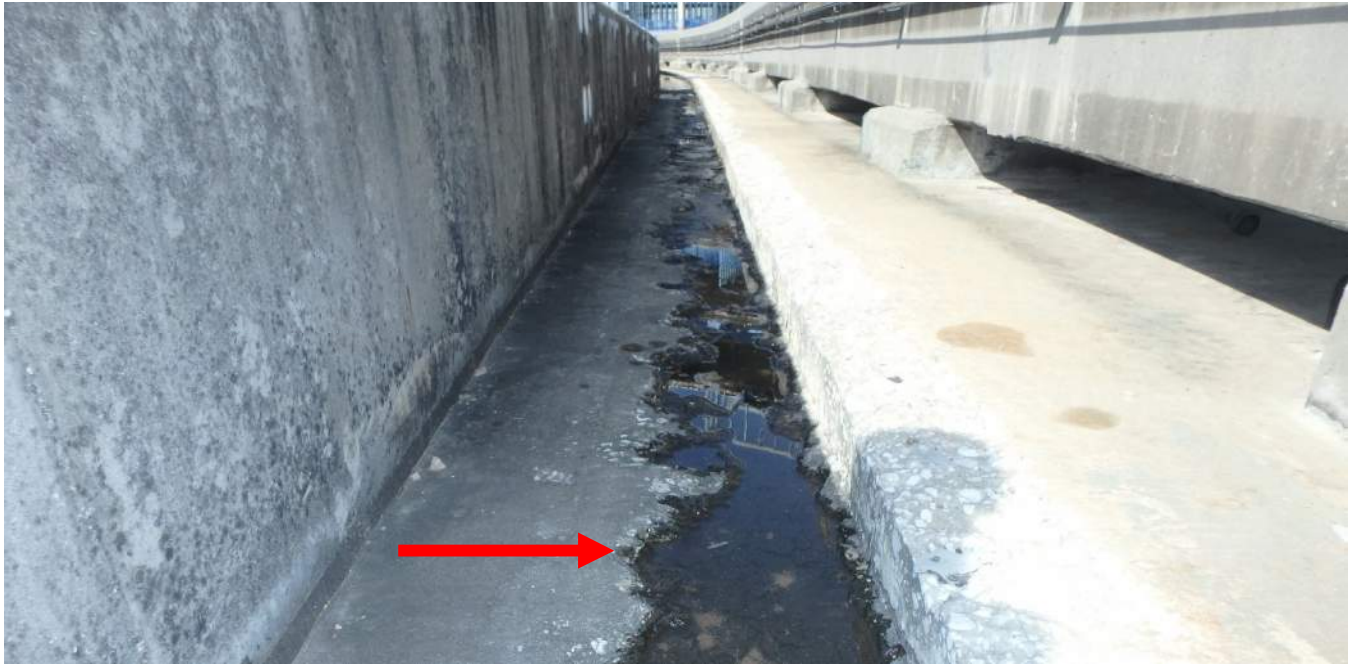
In Spans 6N and 7N (Starter Line), the second pour was saw cut on both sides of the guidebeam and the portions to the exterior of the cut were removed. This work damaged/removed the top of the deck up to 1-3/4" deep x 12" wide, full length of both spans. See the photo below.

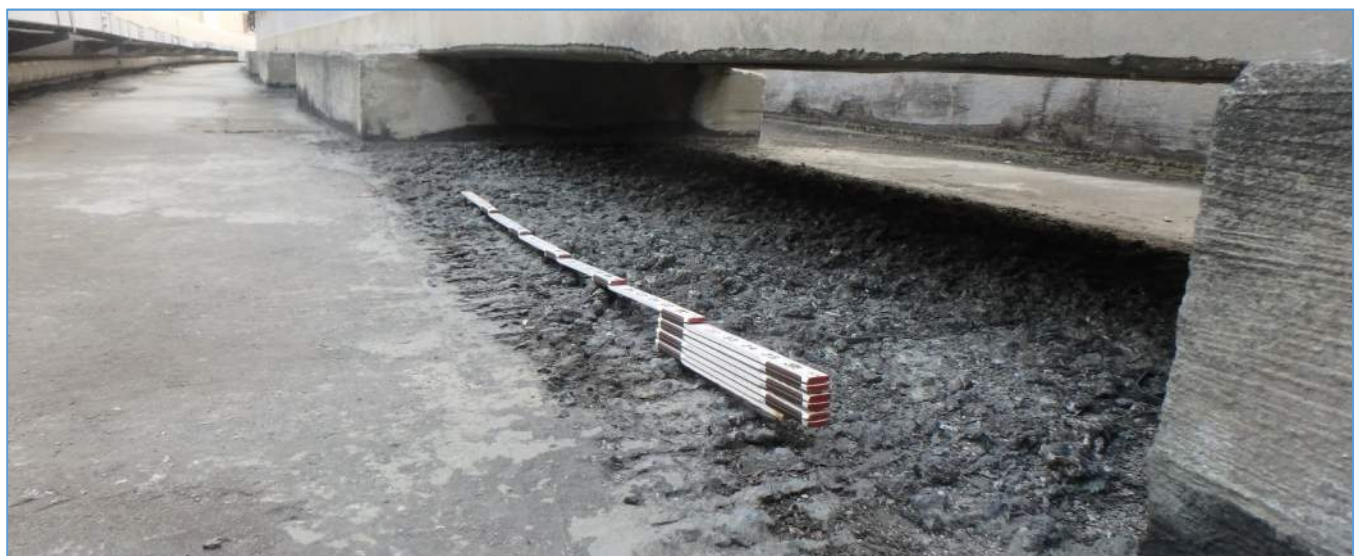
Typical Roughened Deck Top in the South Line

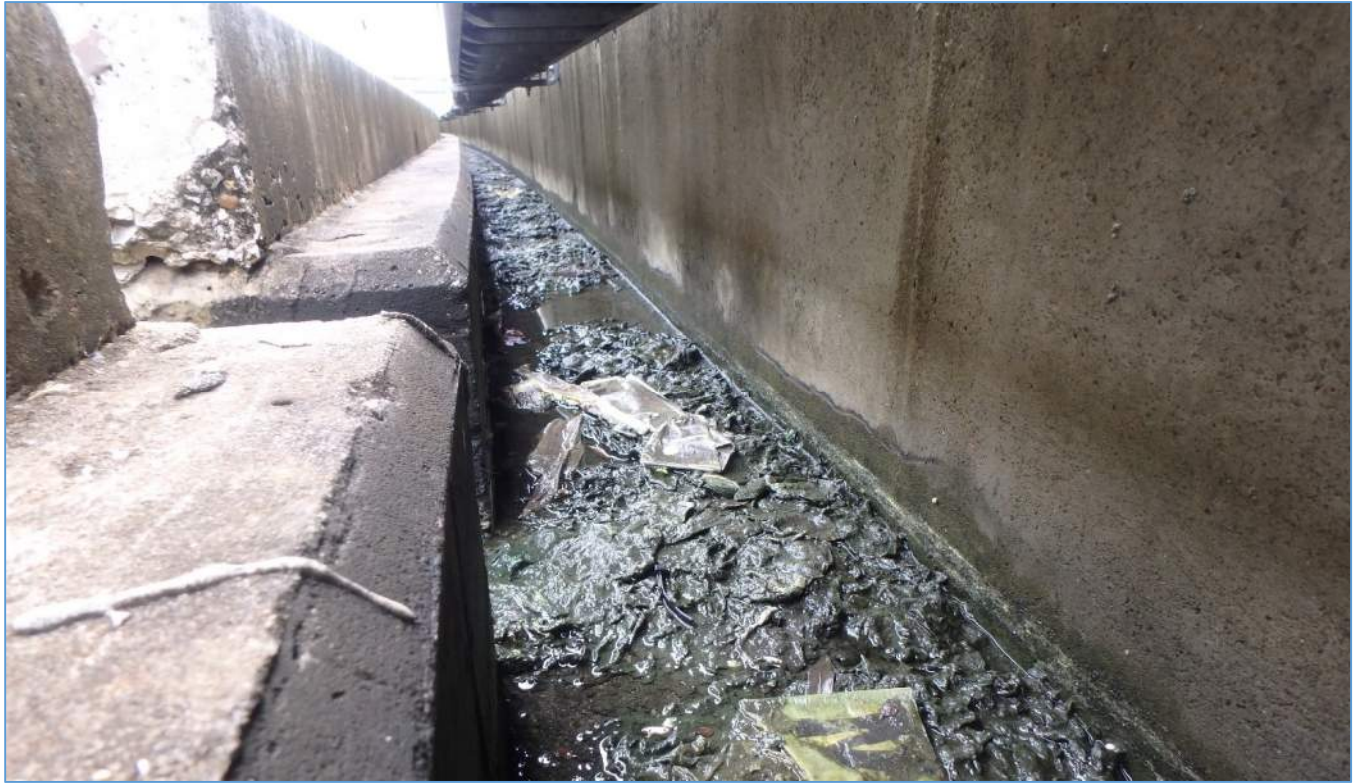
There is soil and debris build-up on top of the deck surface throughout the system; see the photo below. This debris traps moisture and results in drainage problems and corroded metal conduits. More information on these issues is presented in the Drainage and Electrical sections of this report.

Span 20S: Wet Debris Accumulation, Right Side of Second Pour

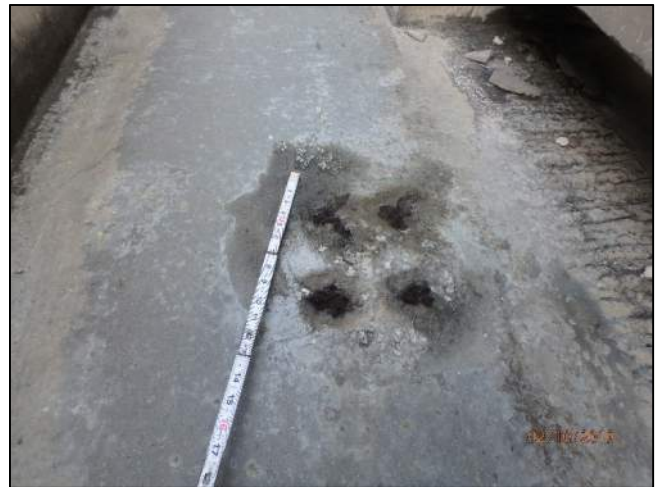
Span 231R: Lift Point Patch Failure

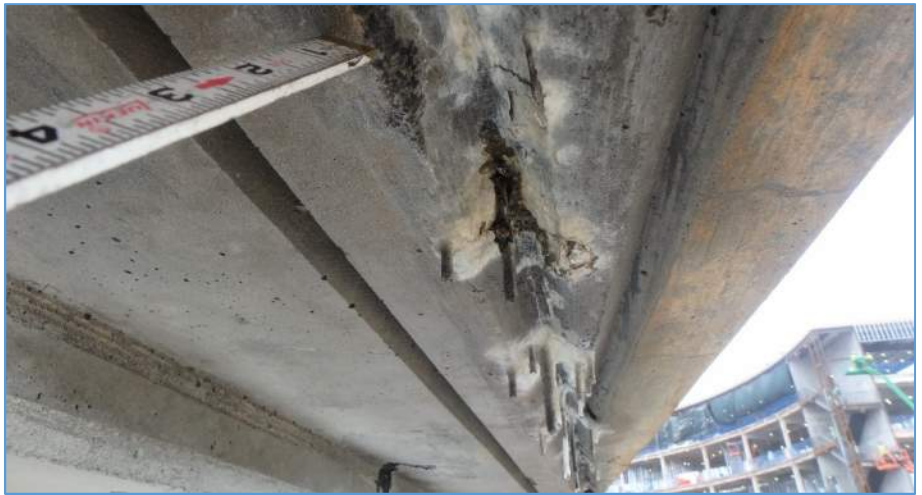
The undersides of the CIP deck overhangs at the switches exhibit cracks with efflorescence; this is heaviest in the switch area around Span 8 (Starter Line). Here there is heavy efflorescence dripping and moisture leaching between the main deck and the overhang extensions. See the photo to the right. Efflorescence is also common within the PT blackout on the undersides of the tee beam flanges.

Span 8N: Heavy Efflorescence and Moisture Leaching in Deck Overhang

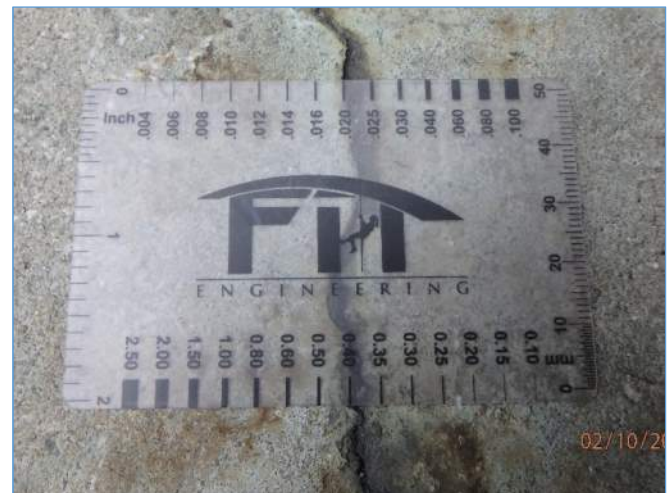
Span 241R: Closeup of Transverse Deck Crack

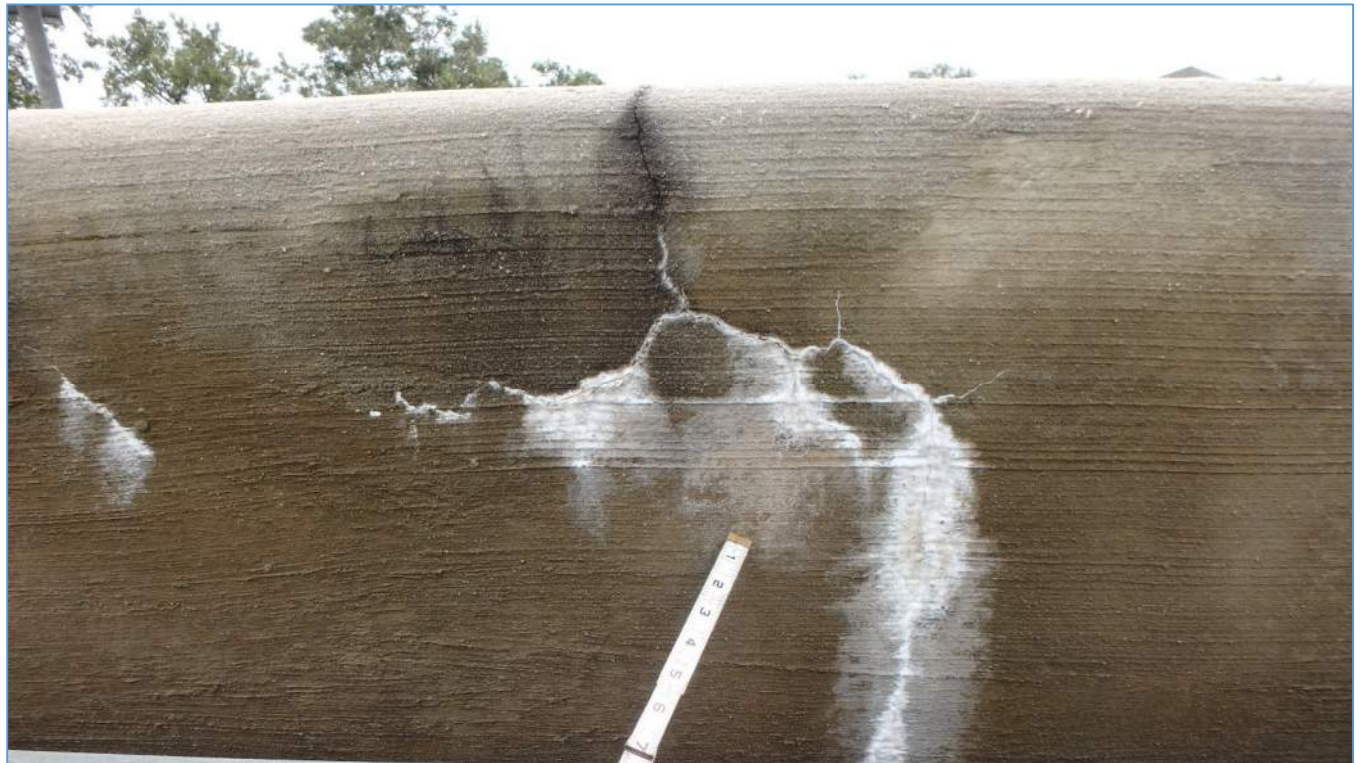
Span 211L: Random Cracking on the Interior Face of the Left Sidewall with Efflorescence

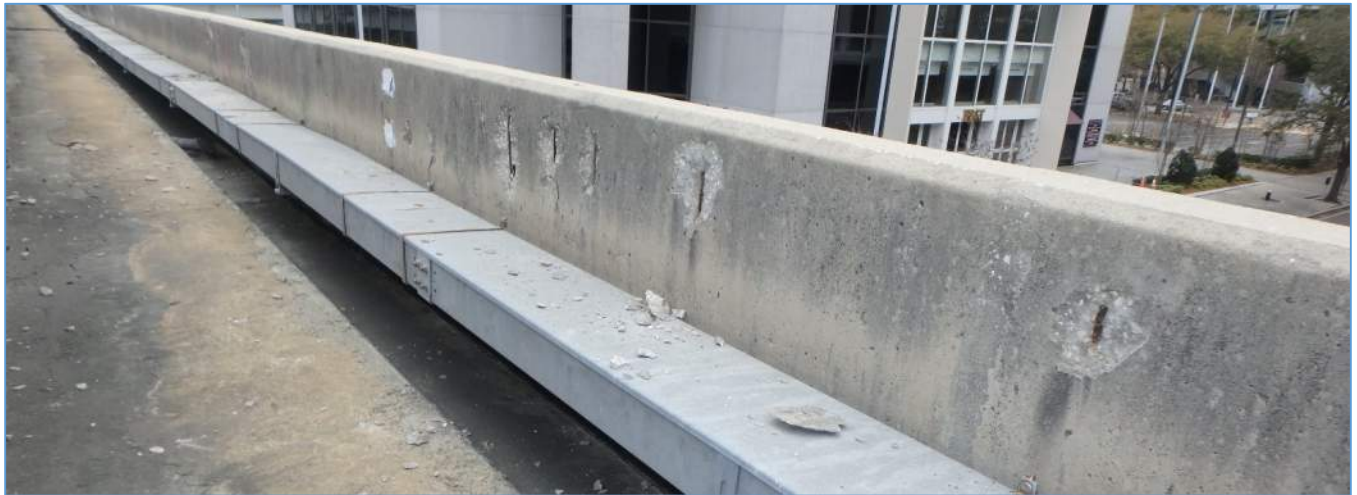
Spalls and popouts with exposed steel due to insufficient concrete cover of the reinforcement is common on the vertical faces of the sidewalls. These deficiencies were noted over approximately 320 linear feet, scattered throughout the system. Many of these locations have been painted by JTA maintenance crews or coated with galvanic spray by inspectors. See the photo below.

Span 55L: Interior Face of Left Sidewall with Insufficient Reinforcement Cover Spalls

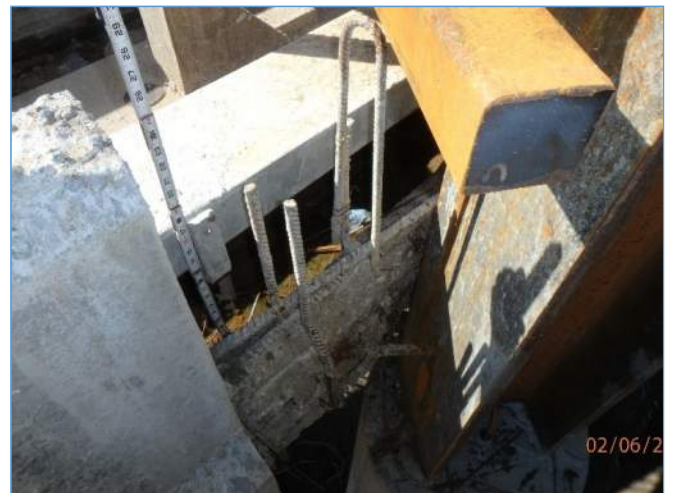
Span 5N: Sidewall Cutout at the JRTC Due to Conflict with Adjacent Building Column

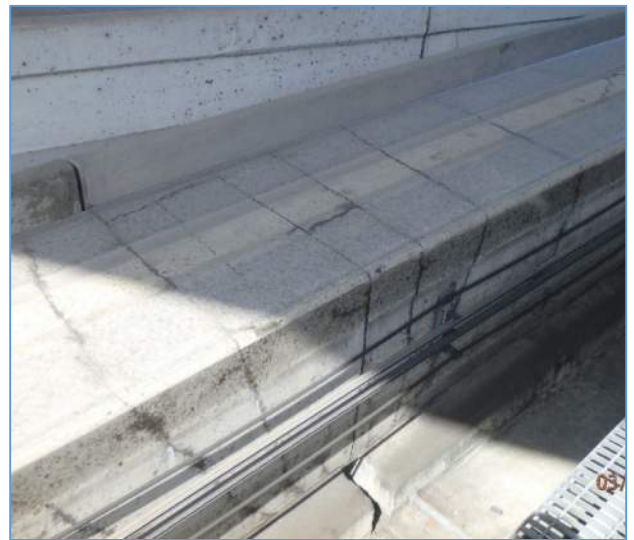
The Skyway guidebeams are in satisfactory condition overall, with no significant changes from the previous inspection. The beams exhibit cracking typical of conventionally reinforced concrete members. There are hairline (less than 0.01" wide) vertical and transverse cracks spaced three or more feet apart that run up the sides and across the top of the member. Likewise, hairline longitudinal cracks are present on the top face at the centerline of the beam, throughout the system. These types of cracks are typical for reinforced concrete in "good" condition. There are isolated locations throughout the system in which the cracking is wider and/or more densely spaced. These locations are noted in Appendix D-8. The worst cracking in the guidebeams is present in Span 253, which is a 334' pile supported slab section of the River Line that is on a tight curve. See the photo to the right.

Span 253: Vertical/Transverse Cracking in Guidebeam

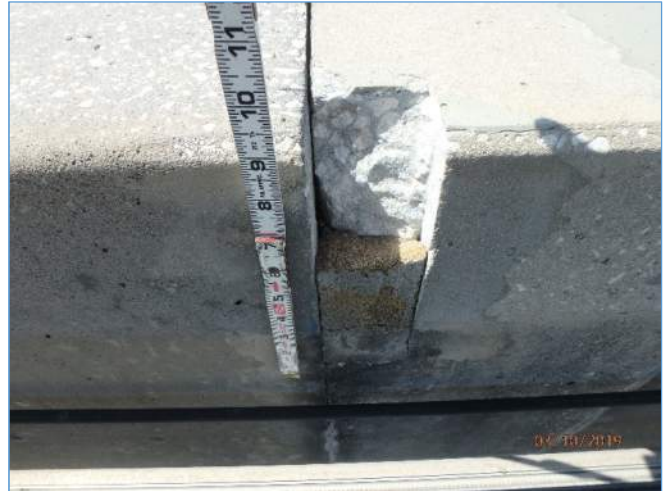
Span R-2L: Failed Patch on Left Side of Guidebeam

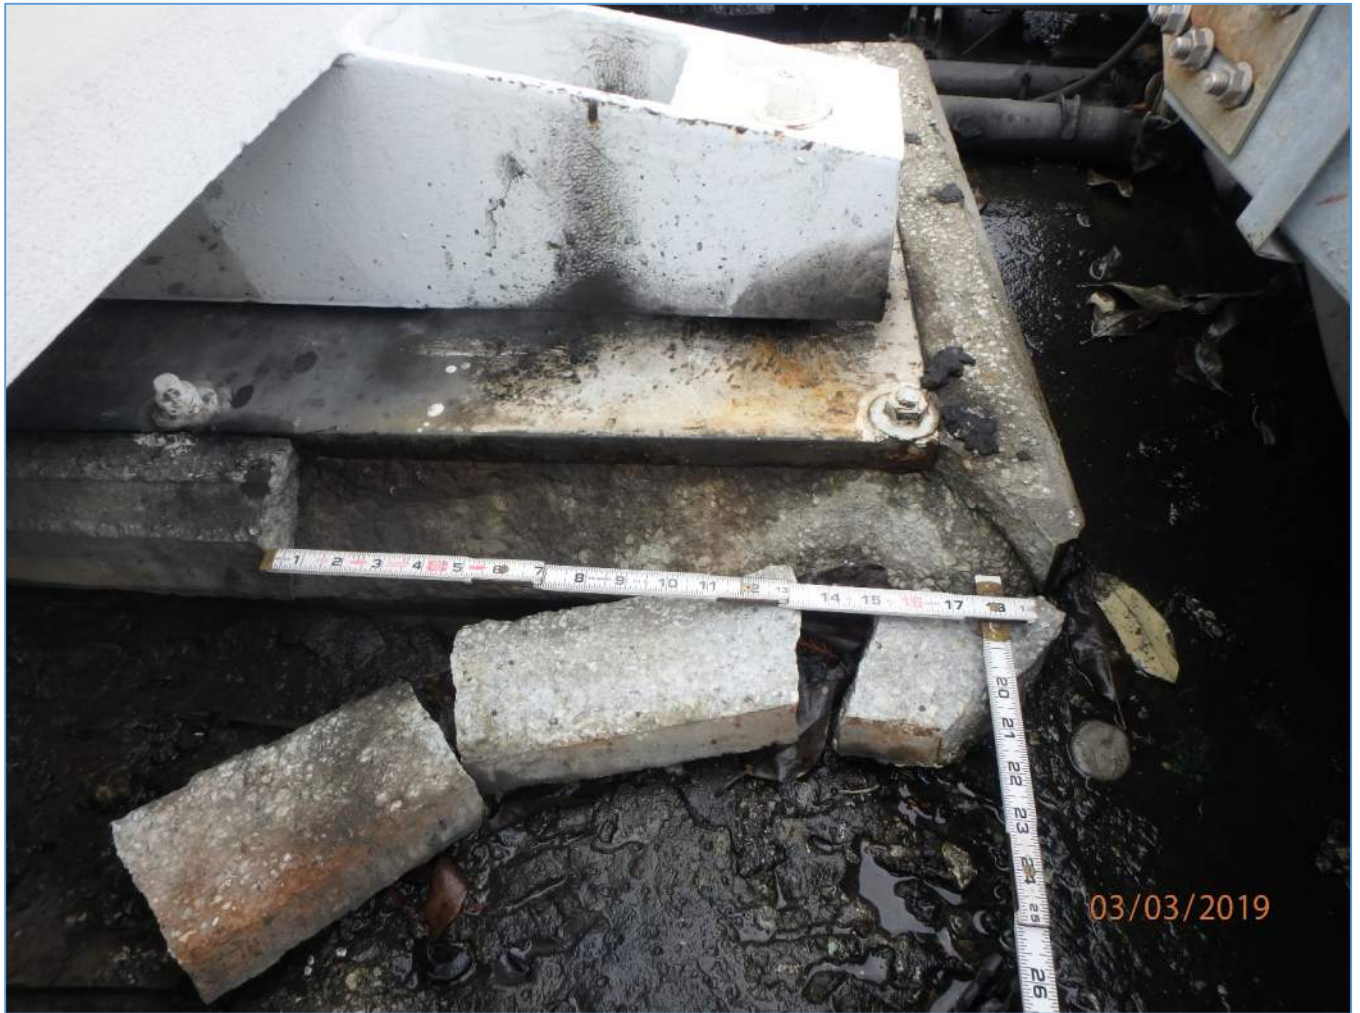
At isolated locations, the concrete pedestals for the switchbeams have wide cracks emanating from the anchor bolts, and fractures and spalls around the perimeter. See the photo on the following page.

Span 31S: Switchbeam Pedestal Fractures and Spalls

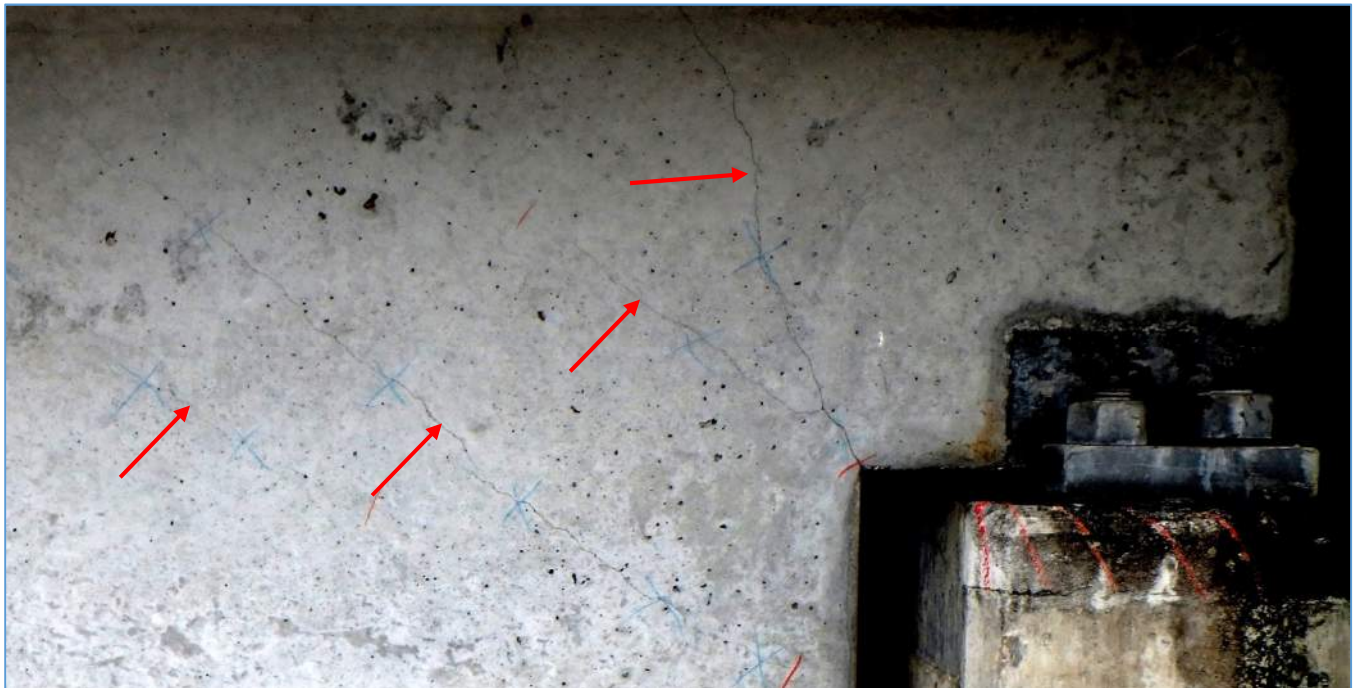
noted in the previous report, approximately 8% of the cracks have increased from the previous inspection, meaning that the cracks either grew in length and/or width. There are two beam ends where cracks were measured up to 0.025" wide for the initial 3 inches of the crack length. These are at the expansion ends of Span 17N, and 46N. See the photos below.

Span 12N: Shear Cracking up to 0.02" Wide on Left Stem End at Pier 12
