JTA Skyway 2019 Routine Inspection of Bridge Structures

Jacksonville Transportation Authority

RS&H, Inc. / FIT Engineering, LLC

Final Report

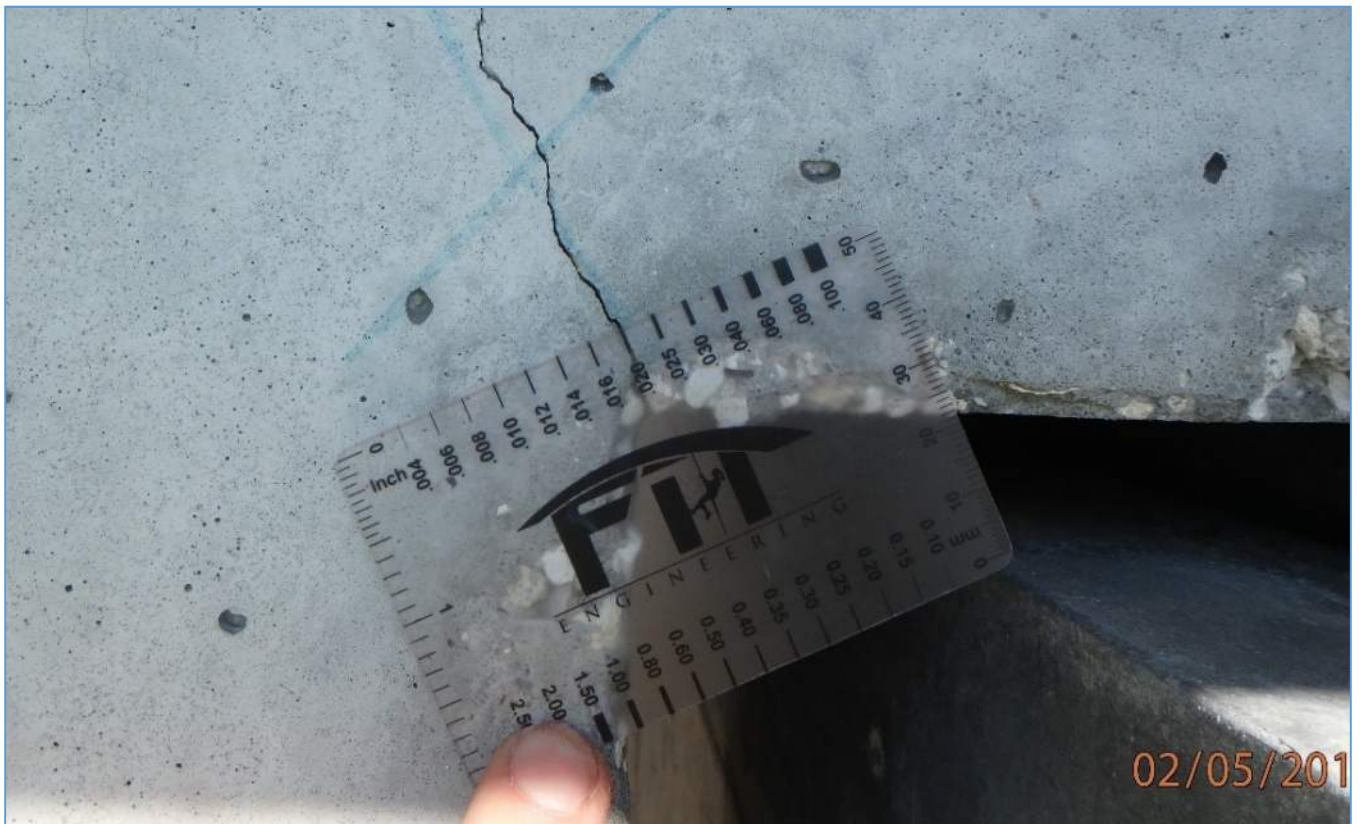
Span 12N: Close-up of Shear Crack in Left Stem at Pier 12

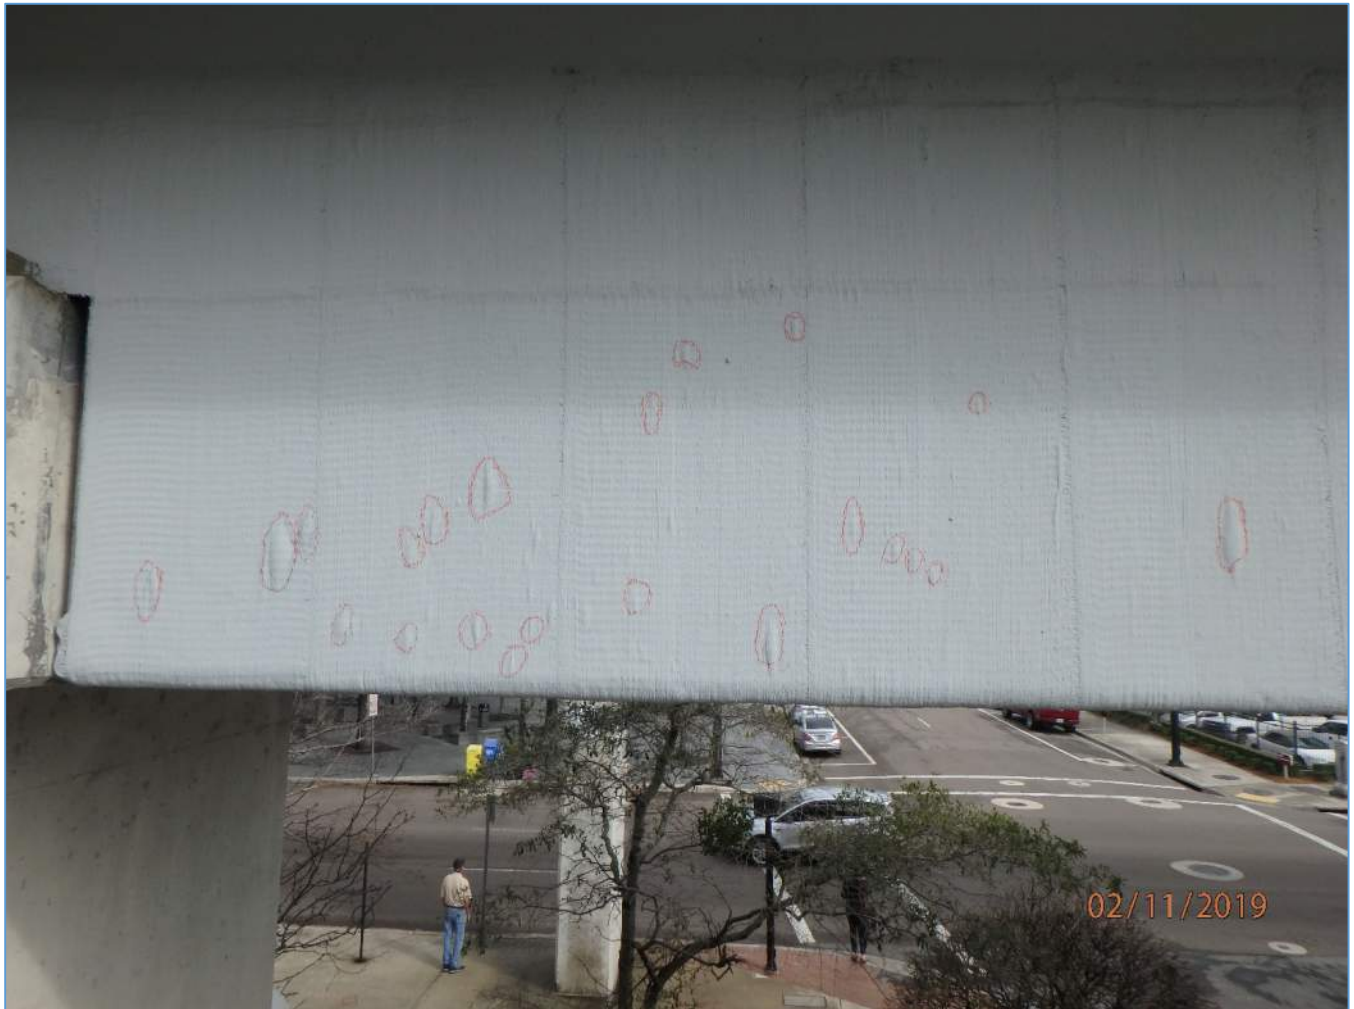
Nearly all of the CFRP wraps have small bulges at isolated locations. These bulges are mostly solid and are likely filled with hardened resin. There are a few locations in the system in which the bulges are delaminated and feel soft, spongy or hollow. The beam with the most delaminations is Span 47R, a cast-in-place beam with 24 delaminated blisters on the exterior face of the right stem, up to 5" x 2". See the photo below.

Span 47R: Delaminated Blisters on CFRP Wrap, Right Stem at Pier 47R

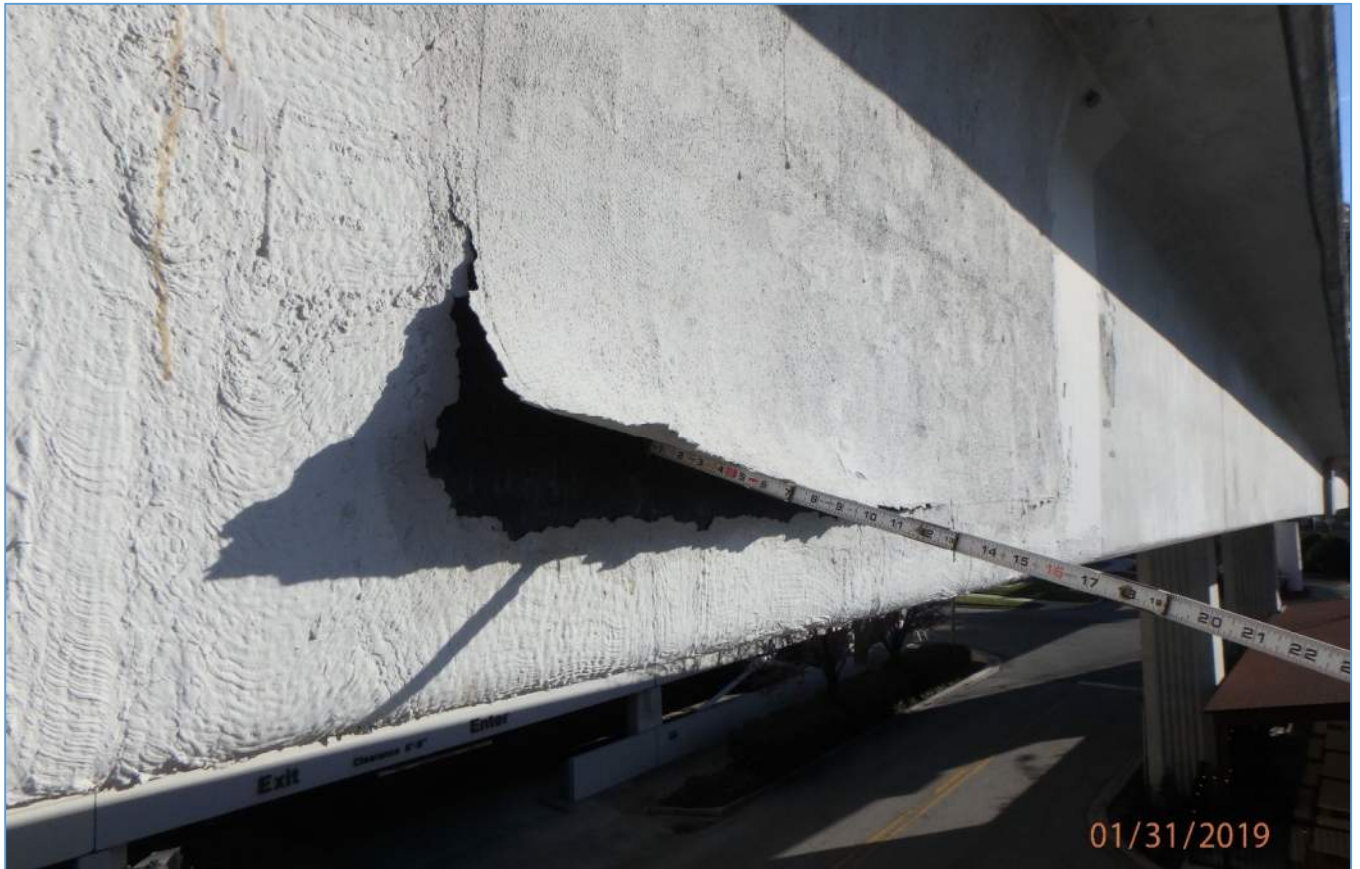
There is one location in which the wrap is failing altogether (material failure) and that is at Span 227L. The CFRP on the exterior face of the left stem is cracked and popping off 3'-4" L x 12" H, 12 feet from Pier 228 and 2'-6" L x 10" H adjacent to the pier. Also the wrap is delaminated nearly completely over the rear 6 feet with peeled and cracked areas. There are numerous delaminations on both left and right stems. Attempts to repair these locations with epoxy injection have been ineffective. See the photo on the following page.

Span 227L: CFRP Failure in at Pier 228

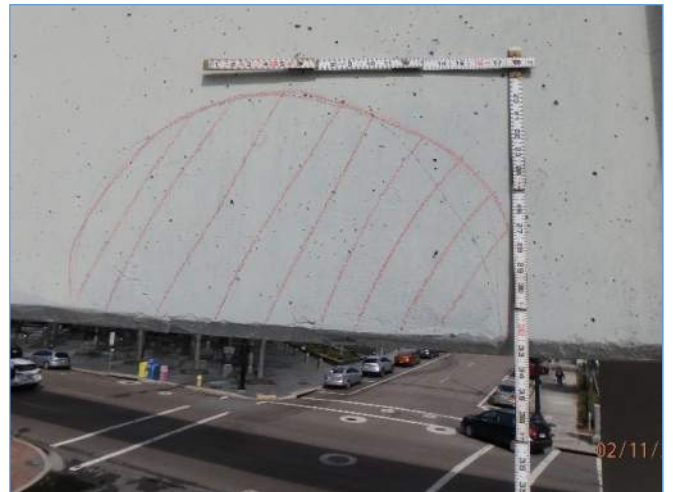
Span 47R: 24" x 14" Delamination, Right Stem Near Pier 48R

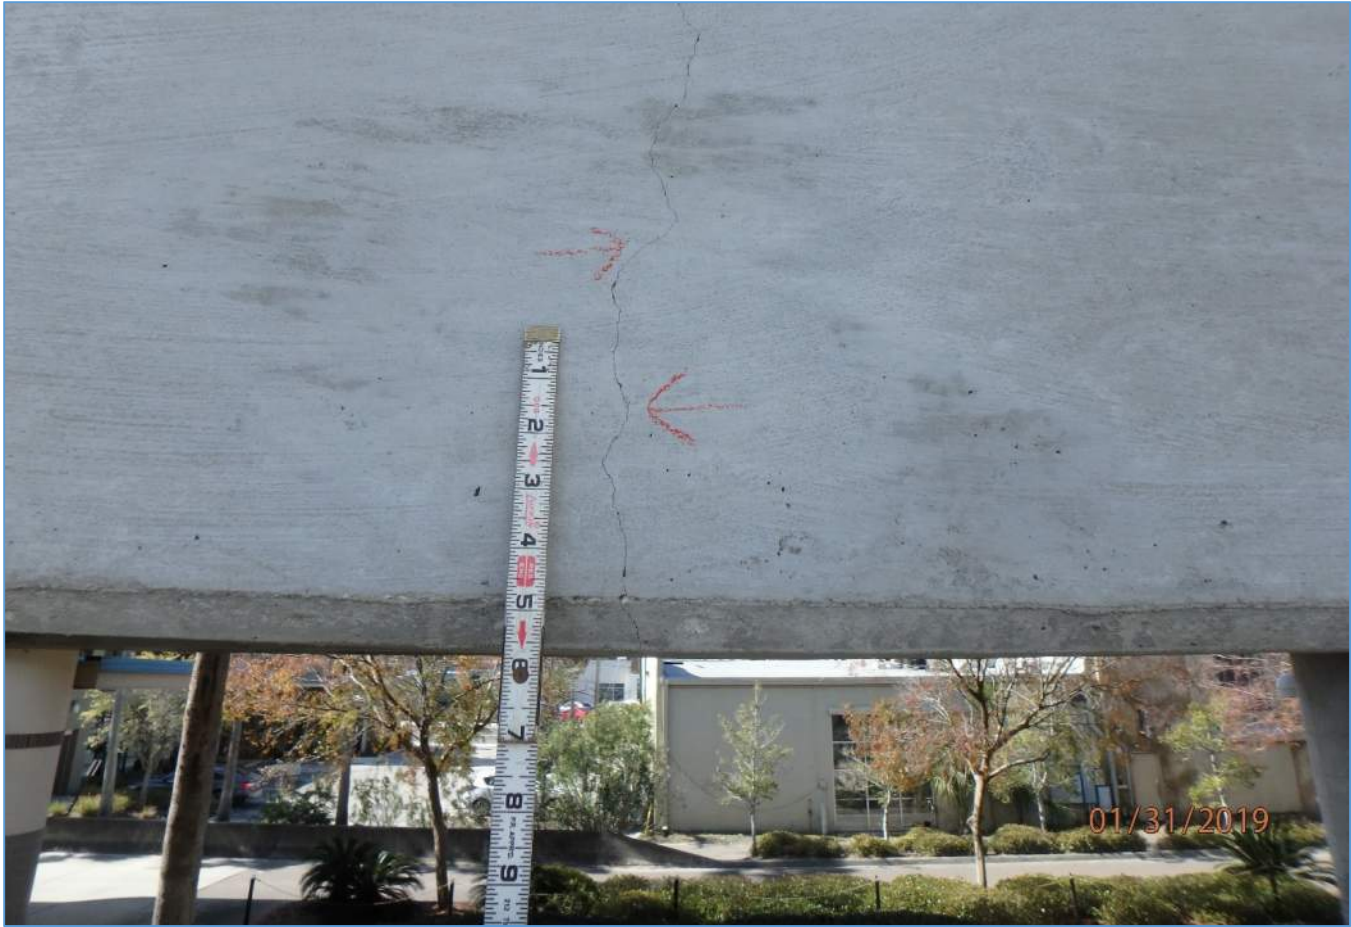
Span 203R – Typical Unsealed Flexural Crack in Cast-In-Place Beam Stems

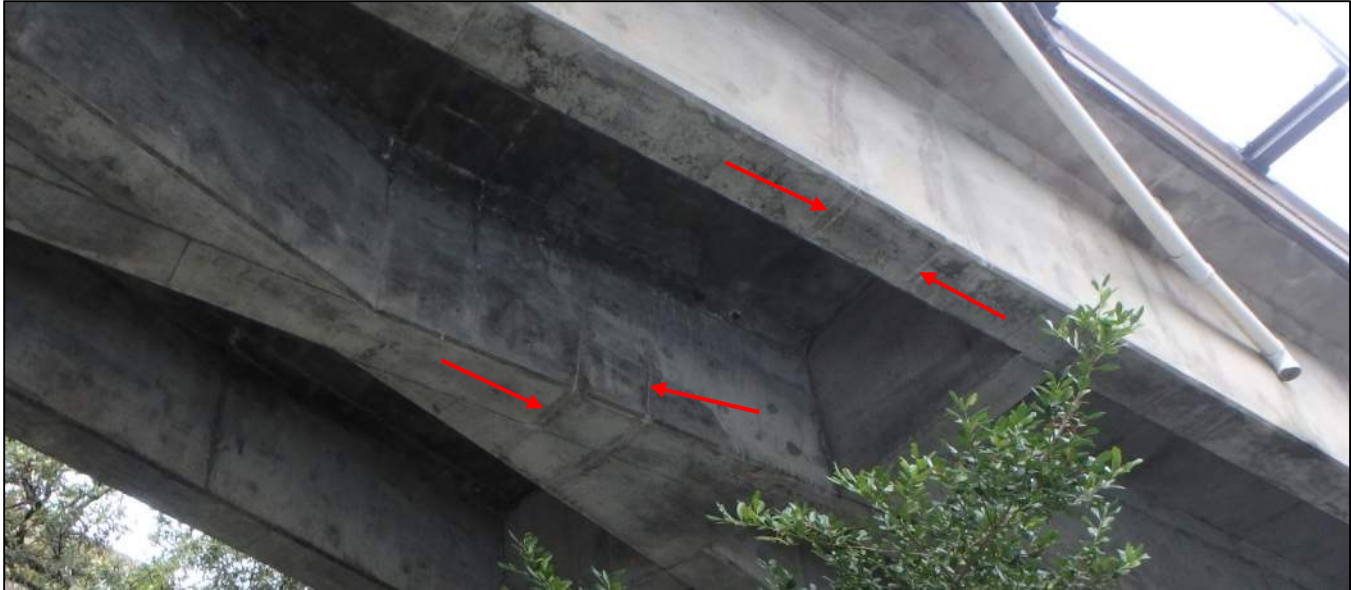
Span 42S – Cross: Typical Sealed Flexural Cracking in Beam Stems

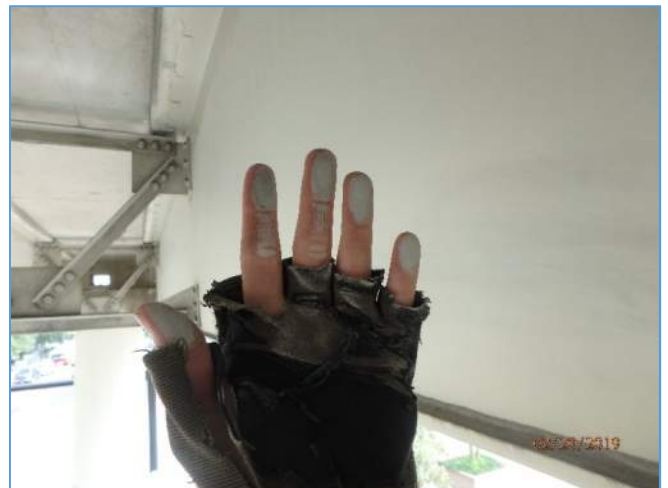
Very Chalky Paint Exterior – Typical Throughout

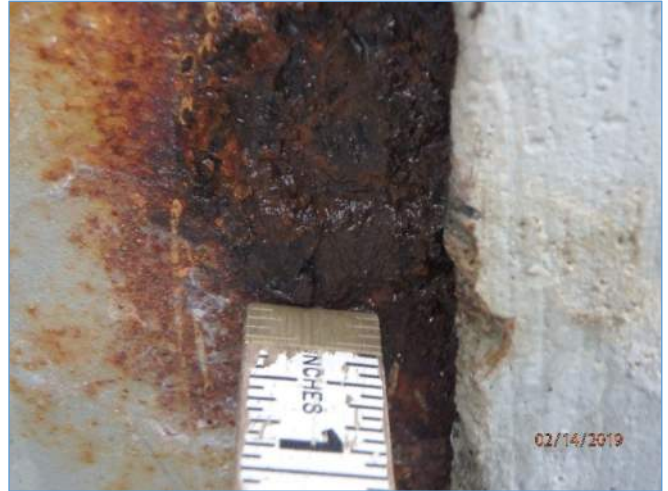
Span 236L: Closeup of Corrosion and Section Loss

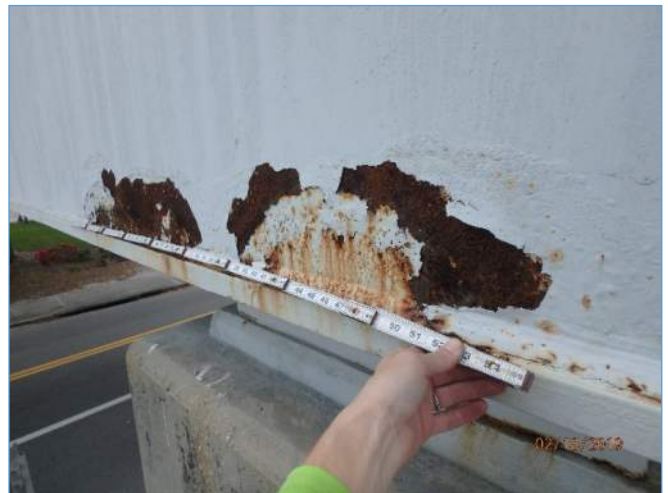
Pier 10N: Corrosion on Cross Girder

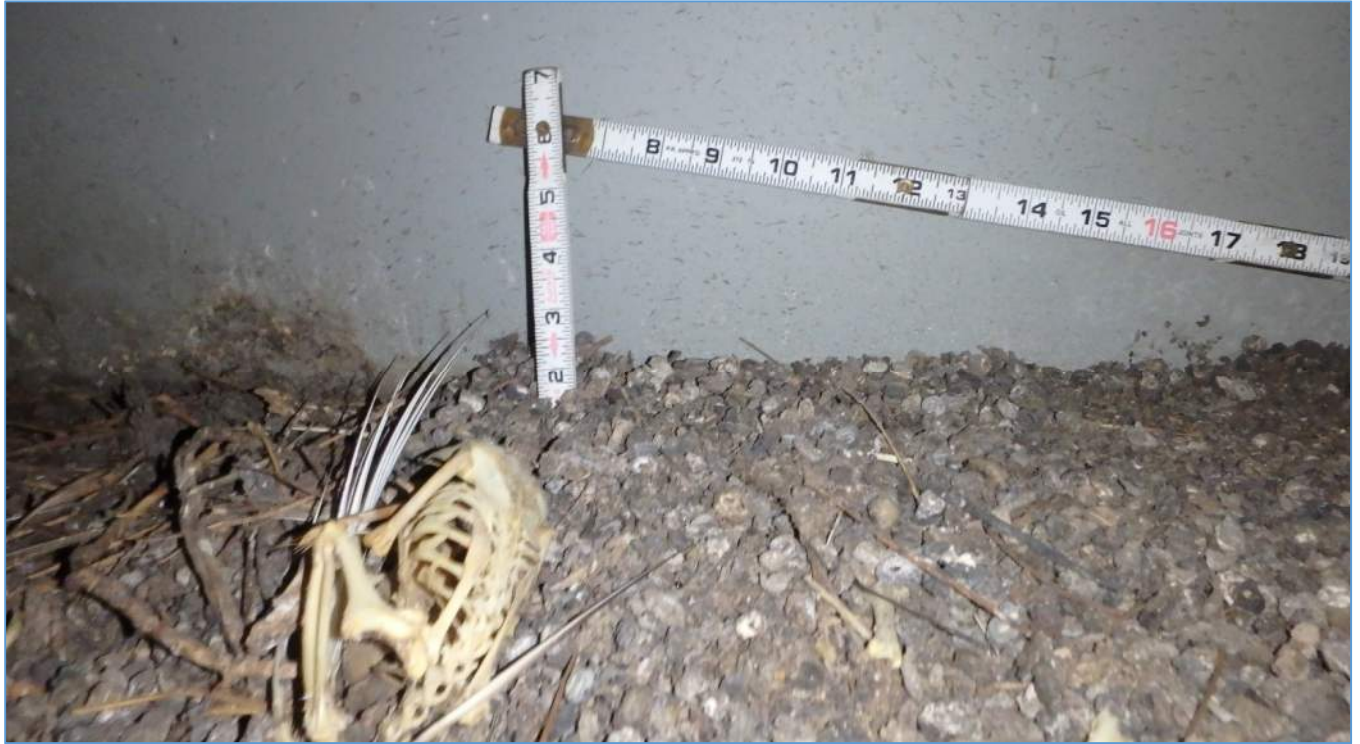
Span R6 LT: Organic Debris up to 2" Deep

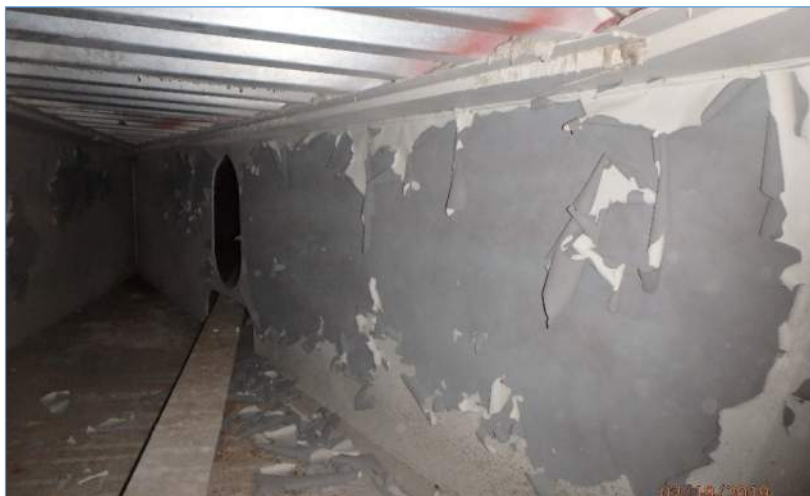
Span 31S: Peeling Paint Exposing Primer

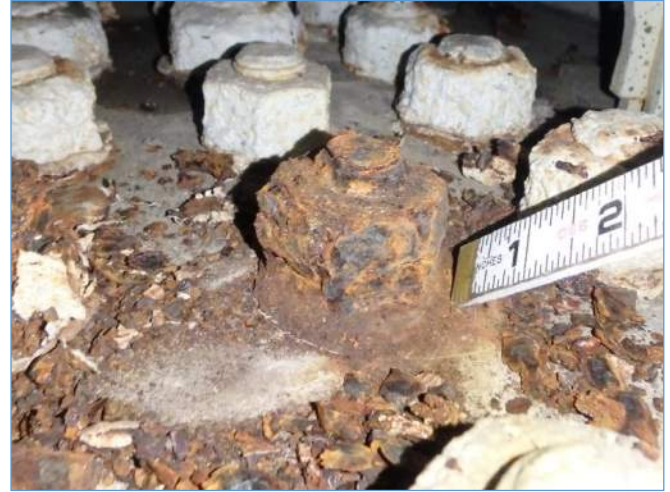
Span 52A LT, Bay 1 Splice (Up to 20% Loss on Nuts)

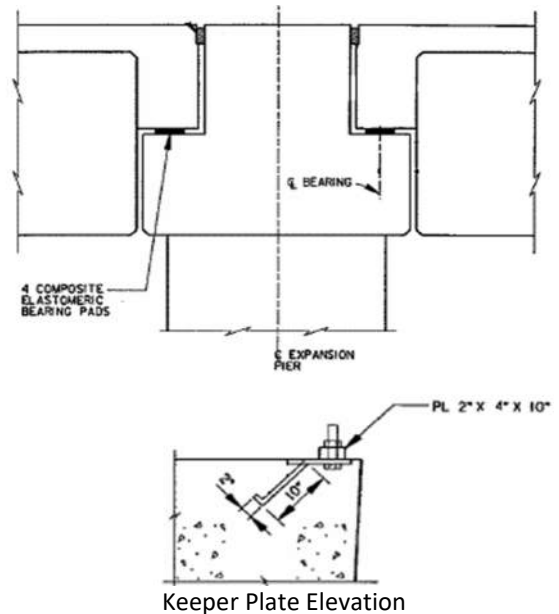
Keeper Plate with Corrosion

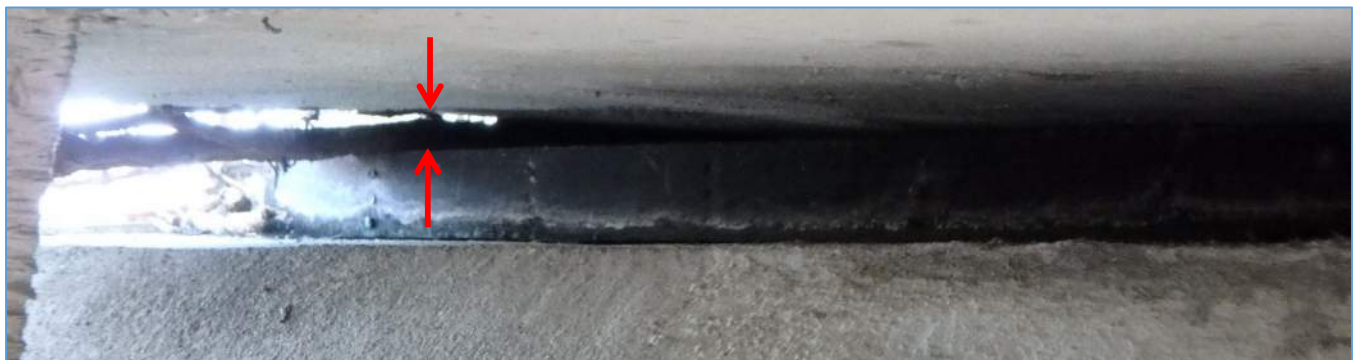
Span M2: Up to 1" Gap for 15" Between Beam and Bearing Pad at Pier M3

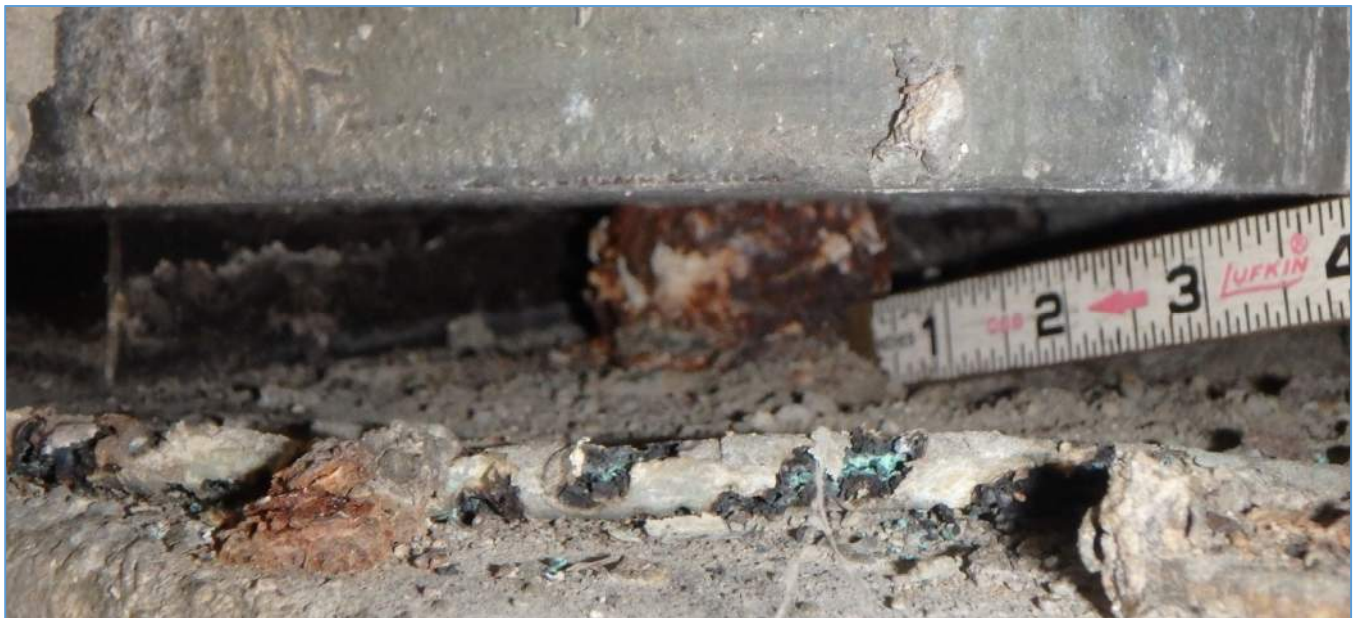
Span 239L at Pier 240L: Surface Corrosion on Bearing Plate Anchor Bolt

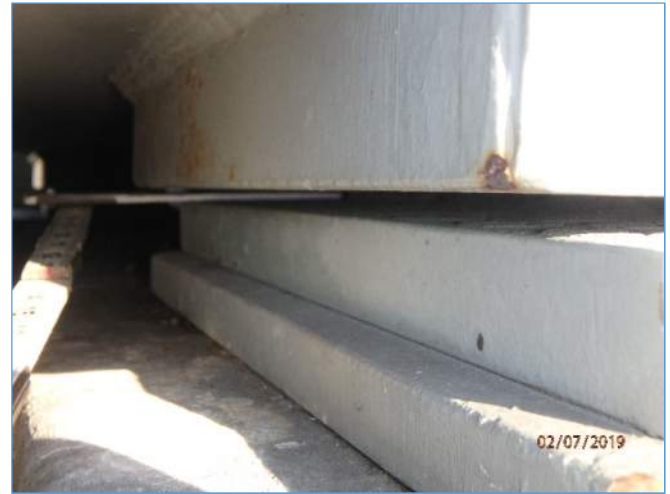
Span 257R at Pier 258R: 1/4" Gap; no right bearing

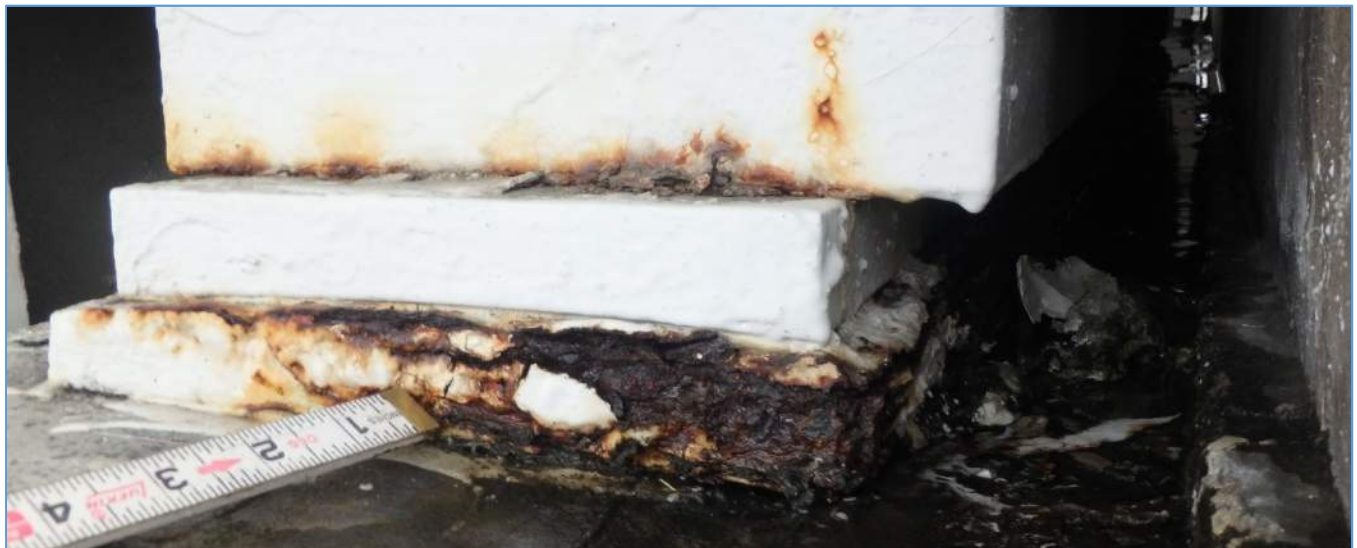
Span 29N at Pier 29N: Heavy Surface and Laminating Corrosion on Bearing Plates

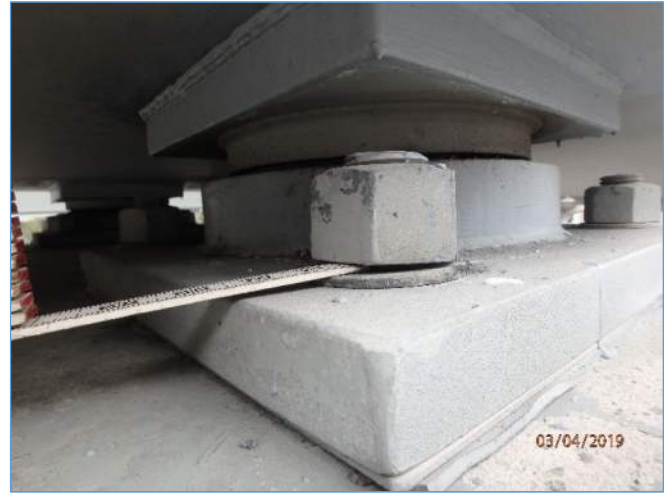
Pier 256L: Loose Bearing Anchor Bolt Nuts

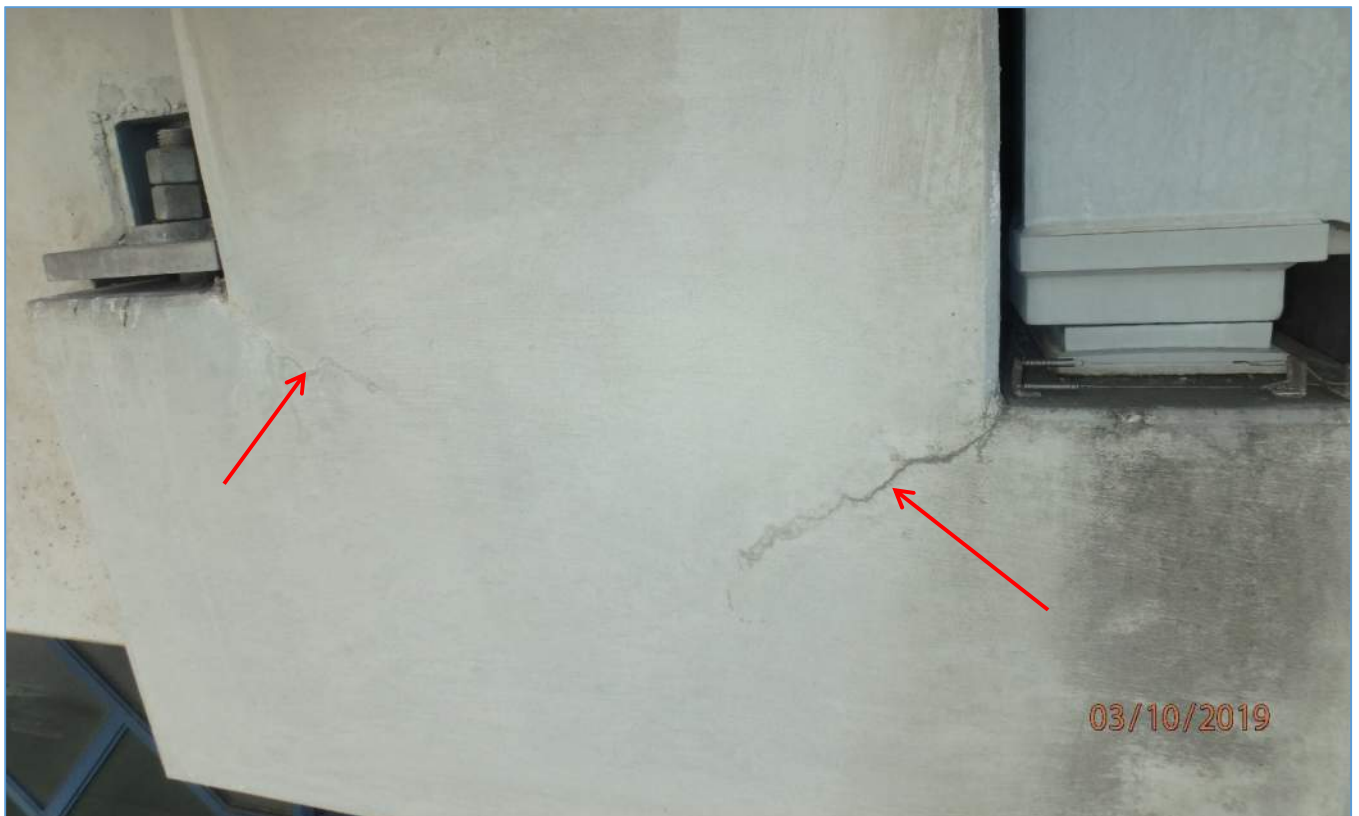
Pier 240, Right Face of Cap: Typical Beam Seat Corner Cracks

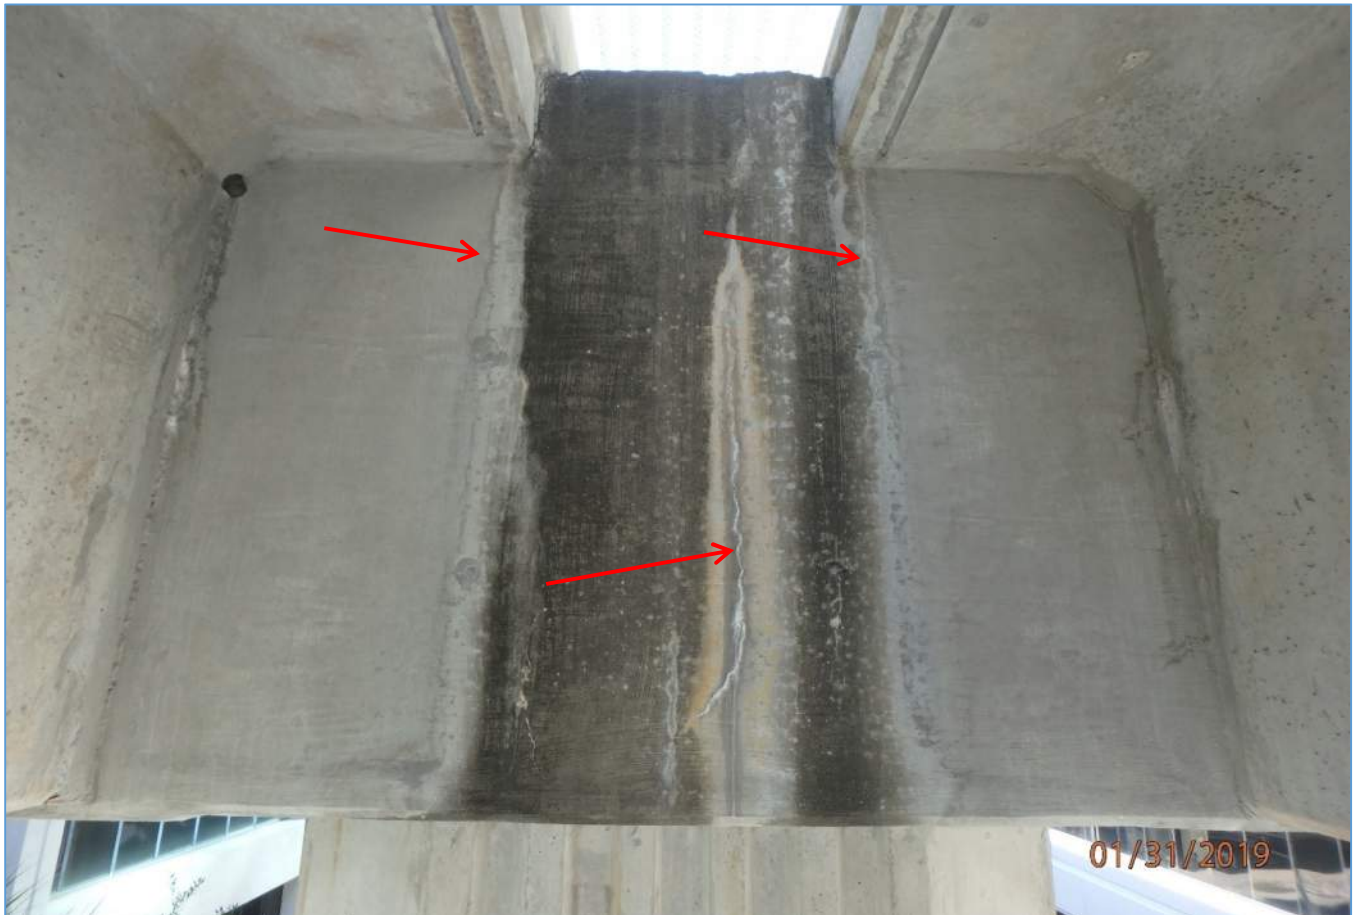
Typical Negative Moment Crack, Full Depth of Cap, Rear Face of Pier 208

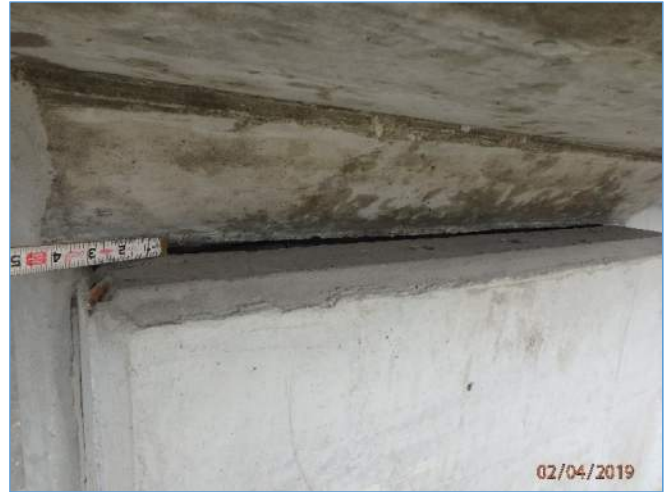
Pier 14N: 3/8" Gap at Top of PT Cover and Failed Caulk

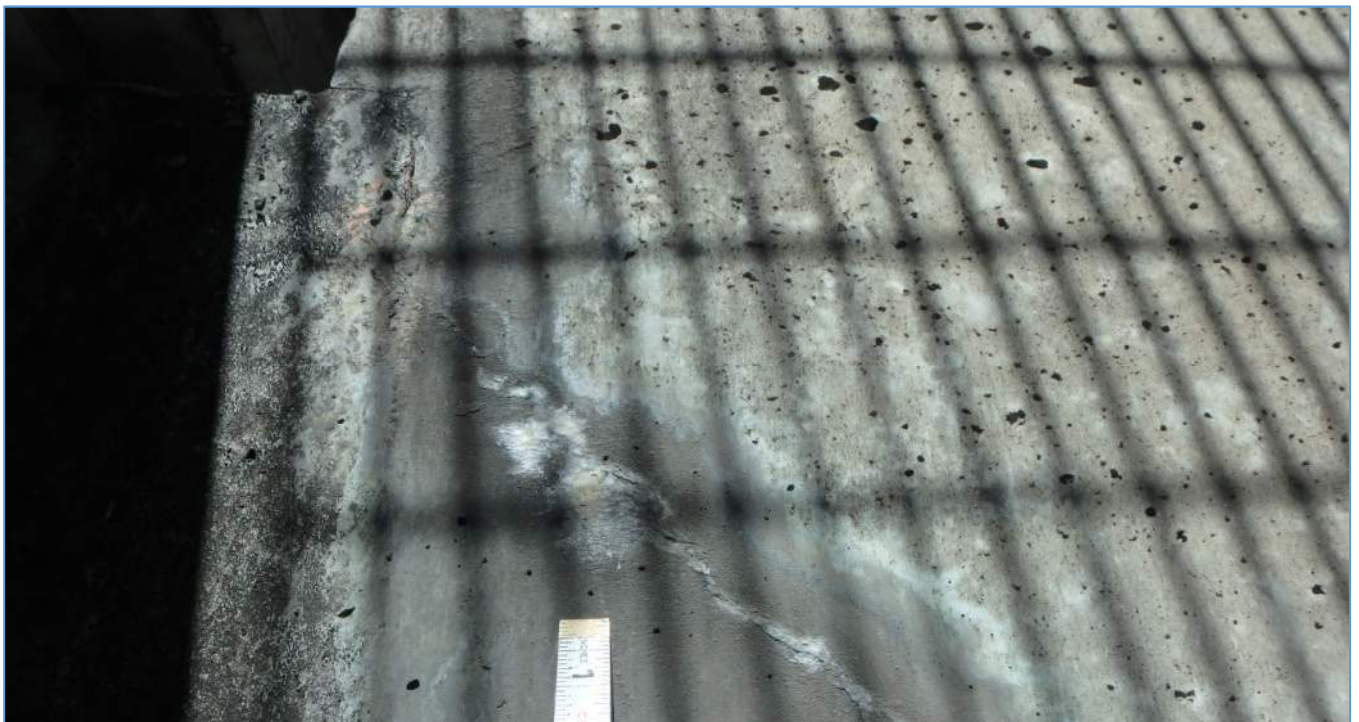
Pier 62: Diagonal Crack Extending Downward From the Left Beam Seat Corner

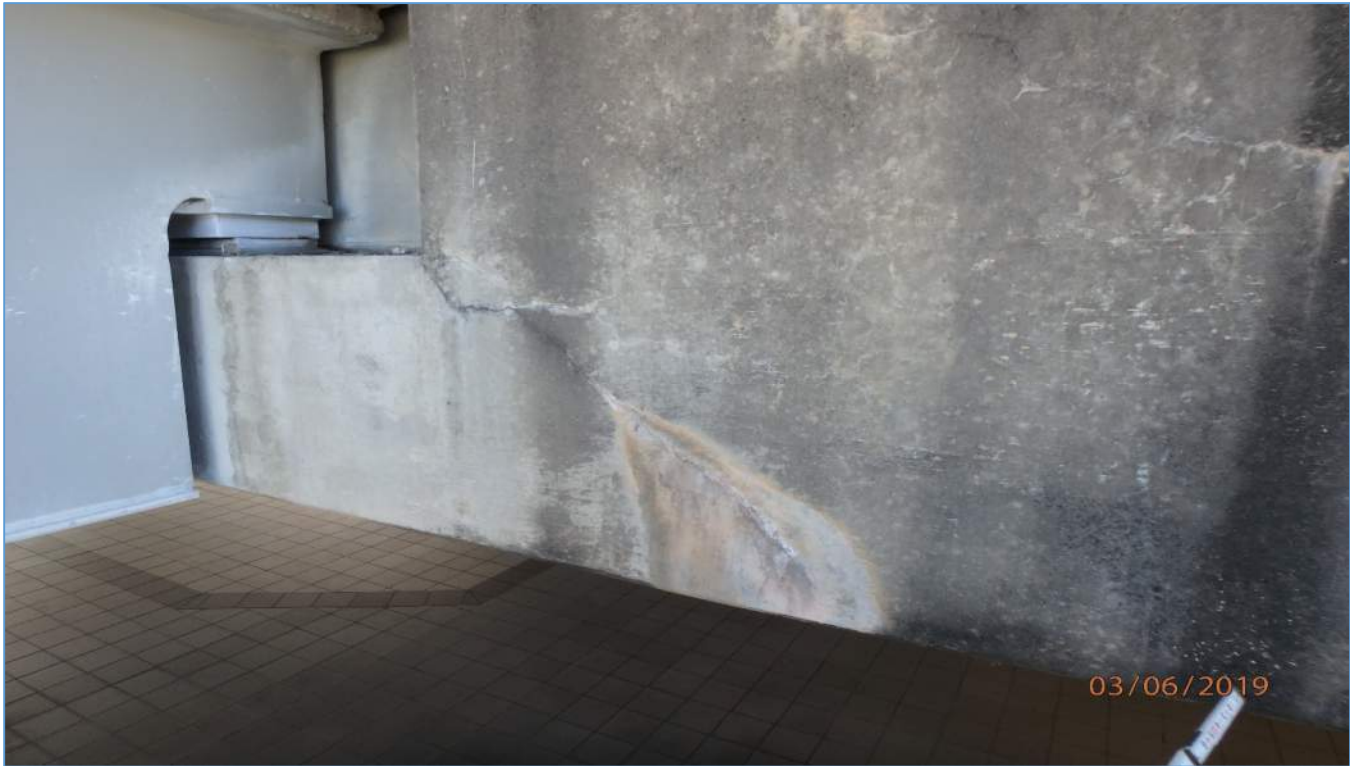
Pier 240: Diagonal Shear Cracks on the Front Face near the LT Column

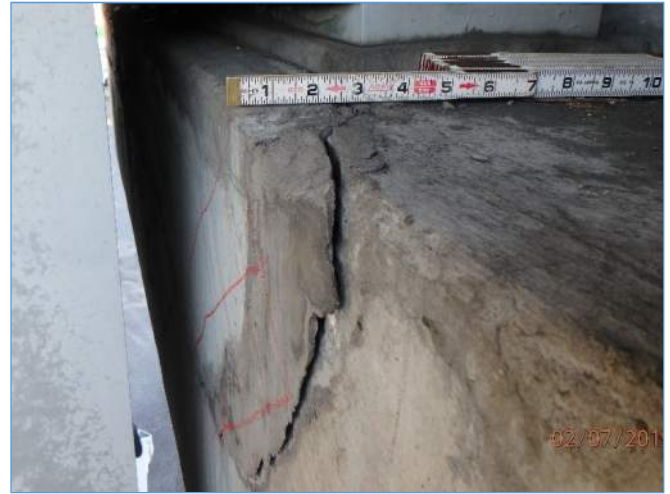
Pier 258L: Large Delamination Below the Right Bearing, Rear Face

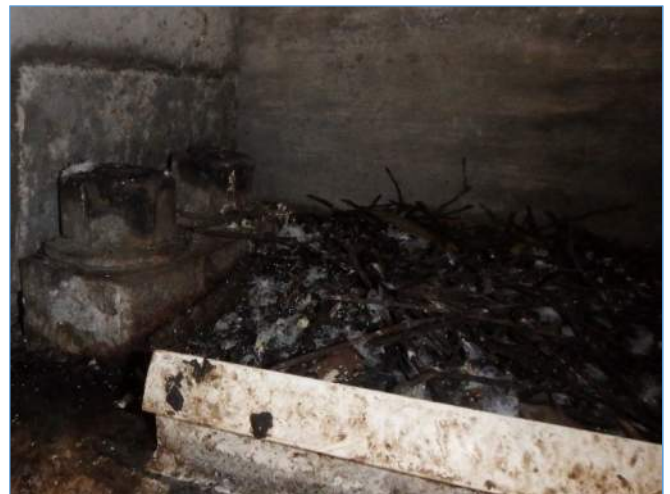
Pier 44: Wet Debris and Nesting Material on Cap

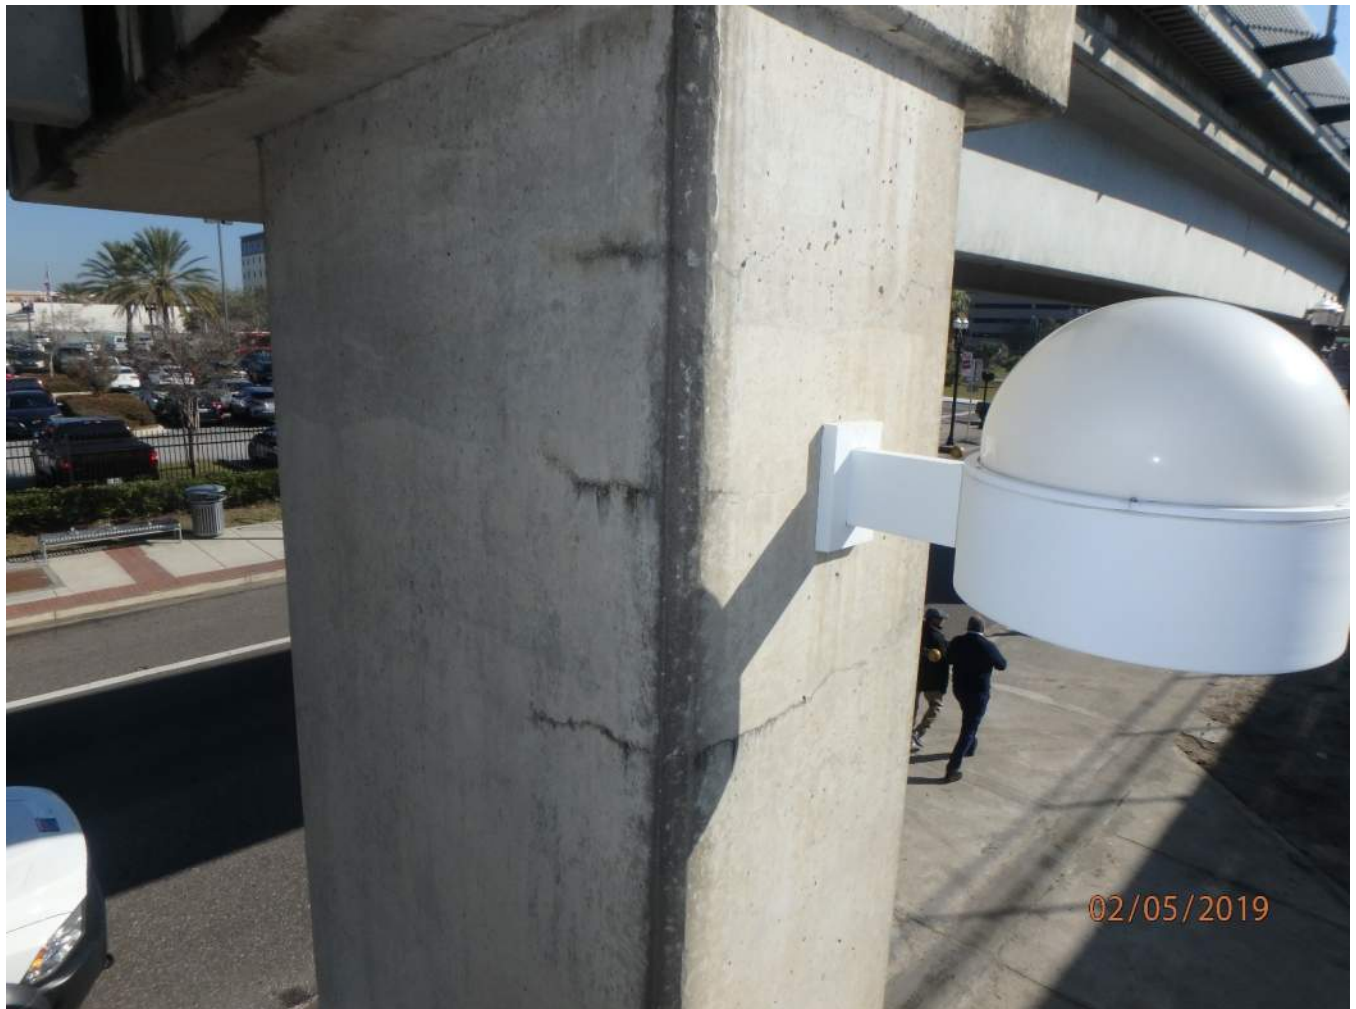
Pier 25N: Horizontal Flexure Cracking in Column with Cantilever Cap

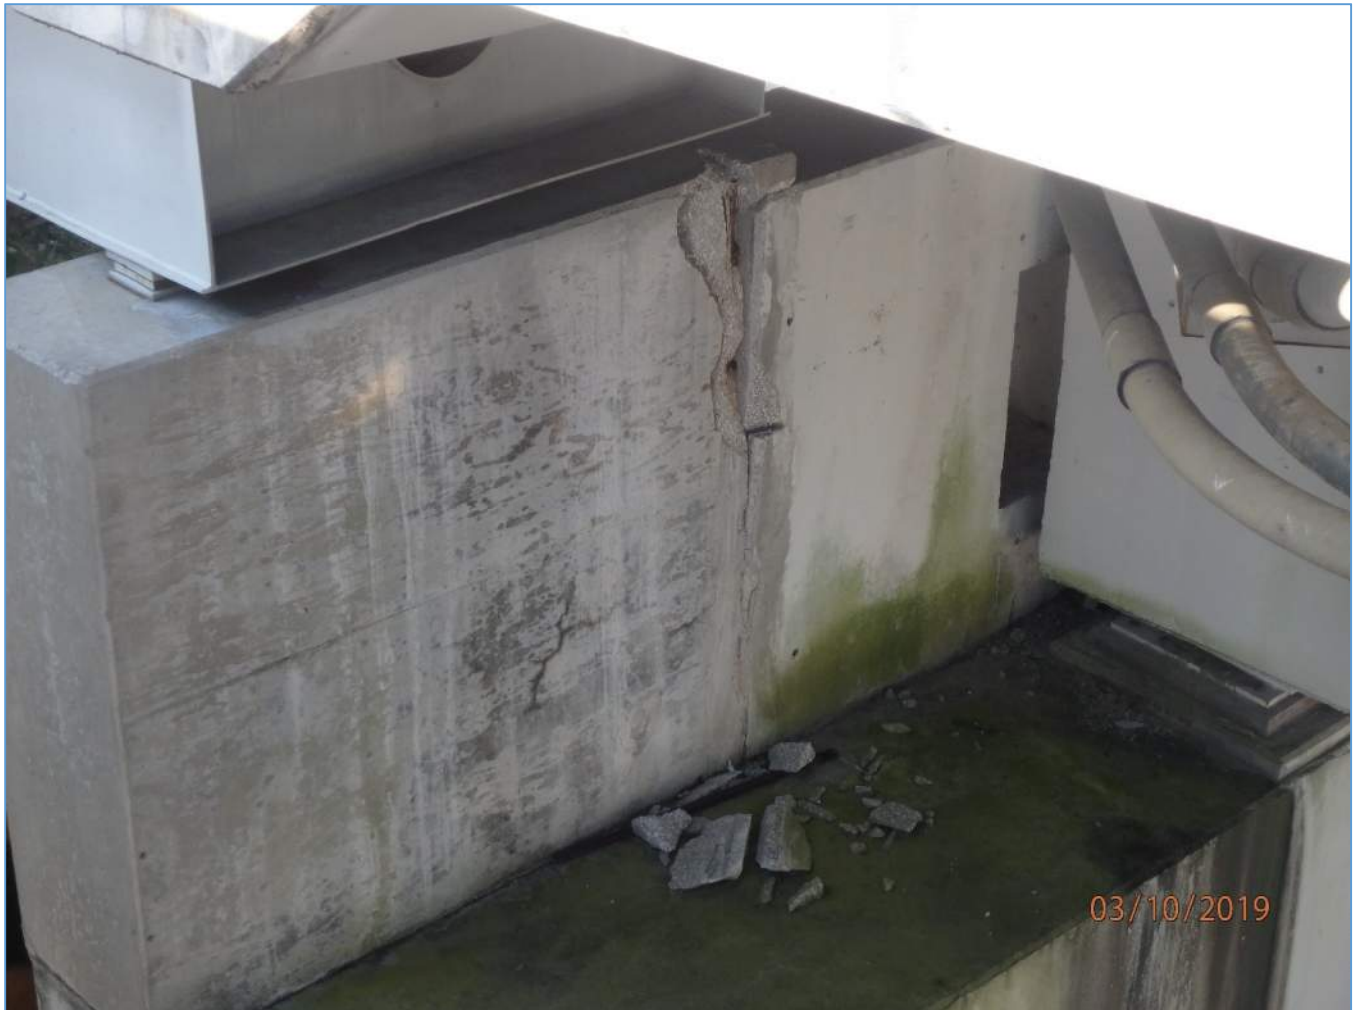
Acosta Bridge Pier R1 LT: Overview of Pedestal Spalling on Front Face

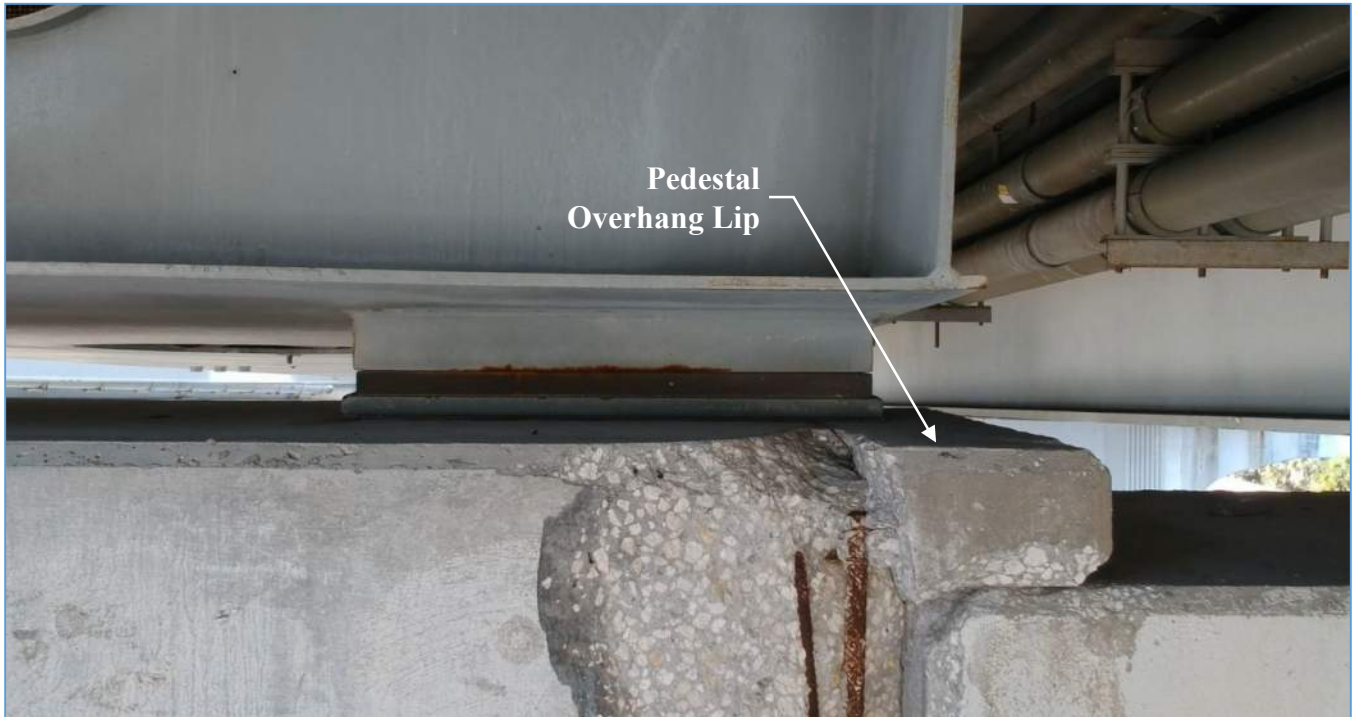
Close-up of Acosta Bridge Pier R1 Left, Front Face

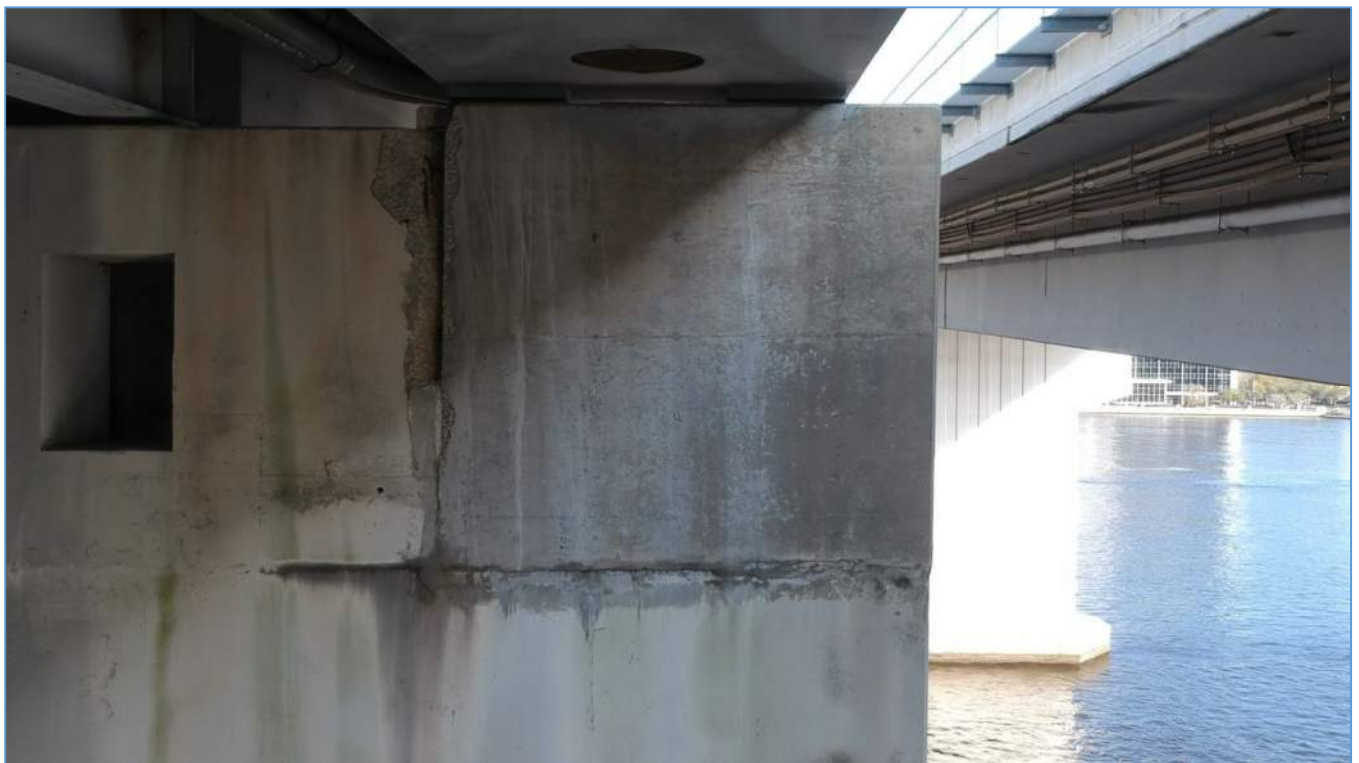
Acosta Bridge Pier R1 Left, Rear Face
