JTA Skyway 2019 Routine Inspection of Bridge Structures

Jacksonville Transportation Authority

RS&H, Inc. / FIT Engineering, LLC

Final Report

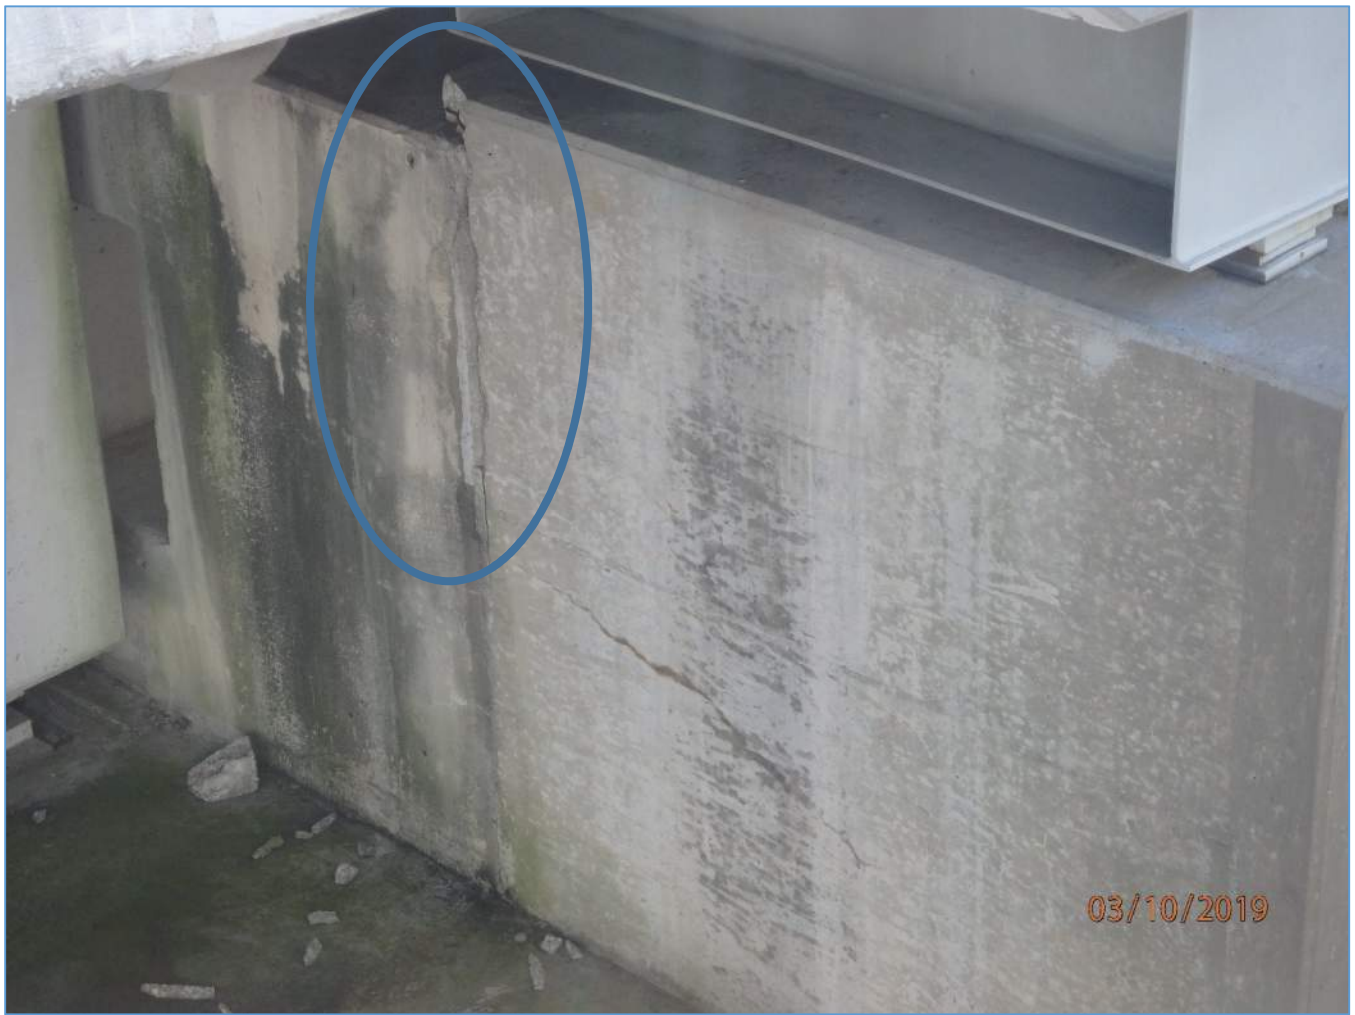
Acosta Bridge Pier R1 Right, Front Face

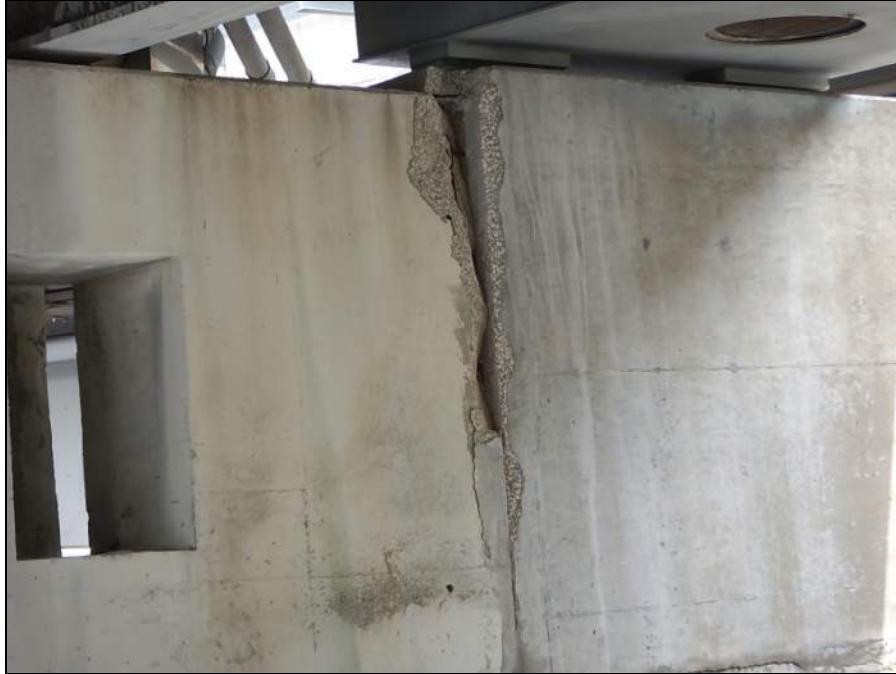
PHOTO 21 – ELEMENT 234 (W.O)
 VIEW OF 69 IN. X 17 IN. X UP TO 3 IN. DEEP SPALLED AREA IN SOUTH
 FACE OF PIER CAP 1, ADJACENT TO MONORAIL SKYWAY EXPRESS

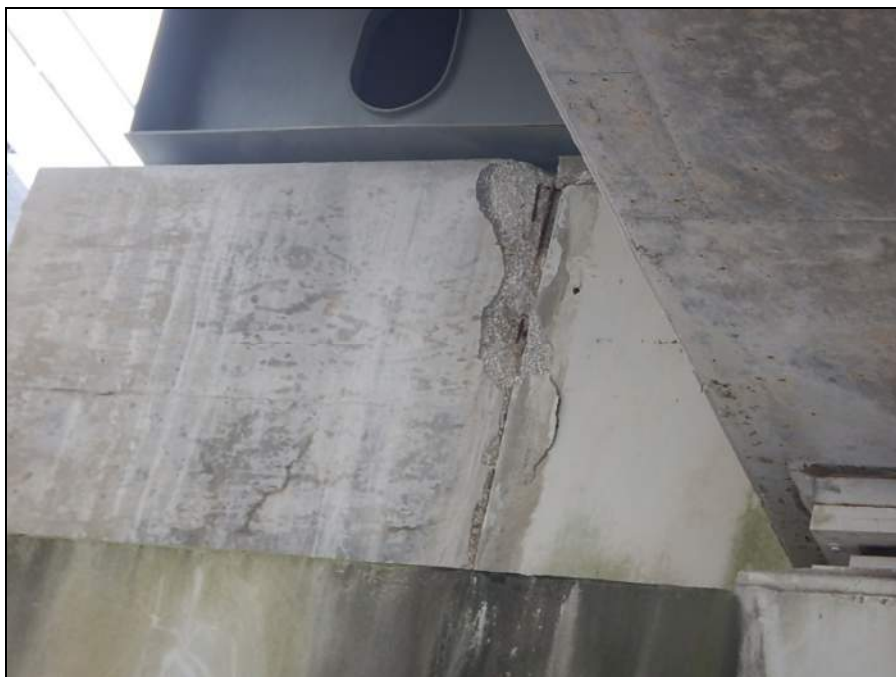
PHOTO 22 – ELEMENT 234 (W.O)
 VIEW OF 92 IN. X 15 IN. X 5 IN. DEEP SPALLED AREA IN NORTH FACE
 OF PIER CAP 1, ADJACENT TO MONORAIL SKYWAY EXPRESS

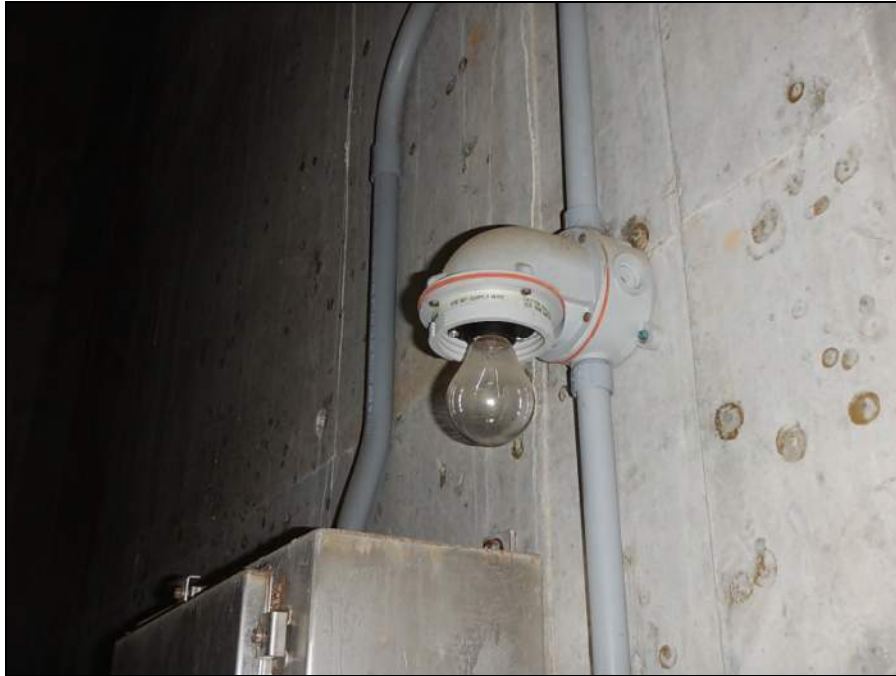
PHOTO 19 – ELEMENT 210
TYPICAL VIEW OF THE GLASS LIGHT LENS COVERS MISSING IN PIER 6

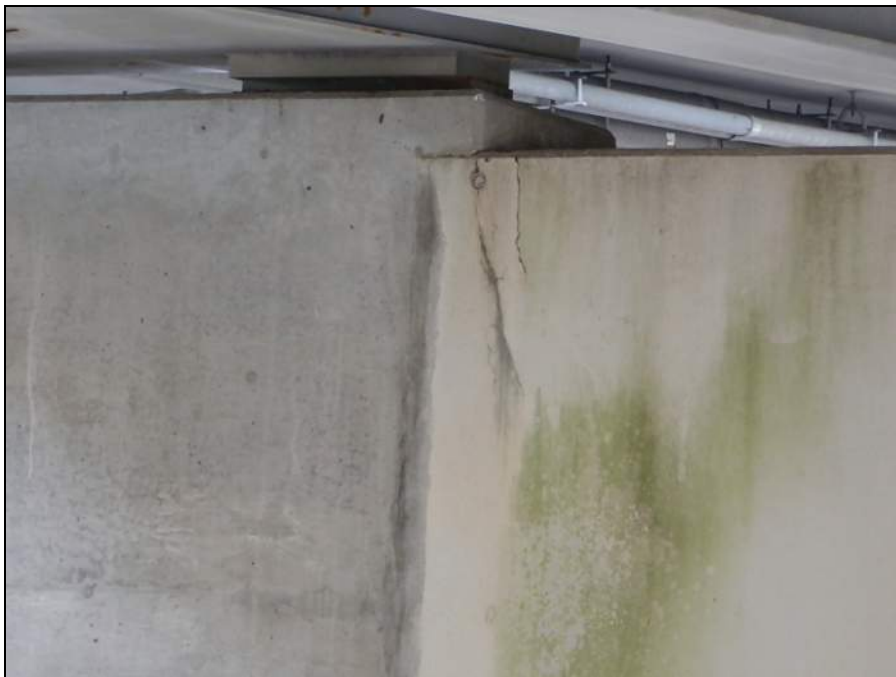
PHOTO 20 – ELEMENT 234
VIEW OF THE CRACKS IN THE SOUTH FACE OF PIER 1, ADJACENT
TO THE PEOPLE MOVER PORTION OF THE PIER
