# Hot spot visual evaluation of breakdown locations in ATLAS18 ITk strip sensors and test structures

## Abstract

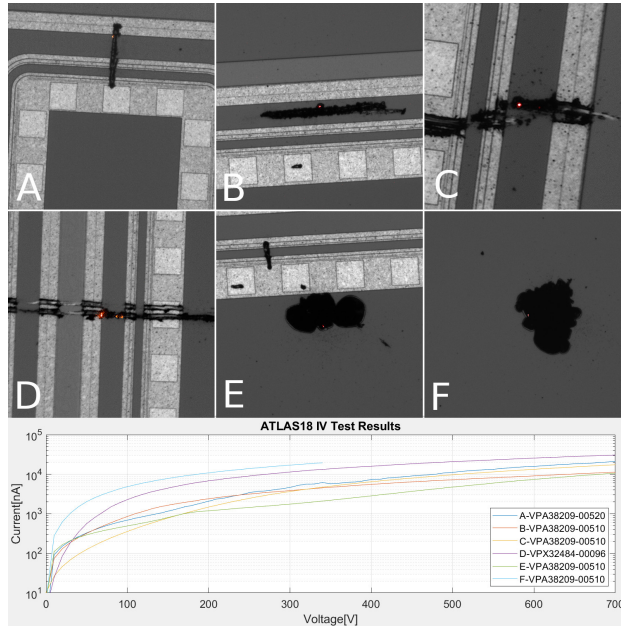
Figure 5: Several examples of intentional scratch damage emissions highlighted in red, IV's at the bottom

which caused emissions clearly imaged usually taken at over  $20 \mu A$  and 60-240 seconds of exposure. The current and exposure times are high on these samples due to the either soft or instant breakdown (bottom of Figure 5). These scratches typically produce emissions from within the scratch so long as the damage is between the bias, guard and edge rings, and especially bright emissions when the scratch bridges them. Images E and F are damages caused by pressing the tungsten carbide scribe in to the surface of the active area, this made a large dark area where breakdown emissions is visible on the edge. In these tests, it was also found that too much damage would create instant breakdown with emissions that were difficult to or could not be captured, as explained in section 2.3.

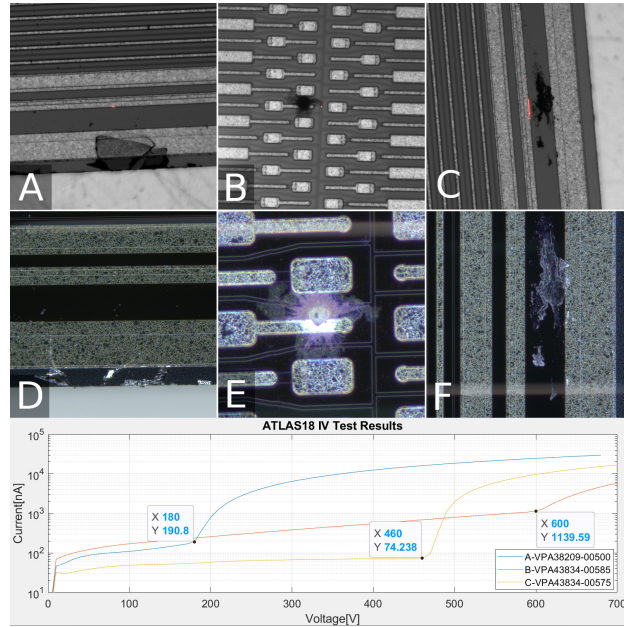
The most common failure mode is that of edge chipping. Often, if a chip on the edge reaches the metal of the edge ring, usually over  $100 \mu m$  from the silicon edge, normal early breakdown will occur (bottom of Figure 6). Figure 6A shows one of these examples, where breakdown emissions appeared in close proximity to a chip reaching well past the edge ring. Figure 6D shows

Figure 6: A-C) Emissions from chips and defects, D-F) Color microscope images of the damaged areas, IV's at the bottom

deep chipping on the edge. Defects also occur like that shown in Figure 6B and 6C which exhibit similar breakdown behavior. Figure 6B shows emissions occurring near a dark spot in the active area, where a defect meets the p-stop. Figure 6E shows the embedded defect in more detail, with it reaching from the strip to the p-stop area. This sample was of interest because the DUT also had significant chipping damage on the edge which was thought to be the source of early breakdown, proven wrong by the identification of this defect via hot spot imaging. Finally, Figure 6C shows a contaminant between the guard ring and edge ring, with the emissions occurring along the guard ring and closest to the contaminant. Figure 6F shows this contaminant in more detail, it may interfere with the edge structure performance.

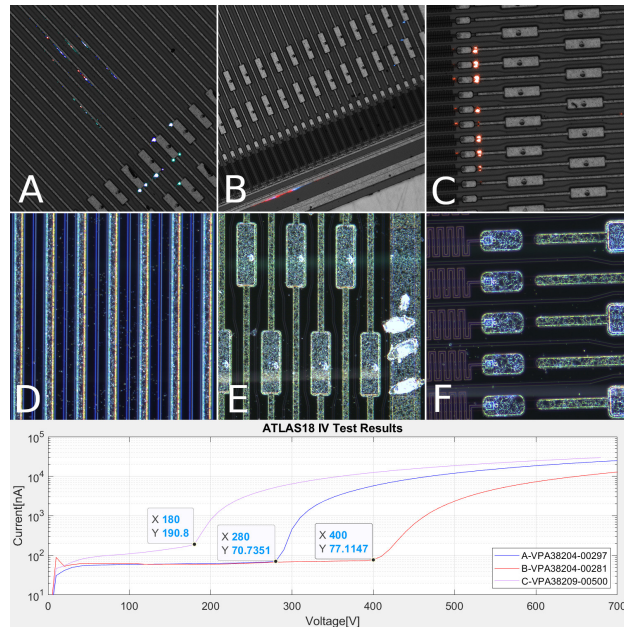
Figure 7: A-C) Three examples of emissions from suspected passivation layer damage from bad wire bond placements D-F) Color microscope imaging showing a speckling in the regions nearby emissions, IV's at the bottom

breakdown (bottom of Figure 7). Figure 7A and 7B have multiple colors demonstrating captures taken with a pause of roughly 5 minutes with the DUT left biased. If the bias is left on and given time, the emissions will actively change position within the region of the damage. Figure 7A was the most dynamic region, where the three different colored emissions have several areas without overlap with other emissions.

This type of emission appears to be correlated with a possible damage source and damage appearance which is visible in all three Figure 7D - 7F. The suspected damage source present on all three samples is that of the bad wire bond placement shown in Figure 7E, where the wire bond foot reaches in to the active area. It is suspected that this caused damage to the passivation layer in the active area, which shows itself physically as the speckling between features clearly visible in Figure 7D - 7F. This wirebond placement issue was corrected in production flow as a result of these investigations.

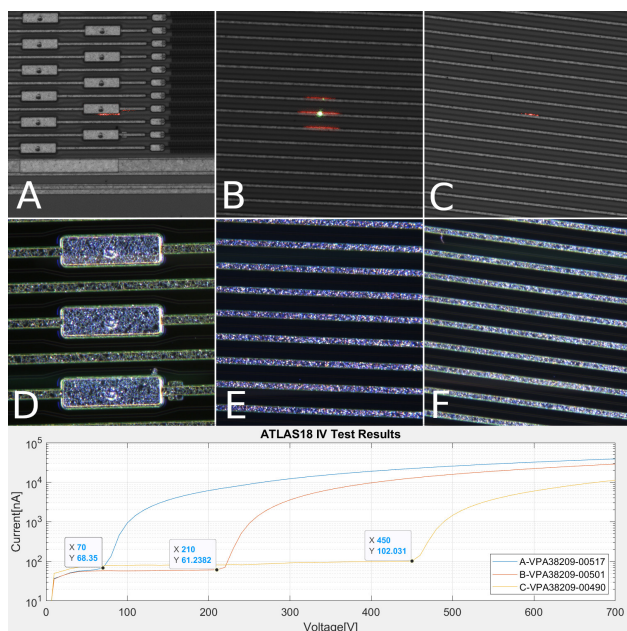
Figure 8: A-C) Emissions created by trapped static charge D-F) Color microscope images showing no physical damage in the area, IV's at the bottom

Another intriguing case of emissions came in the form of not being correlated with any visible physical damage, yet exhibiting normal early breakdown like many other samples (bottom of Figure 8). Instead, these emissions would appear sometimes near the AC pads, as shown in Figure 8A, and sometimes near strips in the active area like that of Figure 8B and 8C. Color microscope captures Figure 8D - 8F show no signs of physical damage in the breakdown areas. It was later found that this was the result of trapped static charge changing the properties of the materials around the strips resulting in loss of isolation between components. It was also found that this type of damage could be cured with 400 nm UV light exposure or with deionizers [10][11]. Figure 8B shows the original emissions found in red where breakdown started at  $-210$  V, as well as post 1 hour UV treatment in yellow where breakdown now started at  $-790$  V instead and the emissions region was much smaller. Figure 8C is yet another example of this phenomenon, similar to Figure 8B, breakdown is happening on the edge of a strip with no obvious damage. It was found that with additional UV exposure time, approximately 4 hours using two 100 W 400 nm UV LED's, all three of these

examples were repaired and no longer broke down before -1 kV.
