NATIONAL TRANSPORTATION SAFETY BOARD

AIRCRAFT ACCIDENT REPORT

WORLD AIRWAYS, INC., FLIGHT 301
McDONNELL DOUGLAS DC-10-30CF, N113W
BOSTON-LOGAN INTERNATIONAL AIRPORT
BOSTON, MASSACHUSETTS
JANUARY 23, 1982

NTSB/AAR-85/06
(SUPERSEDES -- NTSB-AAR-82-15)

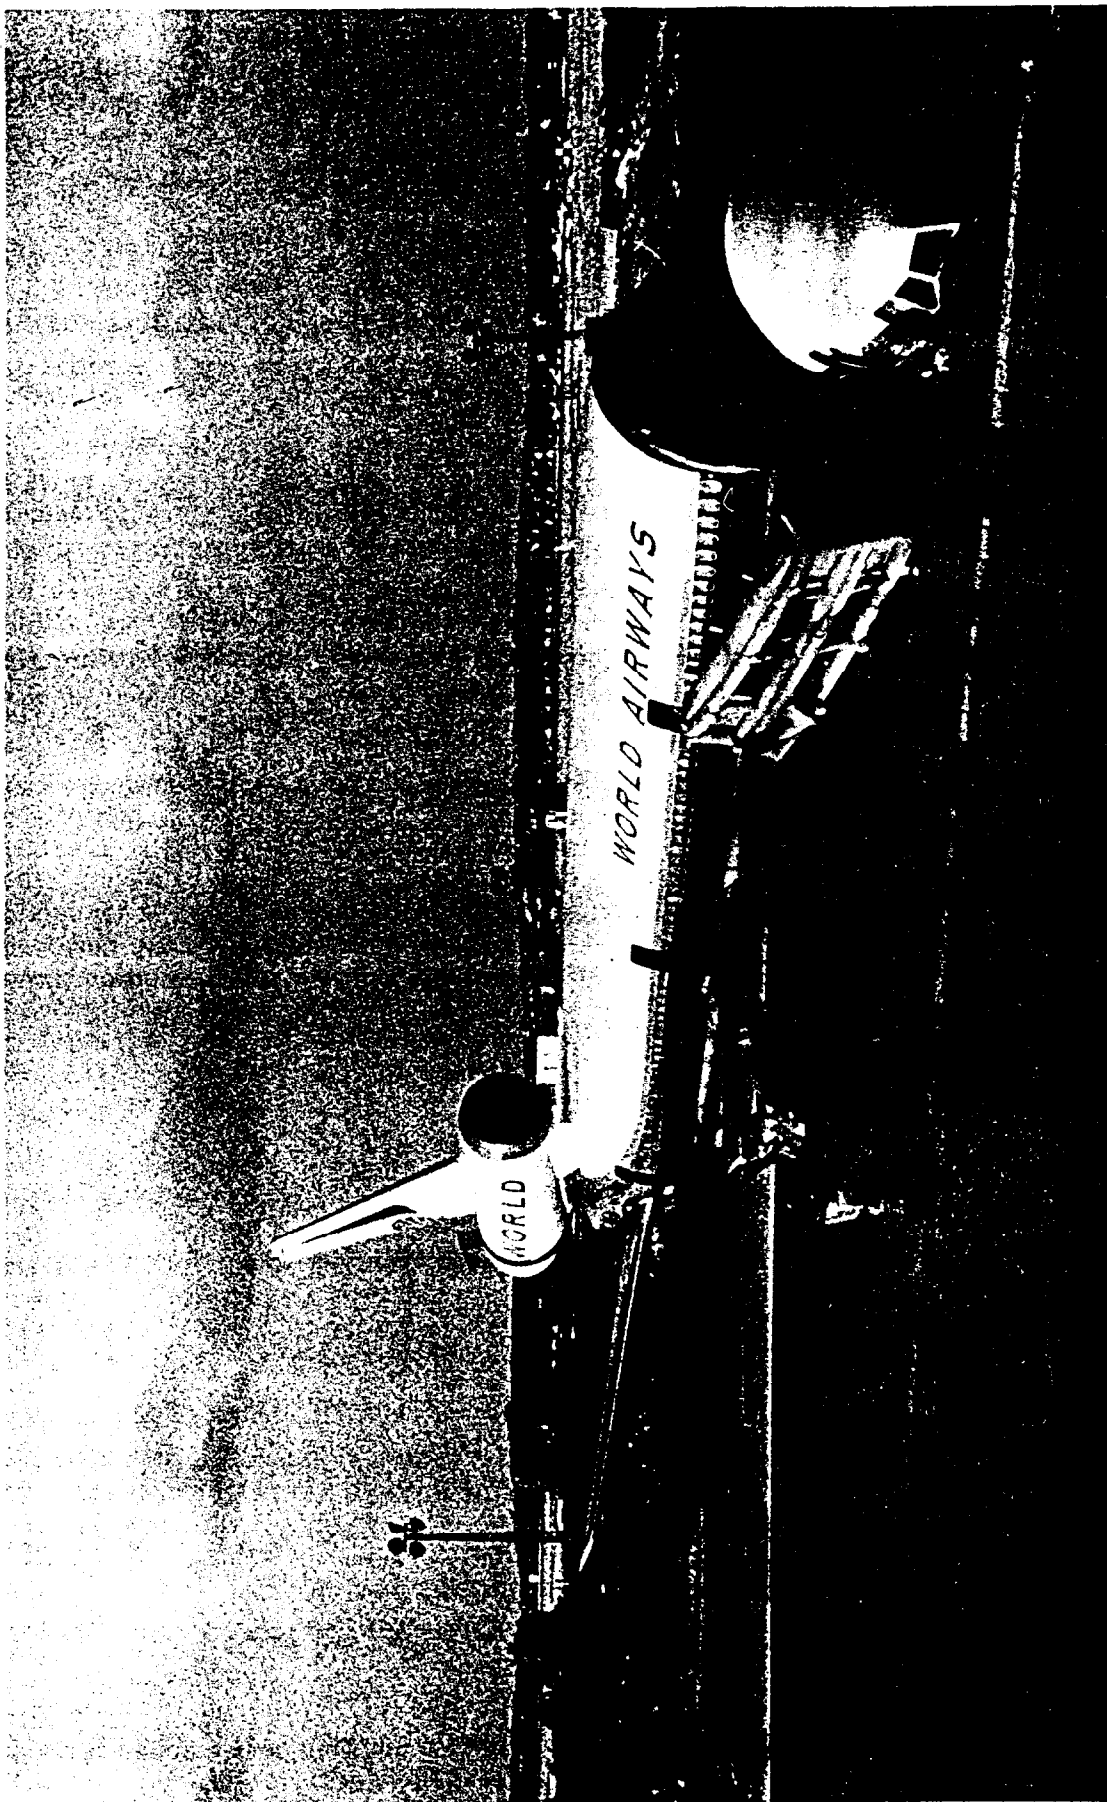
Figure 1.--Flight 30X as it rested in Boston Harbor.

The airplane came to rest immersed in water up to the wings at high tide and in a slightly nosedown attitude. The nose section, which included the cockpit area and first row of main cabin passenger seats, separated from the fuselage along a fracture line from fuselage station (FS) 370 to 475. The nose section remained attached to the main fuselage structure by control cables and electrical wire bundles. The pressure bulkhead at FS 275 had been crushed aft at the fuselage bottom centerline. The main cabin floor beams from FS 392 to FS 475 failed with a progressively downward displacement of each floor beam. The aft edge of this floor section was hanging down at a 45° angle. The cabin seat tracks in this area had fractured into short sections. The fractures were clean and bright, with the fractured surfaces about 45° to the local surface. There was no evidence of compression buckling or previous cracking. The first row of passenger seats, which consisted of a left side module of three seats, a center seat module of two seats, and a right module of three seats, had separated from the floor structure as the result of the seat track fragmentation. The three seat modules were installed in the immediate area of the nose-section/main-fuselage separation. The pressure bulkhead at the forward end of the nose wheel landing gear well had been crushed inward and aft. The shear web on the fore and aft nose landing gear support beams contained a 2-foot vertical fracture at the nose gear drag link support fittings. The fuselage attach fittings for the nose gear drag braces were torn from the fore and aft nose gear support beams, and the gear had folded aft while pivoting about the strut trunnion axis.

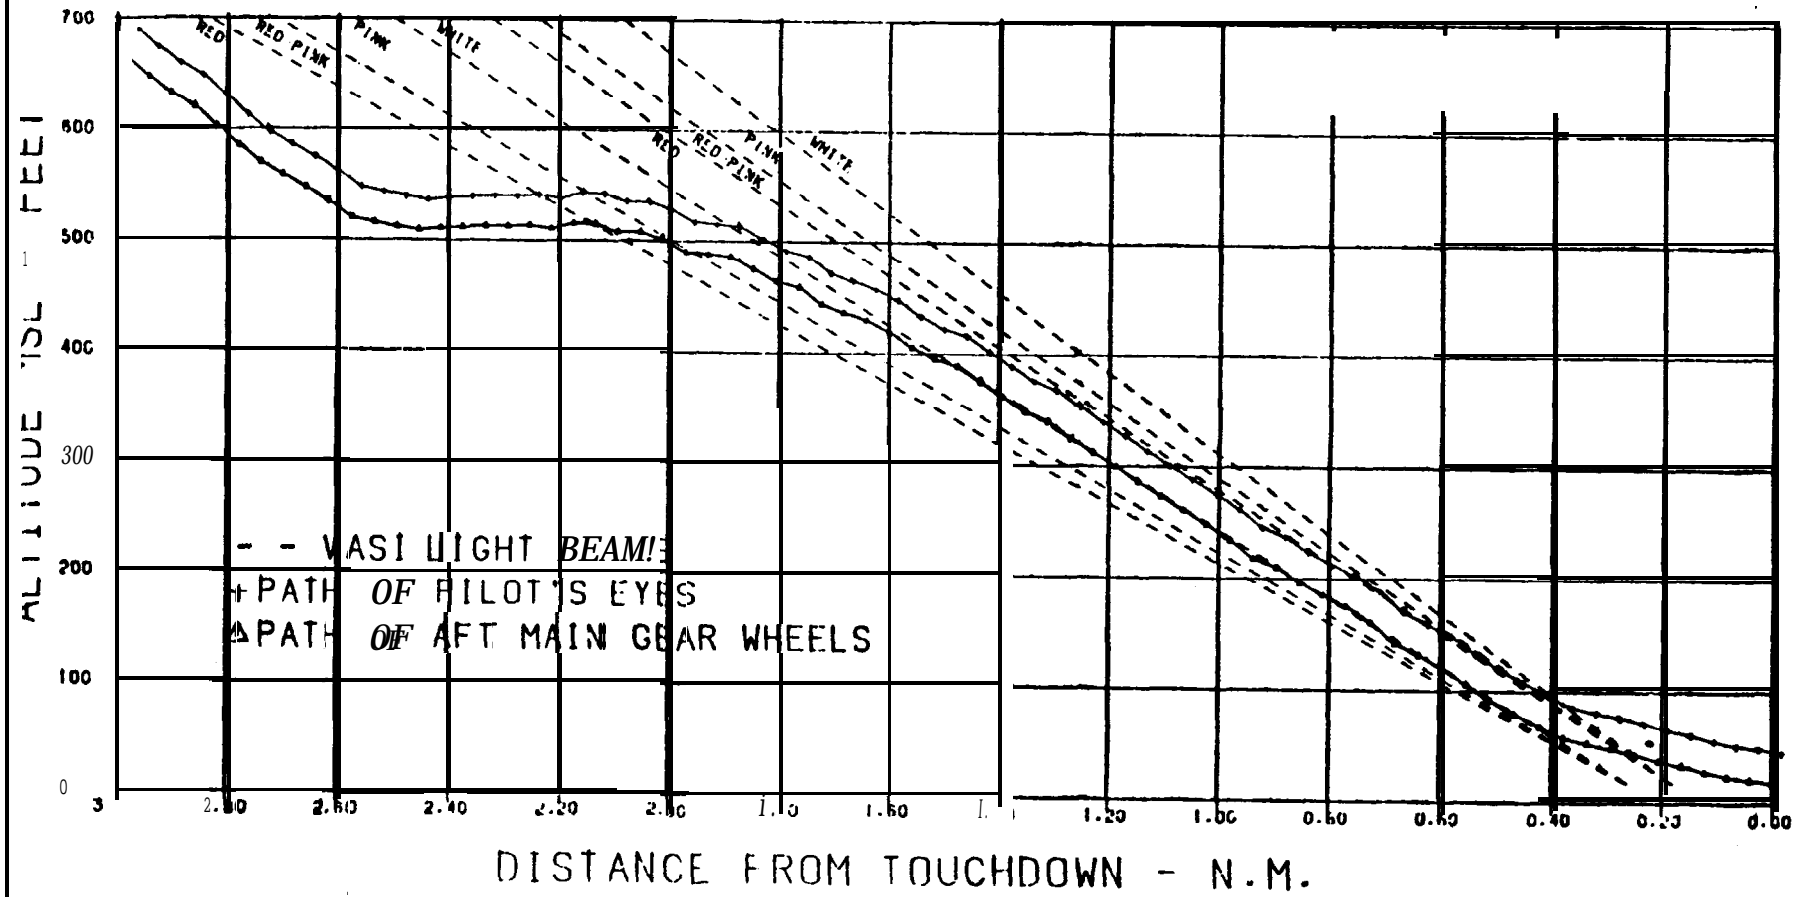
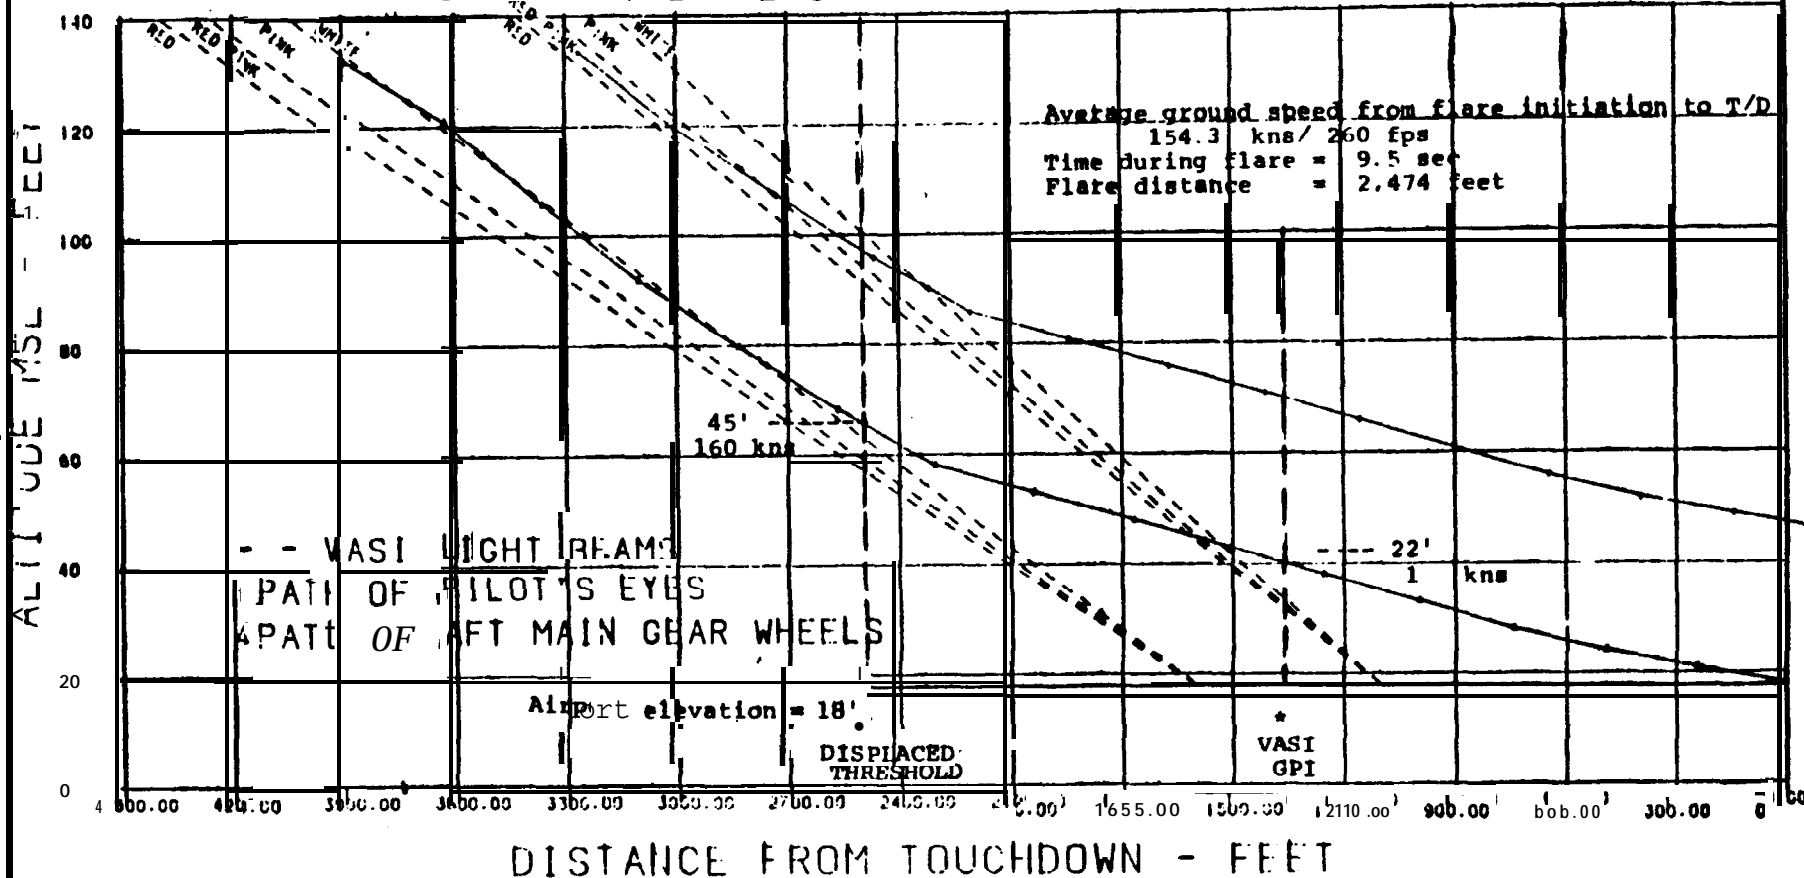
ALTITUDE VS DISTANCE FROM TOUCHDOWN

This examination of data showed that the airplane descended to 510 feet and leveled until the VASI glidepath was intercepted. (See appendix I.) The airplane then descended maintaining an average 800-fpm descent path which would have provided the pilot with an "on glidepath" indication to a height above the ground of about 120 feet. The airplane then deviated from the VASI glidepath so that the pilot would have observed a "slightly above glidepath" indication.^{9/} The airplane passed over the displaced threshold at a height of about 45 feet with an indicated airspeed of 160 kns, 15 kns above the calculated reference speed (Vref) for a gross weight of 365,000 pounds. The landing flare began when the airplane was about 40 feet above the runway and both airspeed and rate of descent were reduced. The pitch attitude was increased about 2° during the flare. The data analysis showed that the airplane touched down with a rate of descent of about 200 fpm and an indicated airspeed of 147 kns. About 6,690 feet of runway was available for stopping the airplane.

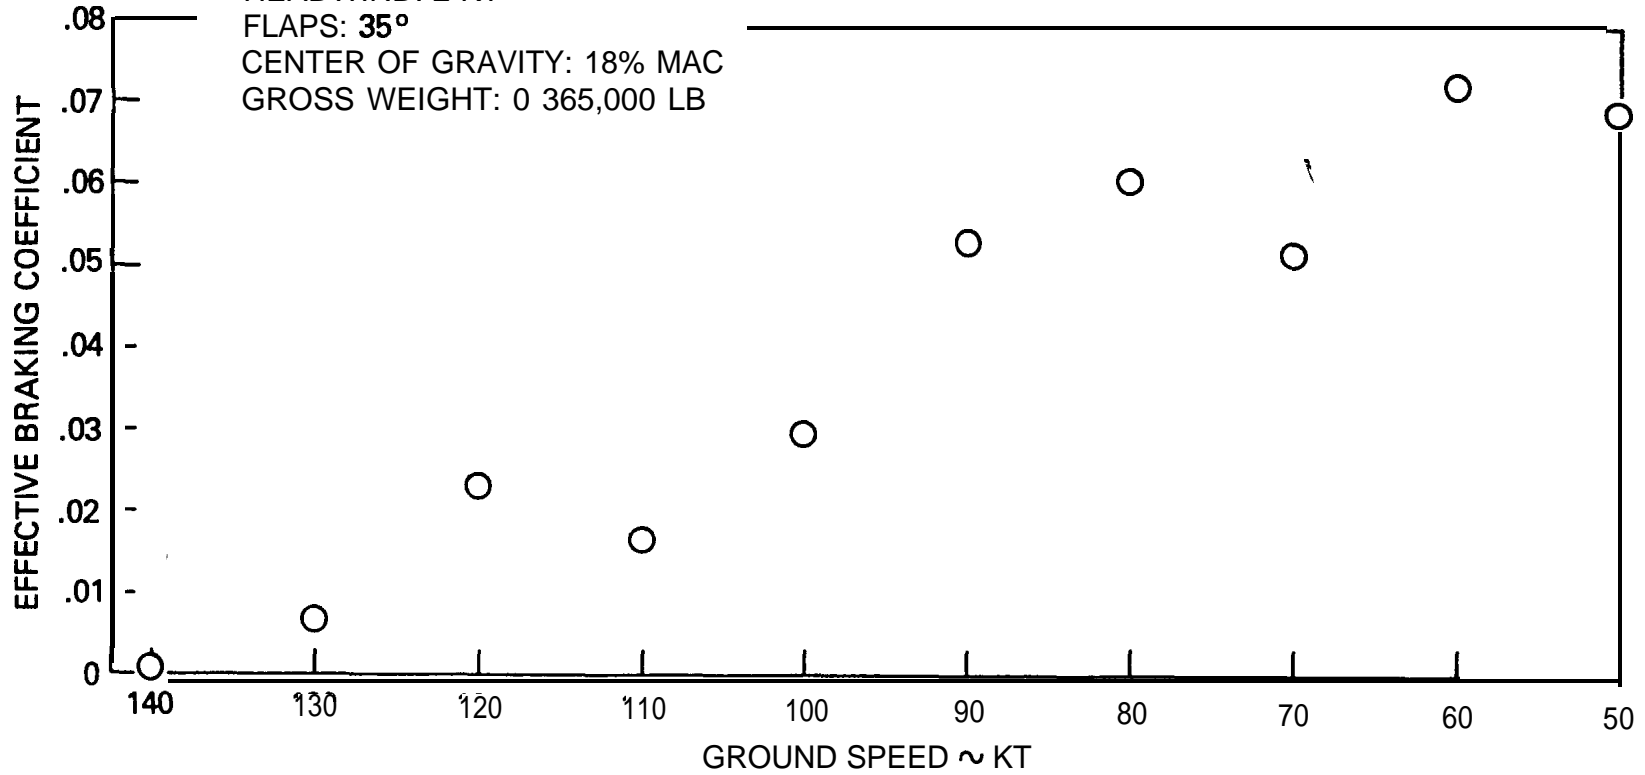
Effective Braking Coefficients Runway 15R Logan

CONDITIONS USED
PRESSURE ALTITUDE: 360 FT
TEMPERATURE: 37°
HEADWIND: 2 KT
FLAPS: 35°
CENTER OF GRAVITY: 18% MAC
GROSS WEIGHT: 0 365,000 LB
