AIRCRAFT ACCIDENT REPORT

UNITED AIRLINES FLIGHT 585
BOEING 737-291, N999UA
UNCONTROLLED COLLISION WITH TERRAIN
FOR UNDETERMINED REASONS
4 MILES SOUTH OF
COLORADO SPRINGS MUNICIPAL AIRPORT
COLORADO SPRINGS, COLORADO
MARCH 3, 1991

**Adopted: December 8, 1992
Notation 5498B**

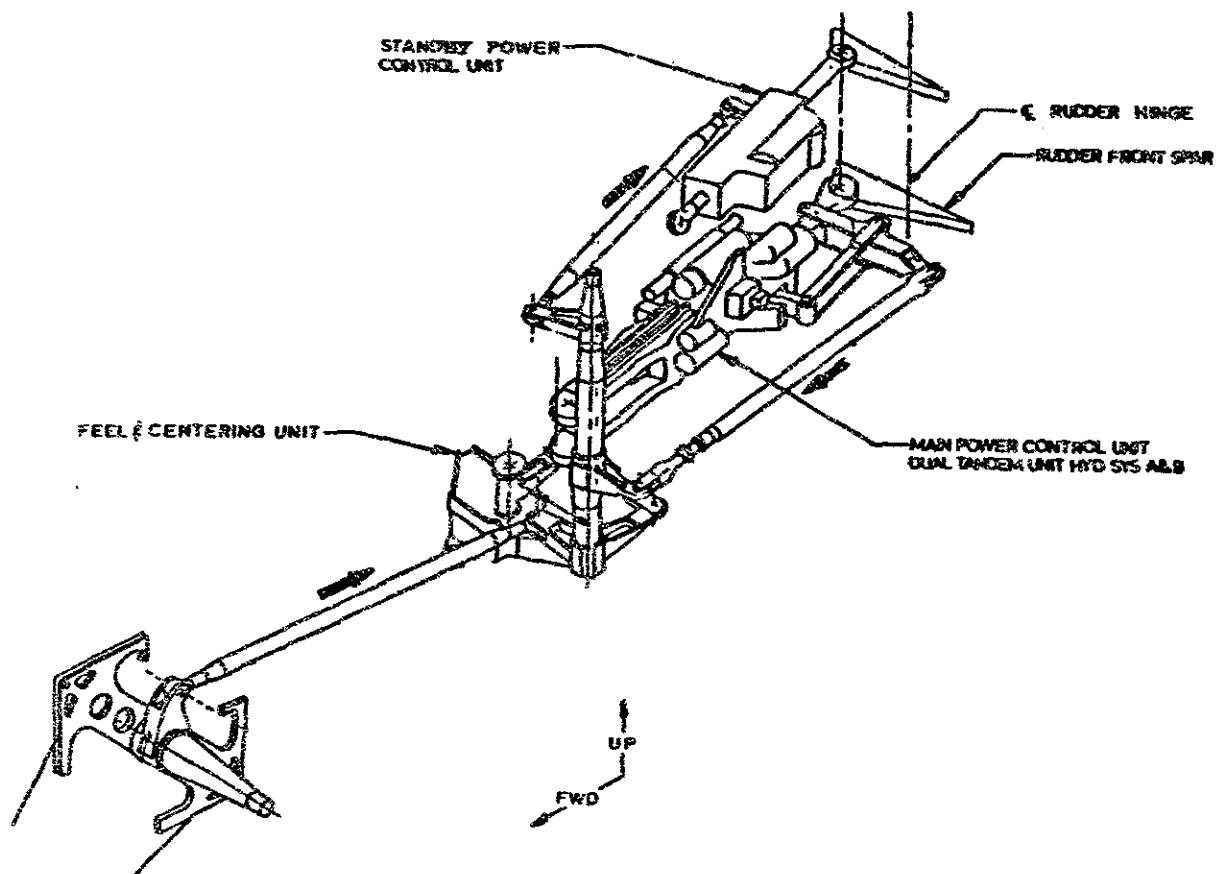
The standby rudder actuator is not normally powered. When operation is selected by the "A" or "B" flight control switches (either switch positioned to STBY RUD), the actuator is powered through the standby rudder system. At least one side of the main power control unit is not powered when the standby actuator is powered. No more than two hydraulic systems can be used to operate the rudder.

Inputs from the rudder pedals or trim actuator are simultaneous to the main (MPCU) and the standby actuator. When pressure is not available for any system, a bypass valve is positioned to connect both sides of the piston in that system's actuator to the same port of the control valve to prevent a hydraulic lock.

Figure 1.—B-737 rudder control system
main power control unit and standby actuator.

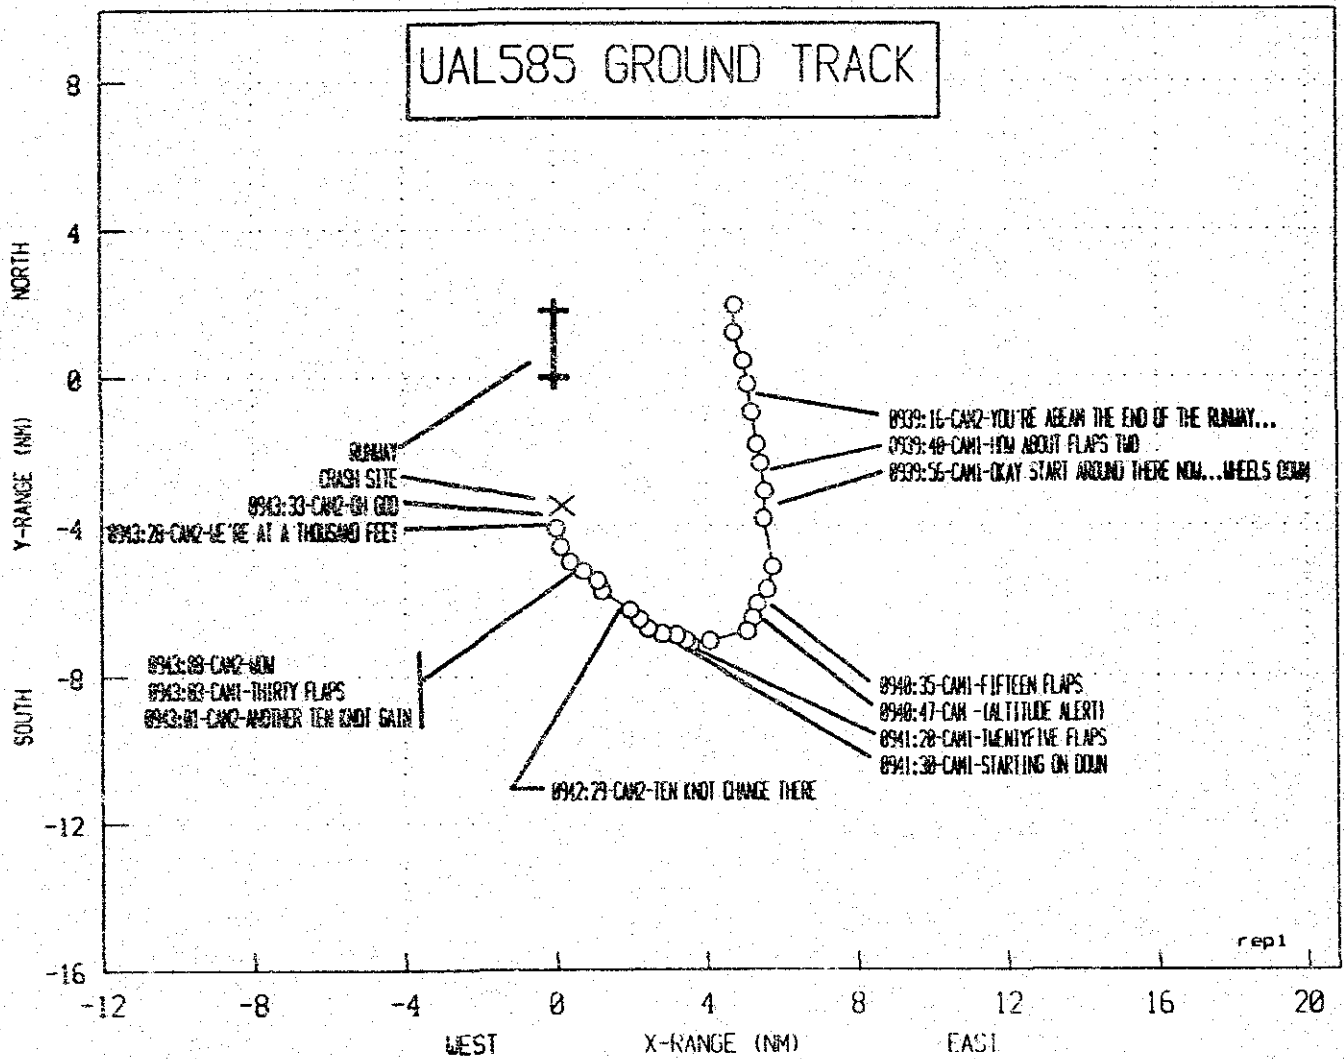
Figure 3 shows the ground track with selected CVR data. Figure 4 is a profile view of the flightpath with selected CVR data.

Figure 3.--Ground track with selected CVR data.

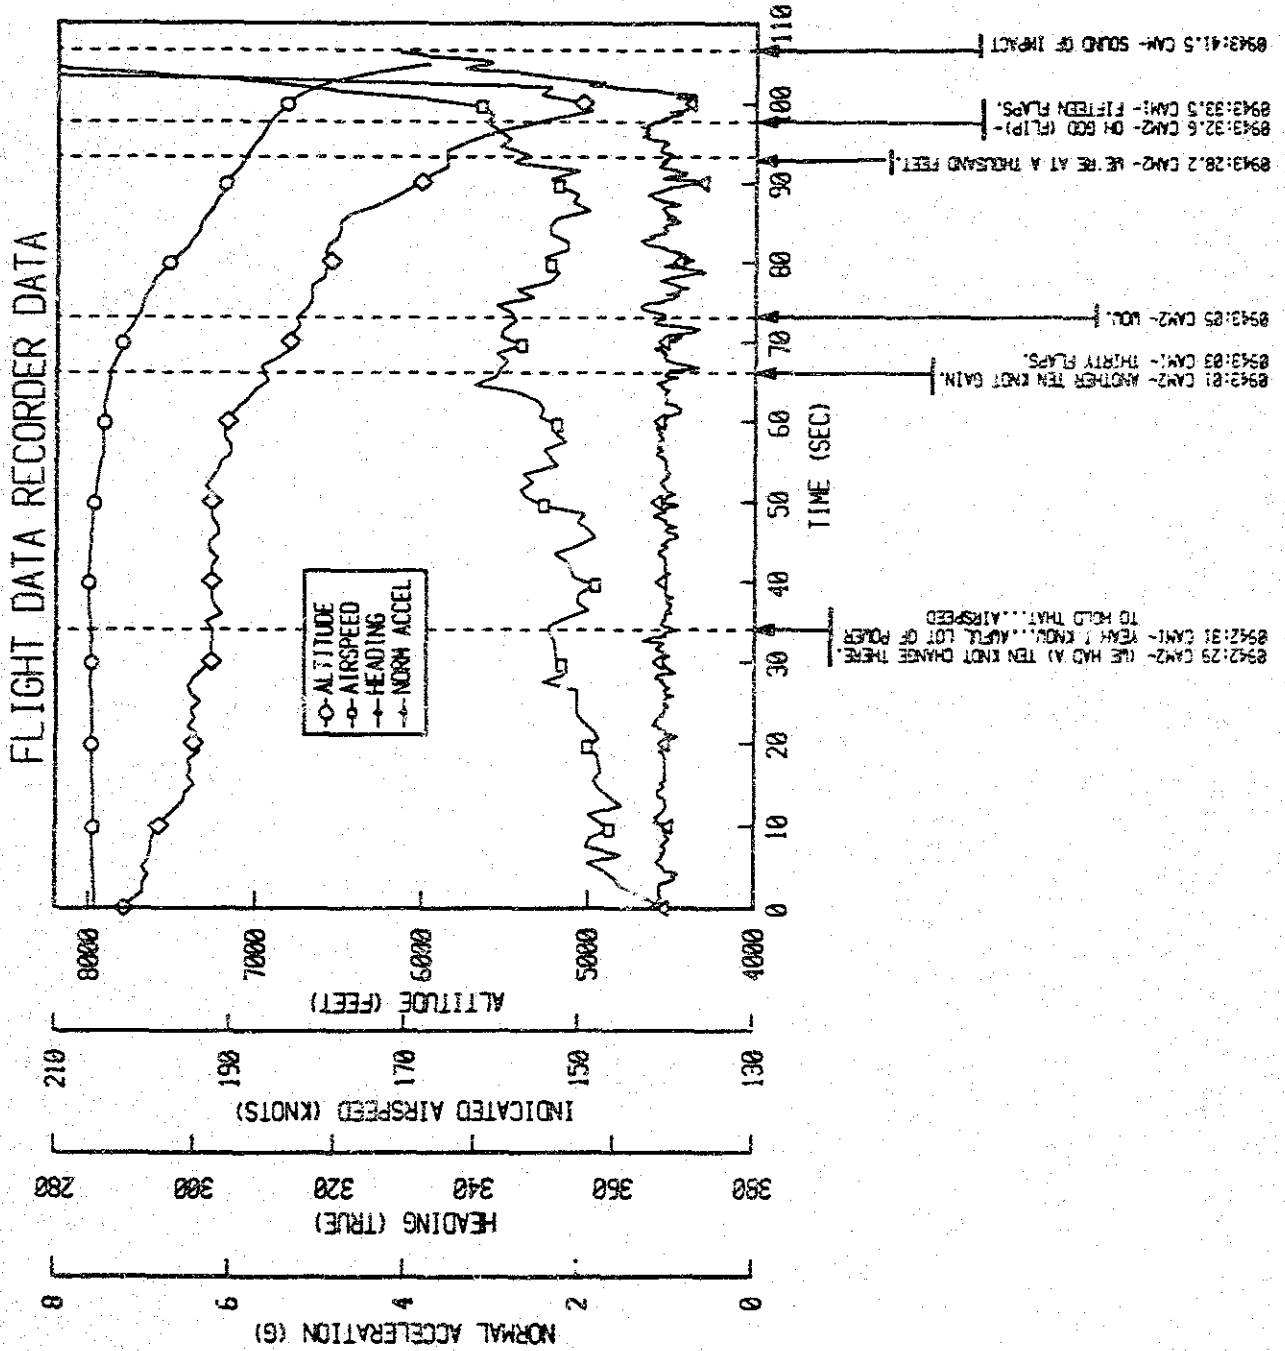
Figure 4.--Profile view of flightpath with selected CVR data.

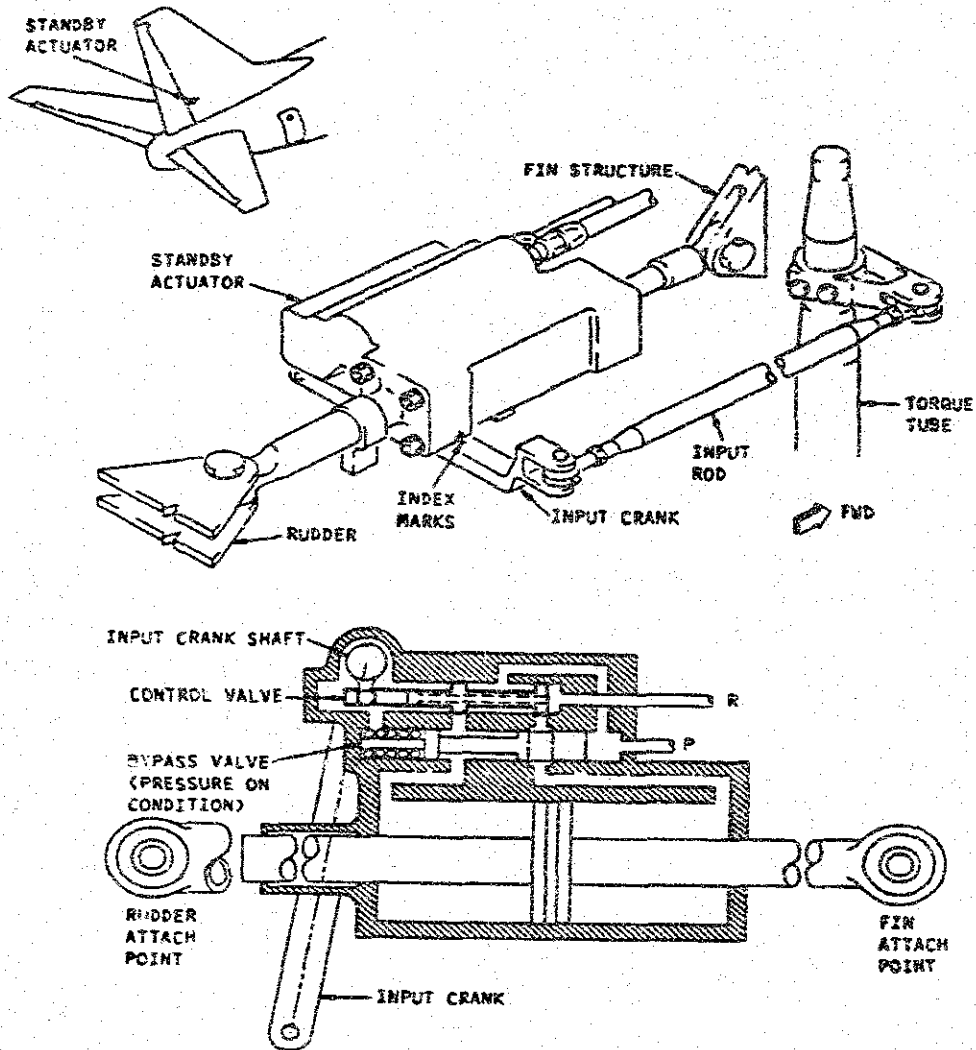
A review of the design of the B-737 rudder control system revealed that binding of the input shaft to the bearing that is threaded in the actuator body could potentially cause flight control problems even though the standby rudder hydraulic system is not pressurized. In the rudder control system, the pilot pedal movement is applied through a mechanical control system to a lever arm to rotate a torque tube in the empennage. Other lever arms attached to the torque tube transmit linear motion to the ends of the input cranks for both the MPCU and the standby rudder actuator. (See figure 5).

In normal operation, the input cranks to both the MPCU and standby rudder actuator will rotate, providing the servo valve command to the units, and the rudder will be hydraulically moved by the MPCU. The rudder movement is in turn fed back mechanically to both the MPCU and standby actuator systems so that when the rudder surface deflects to the position commanded by the pilot, the input cranks on both of the units will be returned to their null positions. Thus, there is a geometric relationship between the rudder position, the input crank of the MPCU, the torque tube, and the input crank of the standby rudder actuator that is retained during normal operation. If, however, the input crank on the standby rudder actuator is not free to rotate with respect to the actuator housing because of galling between the shaft and bearing, the actuator housing, input crank, and control rod will act as a rigid link between the rudder and the torque tube. The inability to

Figure 5.--Standby rudder actuator.

change the length of this link by rotation of the standby rudder actuator input crank within the actuator housing will affect the feedback mechanism between the rudder position and the MPCU input crank. This condition can result in problems ranging from high pilot control force necessary to move the rudder to uncommanded rudder deflections.

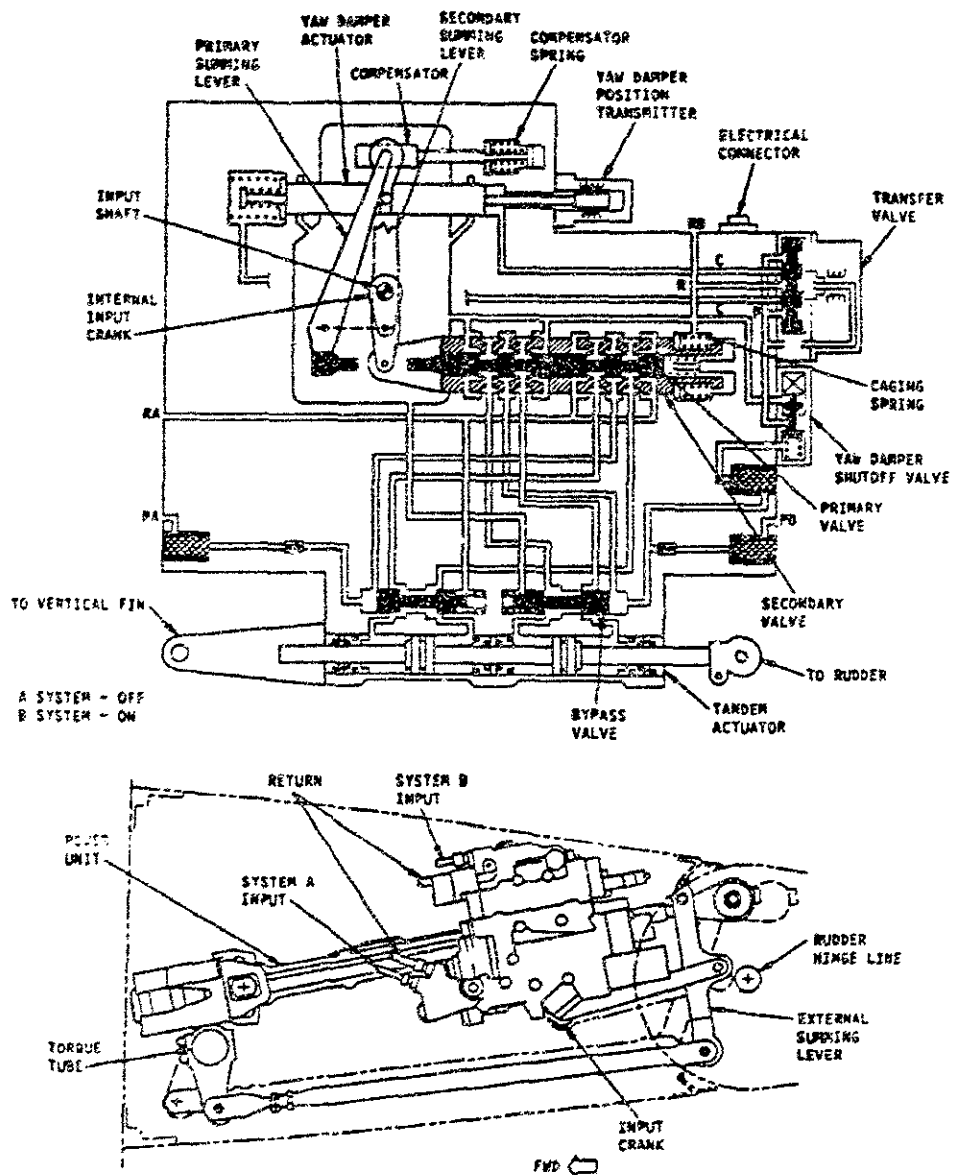
Figure 6.--Main rudder power control unit schematic extracted from B-737 maintenance training manual.

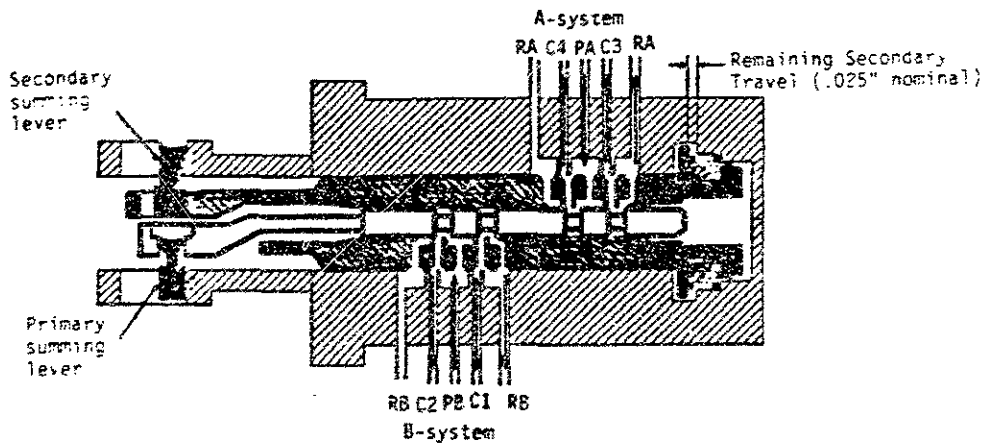
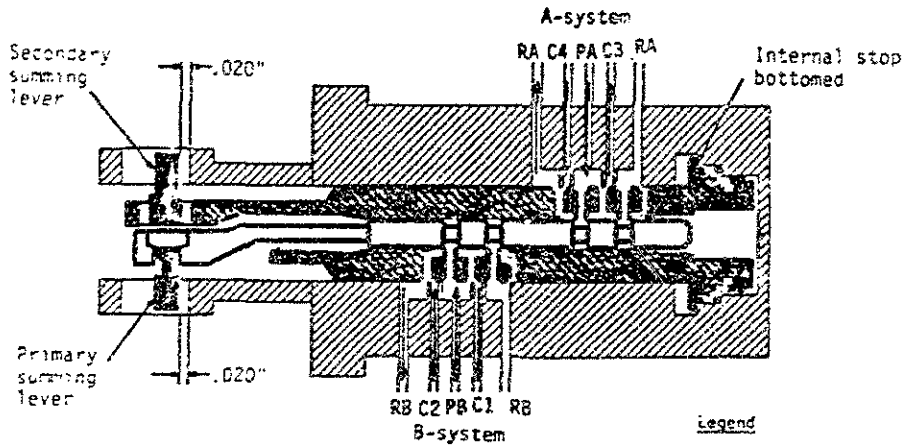
Normal Operation
 Maximum Rate Extend Command
 Primary slide moves .045" (relative to secondary)
 Secondary slide moves .063" (relative to housing)

Abnormal Operation
 Primary slide jammed
 Both slides move .082"
 relative to housing
