## IMPROVEMENTS IN ALADDIN BEND MAGNET STABILITY BY REDUCTION OF LEAKAGE CURRENTS\*

D. J. Wallace<sup>#</sup>, M. Fisher, K. D. Jacobs, G. Rogers, L. Rowley, M. Thikim, W. Trzeciak  
 Synchrotron Radiation Center ( SRC ), Stoughton, WI 53589, USA

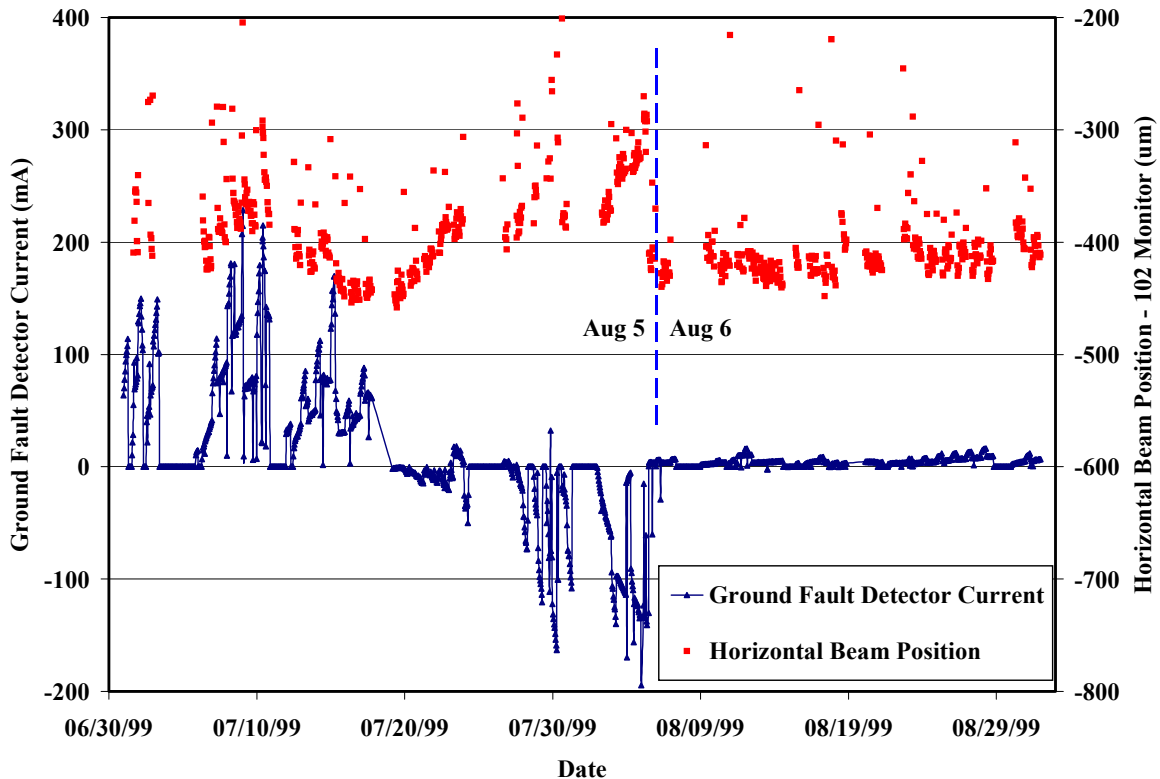
Figure 2 shows a plot of the ground fault detector current (lower continuous trace) and the horizontal beam position in bend magnet 10 (upper disconnected points) as a function of time. This data covers 2 months of normal storage ring operation with the global feedback system [2] providing real time position corrections. It is clear that the ground fault detector current was changing and in some cases changing very quickly on the left half of the plot. The horizontal photon beam position moved by more than 160  $\mu\text{m}$ , which is clearly beyond our position stability target of 20  $\mu\text{m}$ . The main contribution to these leakage currents was bend magnet 11 with an individual leakage current larger than 800 mA.

Figure 2. Ground fault detector current and horizontal beam position at monitor 102 during Aladdin ring operation.

On August 5, 1999 the extremely high leakage currents at bend magnet 11 tripped the ground fault detector and shut down the ring. At midnight between August 5 and 6, the cooling manifolds on bend magnet 11 were electrically isolated in an attempt to correct this problem without changing the contaminated hoses. This point in

time is marked in Figure 2 by the vertical dashed line. It is clear that the ground fault detector current was significantly reduced and the horizontal beam position became much more stable after manifolds were isolated. Since August 6, 1999 there have been no bend magnet power supply shutdowns due to ground faults. The smaller changes in beam position after August 6 are due to leakage currents from the remaining 10 bend magnets with grounded manifolds.

An electrolytic reaction can be minimized by reducing the voltage across the electrodes. This was done in this situation by ungrounding the supply and return water manifolds for each half of each bend magnet. This was accomplished by inserting 6 concentric pieces of PVC pipe around each manifold in the appropriate places to electrically isolate the manifold from ground. When this was done the manifolds floated to a voltage based on the cumulative resistance of the 9 small hoses relative to the high resistance of the larger, 32 inch long hose. This is basically a voltage divider circuit. In bend magnets 10 and 11 respectively the voltage drops at 800 MeV, from the field coils to the manifolds, have been reduced from 103 VDC to 6 VDC and from 96 VDC to 5 VDC. Furthermore, the added high, series resistance of the 32 inch long elastomer hose reduced all leakage currents by more than a factor of 100.
