AIRCRAFT ACCIDENT INVESTIGATION REPORT

**China Airlines
Airbus A300B4 – 622R, B-1814
Da-Yuang, Tao-Yuang
February 16, 1998**

May 18, 2000

Civil Aeronautics Administration

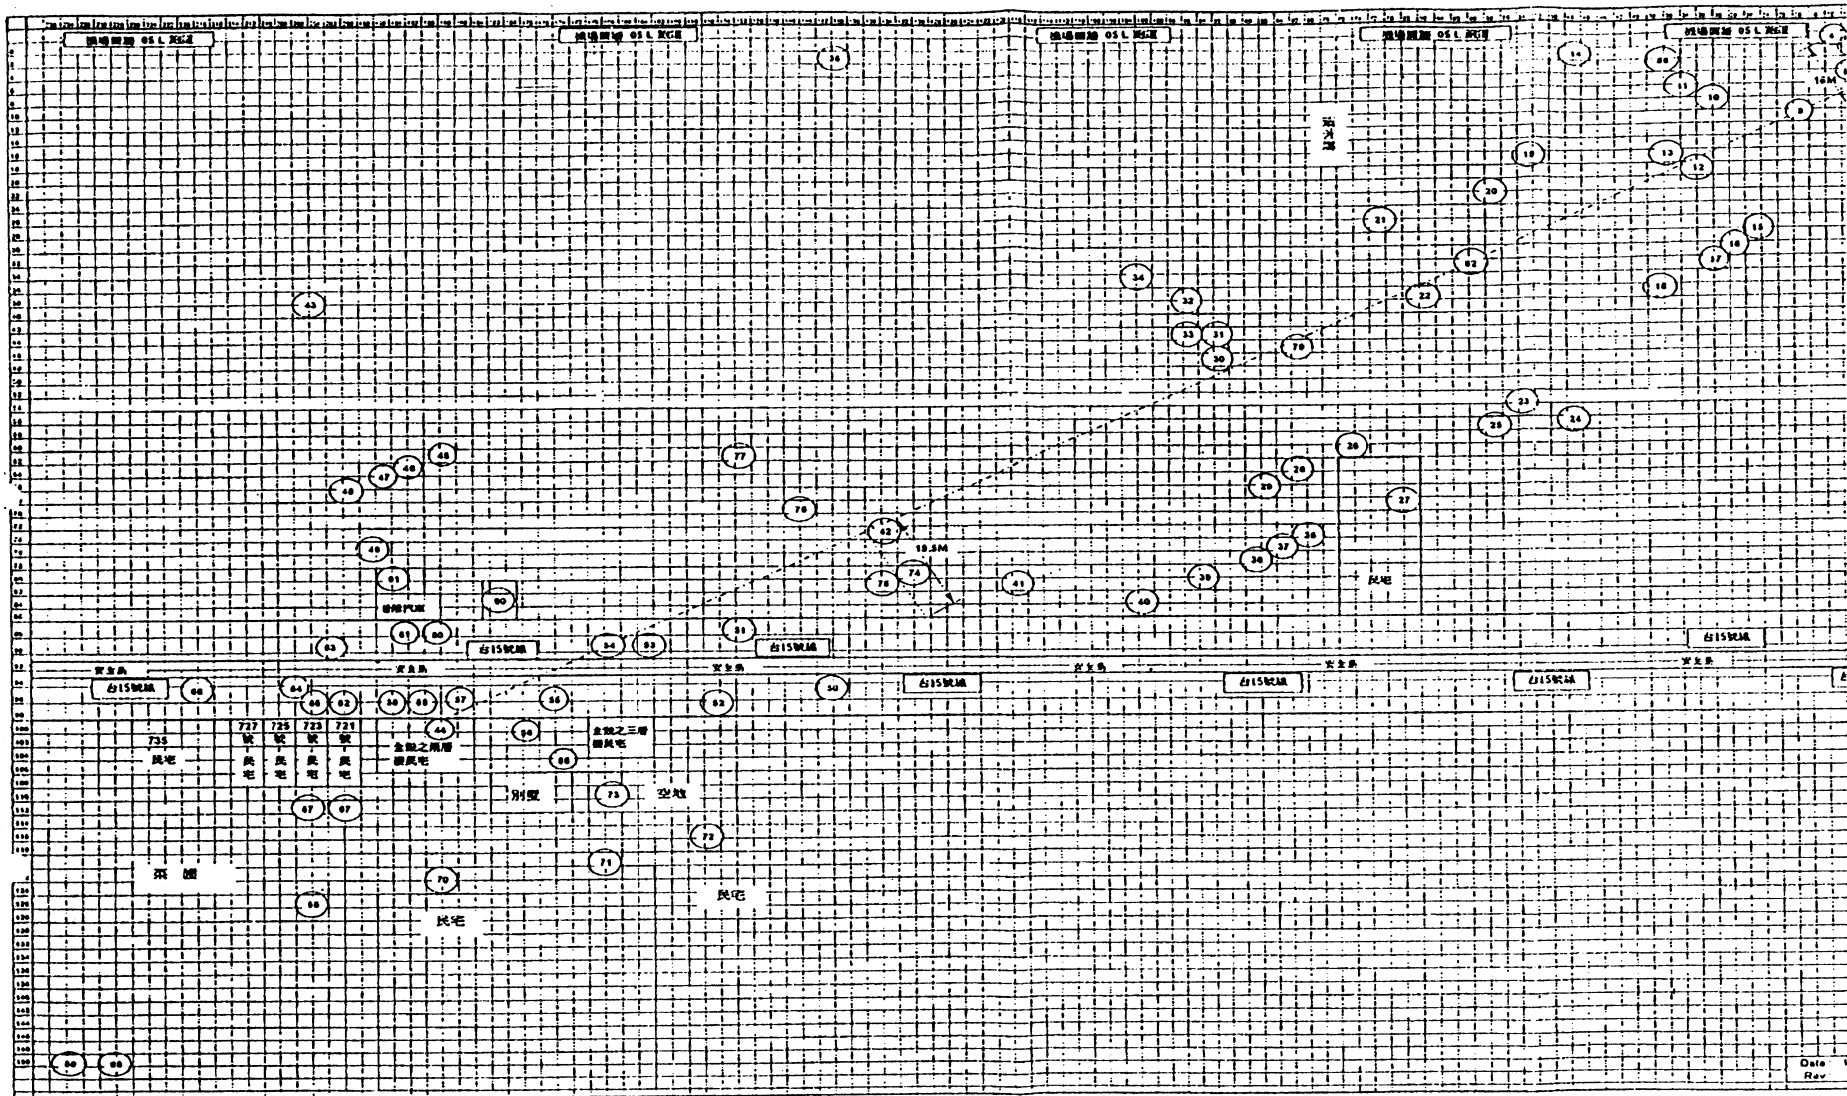
Appendix 8 Wreckage Distribution Map

The aircraft hit the ground on waste land and broke up progressively. Some parts came to rest on the highway No. 15 alongside the field, and some others badly damaged several multi-storied buildings on the far side of the highway.

fuselage. The scar was oriented at a magnetic heading close to 020°. Within the scar, a small frame part of the rear fuselage was identified. This part embedded in the ground was found at 3 meters from the extremity of the triangle.

Going further along the wreckage path, two holes were found approximately equidistant from the triangular mark. Due to the shape and the distance (16 meters), these two traces were identified as having been made by the engines. The fan cases of each engine were found in front of these holes on the wreckage path.

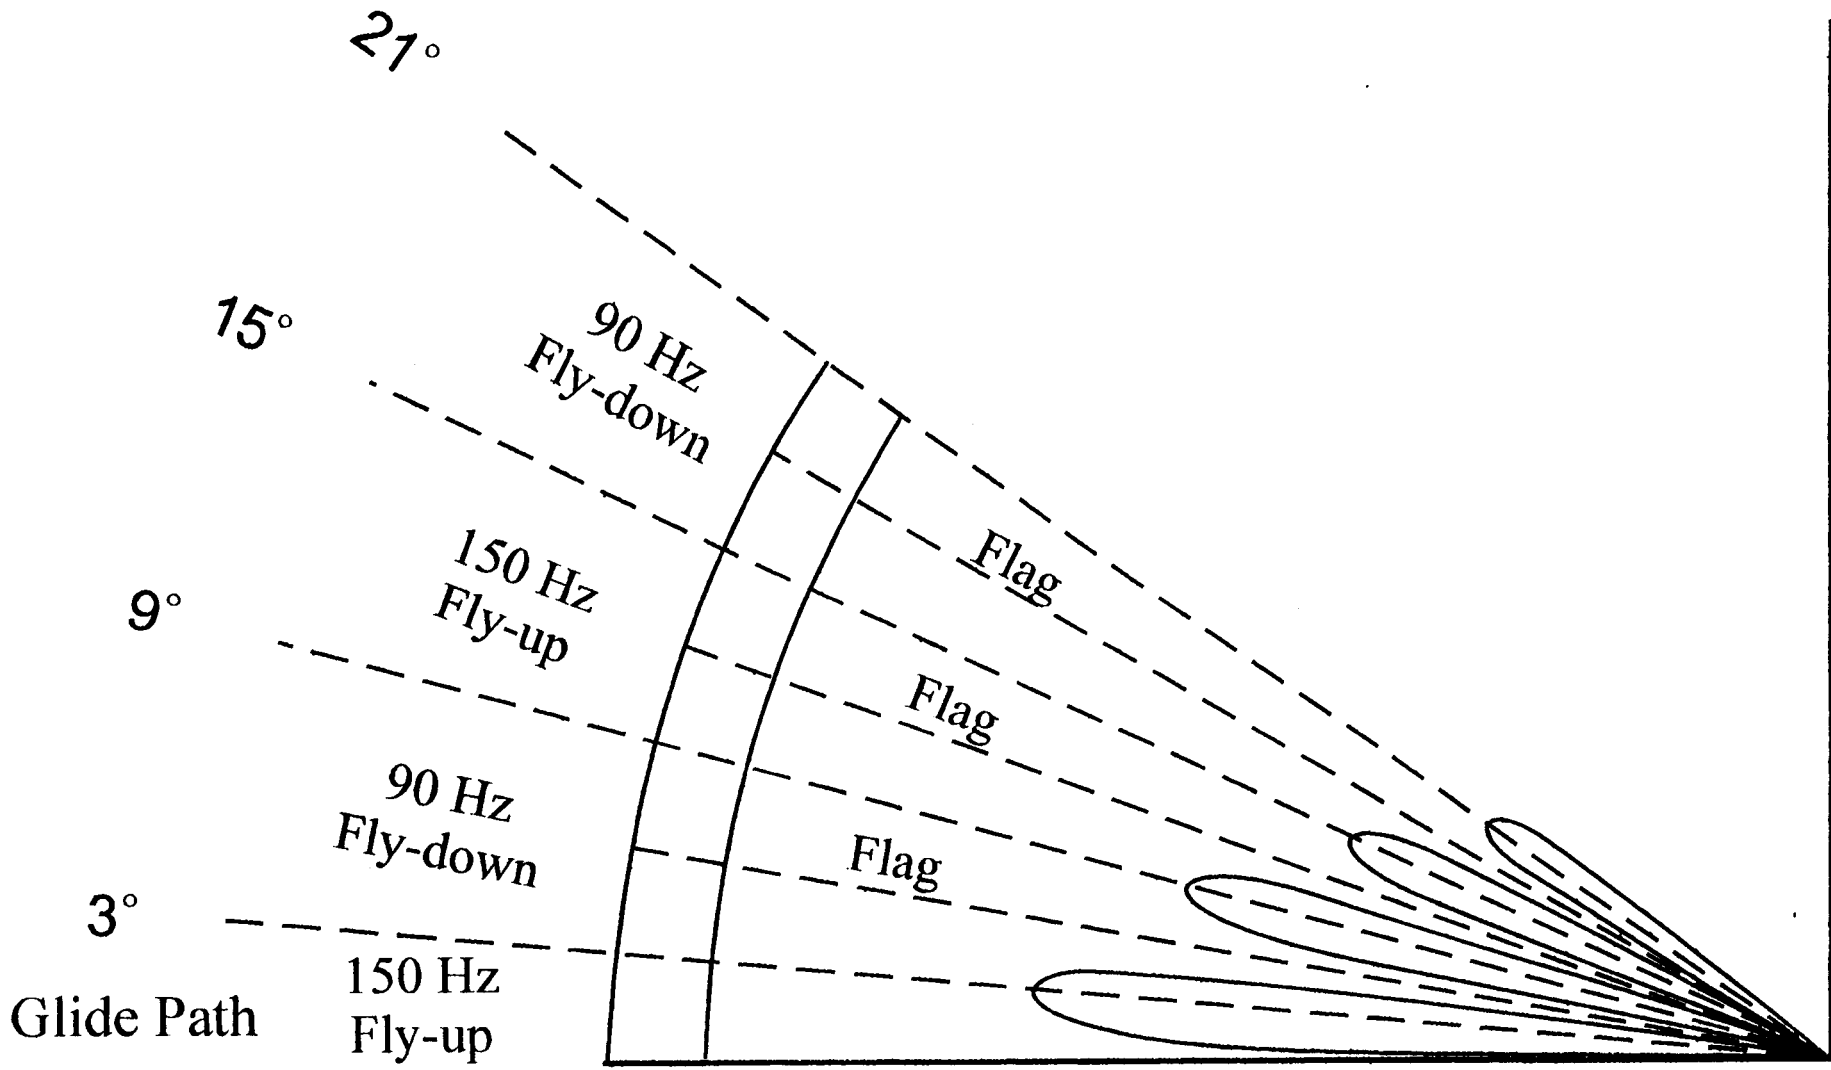
B-1814 Approach Diagram Relevant to the Glide Slope

12:04:26 UTC, Taipei Tower confirmed the landing clearance. After that, the F/O announced the FMA modes, which were LOC green and G/S blue. This indicated that the AP was in LAND mode. For the lateral mode the AP had already captured the localizer. For the vertical mode, it means that the capture of the G/S was armed. The conditions for capture were not present. It requires less than two thirds of a dot to switch to G/S* (glide capture) mode. The AP can capture the glide even if the aircraft is arriving from above. But the normal and safe procedure is to arrive from below.

At 12:05:04 UTC, it is noted that the auto pilot considering that the aircraft was below the glide slope began bring the nose up to level off as the glide slope deviation passed in the 'normal range' of the 'fly up' indication, and attempted to maintain speed by increasing thrust because of the decreasing speed caused by the increasing angle of attack.
