Accident

Aircraft Type and Registration:	Airbus A321-253NX, G-OATW
No & Type of Engines:	2 CFM International SA LEAP-1A33 turbofan engines
Year of Manufacture:	2020 (Serial no: 10238)
Date & Time (UTC):	4 October 2023 at 1151 hrs
Location:	London Stansted Airport
Type of Flight:	Commercial Air Transport (Passenger)
Persons on Board:	Crew - 11 Passengers - 9
Injuries:	Crew - None Passengers - None
Nature of Damage:	Damage to several cabin windows and impact damage to the left horizontal stabiliser
Commander's Licence:	Airline Transport Pilot's Licence
Commander's Age:	54 years
Commander's Flying Experience:	4,905 hours (of which 2,300 were on type) Last 90 days - 128 hours Last 28 days - 27 hours
Information Source:	AAIB Field Investigation

Synopsis

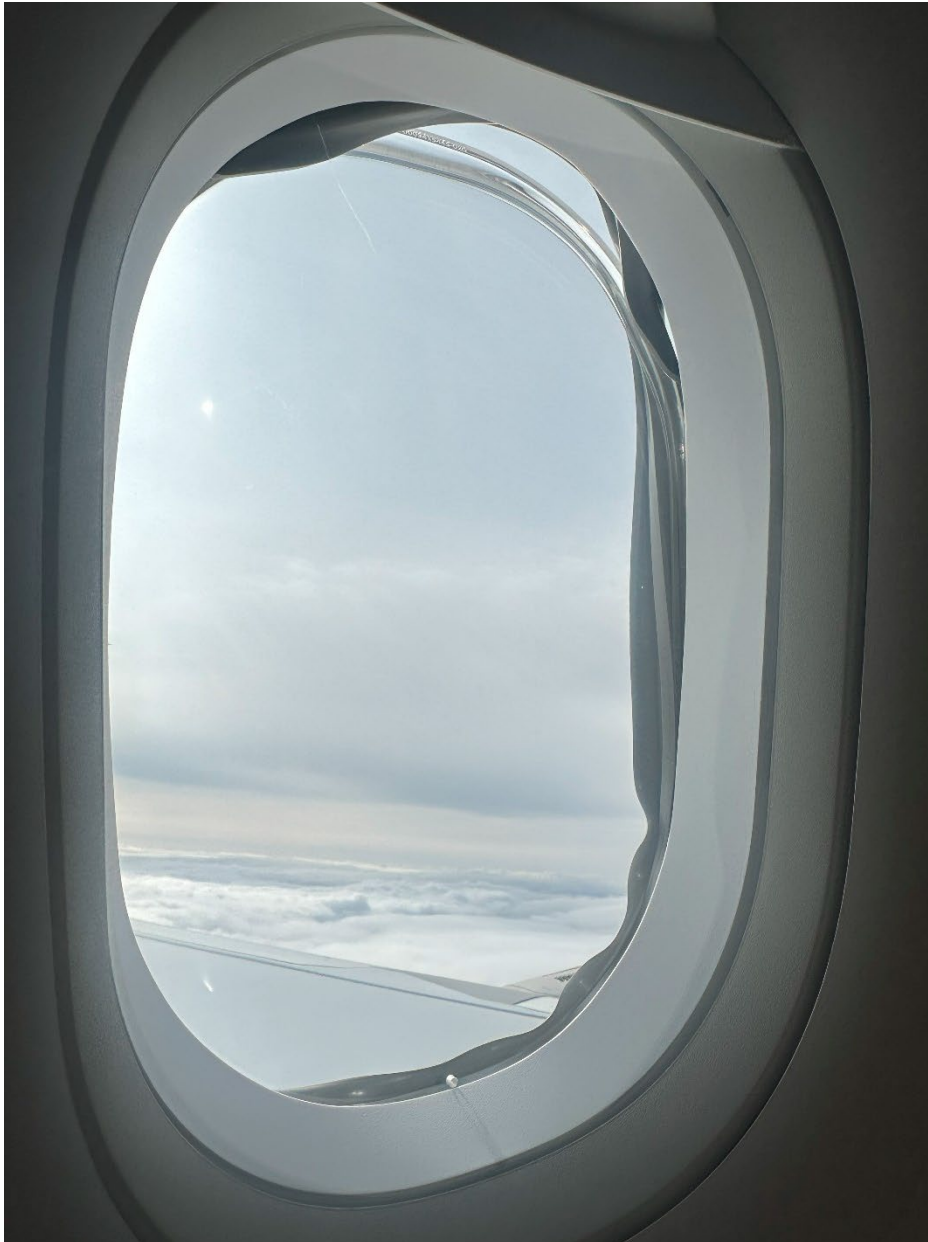
The aircraft departed a few minutes ahead of schedule and took off from Runway 22. Several passengers recalled that after takeoff the aircraft cabin seemed noisier and colder than they were used to. As the aircraft climbed through FL100, and the seatbelt signs were switched off, the loadmaster, who had been seated just in front of the other passengers, walked towards the rear of the aircraft. He noticed the increased cabin noise as he approached the overwing exits and his attention was drawn to a cabin window on the left of the aircraft. He observed that the window seal was flapping in the airflow and the windowpane appeared to have slipped down². He described the cabin noise as 'loud enough to damage your hearing'. Figure 1 shows the window in flight.

View of the left side cabin window aft of the overwing exit

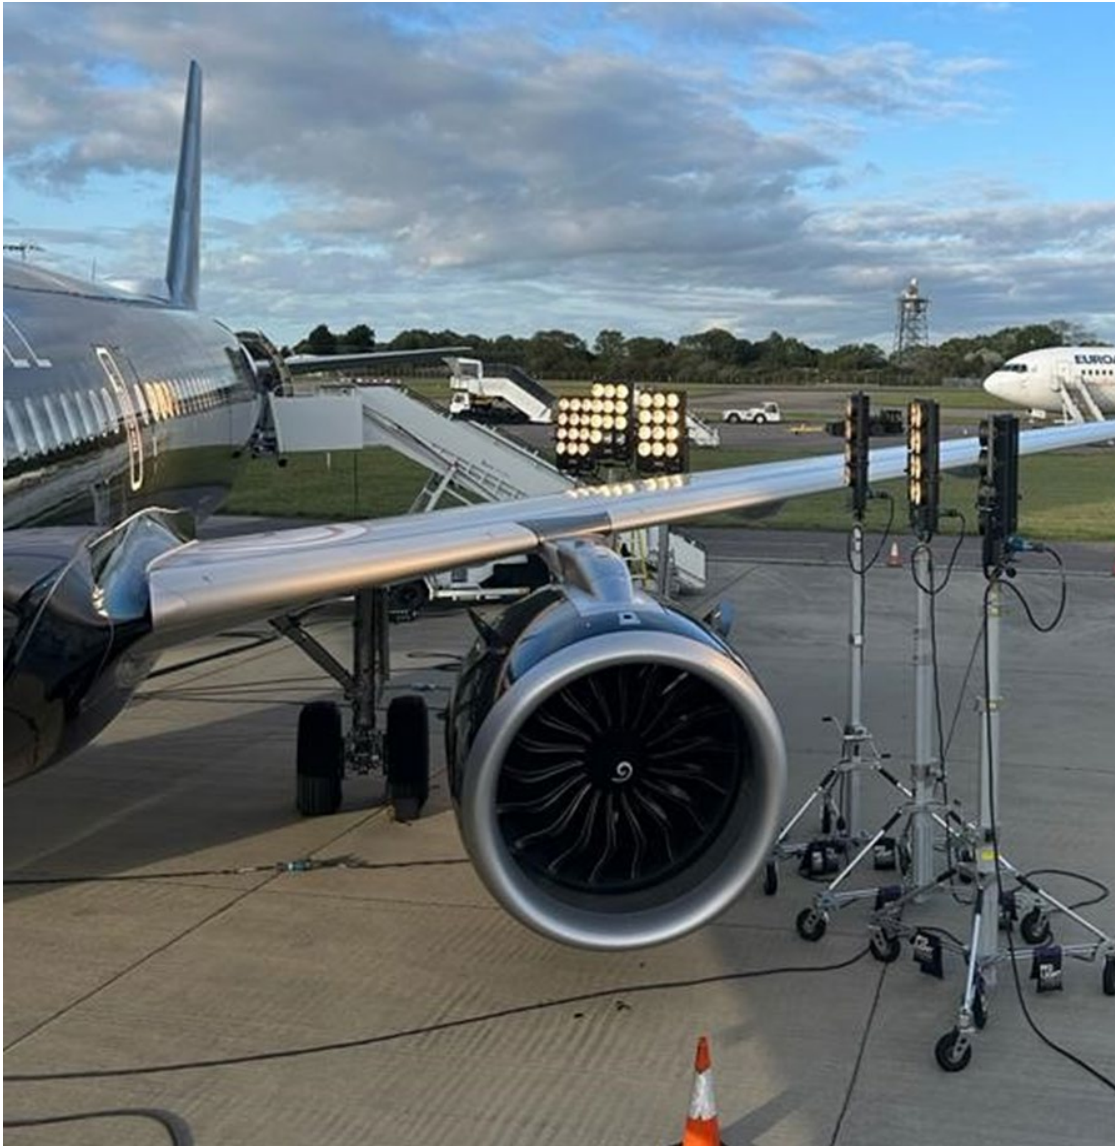
The day before the occurrence flight the aircraft had been used for filming on the ground, during which external lights had been shone through the cabin windows to give the illusion of a sunrise. The lights were first shone on the right side of the aircraft for approximately five and a half hours, with the light focused on the cabin windows just aft of the overwing exits. The lights were then moved to the left side of the aircraft where they illuminated a similar area on the left side for approximately four hours. Photographs taken during filming showed six sets of flood lights on both sides of the aircraft. Figure 2 shows the lights positioned on the left of the aircraft.

Flood lighting on the left side of the aircraft

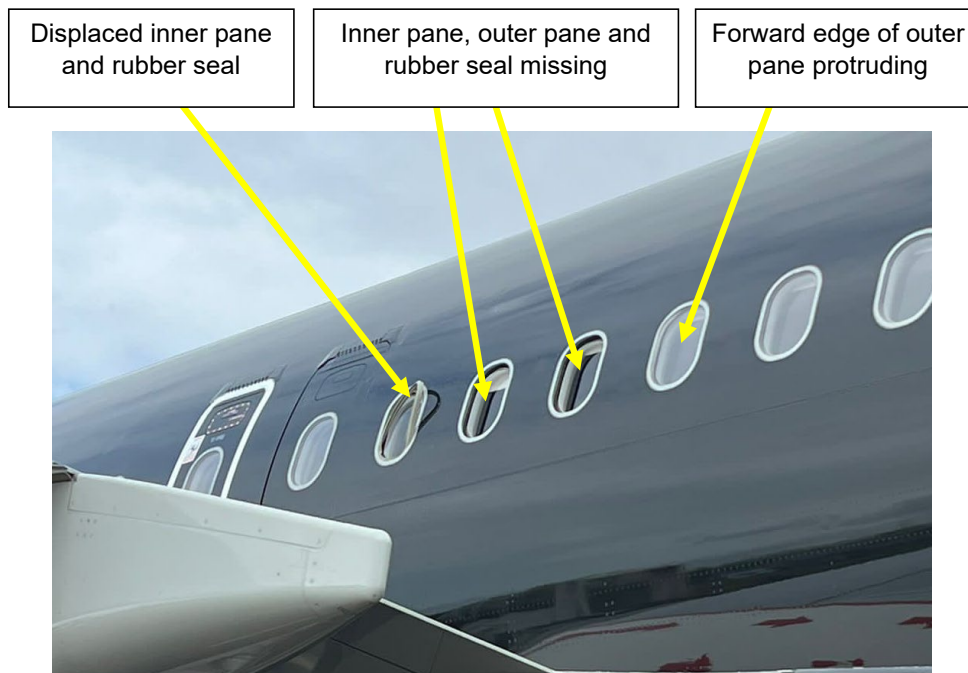
**Figure 5**

Two cabin window assemblies were missing in their entirety, and the inner pane and seal from a third were displaced but partially retained (Figure 5). The forward edge of a fourth window protruded from the left side of the fuselage (Figure 6). The four windows were adjacent to each other, just aft of the left overwing exit. All the scratch panes remained in place, so there was no direct, unrestricted aperture into the passenger cabin.

Displaced and missing windowpanes on the left side of the aircraft

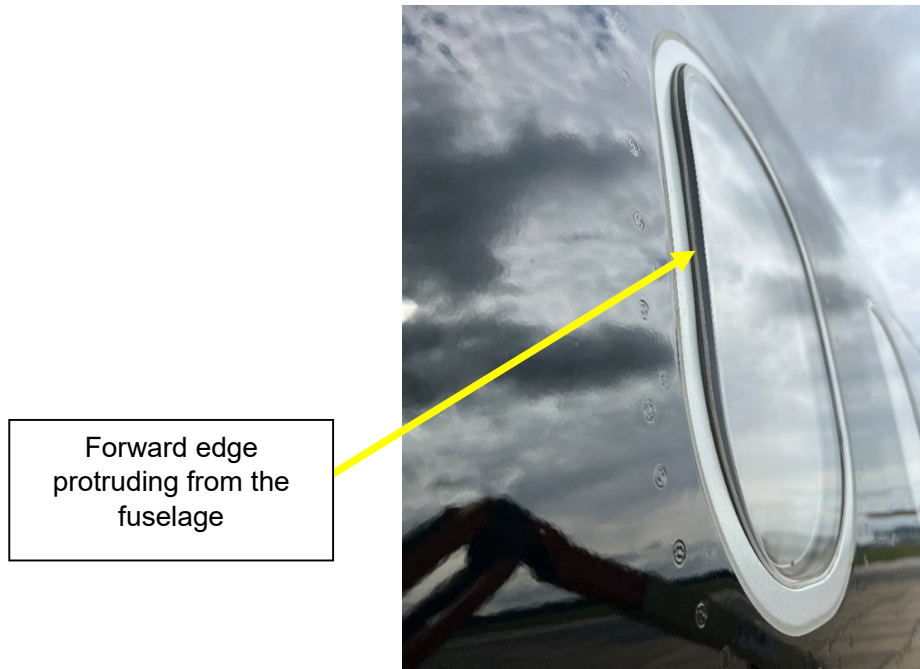
Figure 6

Forward edge of the outer pane protruding from the fuselage

The inner and outer windowpanes were both distorted in the area that protruded from the fuselage. The outer windowpane was more damaged than the inner, and the distortion affected the interface with the slot in the rubber seal (Figure 10). After the windowpanes were removed from the rubber seal, they could not be refitted because of the distortion. The rubber seal appeared undamaged.

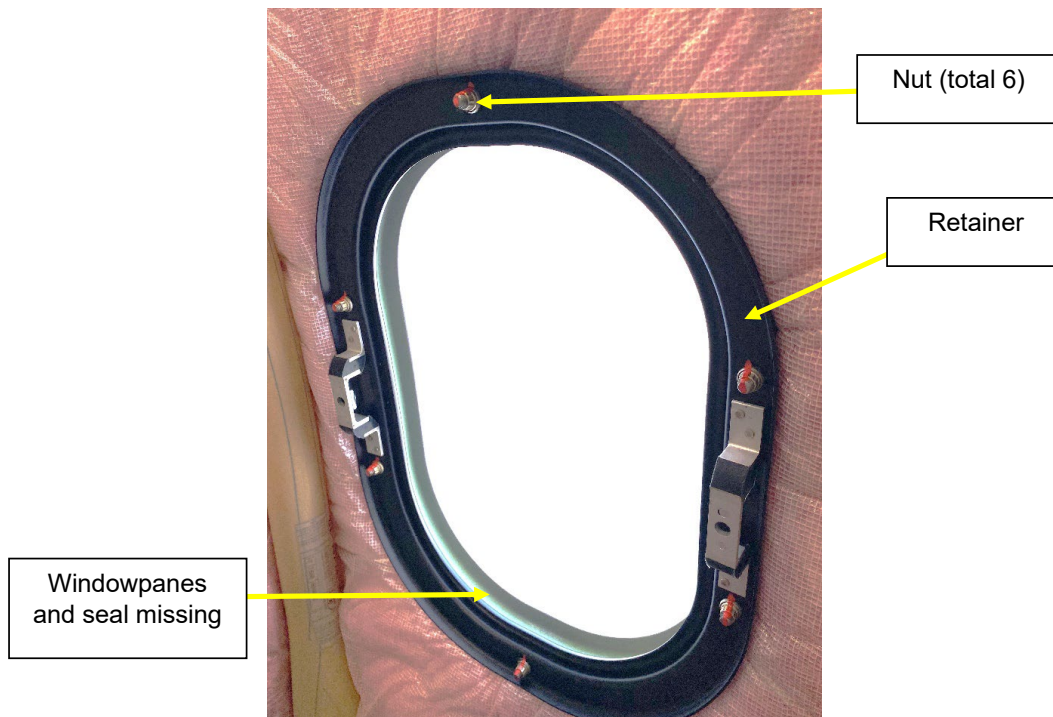
Figure 7

Removal of the cabin lining inside the passenger cabin revealed that, despite the missing and dislodged windowpanes, the window retainers were in good condition and correctly installed (Figure 7).

Correct installation of the retainer but the window assembly is missing

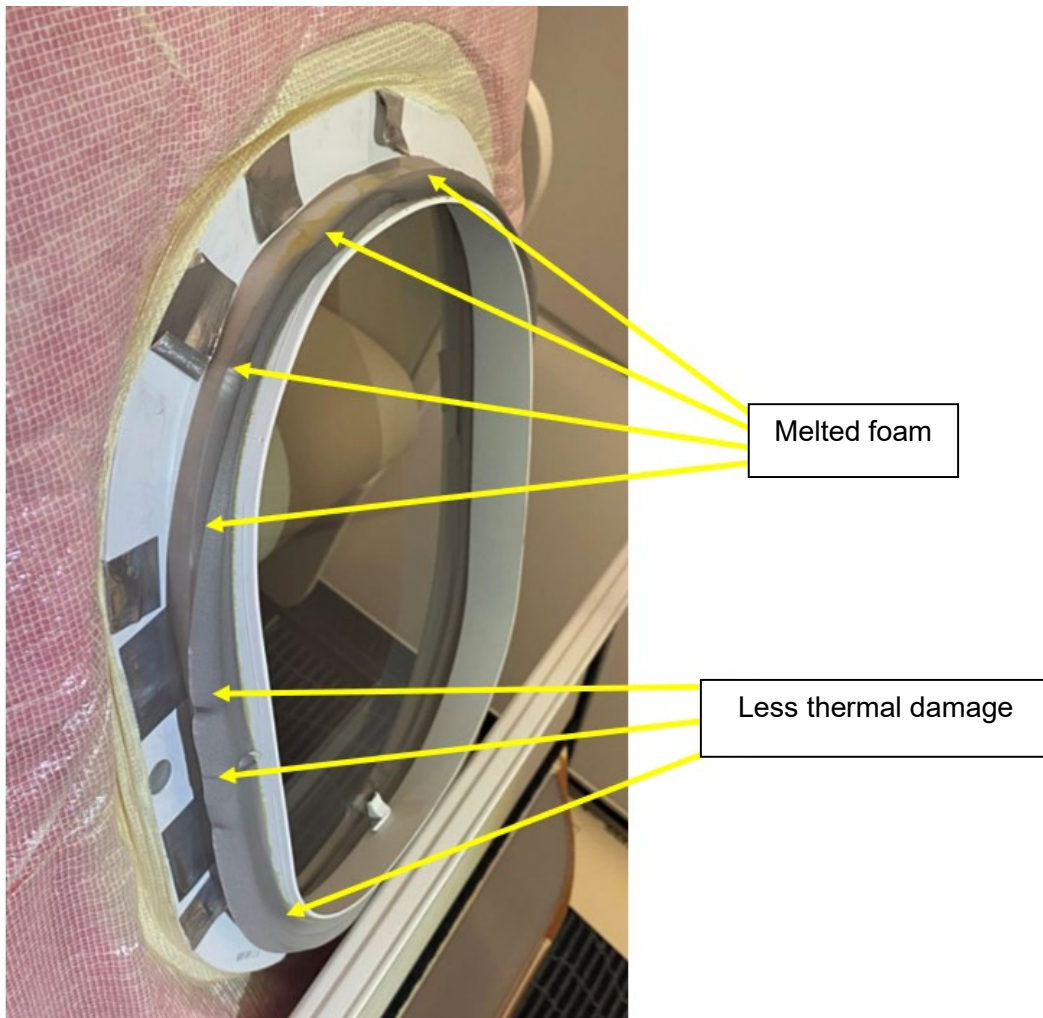
Figure 8

The foam ring material on the back of the cabin liners was found to be melted in the areas adjacent to the windows that were damaged or missing (Figure 8).

Foam ring material affected by elevated temperatures

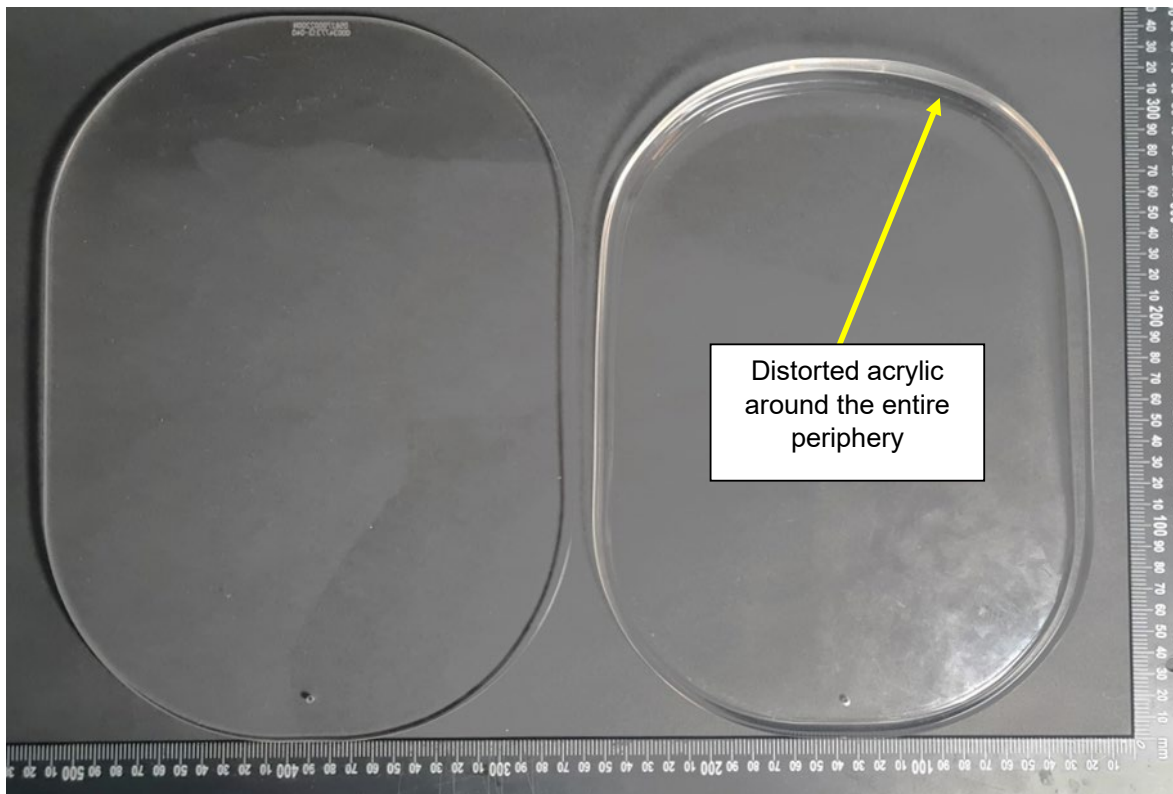
Figure 9

The inner windowpane that was loosely retained after the aircraft landed was found to be shrunk and deformed around its periphery (Figure 9). The corresponding rubber seal was undamaged, but the deformed windowpane no longer formed an effective interface with it.

A serviceable inner windowpane (left) and the damaged inner windowpane (right)

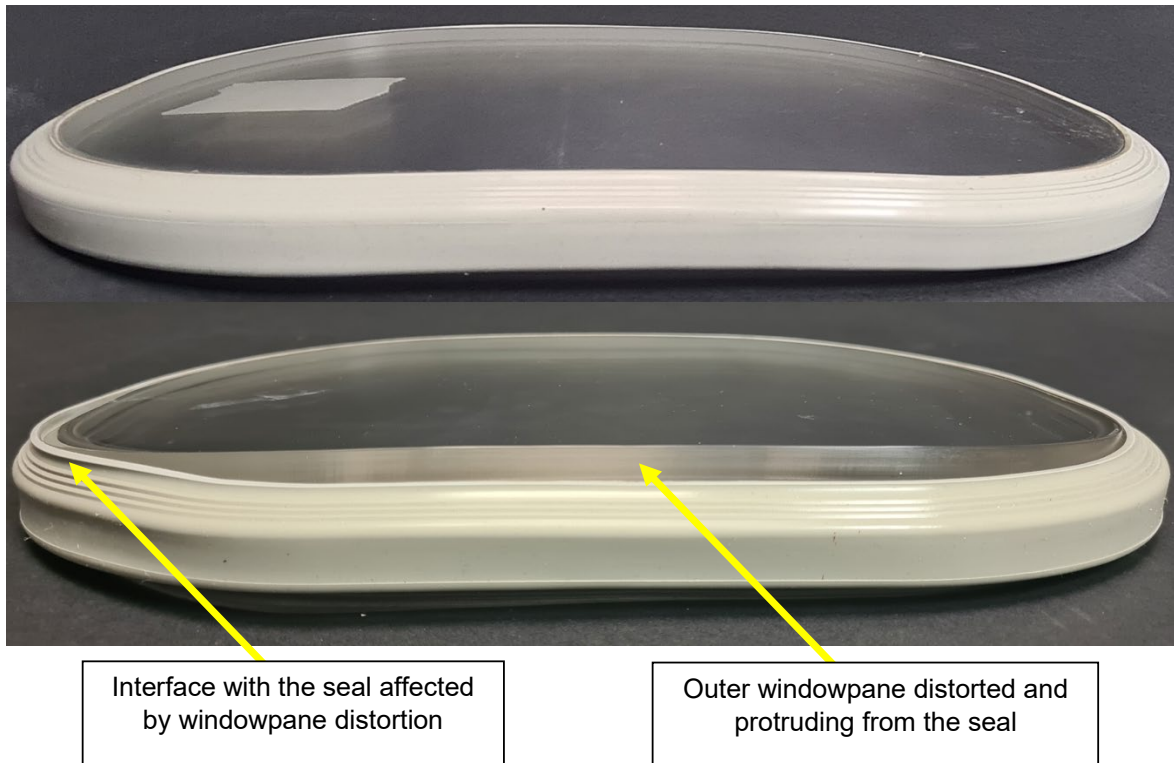
**Figure 10**

A serviceable window assembly (top) and the protruding assembly (bottom)

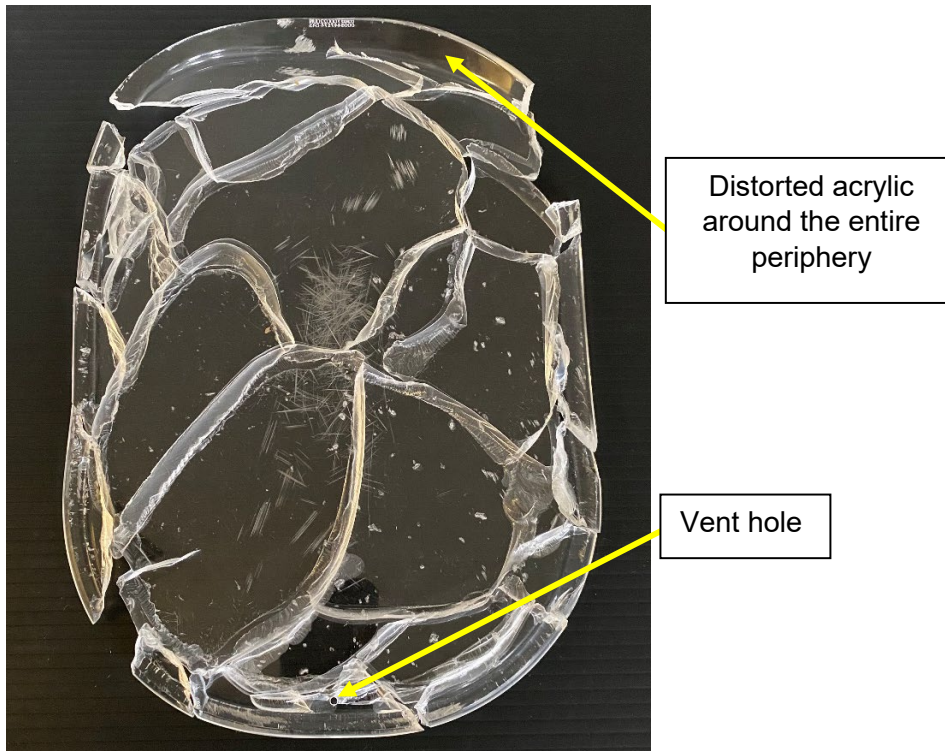
Figure 11

A vent hole in one of the broken parts showed that the shattered remains were from an inner windowpane⁵ (Figure 11). The window was distorted around its periphery and had shrunk.

Reconstructed remains of the shattered windowpane

A shattered inner windowpane was recovered from the entrance to a rapid-exit taxiway. The broken remains showed thermal distortion around its periphery, and it was apparent that the windowpane had shrunk. The distortion and shrinkage meant that the windowpane no longer formed an effective interface with the slot in the rubber seal. This made it more likely to fall out due to vibration or the differential air pressure between the passenger cabin and the outside environment.

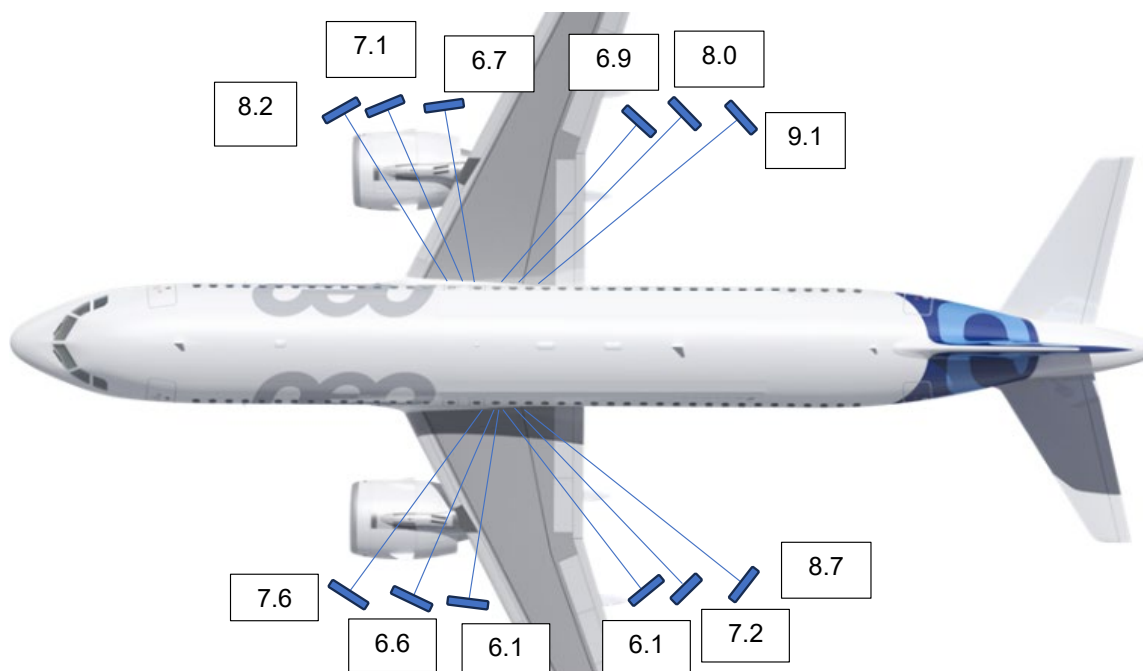
Figure 12

Photographs of the filming showed that the lights were approximately 6 to 9 m from the window areas where damage occurred (Figure 12).

Approximate distance of the flood lights from the fuselage during the filming activity

The day before the occurrence flight both sides of the aircraft were illuminated by six halogen light arrays with a combined power output of approximately 72,000 W. The lights were positioned closer to the aircraft than the minimum recommended distance and the acrylic windows absorbed IR radiation, with very limited ability to dissipate this energy into the surrounding structure or air. As time progressed, the temperature of the acrylic increased to the point that the material softened and started to deform and shrink. The window retainers apply a compressive force around the periphery so, as the acrylic softened, this force may have exacerbated the distortion. The temperature that the acrylic achieved is unknown, but two of the windowpanes had reduced in size by approximately 6%. The manufacturing process specification indicates a maximum of 10% shrinkage at 110°C so it is likely that these windows achieved a temperature that was approaching this value. This is beyond the aircraft's certified operating limits.

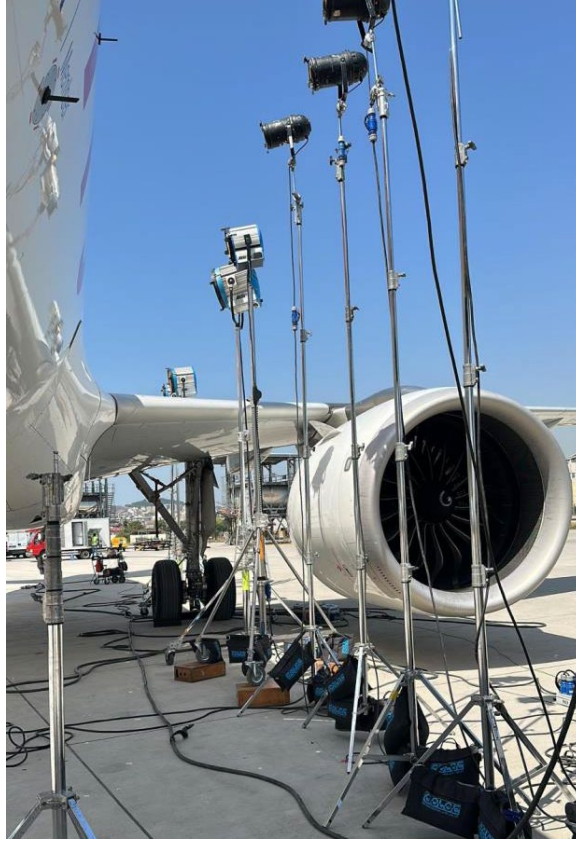
Figure 14

An Airbus A321 sustained cabin window damage during a filming event when the aircraft was outdoors. Spotlights were positioned just inboard of the engines, approximately 1.5 to 1.8 m from the cabin windows (Figure 14).

Lighting arrangement during a previous filming event
(image used with permission)

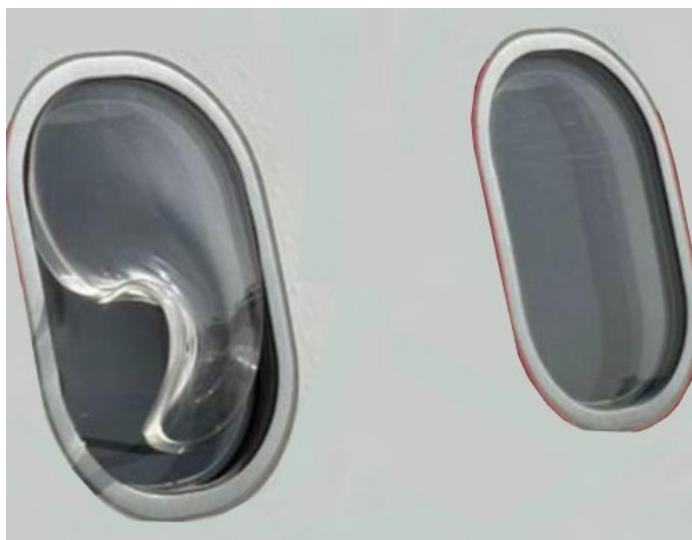
Figure 15

The AAIB does not know the specifications of the lights or how long they were turned on. The window damage was readily visible after the filming (Figure 15).

Thermal damage sustained by an outer windowpane on an Airbus A321
(image used with permission)

When the damage was reported to Airbus, it was not aware of any other occurrences, and considered the circumstances to be outside the anticipated operating conditions. No action was taken apart from providing technical advice to repair the aircraft.

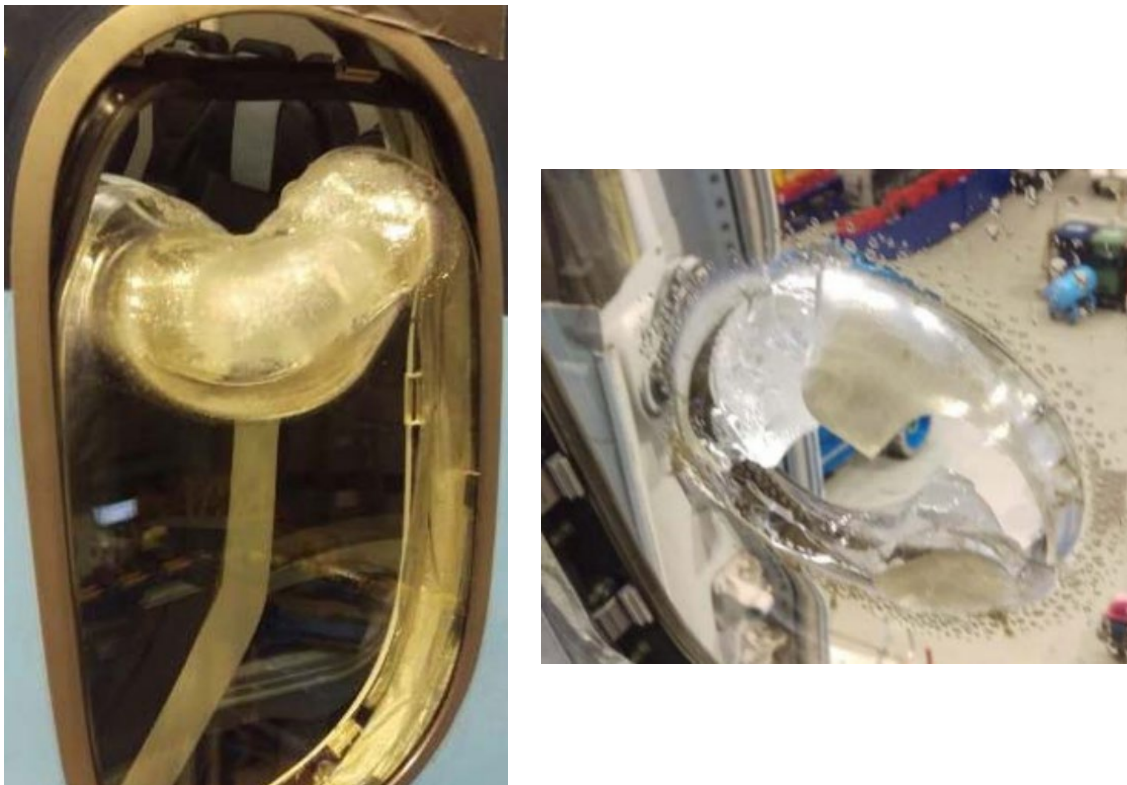
Figure 16

One operator informed the AAIB that six cabin windows were damaged on a Boeing 787 during a filming event inside a hangar. The windows were illuminated using three 2,000 W lights positioned on mobile platforms outside the aircraft. The windows suffered significant deformation and one had a hole burned through the windowpanes (Figure 16).

Deformed outer windowpane and a hole through the cabin window
(images used with permission)

- Keep the lights well away from the cabin windows
- Use lights that do not emit heat or lights that minimise heat generation (low IR)
- Minimise the time the lights are on
- Turn the lights off when they are not required
- Monitor the temperature of the cabin windows
