# Report on Running Channels in iseg 32-Ch HV Power Supplies

*DRAFT, 15 November 2006*

We report a study and solution of the so-called "running channel" (**RC**) phenomenon observed in the iseg<sup>d</sup> 32-channel HV power supplies for the ATLAS Liquid Argon Calorimetry.

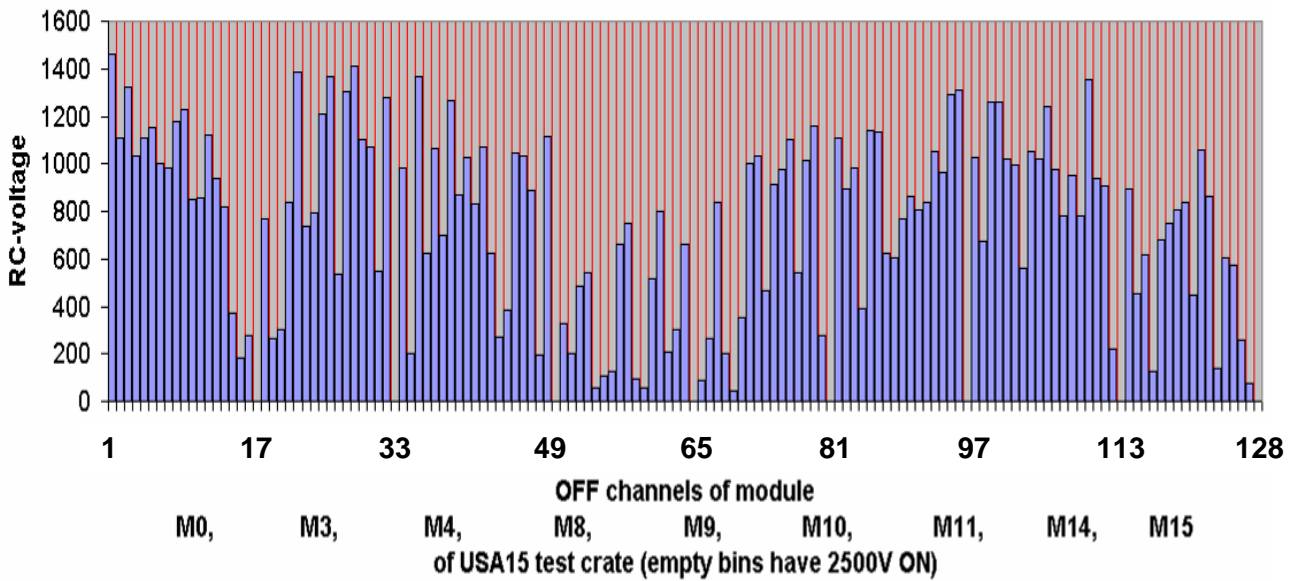
Figure 1. Distribution of voltages in channels switched “OFF” when  $V_{\text{bulk}}=2550$  V. These 200  $\mu\text{A}$  high-current HV modules have 350 M $\Omega$  divider resistors, and are more prone to exhibiting RCs.

Figure 1 and Figure 2 show, for modules with 350 M $\Omega$  dividers (which are most sensitive to leakage currents), the distribution of RC's when a single HV output is raised to 2500 V (ensuring the bulk supply is at 2550 V), while all other channels are set to “OFF”. The RC voltage distribution appears in almost all channels and peaks at about 1000 V.

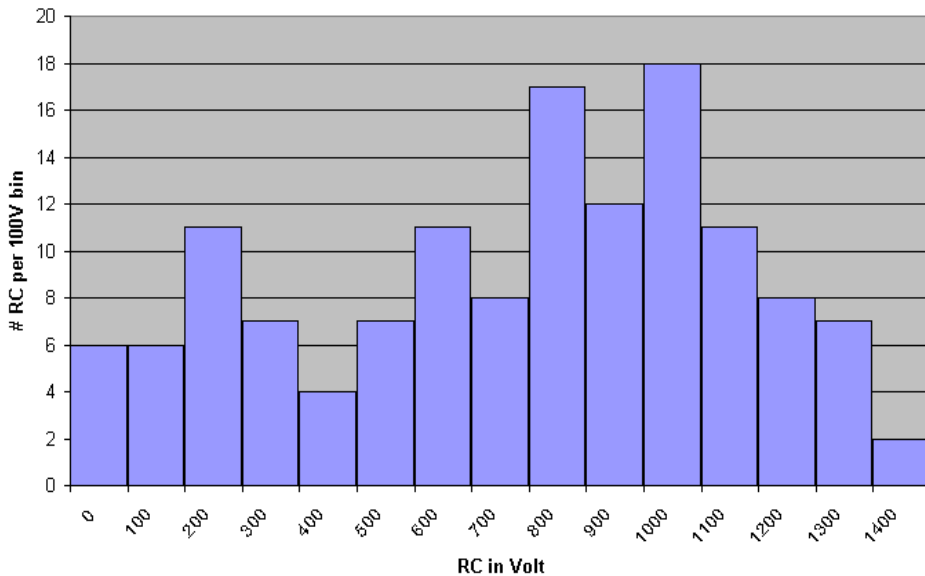
Figure 2. Voltage distribution of the "OFF" channels above.

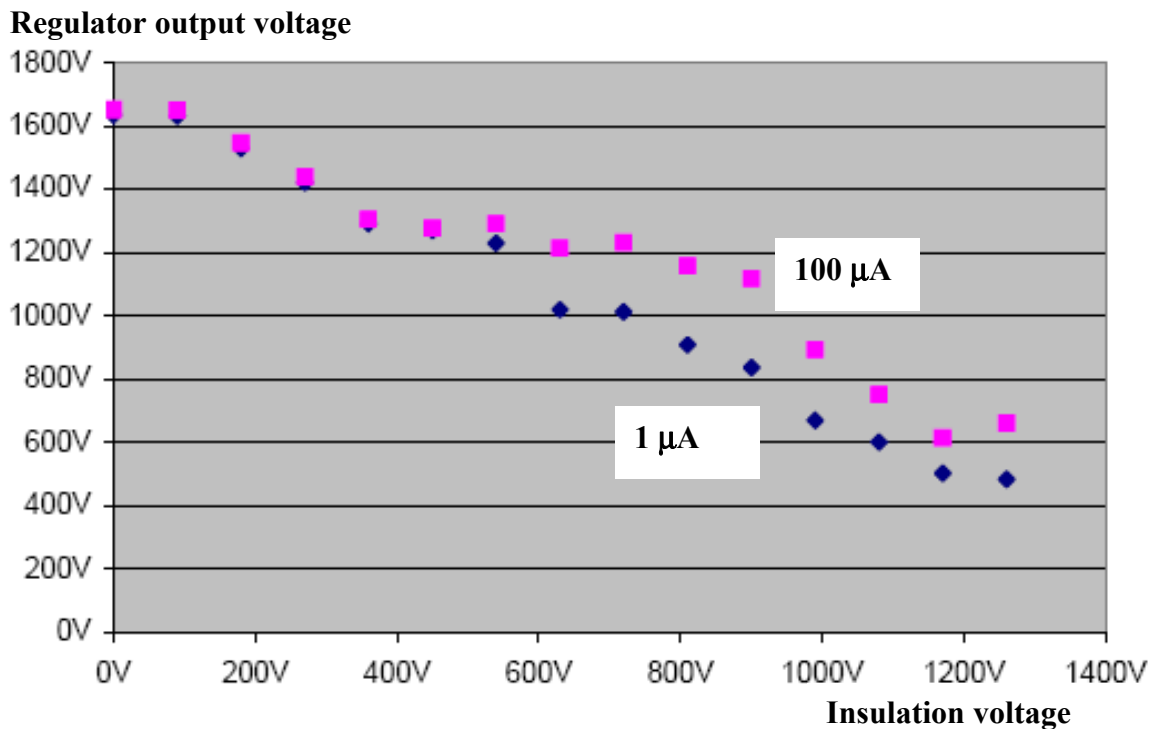
As shown in Figure 3, the leakage current measurements done at iseg on 15 factory-new samples (VR pairs) show, apart from the 'knee'-lowering effect as function of the insulation voltage, a change in the avalanche slope, which becomes smoother as the applied insulation voltage is higher.

The avalanche curve was measured after driving the samples for 22 hrs at 70° C and 80% rel. humidity. To be noted is the fact that, already at isolation voltages above ~250 V, the VR's run out of specification i.e. the leakage current is above 100 uA for output voltages of 1500 V.

Figure 3. Leakage currents as measured for different insulation voltages and different output voltages.

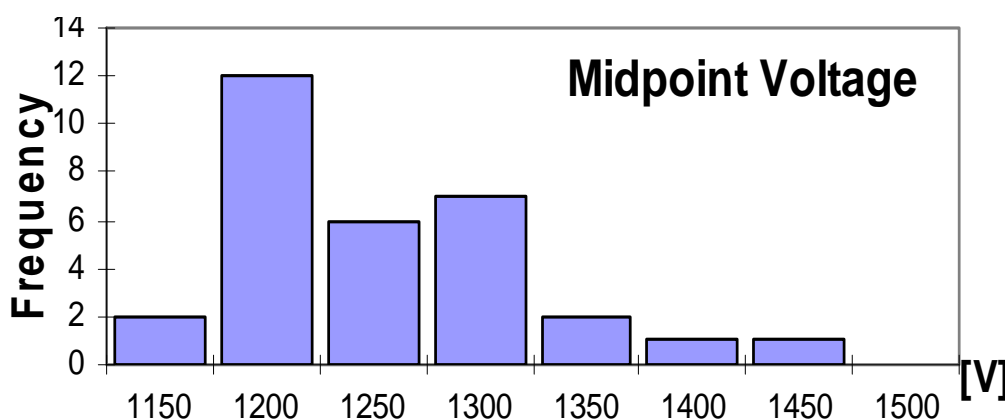
We have measured the "voltage balance" of the two VR's in series in each channel of a particular module, and found that (within statistics) there is no evidence that the VR's operate at voltages exceeding their specification, see Figure 4. Indeed, it seems the devices work in well-balanced pairs as intended.

Figure 4. Voltage at point between the series connected VRs; 31 channels.  $V_{\text{mid}}$  for RCs: 1198V (Ch7;  $V_{\text{out}}=602\text{V}$ ), 1445V (Ch30;  $V_{\text{out}}=19\text{V}$ ), 1481V (Ch31;  $V_{\text{out}}=125\text{V}$ ).  $V_{\text{bulk}}=2550\text{V}$ .

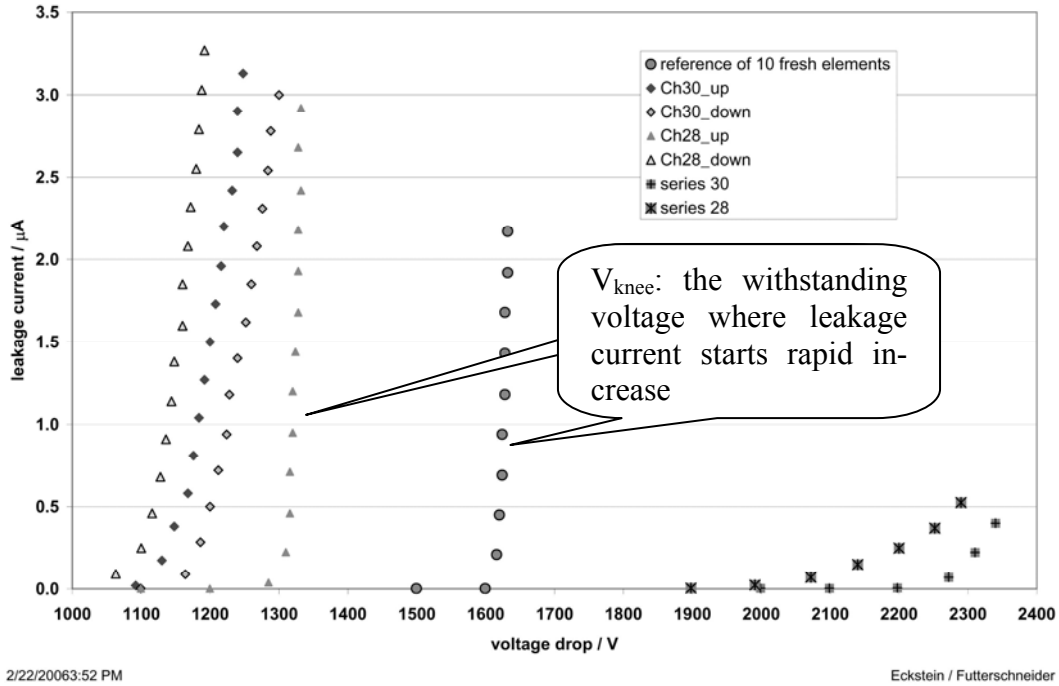
Both "fresh" (i.e. new) VR's were tested, as well as de-soldered VR's from RC's (channel 28, 30; "up" is the VR at the side of the bulk HV and "down" indicates the VR near the channel output) at TU-Dresden, and the leakage currents were measured as function of voltage drop across the individual regulators, see Figure 5.

Also in this Figure, the leakage current through two VR's in series is plotted versus the total voltage across the series, and is in good agreement with the individual device measurements.

Figure 5. Leakage currents vs. applied voltage across Voltage Regulator devices.

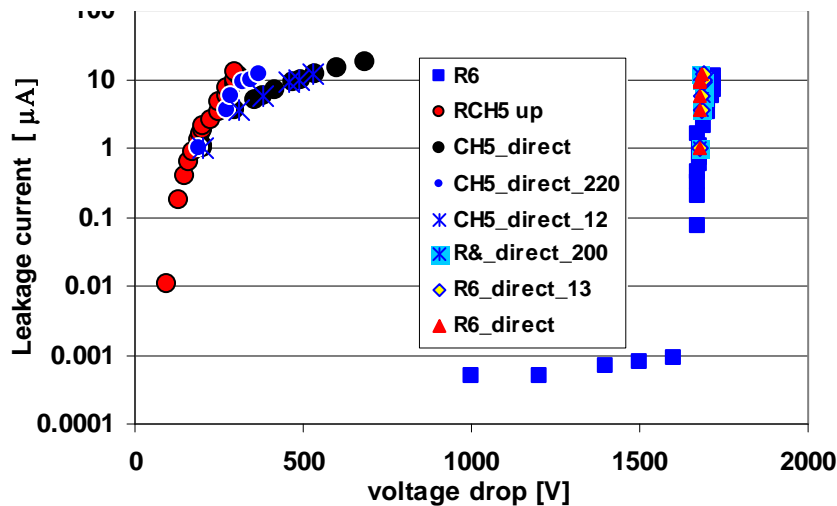
Additional measurements on individual VRs have been performed at TU-Dresden, see Figure 6, and show that the RC phenomenon is universal for the VR devices, i.e. given time all devices will "run". Over time, the "knee" becomes softer and the 1  $\mu\text{A}$  voltage point moves down to as low as 200 V!

Figure 6. Leakage current vs. applied voltage across single VR devices.

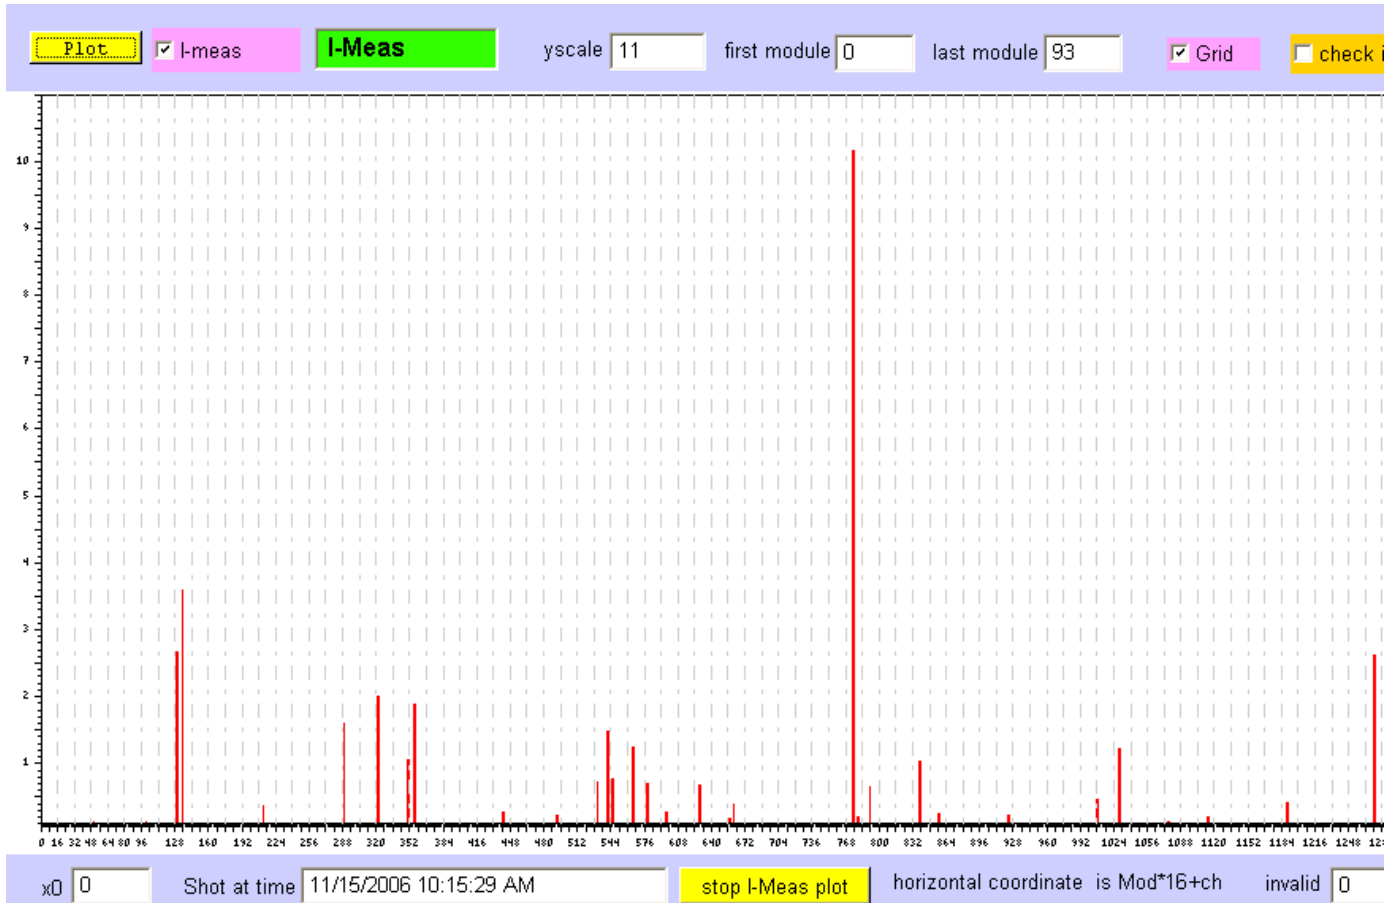
Figure 7. Currents ( $\mu\text{A}$ ) in 1120 HV channels (i.e. 70 HV boards). 27 channels that are “OFF” show currents in excess of 200  $\mu\text{A}$ ; 12 channels are above 1  $\mu\text{A}$ .

*We recommend that iseg replace diodes and/or optocouplers used in the current measurement circuitry in each channel that shows more than 200 nA of leakage current. This is best achieved by pre-selecting these components for low leakage current.*
