CERN-ACC-2014-0322

Analysis of the Failures and Corrective Actions for the LHC Cryogenics Radiation Tolerant Electronics and its Field Instruments

Ch. Balle, J. Casas, N. Vauthier

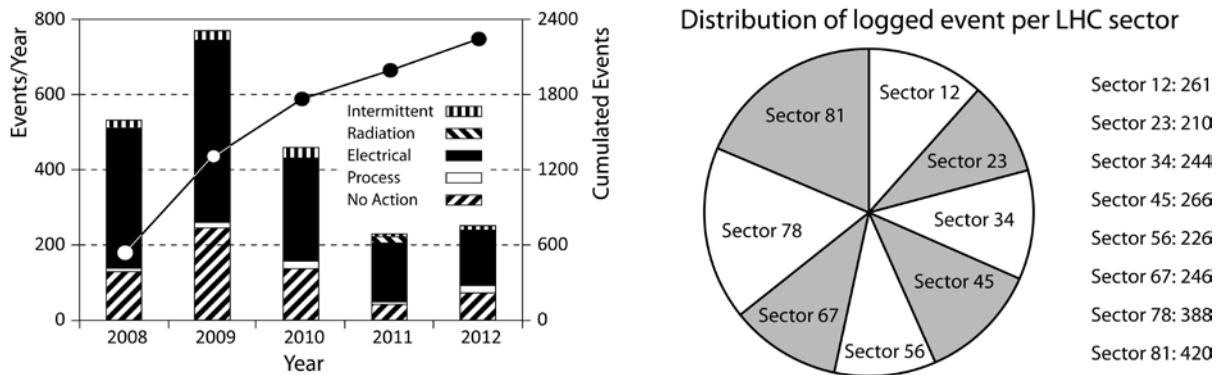
Figure 1a shows the historic accumulation of the events logged by mainly the LHC operators, the peak in 2009 correspond to a consolidation campaign that was performed after the LHC accident; the 28 events for year 2013 are not shown. Figure 1b shows a higher quantity of events for sectors 78 and 81, these were the first installed sectors that were used to fine tune our commissioning procedures. About 20 events are logged per month during the last two years of operation.

FIGURE 1. Historical accumulation per year and type (a); and per LHC sector (b) of logged events that report a malfunctioning LHC instrumentation channel.

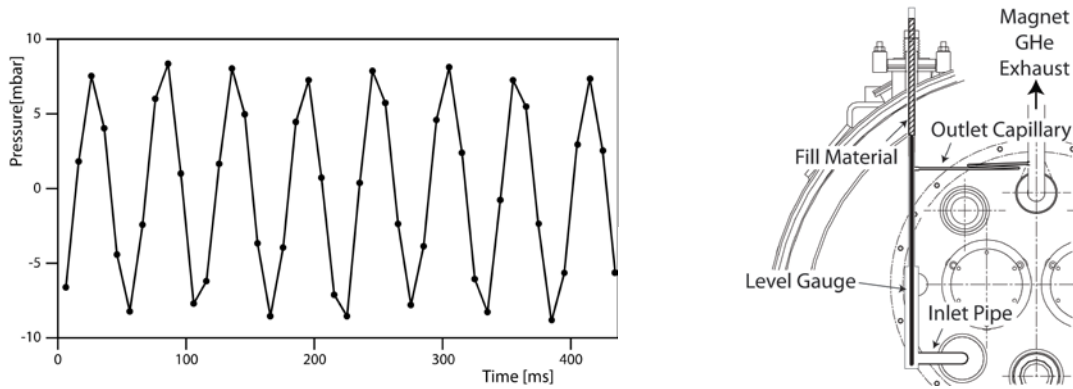
For the LHC, some superconducting liquid helium level gauges installed in stand-alone superconducting magnets operating at 4.2 K exhibited a very erratic behavior or showed no liquid while the superconducting magnet was overfilled and spilling excess liquid helium into the cryogenic distribution line (QRL). The reason was a very large heat in-leak through the gauge insertion tube that presented thermo-acoustic oscillations; they were confirmed when measuring a pressure oscillation at about 18 Hz at the level on the warm electrical feed-through (see Figure 2a). This heat in-leak vaporized excess liquid and additional gaseous helium circulated through a relatively long and narrow outlet capillary (see Figure 2b). The resulting pressure head causes a much lower level in the gauge reservoir when

FIGURE 2. (a) Pressure oscillations observed when the LHC magnet is immersed in liquid helium. (b) Cross section of a magnet, its liquid He level gauge container and interconnecting pipes.

comparing with the magnet liquid vessel. To mitigate this problem, filling material to damp the thermo-acoustic oscillations was added above the gauge and furthermore, in some cases, an additional gaseous helium exhaust was made by connecting the top of the gauge with a direct connection with the QRL lines. This problem was considered as a significant operational hindrance that required a mechanical intervention to be performed on the first possible occasion. The LHC incident of September 2008 permitted to solve this issue by the exchange of the long and 3mm internal diameter narrow outlet capillary with a short and flexible 6mm inner diameter tube.

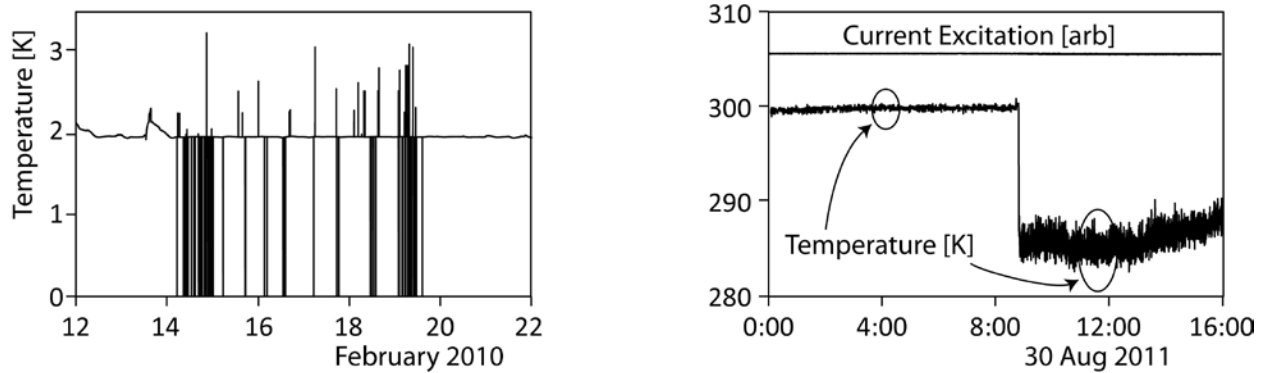
interconnected and present a very low impedance, however when using the sensors cables for estimating ground noise it does present a rich level of harmonics. Ground noise would be expected to manifest as ac noise around the median level of the expected signal, however for the insulated cards a down-conversion mechanism probably exist that transfers the high frequencies into very low frequency components that sometimes result in an effective dc offset (see Figure 3b), note the noiseless record for the excitation current fed onto the resistive platinum sensor. This mechanism is difficult to reproduce in the laboratory, adequate filtering mechanisms are being investigated for future consolidation and for some leads passive capacitive filtering has been added to tackle this problem.

FIGURE 3. Interference or noise induced by external perturbations (a) Noise on magnet temperature during 4 days (b) Noise due to a “local” ground reference observed on the current lead temperature, note that no noise is present in the excitation current.

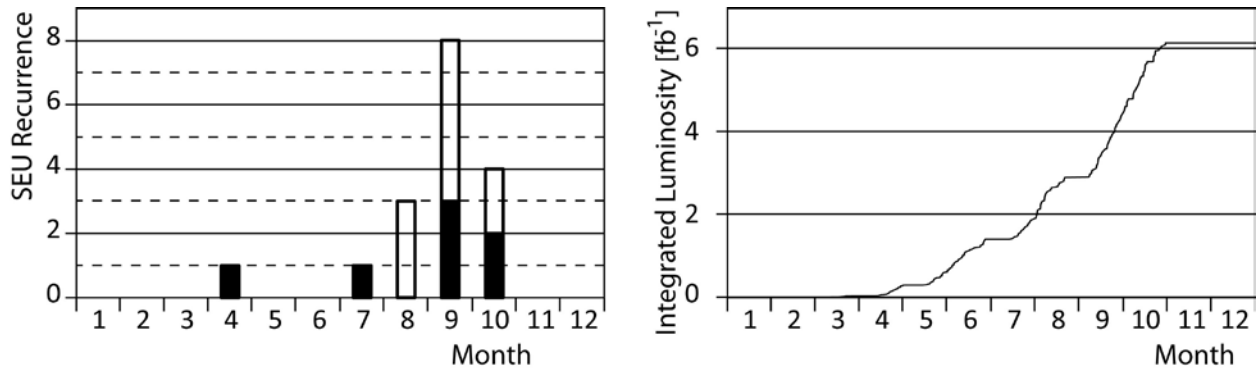
SEU were observed exclusively on the galvanic insulated cards of the current leads, see figure 4. The rate of SEU events depends on the beam luminosity as can be seen when comparing Figure 4 a and b, the faster the increase on the integrated luminosity rate the higher the probability of SEU occurrence.

FIGURE 4. SEU and luminosity during year 2011. (a) SEU recurrence per month. The black part of the histogram corresponds to a SEU that result in a beam dump. (b) Integrated luminosity for the LHC beam in the CMS experiment.

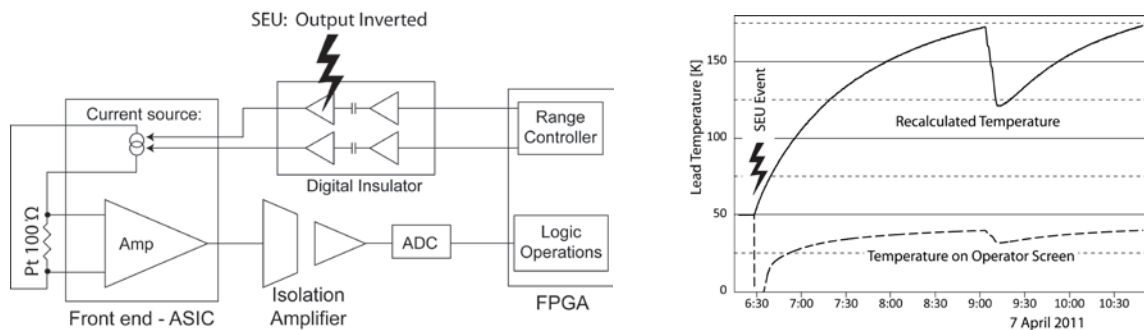
The SEU on the insulated cards is traced to a commercial digital insulator circuit that transfers the range control bits. An SEU event switches the nominal excitation current from 100 μA to either 10 μA or 1 μA (see Figure 5 a). A current one or two orders lower in magnitude result in a voltage (resistance) measurement reduced by the same proportion, yielding a completely wrong temperature measurement on the operator screens. Figure 5 b shows the temperature of an HTS lead when affected by the first ever SEU on this particular equipment, it provoked a beam dump because of a completely wrong temperature measurement at the interface between the High Temperature Superconductor (HTS) and copper conductors. On this particular event, once the “observed” temperature reached about 30 K, the cryogenic operation team gave the green light to apply current on the magnet in spite of an HTS material in the non-superconducting state. Such a SEU is potentially dangerous for the integrity of the equipment and fortunately the quench protection detection triggered the discharge of the circuit. This event was thoroughly investigated and, from then on, the signature of these events was well understood by the cryogenic operation. This type of SEU was consolidated during the 2011-2012 Christmas shutdown by placing electrical straps to force the current excitation to the nominal value. Since then, not a single SEU has been observed again.

FIGURE 5. SEU on insulated card. (a) Particle switches output on digital insulator of the “Range Controller” and (b) temperature trend for the actual lead temperature (solid line) and shown on operators screen (dashed line). The typical nominal temperature is 50 K as is the case before the SEU.

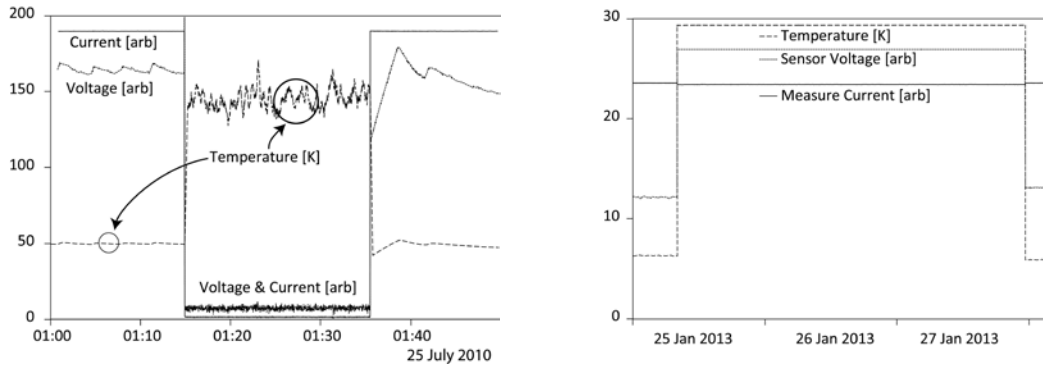
The intermittent loss of electrical connections is a recurrent effect observed for some LHC channels; it manifests either as a channel in error or as a “noisy” measurement often accompanied with an offset with respect to the expected value. This problem has already caused some beam dumps and many delays in permitting the powering of magnetic circuits because of the loss of appropriate cryogenic conditions. The loss of electrical continuity can be evaluated from the data transmitted by the field electronics that for resistive sensors include the excitation current amplitude and the associated sensor voltage; on the gateway [5] these values are used to calculate the sensor resistance and make the conversion into physical units. Figure 6 shows the opening of the excitation current (a) for a current lead 100 ohm platinum sensor; and of the sensing voltage terminals (b) for a cernox™ sensor installed in the

FIGURE 6. Effects of an intermittent loss of electrical continuity on the thermometer temperature (dashed line), excitation current (continuous line) and sensor voltage (dotted line). Intermittent opening of the (a) current and (b) sensor voltage terminals.

QRL. The opening of the excitation current loop is easily detected, in normal conditions the current amplitude has a narrow range of values and its opening sets a very low value; the control system was consolidated to set in error any channel with an abnormal excitation current value. During an intermittent opening of the current loop, the inferred temperature may look as correct and it is important to notify the cryogenic operator that the data is erroneous.

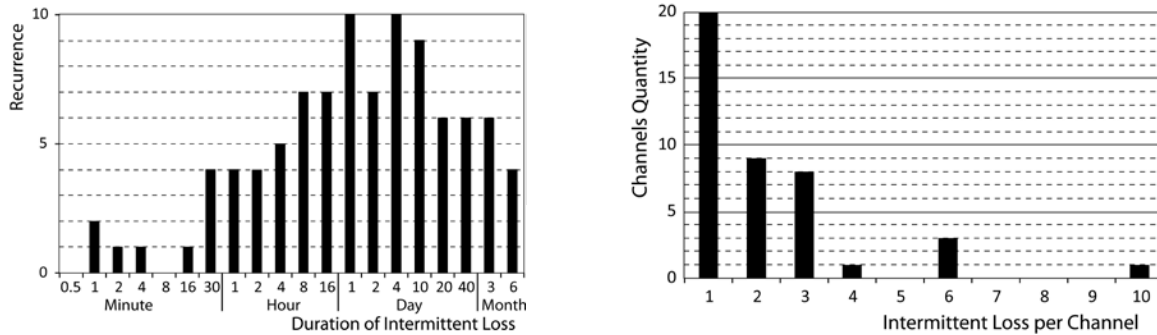
The duration of the intermittent loss of electrical connections is random and can vary from about half a minute up to half a year (see Figure 7 a); the sampling rate of the field electronics is 1 second and shorter perturbations cannot be detected. This effect has been observed in 42 channels; about half of them had 2 or more intermittent losses of electrical continuity (Figure 7 b). Most events last about a day; this is probably due to the typical repair delay when operation reports malfunctions on critical channels.

FIGURE 7. Statistics on the intermittent loss of electrical connections; (a) recurrence versus duration of the event and (b) quantity of channels with an intermittent loss versus the loss recurrence per channel.

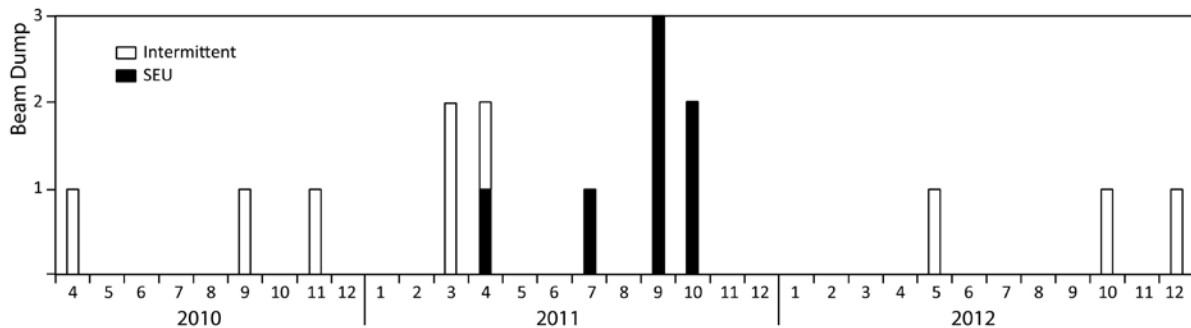
The most visible events are those that result in a beam dump and Figure 8 shows their monthly distribution since April 2010. The beam dumps are catalogued in various sources and 63 events are due to the cryogenic system that includes SEU on commercial components, cold-compressor faults, process instabilities, etc. For the field instrumentation malfunctions there are 16 dumps or 24% of the total accounted for the LHC cryogenics. About half of these dumps were caused by SEU and this type of event is consolidated since December 2011.

FIGURE 8. Quantity of beam dumps since 2010 caused by a malfunction on an instrumentation channel.
