Post-irradiation examination of a prototype tantalum-clad target for the Beam Dump Facility at CERN

The Beam Dump Facility (BDF) is a planned new fixed-target installation in CERN’s North Area that is expected to start operating by the end of the decade. A high-energy proton beam of 400 GeV/ c will be delivered in 1-s pulses of 4×10^{13} protons every 7.2 s, amounting to 4×10^{19} protons on target (PoT) per year and a resulting average thermal power deposition of 305 kW. The experiment requires high-Z and high-density target materials and involves challenging thermomechanical conditions; hence, a core made of refractory metals is proposed in conjunction with a water-cooling circuit. Since direct contact of water with the target materials—tungsten and a molybdenum-based alloy, TZM—would induce erosion and corrosion, the target blocks are clad with a tantalum alloy by means of hot isostatic pressing. To verify the reliability of the design and manufacturing process of the BDF target, a reduced-scale prototype target was manufactured and irradiated with an accumulated 2.4×10^{16} PoT in 2018. This paper presents the results and conclusions of the post-irradiation examination (PIE) c

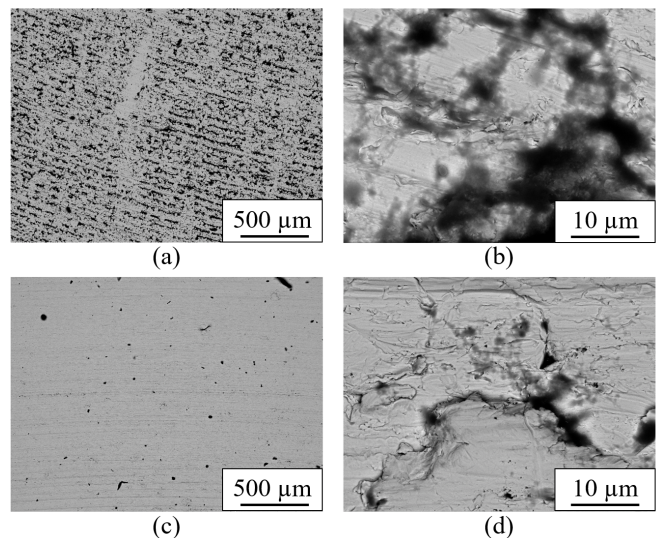
tions, or pores caused by the beam impact; however, the turning grooves in the central region were more strongly pronounced, and lubricant residue was detected. Examination of the discoloration in the center areas revealed that the previously observed orange-like color was caused only by the lighting used during dismantling, and dark gray was seen in the LOM images. Block 3 presented the strongest discoloration, and it was thus analyzed further. The deposit that was extracted from the discolored region using C-tape exhibited multiple elements, with no particular element being clearly prominent. The SEM images of the DS face of Block 3 (Fig. 7) show greater concentrations of deposits in the turning grooves, matching the surface topography. At a higher magnification, spots with a grayish-to-blackish color arranged in an irregular network were observed, and they were denser and more pronounced in the central region. Especially at surface irregularities such as separations, material overlaps, or scratches, dense deposits were detected in all regions. EDS analyses were performed, focusing on apparent spots that showed carbon and nitrogen as the main elements. Areas in the central and outer regions that exhibited no evident spots were also investigated. Using a low acceleration voltage of 5 kV, it was found that the area of

FIG. 7. Light optical microscopy images taken in the (a),(b) central region and (c),(d) outer area on the DS side of Block 3.

No relevant geometrical changes such as swelling, corrosion, cracks, separations, pores, or melting were observed in the Ta alloys; therefore, it was considered that both cladding materials—Ta and Ta2.5W—were reliable. The flat surfaces in the center region exhibited Ra values above the expected threshold and strongly pronounced turning grooves; this led to a higher level of carbon deposition in combination with the beam impact. It was suspected that this was caused by insufficient lubrication during the turning process after HIPing. In addition, lubricant residue was observed, which can cause local heating and increase the carbon concentration. As carbon deposition on the target blocks is undesirable, it is recommended that the surface roughness in the center should be decreased and the cleaning process of the blocks should be improved.

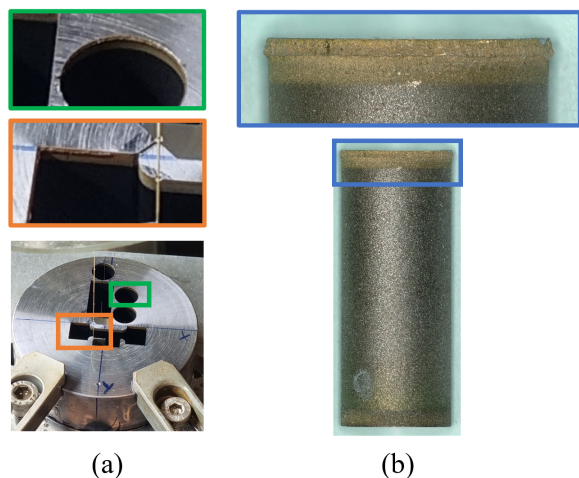
FIG. 9. Burrs detected on the upper side of (a) Block A and (b) the thermal-diffusivity cylinder after the first cutting step.

During the specimen extraction, the EDM wire consistently fractured and needed to be re-fed continuously during the first separation cuts from the blocks. The morphology of the W surface after EDM cutting showed intergranular separations and areas with detached W grains. In addition, the tensile specimen 14T3 and the shear specimen 14S2 fractured during their final EDM cutting steps before testing. The fracture of 14T3 appeared close to the interface on the DS side. During the first cutting steps, deformations inside the cladding bulk material were detected (see Fig. 9). This behavior was only observed sporadically on the upper block sides that had first contact with the water jet.

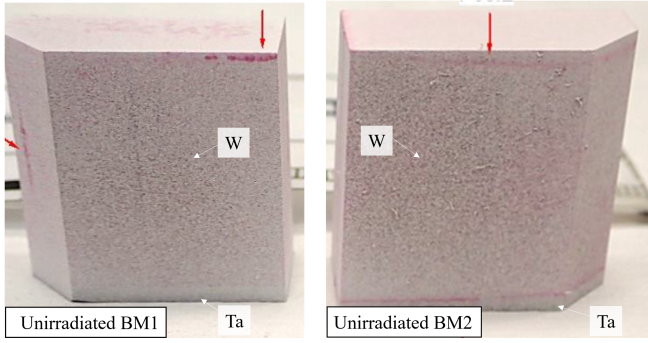
that all the cracks observed in 14M1, BM1, and BM2 were superficial.

FIG. 16. Dye penetrant testing performed on the unirradiated samples BM1 and BM2.

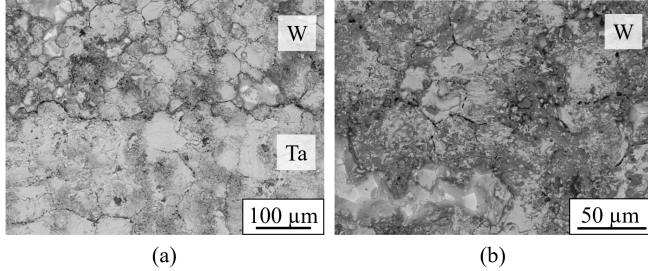
FIG. 17. SEM images of cracks found in the unpolished specimen BM2 (a) at the interface and (b) in the core close to a cutting edge.

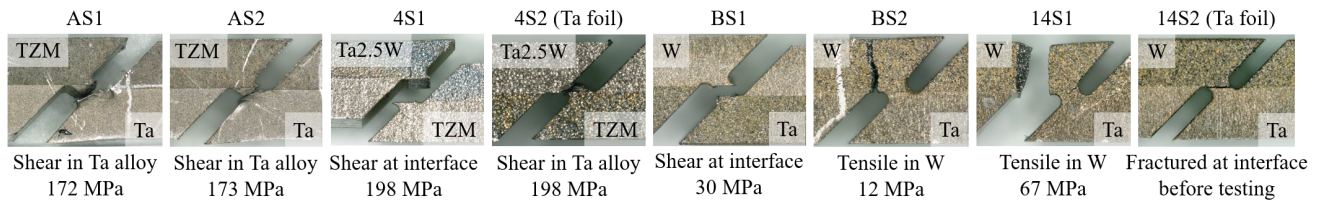
During the shear-specimen testing, different types of fracture were observed, such as tensile fractures in the W and shear fractures in the cladding material or at the interface (see Fig. 18). The reported stresses were calculated with an interface area of $1.0 \times 3.6 \text{ mm}^2$ for each specimen. For the TZM core materials, the extension to fracture was in the range 80–750 μm, with the unirradiated samples (AS1 and AS2) failing at higher strain values than the irradiated ones (4S1 and 4S2). Sample 4S1 showed the lowest overall strain and presented the only shear fracture at the interface, while the other three [AS1, AS2, and 4S2 (Ta foil)] failed in the Ta alloy close to the interface. All W shear specimens exhibited very low extension to their fracture values (<10 μm). Two specimens (BS2 and 14S1) displayed tensile fractures in the W bulk material far away from the interface region: BS1 had a shear fracture at the interface, and 14S2 fractured at the interface during the final EDM cutting step (before testing).

FIG. 18. Fractures of the shear specimens after testing with each fracture type, position, and breaking strength at 22 °C.

The shear specimens that did not fracture at the interface presented higher interface strengths than the fractured bulk materials (see Fig. 18). The breaking strength of the shear fractures that occurred in the Ta cladding (AS1 and AS2) were slightly above the previously derived USS of Ta (150 MPa). Samples 4S1 (shear fracture at the interface) and 4S2 (Ta foil; shear fracture in the cladding close to the interface) had the same breaking strength (198 MPa) despite presenting different fracture types. Sample 4S1 exhibited a secondary crack inside the Ta2.5W cladding, and both values were close to the previously calculated USS of Ta2.5W (215 MPa). Hence, good diffusion bonding was observed in all TZM shear specimens due to their high interface strengths.

The conclusions for the W shear specimens were not as clear (see Fig. 18). Half of the specimens (BS2 and 14S1) showed tensile fracture in the W bulk material far away

from the interface, indicating interface strengths greater than that of W; however, at 12 and 67 MPa, the breaking strengths were unexpectedly low, as the expected UTS of W was 181 MPa [24]. The other two samples (BS1 and 14S2) fractured at the interface, and 14S2 (Ta foil) broke during the final cutting step. The fracture surfaces of BS1 and 14S2 were similar, as two fracture regions were distinguishable; this was not observed in the TZM sample 4S1 (see Fig. 20). It was assumed that patches without diffusion bonding were present in the W samples, causing premature fracture at lower interface strength if the location of these patches correlated with the small interface area of the shear specimens ($1.0 \times 3.6 \text{ mm}^2$). These observations were independent of beam-induced stresses or the presence of Ta foil.

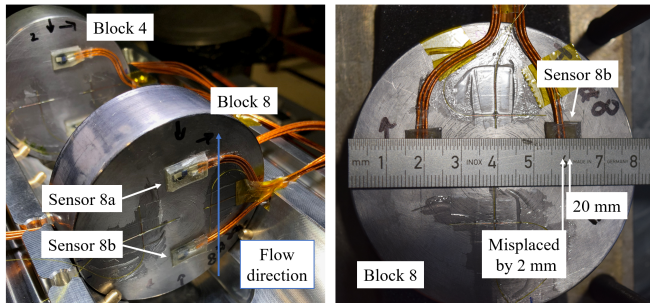
FIG. 19. Temperature instrumentation installed on Block 8 before irradiation.

During the operation of the prototype BDF target, increased temperatures were measured by one of the sensors attached to Block 8. The PIE did not result in any findings for Block 8 that could explain the behavior of Sensor 8b (see Fig. 19); however, upon examination of past data from the target instrumentation, some observations stand out. Sensor 8b was placed in the only water channel that had temperature sensors on both sides (US and DS). In general, the water channels had a width of only 5 mm, and the temperature sensor on the opposite side to Sensor 8b failed during operation. The flow of the cooling water started from Block 1 and passed sensors 8b and 9b of blocks 8 and 9 first; this could have resulted in a small amount of turbulence due to the sudden change of flow. The sensor was constantly attached to the block, because no noise was measured and its temperature reading showed an appropriate reaction to the pulse-cycle time. It was determined that no cavities were present in the cover agent because the base temperature was not increasing. The heating ramps observed during impacts correlated with those from the other three sensors in the same water channel, but the cooling rate measured by Sensor 8b did not match those of the other sensors.

None of the findings from this study can explain the elevated temperature measured by Sensor 8b (see Fig. 19). In summary, this sensor did not malfunction, the temperature curve measured during beam impact behaved correctly, and the values were physically realistic; however, the cooling rate seemed to be compromised. It is possible that impairment of the cooling rate could have been caused by a thicker layer of cover agent or by compromised water flow due to the presence of sensors on both sides of the water channel. In addition, Sensor 8b was placed slightly closer to the beam-impact location than intended, and the beam was offset toward the sensor. For future instrumentation, it is recommended that temperature sensors should only be installed on one side of a water channel.
