BY MARK LACAGNINA

EMS Control Loss

Investigators were unable to determine why a loss of control occurred during an emergency medical services (EMS) flight the night of Dec. 14, 2004, in Apache Junction, Arizona, U.S. The final report by the U.S. National Transportation Safety Board (NTSB), issued in late April 2007, discussed four previous control system discrepancies encountered by pilots of the Eurocopter AS 350B3 and a phenomenon called “hydraulic servo transparency.”¹ However, the report contained no analysis of the findings of the investigation.

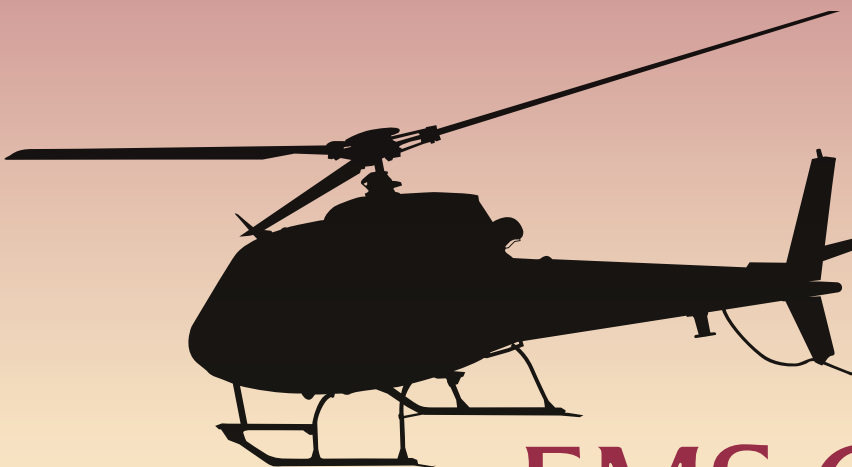
During final approach, the AS 350B3 pilot could not move the cyclic.
