STS-1 Orbiter Final Mission Report

August 1981

National Aeronautics and
Space Administration

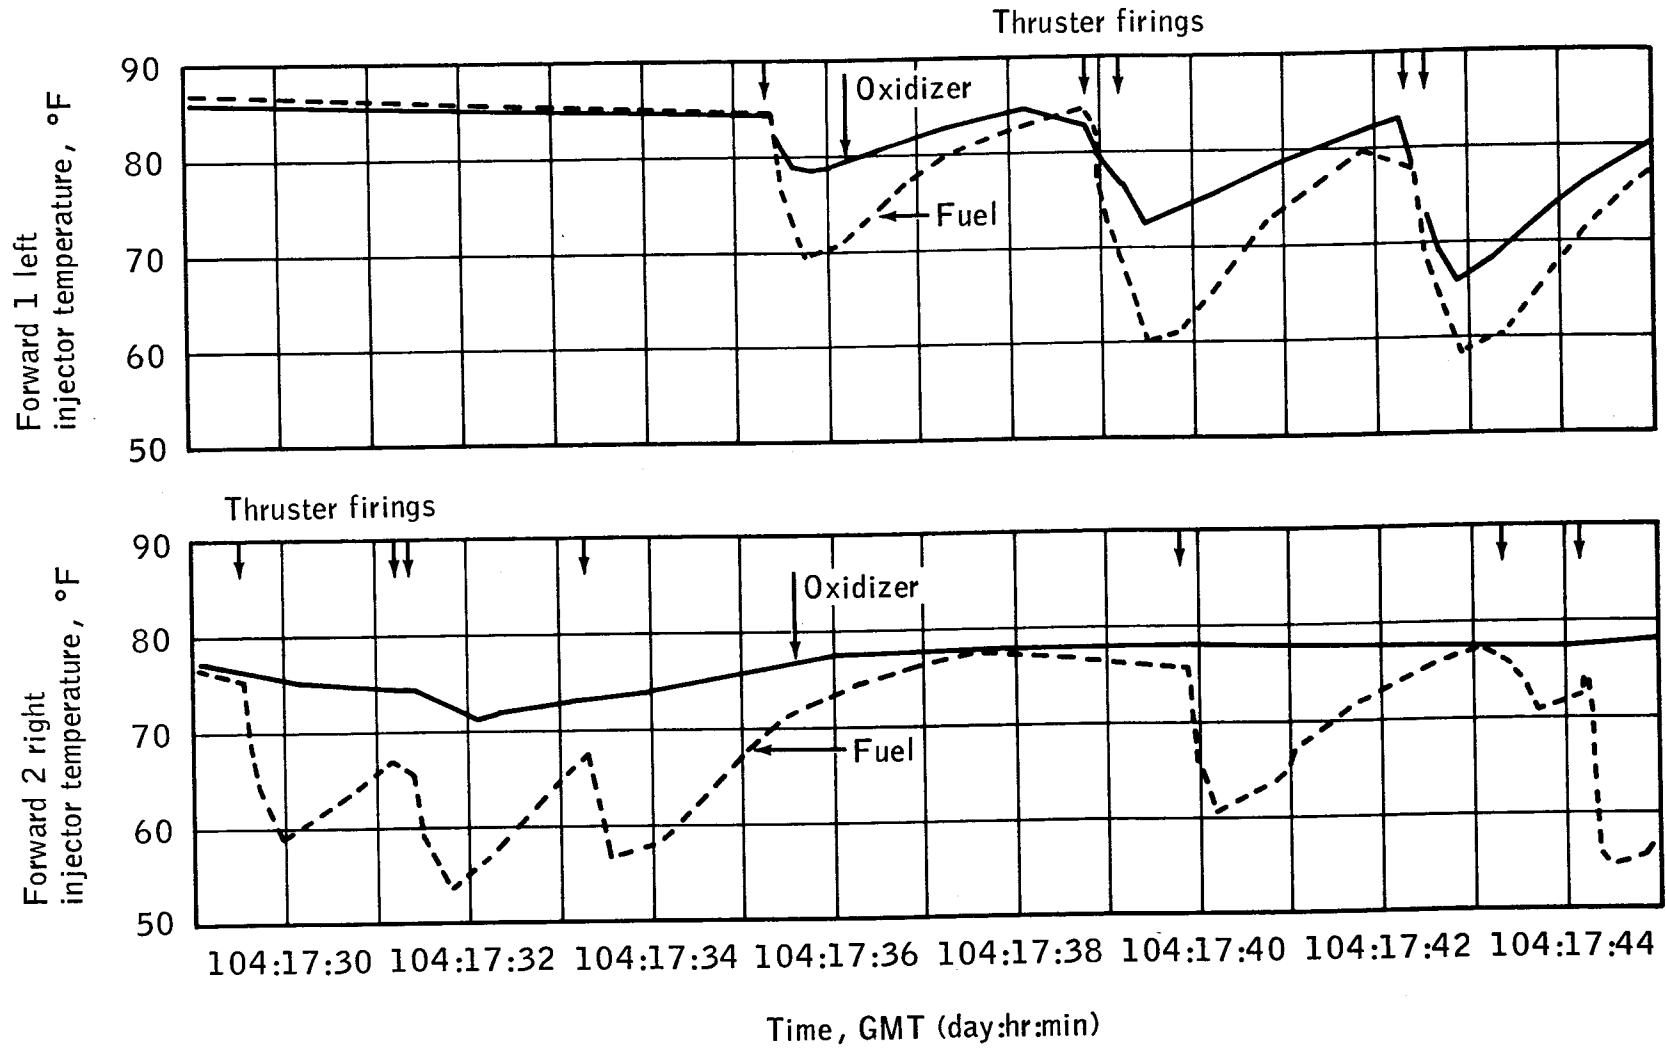
The oxidizer leak detector on thruster forward 2 right (F2R) did not track the transient evaporation cooldown that occurred on the fuel leak detector. An apparent thermal open exists between the oxidizer leak detector and the injector tube, and, therefore, a large thermal lag exists between the tube temperature and what the leak detector senses (fig. 2-4). See section 8.0, flight test problem report 50, for a discussion of this anomaly.

Figure 2-4.- Oxidizer leak detector - injector tube thermal log data.

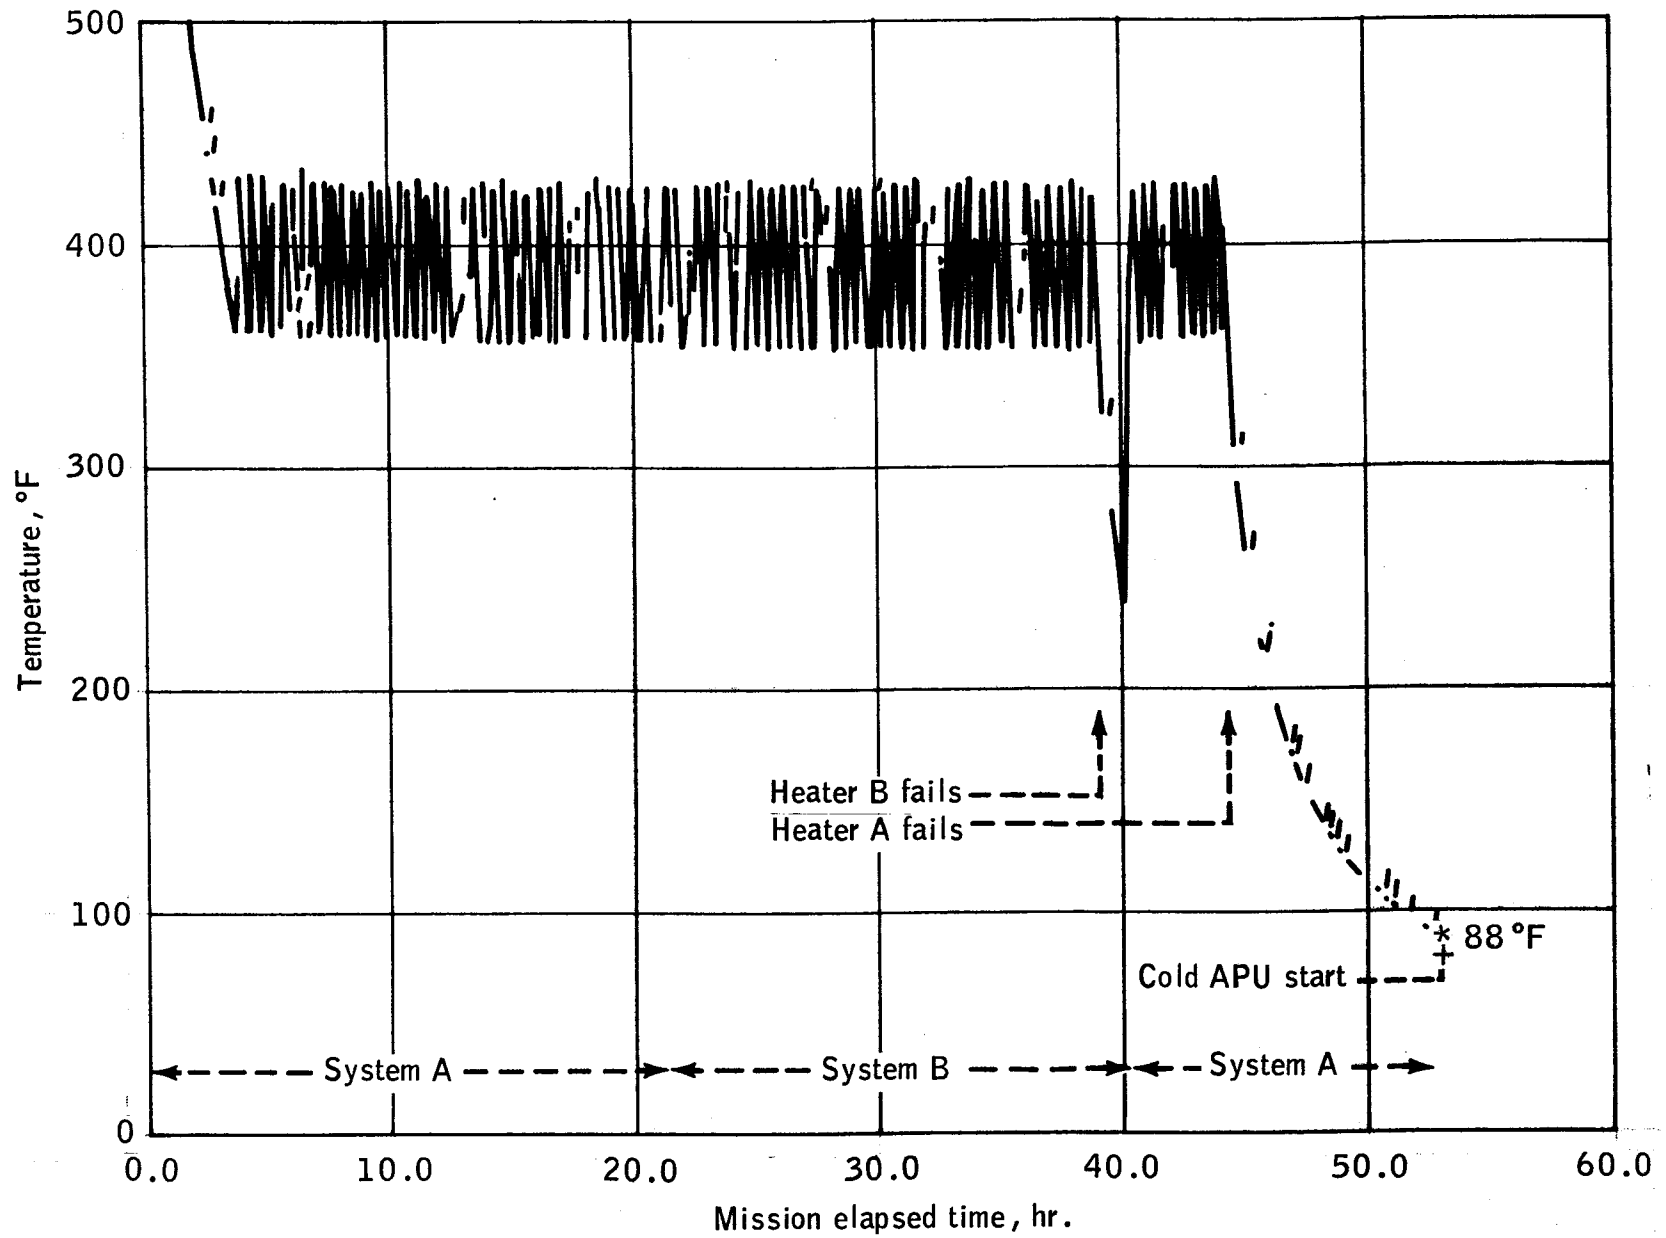
Failures occurred in both of the APU 2 gas generator heaters. Both failures occurred late in the mission, as shown in figure 2-5 (see section 8.0, flight test problem report 19). The fuel pump and valve temperatures were 75° to 80° F, and the gas generator temperature was 88° F at APU start. The cool gas generator temperature necessitated a "start override" start of APU 2, and this initiated 209 sec of injector cooling before starting. APU 2 started within 4 sec after the cooling cycle was completed.

Figure 2-5.- APU gas generator heater failures

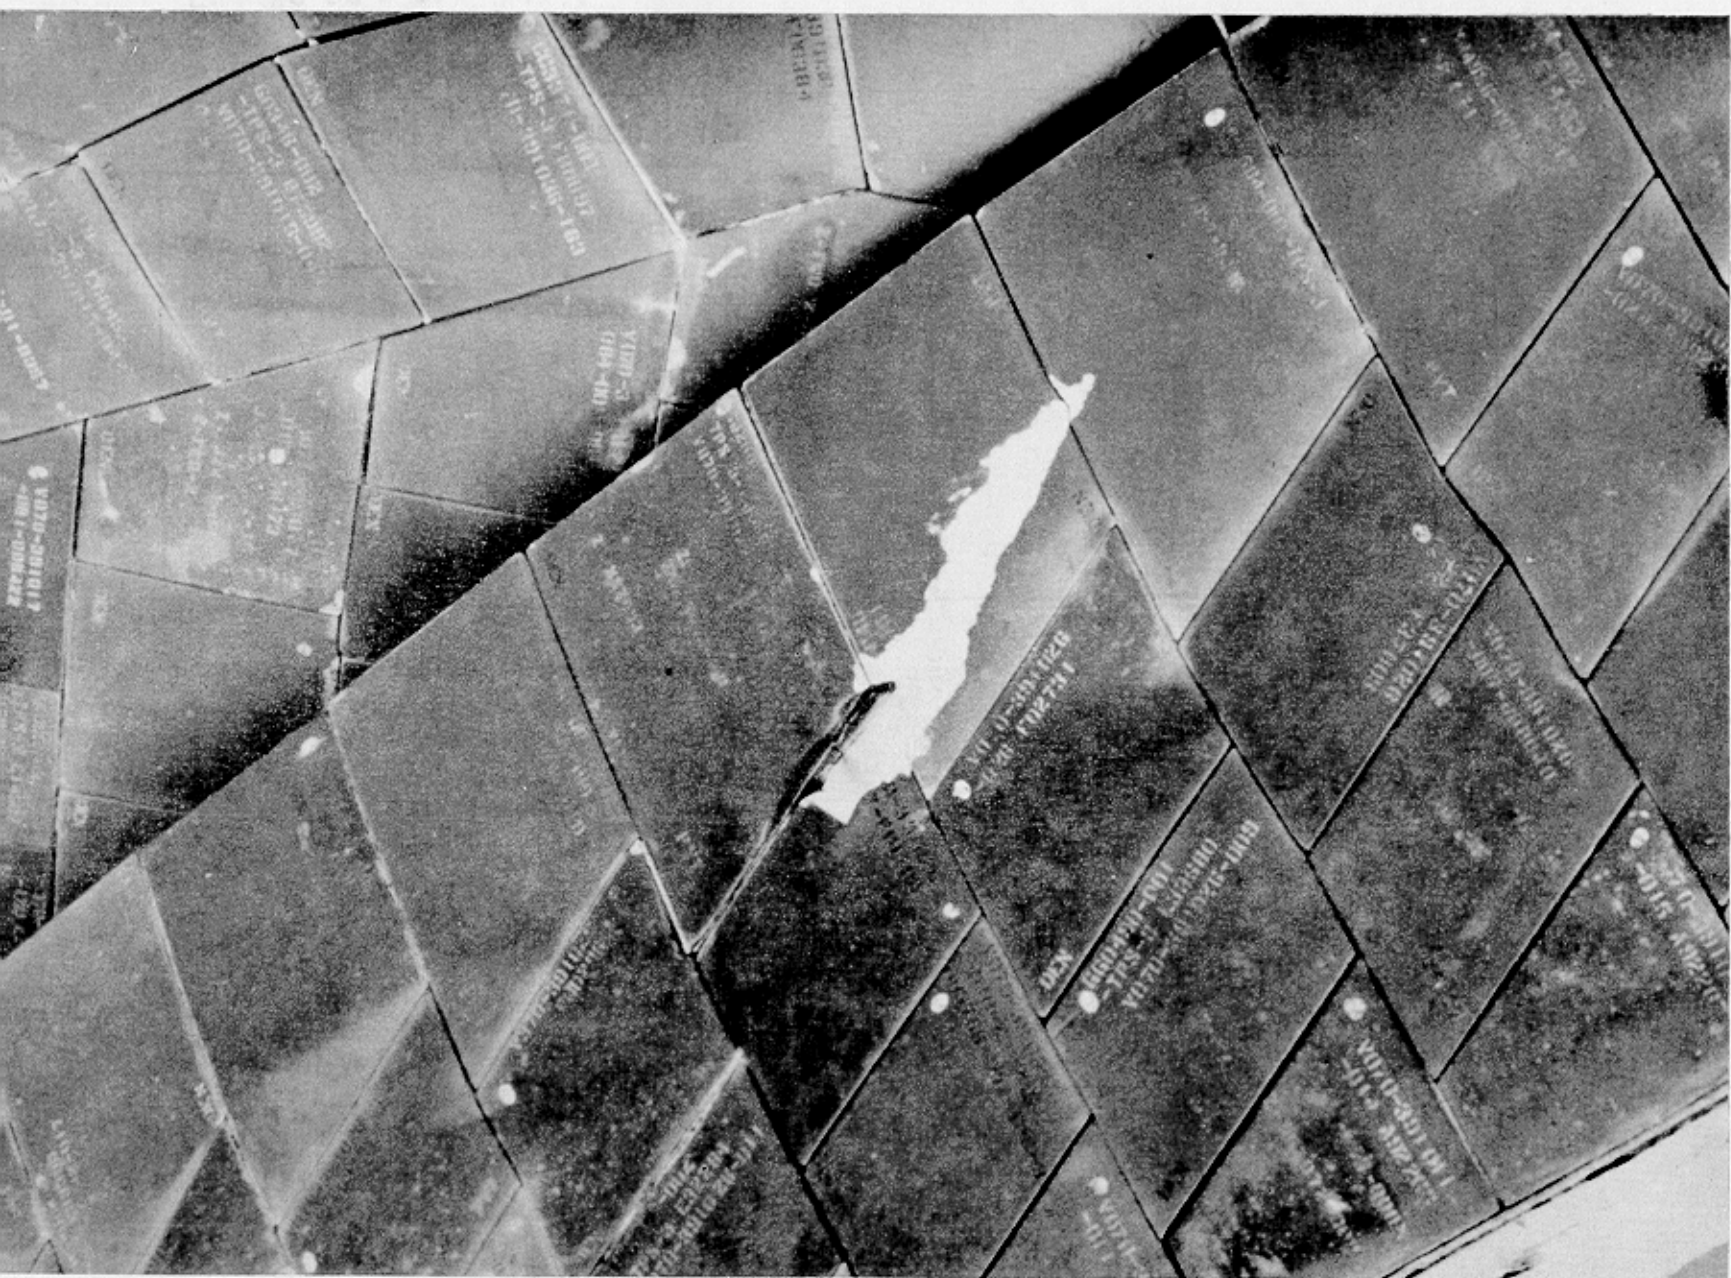
Figure 2-21.- Thermal damage to right nose landing gear door.

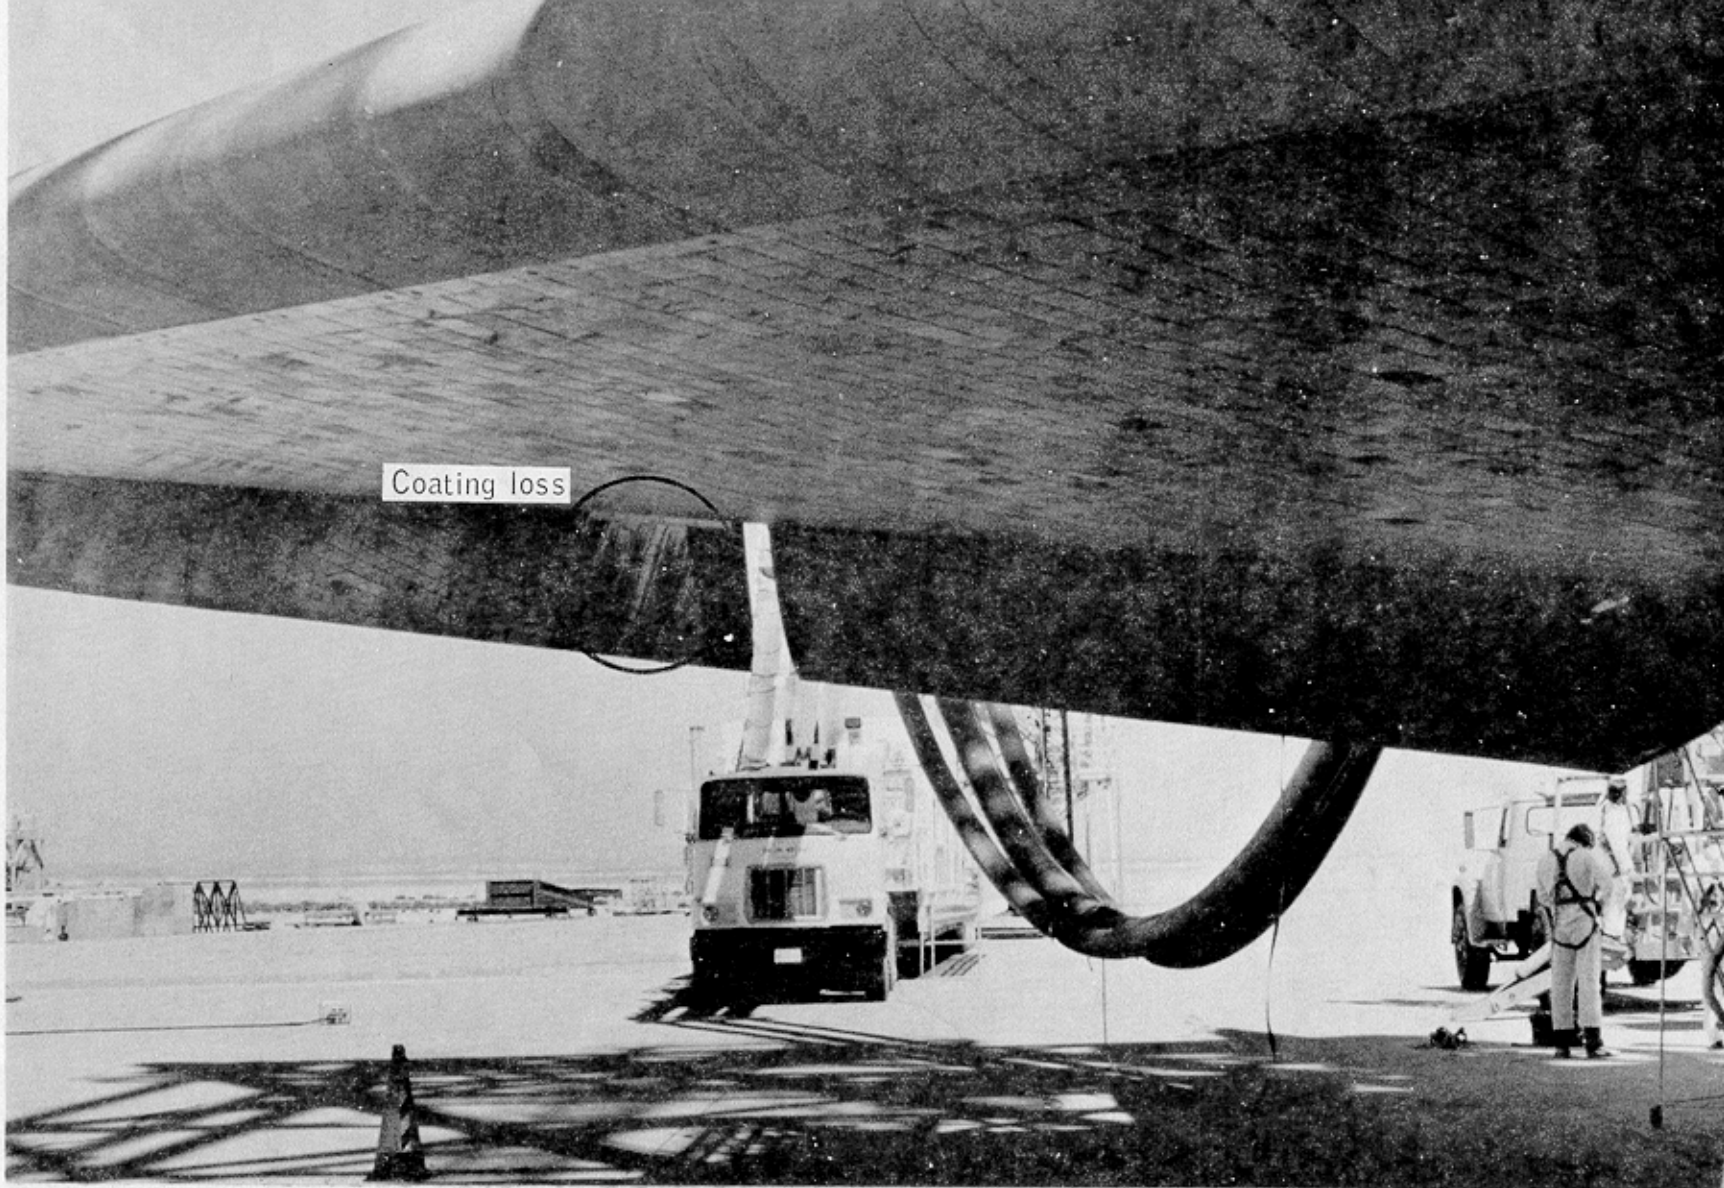
Figure 2-22.- Coating loss on lower surface of right inboard elevon.

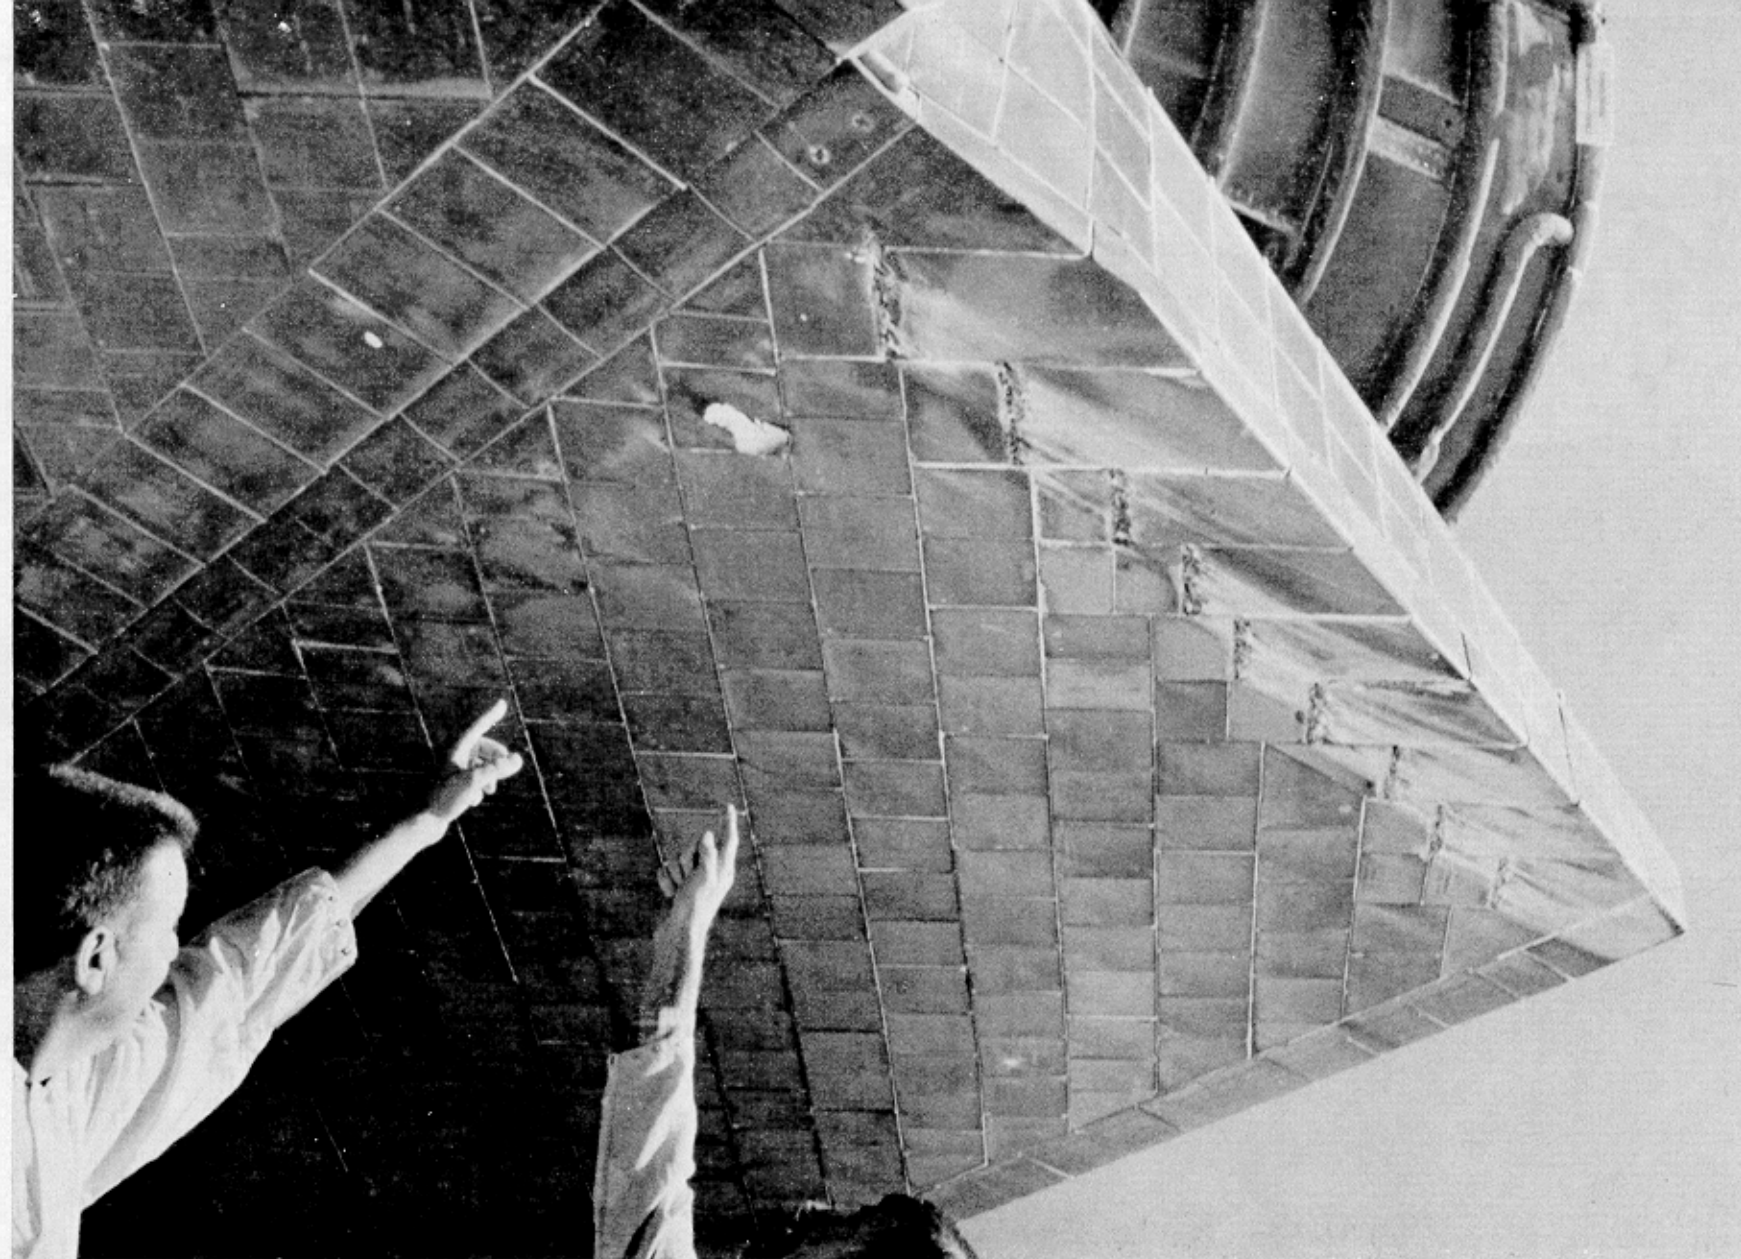
Figure 2-23.- Impact damage to left lower forward region of body flap.

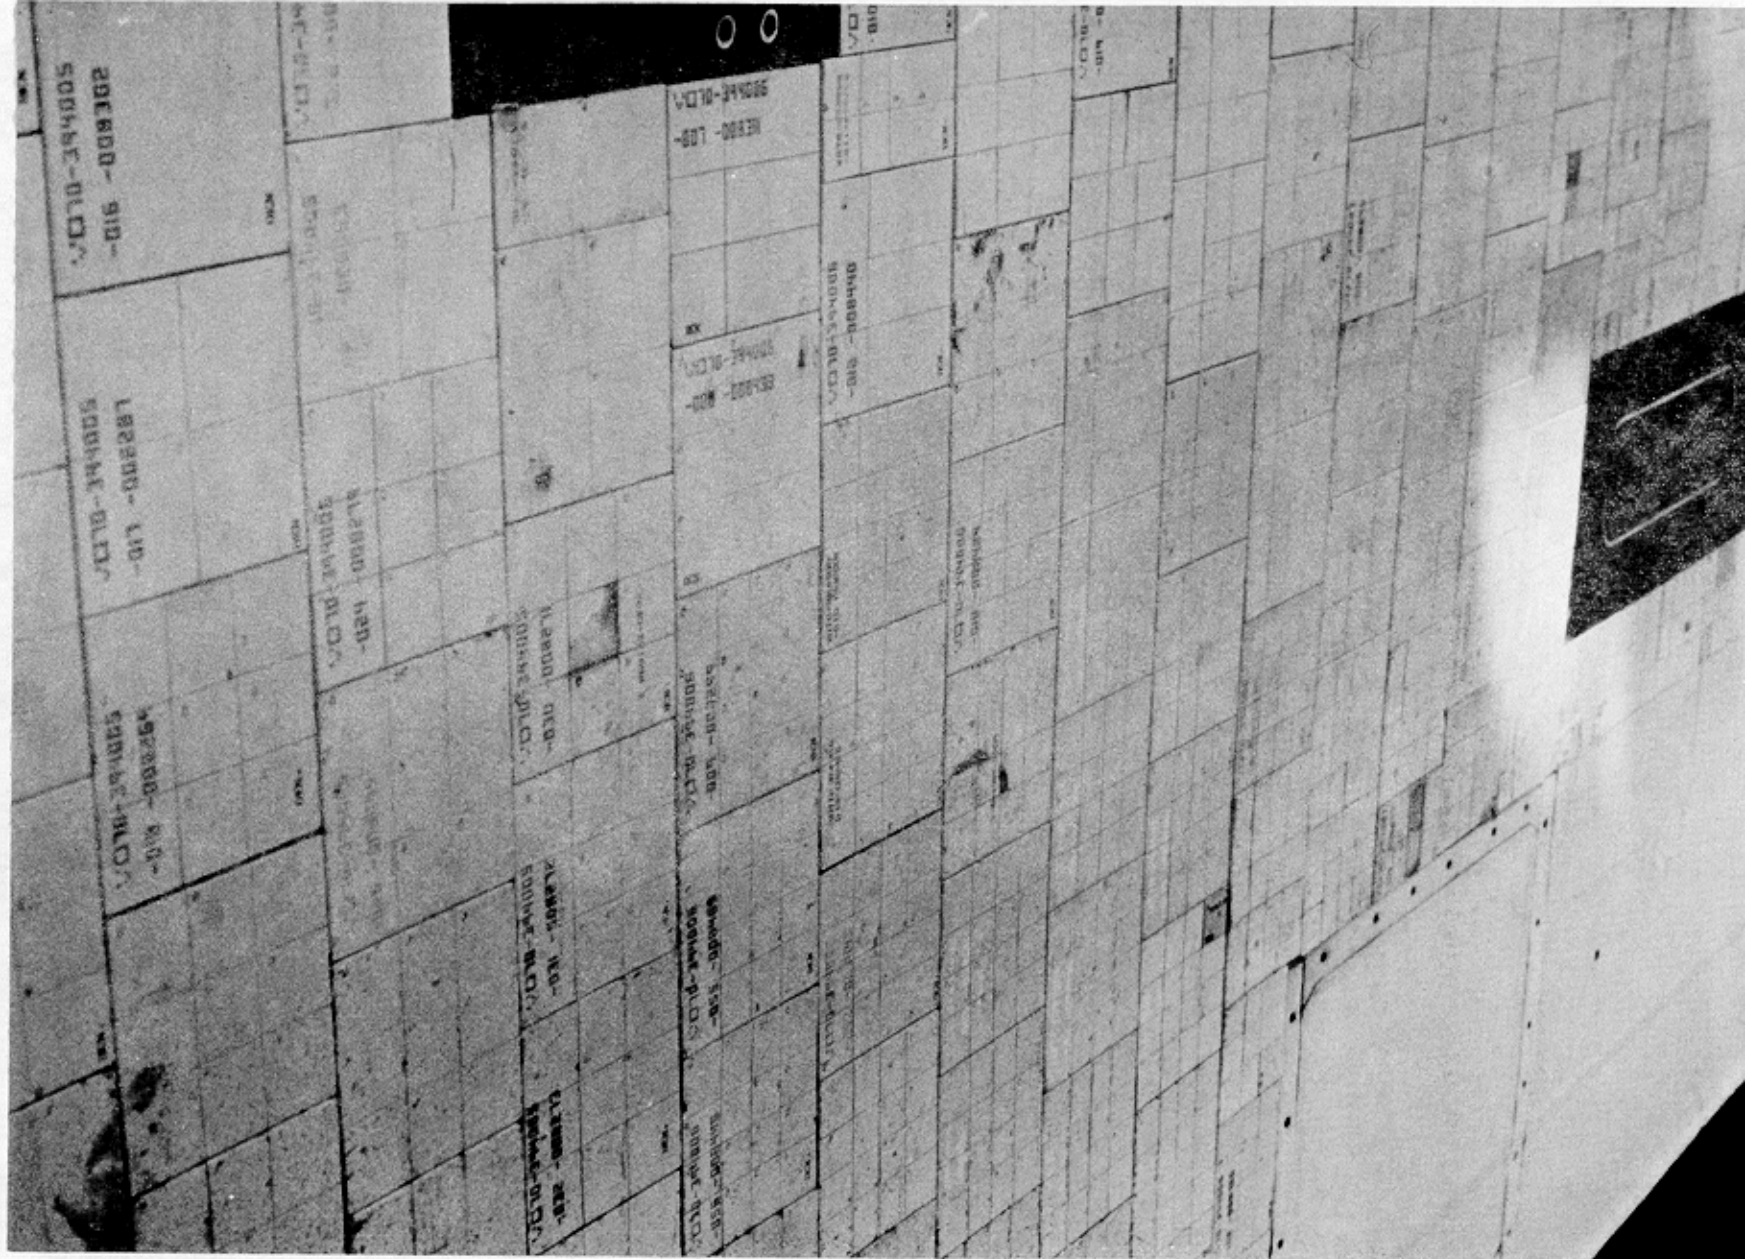
Figure 2-24.- Coating loss caused by unknown contaminant.

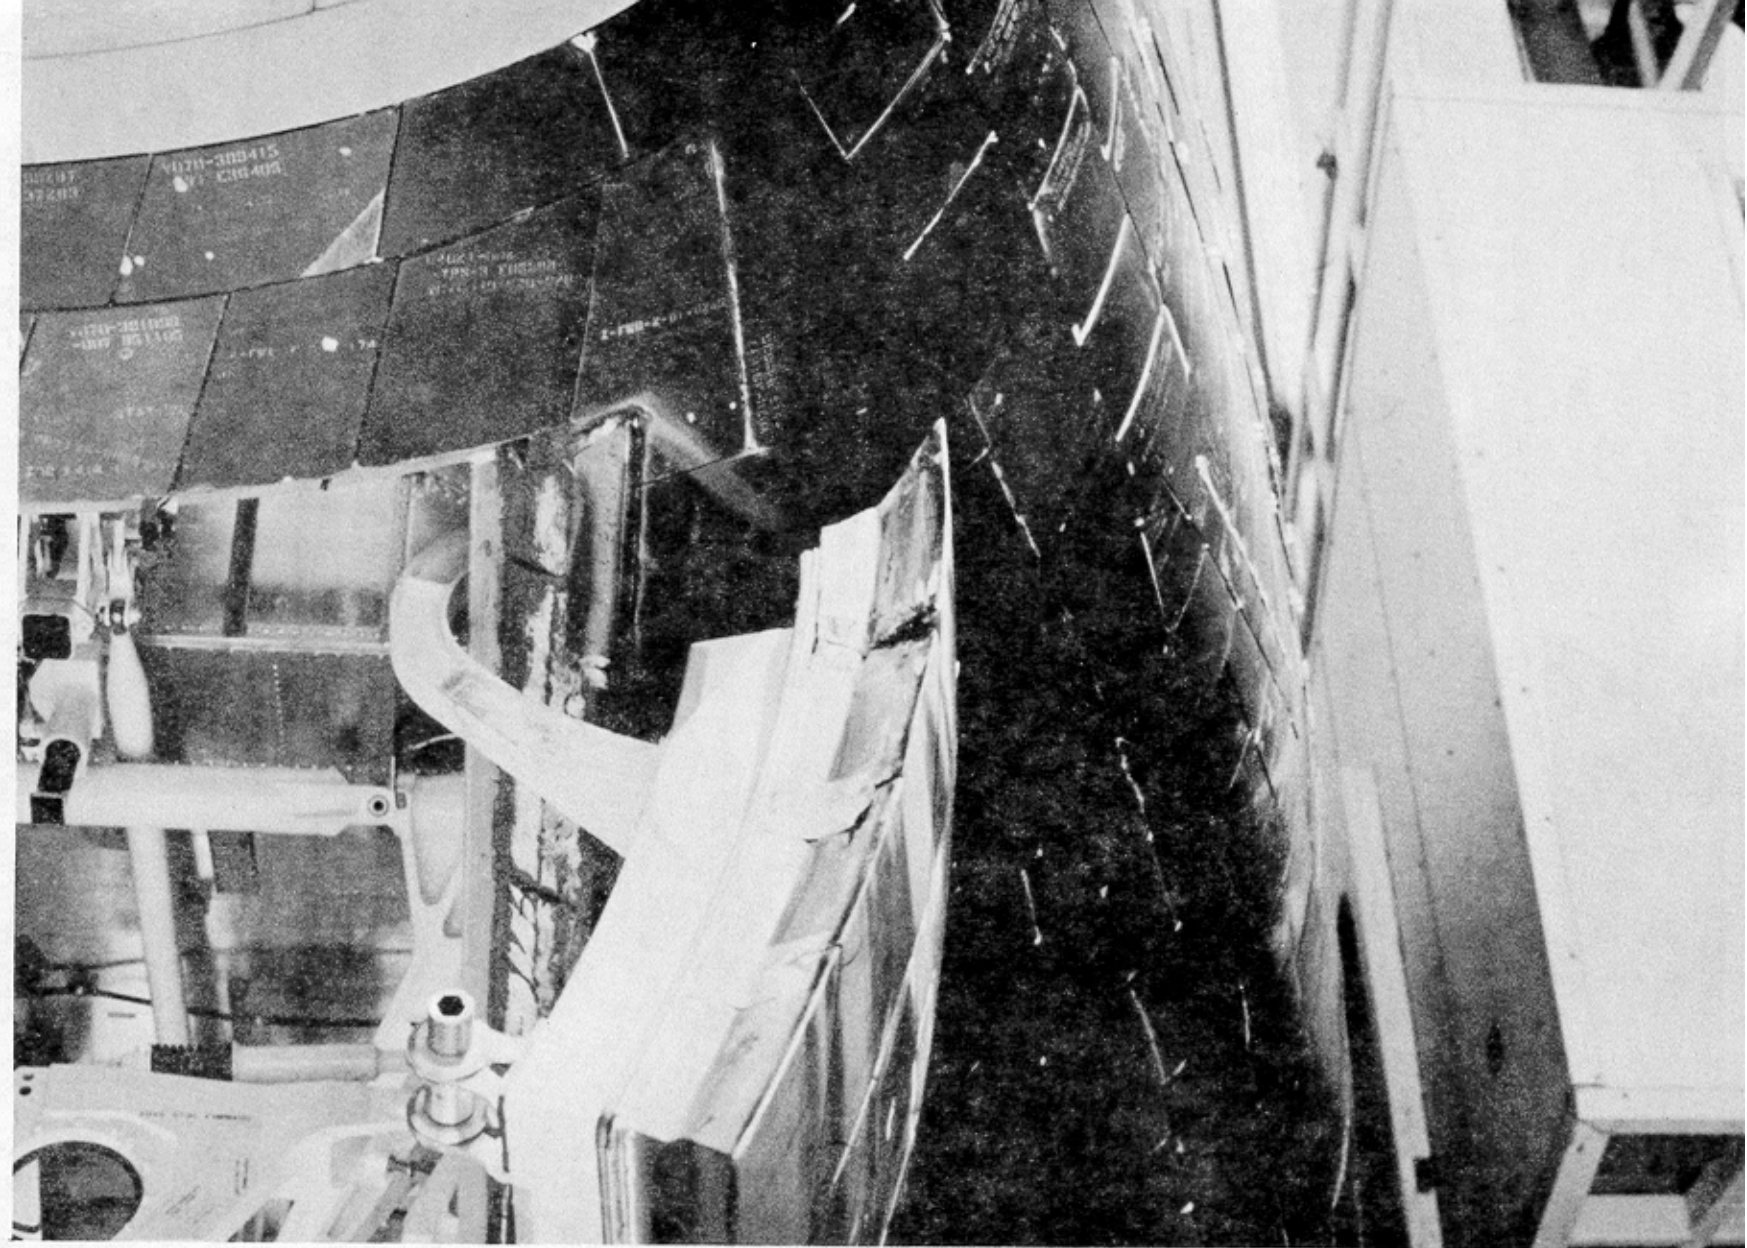
Figure 2-25.- Breaching of thermal barrier on leading edge of left nose gear door.

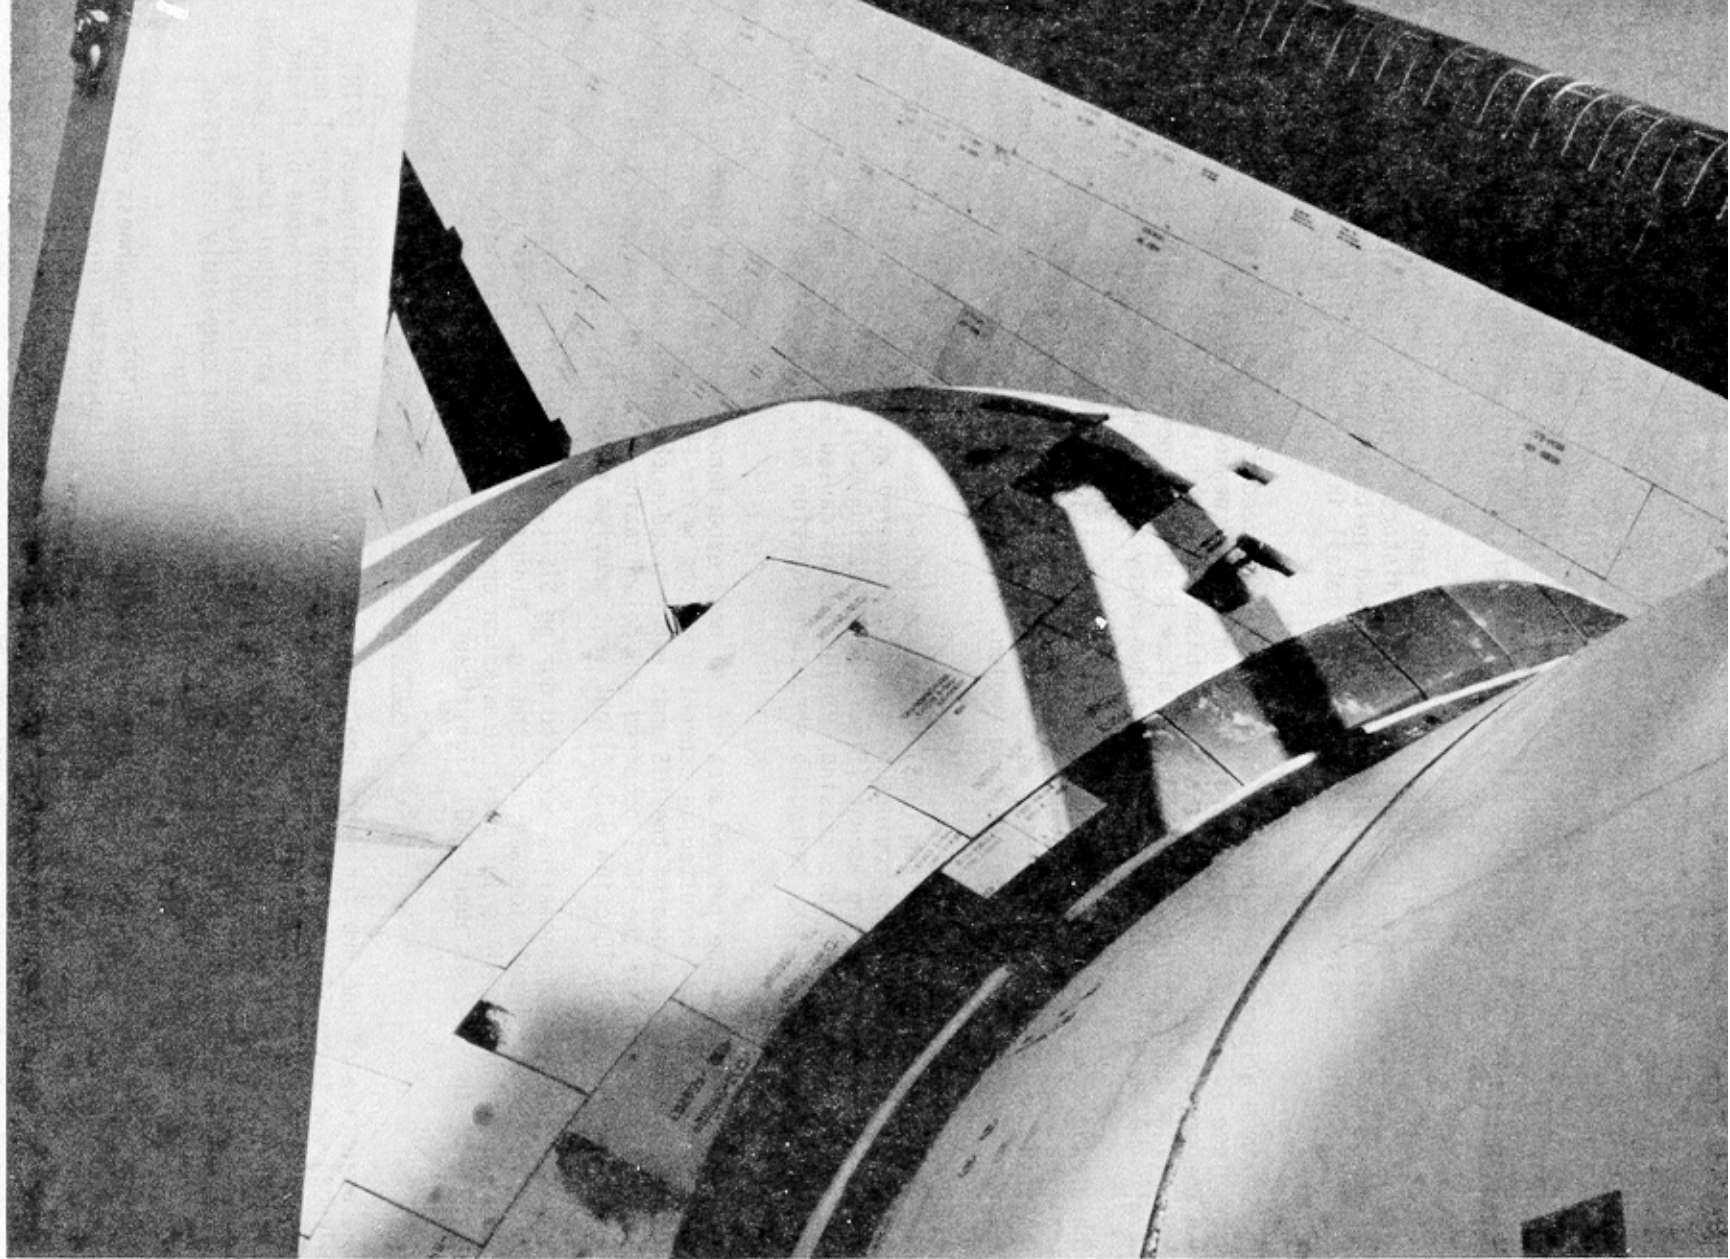
Figure 2-26.- Areas of lost tile on right OMS pod.

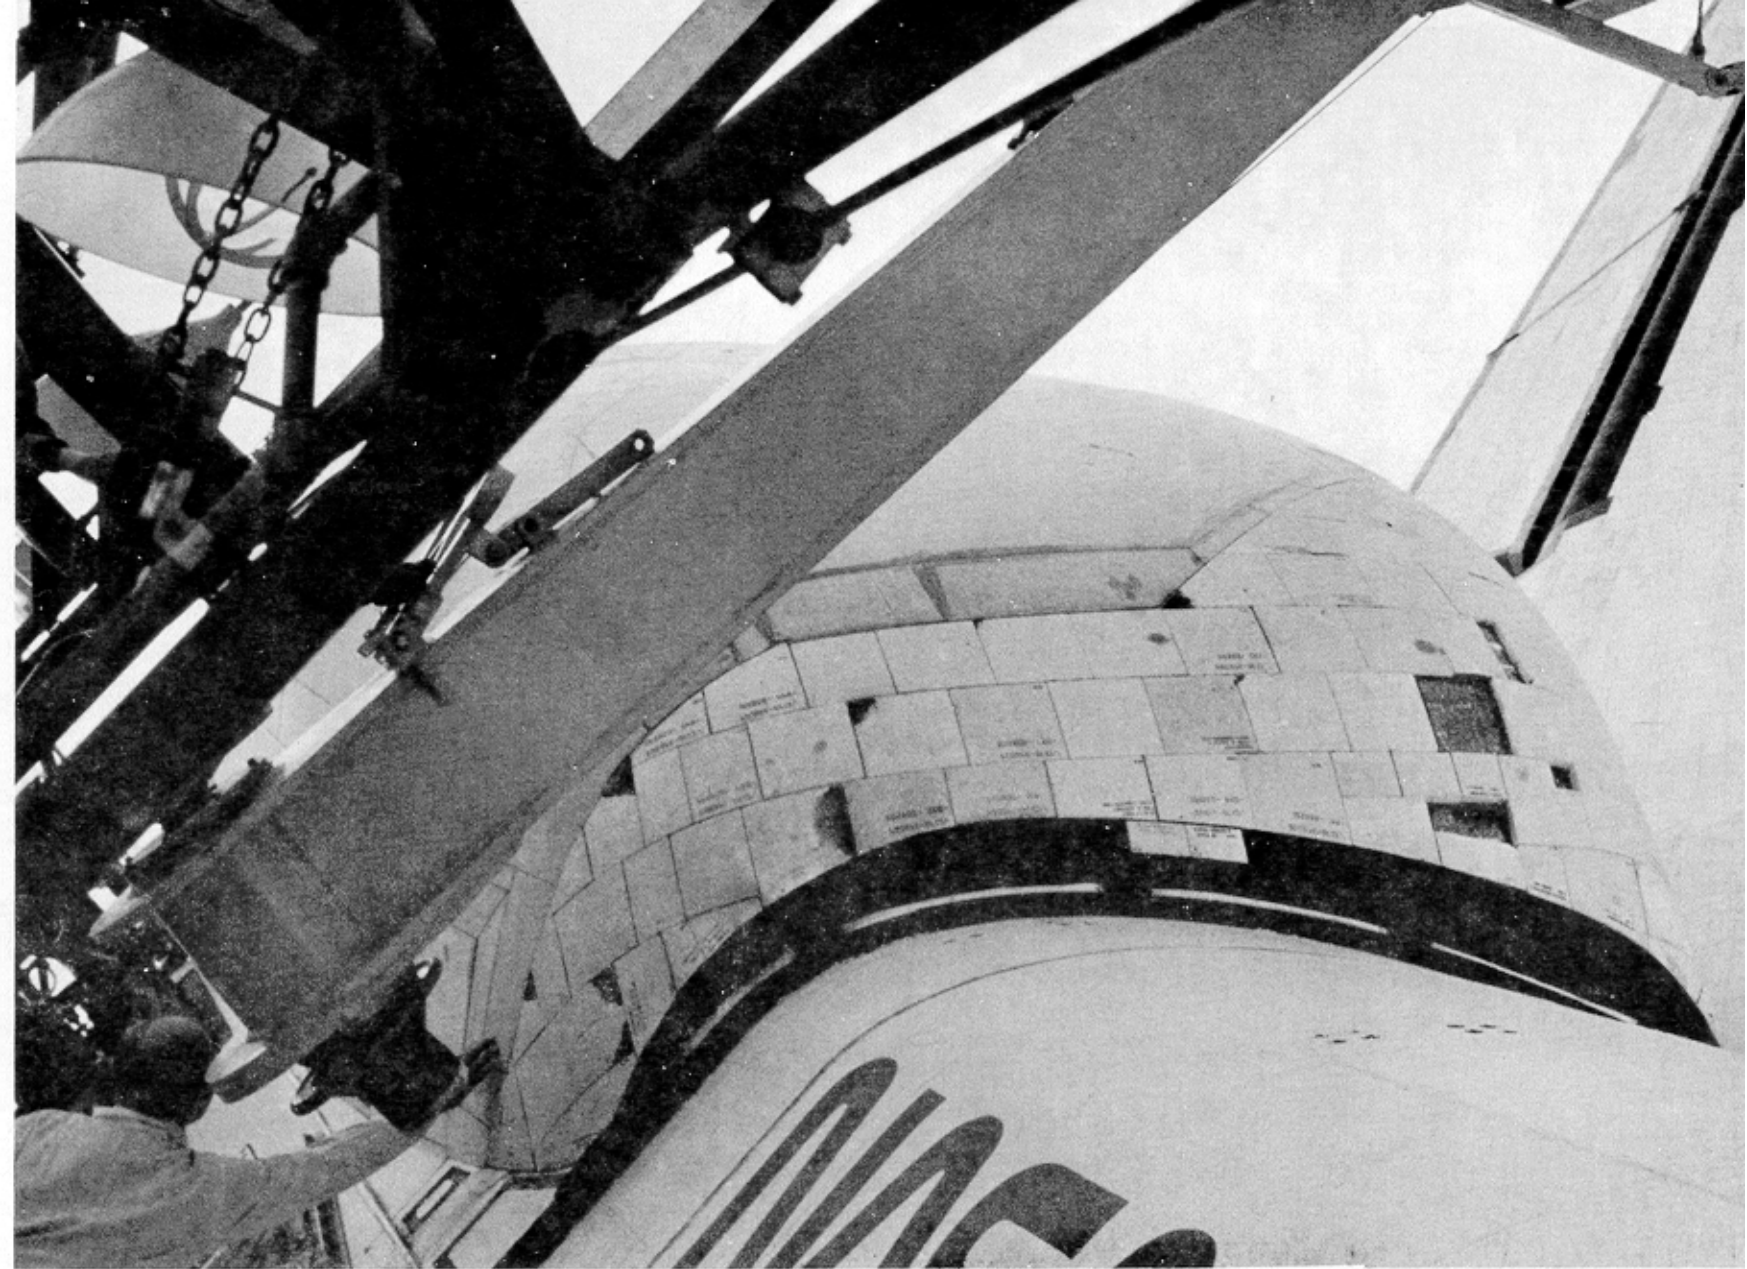
Figure 2-27.- Scorching of tile on forward edge of OMS pod.

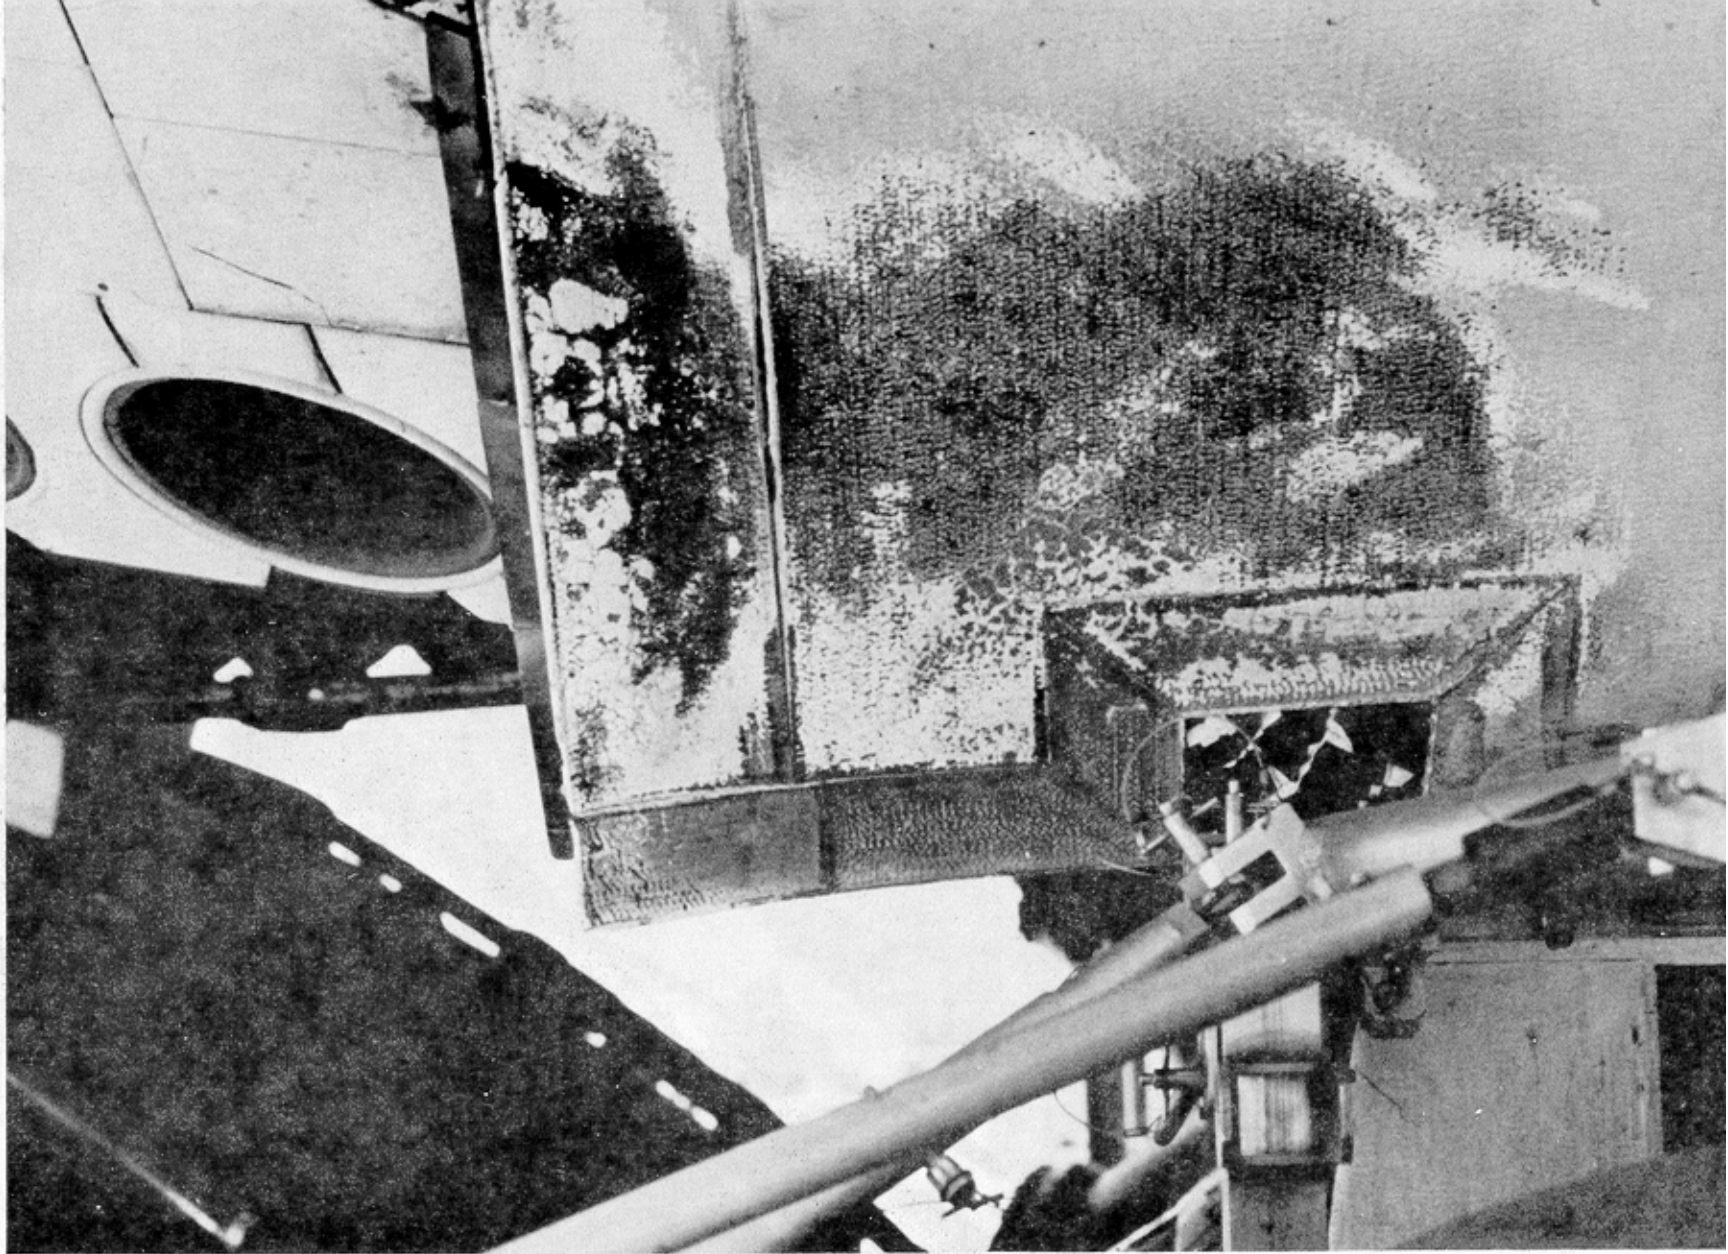
Figure 2-28.- Delamination of OMS pod structure.
