Lessons Learned from Waldo Canyon

FIRE ADAPTED COMMUNITIES
MITIGATION ASSESSMENT TEAM FINDINGS

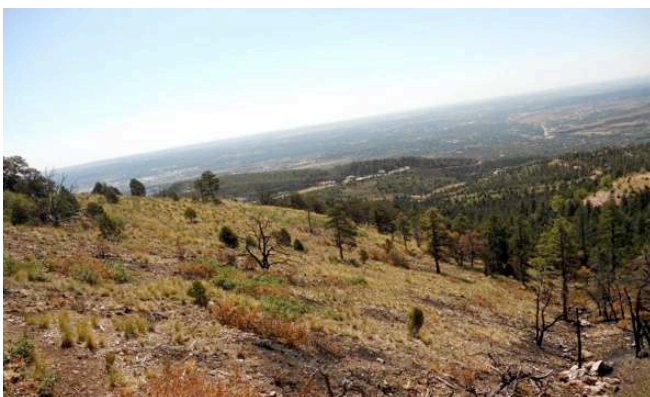
In places where there had been a continuous layer of dry, shrubby fuels (decadent Gambel oak), the treatment broke the layer into clumps (Figure 1).

Figure 1: Solitude Park parcel dominated by Gambel oak, where the results of the fuel treatment by breaking up a continuous layer of shrubby fuels, are still obvious. The Waldo Canyon Fire spread to this treated area. It was extinguished before it spread to homes. Source: USDA Forest Service.

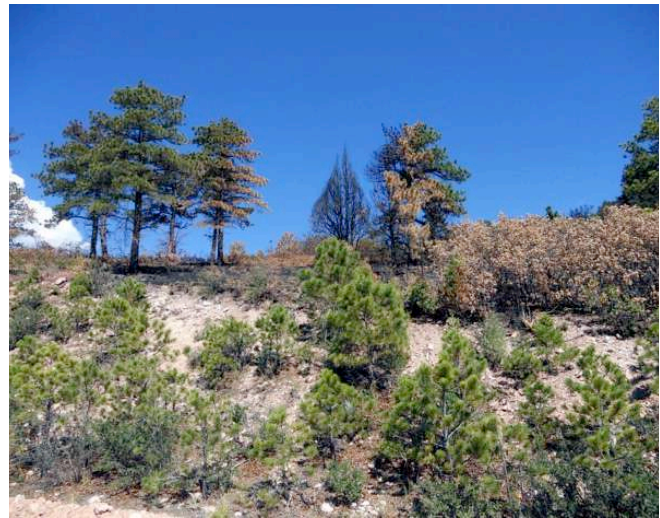
Figure 2: The wildfire stopped or was extinguished in the middle of this treated area. Source: USDA Forest Service.

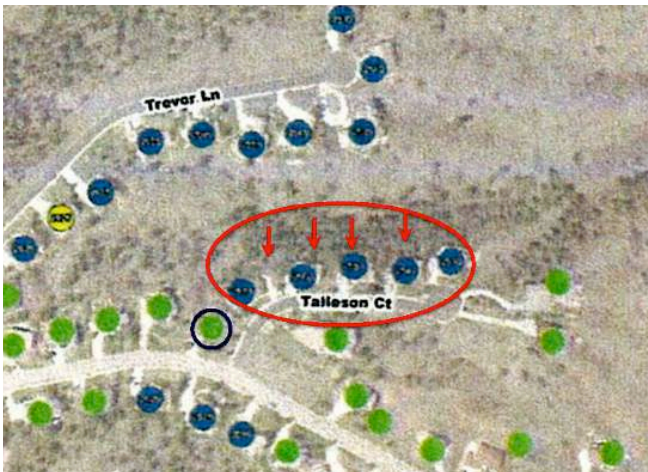
Figure 5: Five homes on Talleson Court were destroyed (red circled). These homes were located at the top of a slope and each had overhanging decks. One home suffered minor damage (blue circled).

first igniting a wooded area within the community with a subsequent direct flame contact exposure to the home (Figure 5). These homes were located at the top of a steep slope (> 30%) and were rated as being in an “extreme” hazard zone by the Colorado Springs Division of the Fire Marshal.

Mitigation strategies for this threat would include thinning trees and removing ladder fuels. Building a cross-slope retaining wall using noncombustible materials down-slope from the homes could also be an effective strategy for shorter brush-type vegetation⁴. However, this would not work in a wooded area with taller trees since a crown fire would burn over top a typical retaining wall. This mitigation strategy is an example of where a communitywide effort would produce the most effective results.

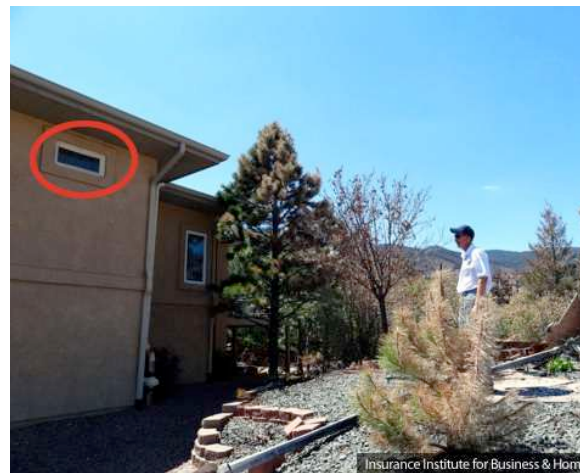
Figure 7: This damaged Talleson Court home was approximately 30 feet from a destroyed home. Two windows were damaged (one is circled in red; another window of the same size is located to the left of the one shown). The tall pine tree had lower branches removed and noncombustible gravel was used within approximately 10 feet from the house. Note the scorch on the destroyed home side of the pine tree and small tree in the foreground. Source: IBHS.

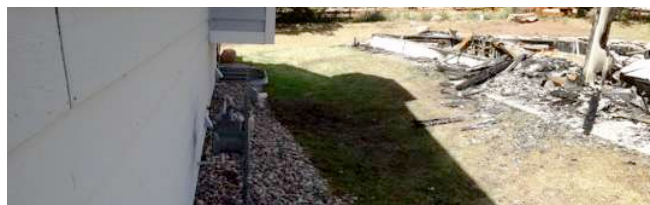
Figure 11: The distance between the destroyed home on the left and the damaged home on the right was approximately 16 feet. Source: IBHS.

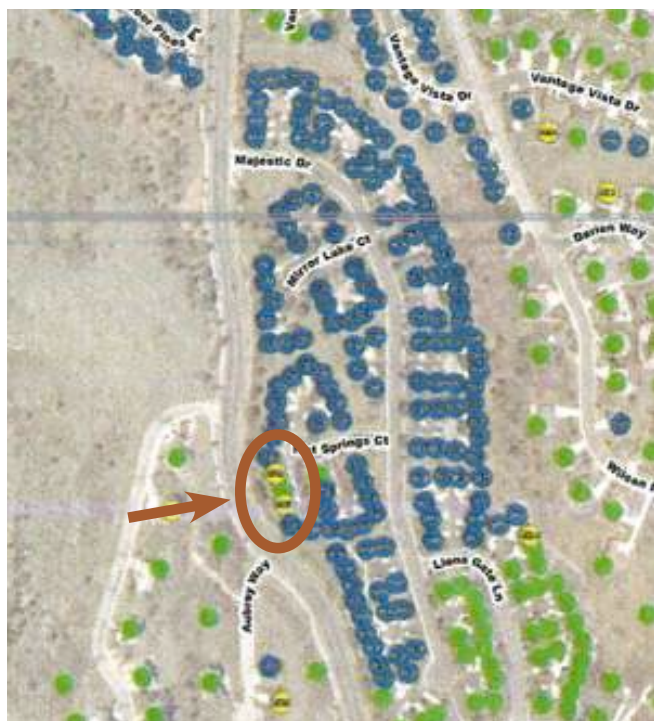
Figure 10: Majestic Drive area of the Mountain Shadows neighborhood showing destroyed (blue), damaged (yellow) and undamaged (green) homes, as shown in the preliminary damage assessment survey map. An undamaged home in the middle identified by an arrow was not included in this field assessment. Source: Colorado Springs Division of the Fire Marshal.

Ignition of the destroyed home at 2551 Hot Springs Court, shown as the upper most home in the red circled area in Figure 10, was either from the adjacent destroyed home located 16 foot away or through direct ember ignition. Defensible space was very good; rock mulch surrounded the home and the balance of the property consisted of irrigated lawn. The wood “half wine-barrel” planters were either largely undamaged, or burned on the house-facing side, indicating exposure from the burning house.

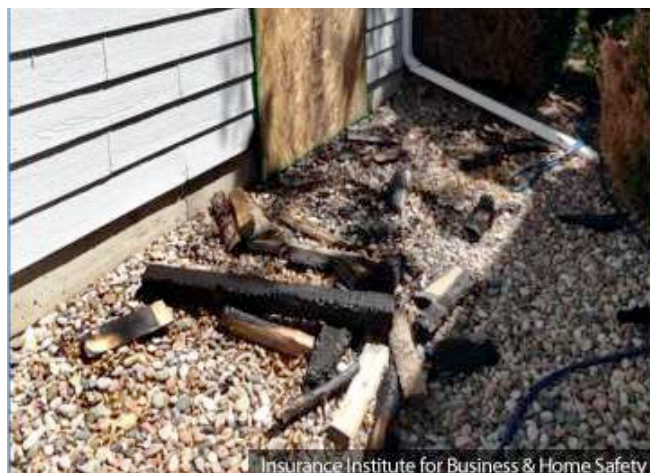
Figure 12: Embers ignited a firewood pile located next to the garage of this home. The direct flame contact exposure from the burning firewood ignited the composite wood (hardboard) siding product. Source: IBHS.

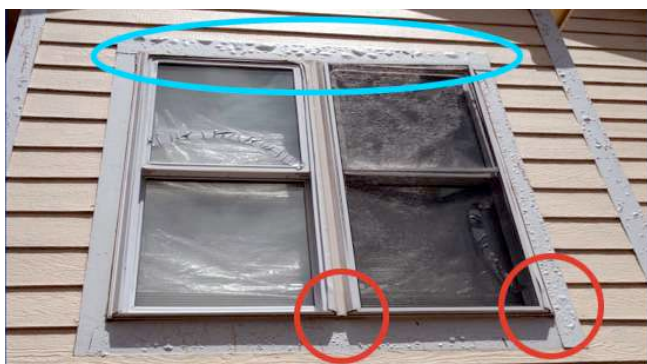
Damage to the remaining non-destroyed home on this court consisted of bubbling paint on window and other trim boards and a deformed vinyl window frame (Figure 13). The distance to the destroyed home was approximately 20 feet.

Figure 13: Radiant heat from the burning home, which was destroyed and was located 20 feet from this damaged home, was sufficient to cause paint on the wood trim to bubble (circled blue) and thinner components on the vinyl window frame to deform (circled red). Source: IBHS.

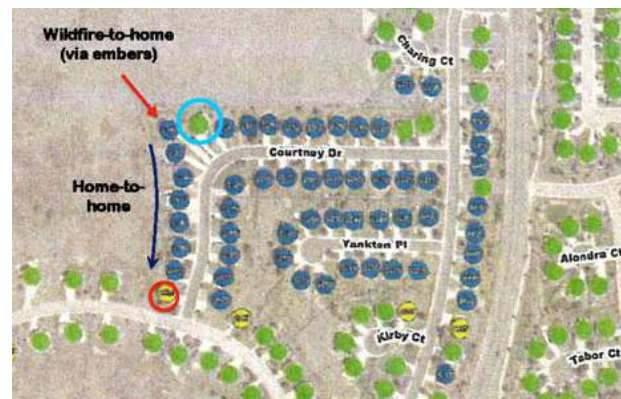
Figure 14: Homes on Courtney Drive that were destroyed by home-to-home spread after an initial wildfire-to-home ignition (indicated with red arrow). One home at the top of slope (red circled) suffered minor damage. The home to the east (right) of the wildfire-to-home, shown as a non-damaged green dot in this figure (blue circled), also had minor damage. Source: IBHS.

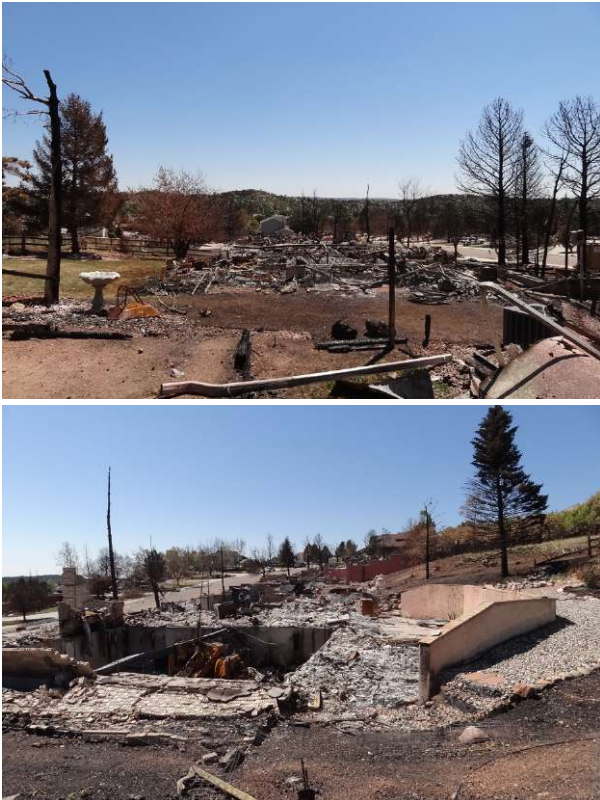
Figure 15: A composite figure showing destroyed Courtney Drive homes, as viewed from upslope and down slope different perspectives. Source: IBHS.

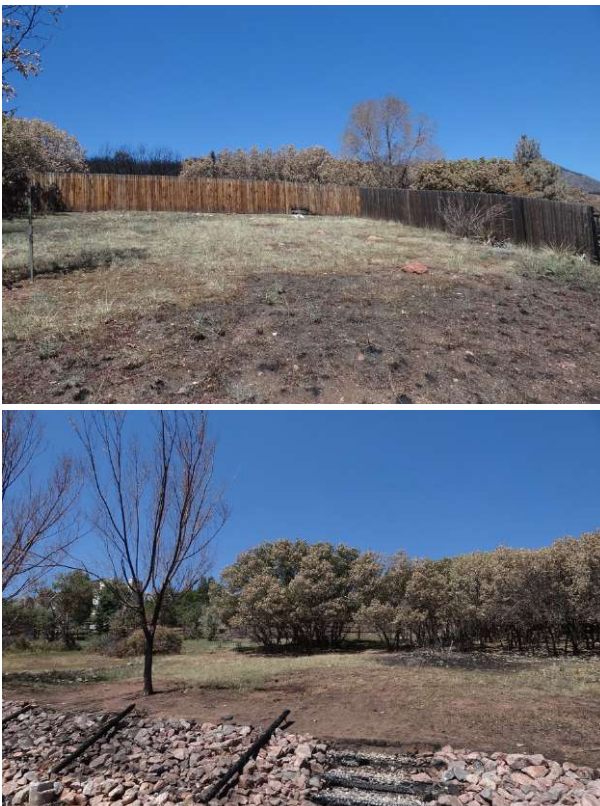
The defensible space around the destroyed homes was adequate. Observations during the site visit showed that burned and scorched vegetation and other combustibles were from radiant heat and / or fire spread out from the burning homes rather than the wildfire (Figures 16 and 17).

Figure 16: Composite figure of backyards of two destroyed homes on Courtney Drive; photos taken from the home site location. Damage to vegetation and other combustible components was from burning home, not wildfire. Source: IBHS.

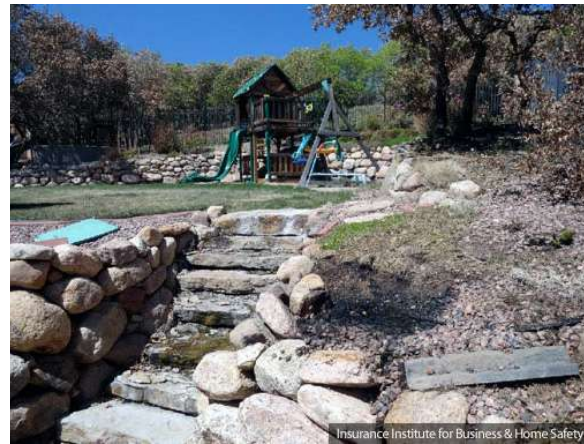
Figure 17: Damage to the play structure slide resulting from radiant heat exposure from the burning Courtney Drive home. Deformation of plastic components (slide and roof) was observed. Scorch or charring of wood structural support members was not observed. Source: IBHS.

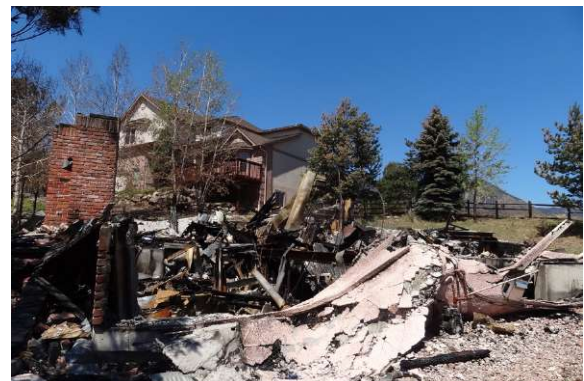
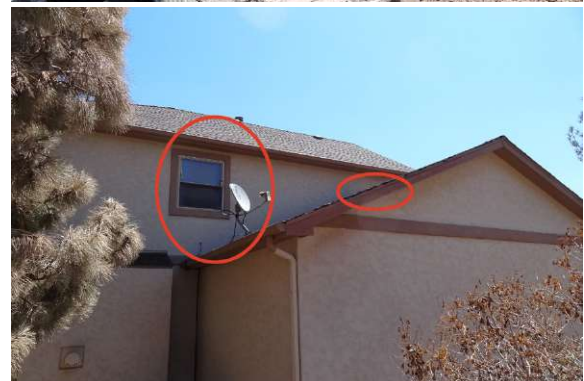
Figure 18: A composite figure of two damaged homes on the west side of Courtney Dr. The up-slope home is above and the down-slope home is below. The charred combustible siding in the up-slope home is not visible in this figure. The damaged components in the down-slope home are circled. Source: IBHS.

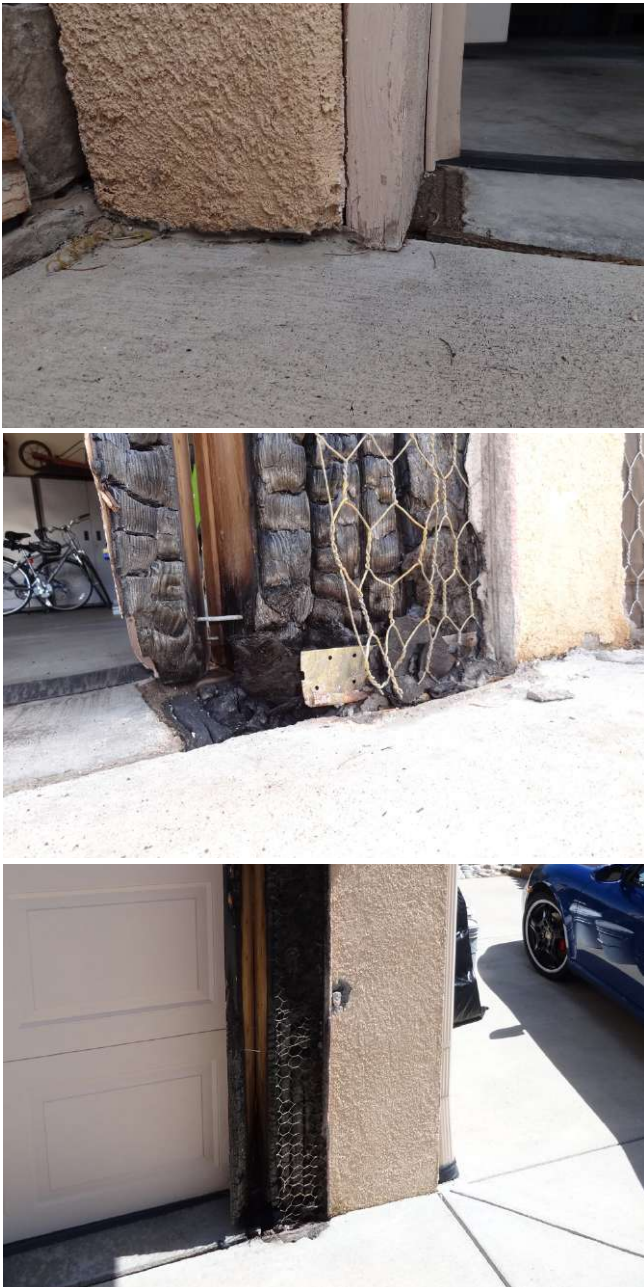
Figure 19: Photographs of the left, middle and right side columns of the two-car garage at a home on Lanagan Street. Note the low clearance between the concrete driveway and the EIFS system, as shown in the left-hand side column. The metal weep screed is visible at the base of the middle column. Source: IBHS.

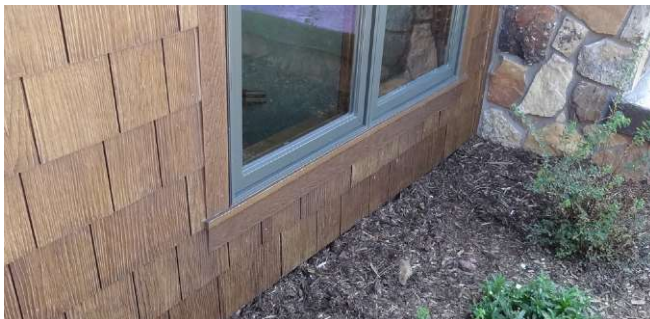
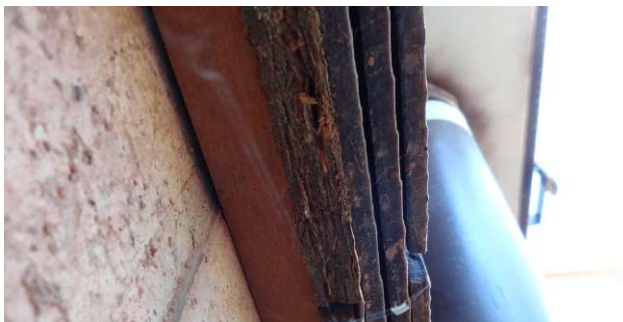
Figure 21: The siding on this home was a noncombustible fiber-cement shingle product (upper photo). The assembly at the base of the wall, showing combustible wood-based sheathing, is shown in the lower photo. Source: IBHS.

In each of the construction conditions discussed in this section, increasing the ground-to-siding clearance would result in a less vulnerable assembly. Mitigation strategies for the Lanagan Street home would include increasing the height of the concrete foundation to increase the distance between the driveway and the beginning of the EIFS cladding system. Use of a six-inch driveway-to-EIFS clearance would correspond to the already code-required earth-to-wood clearance for wood-based siding products. A six-inch clearance may or may not be the optimal separation to avoid ember accumulation-related damage via smoldering and / or flaming combustion, but based on these observations, it would be the preferred option to the observed much lower earth-(or ground)-to-siding clearances.

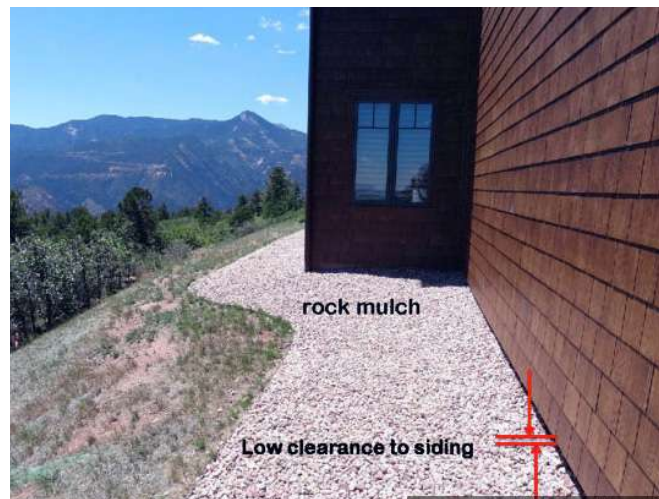
Figure 22: The back side of the home on Outer Vista Point Road. Noncombustible rock mulch and fiber-cement shingle siding products were used. The low clearance may allow for the underlying wood-based sheathing product to be vulnerable to ember accumulation at the base of the wall. Source: IBHS.

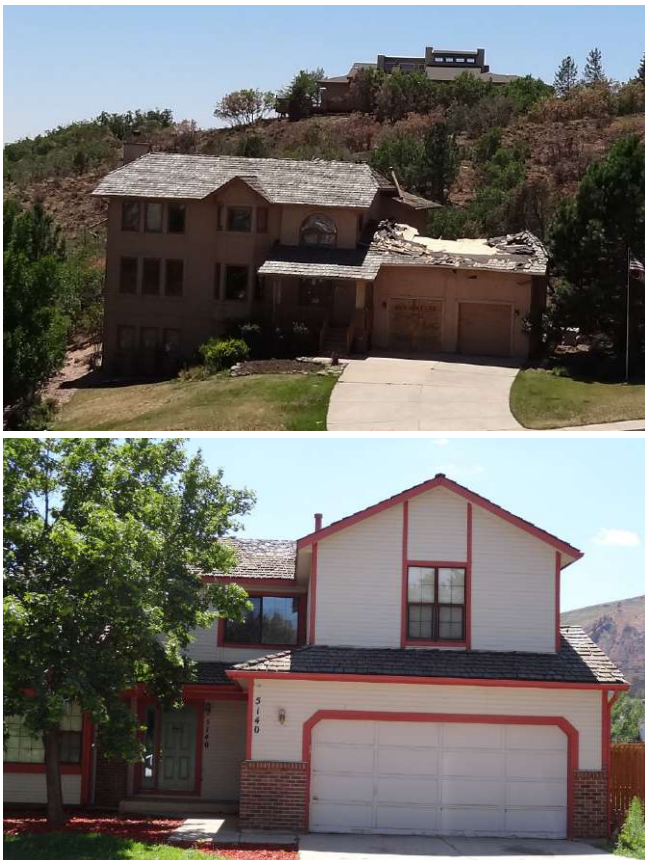
Figure 25: Homes on Rossmere Street (upper) and Champagne Drive (lower), each had wood shake roof coverings that were ignited by wind-blown embers. Source: IBHS.

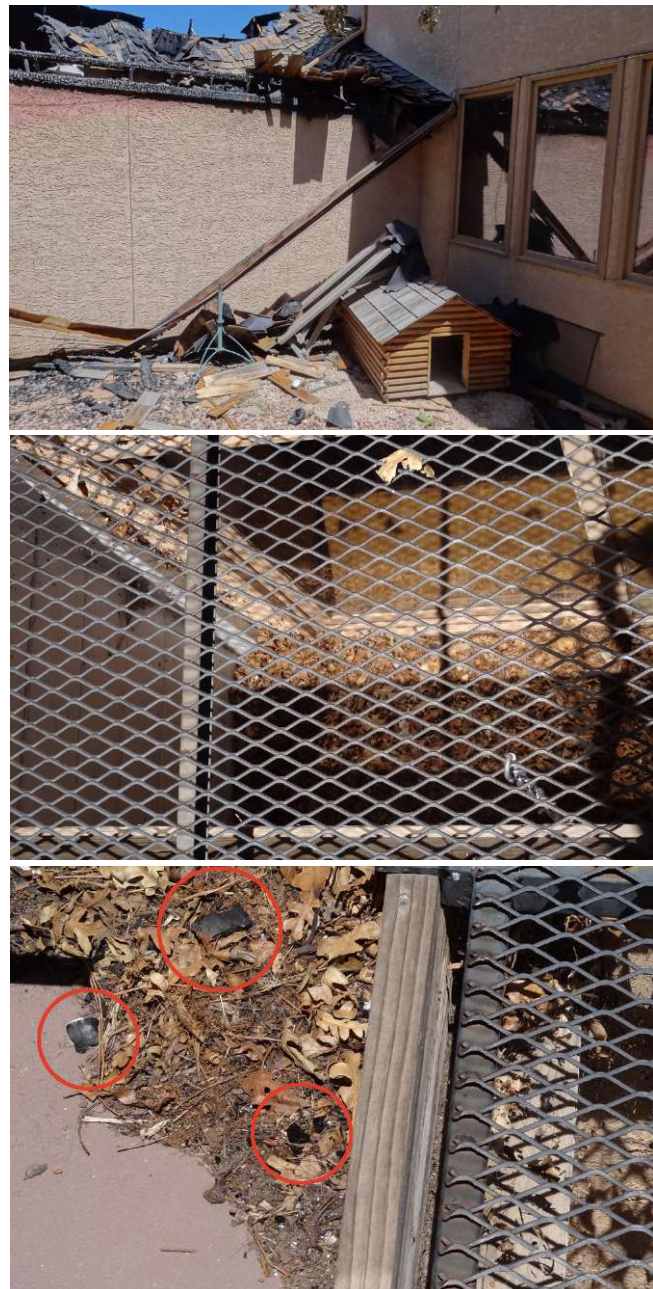
Figure 26: Combustible materials were present in the near-home zone of the Rossmere Street home. Embers are evident in the right-hand middle photo (embers circled in red). Source: IBHS.

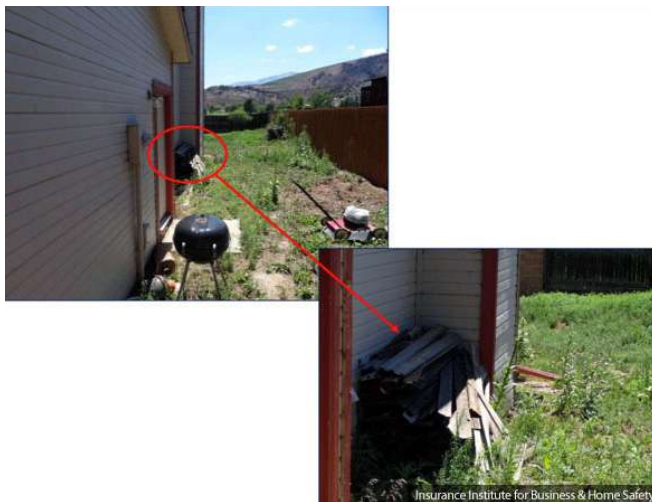
Figure 27: Combustible materials were present in the near-home zone of the Champagne Drive home. Source: IBHS.

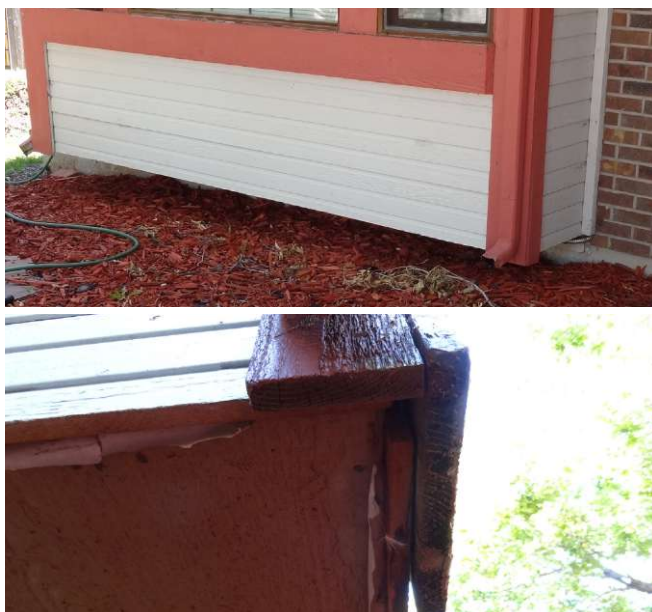
Figure 28: The "bump out" design feature at the front of the Rossmere Street home would be been vulnerable, if the wood mulch had been ignited by the observed ember exposure. Given the low earth-to-wood clearance, flame spread to the bump out would have provided a flame contact exposure to the combustible underside feature. Source: IBHS.

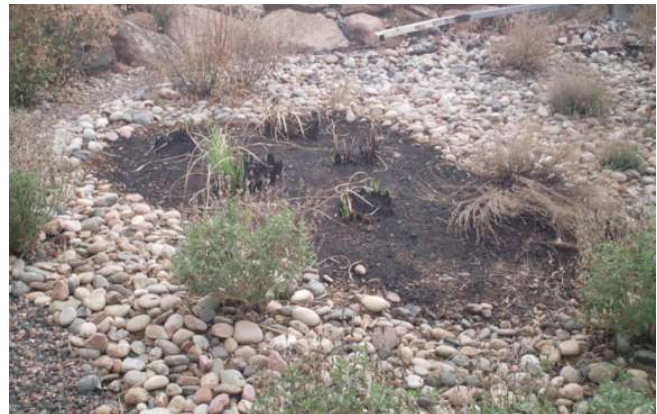
Figure C2: Ember ignition in landscaping contained by rock border. Source: NFPA.

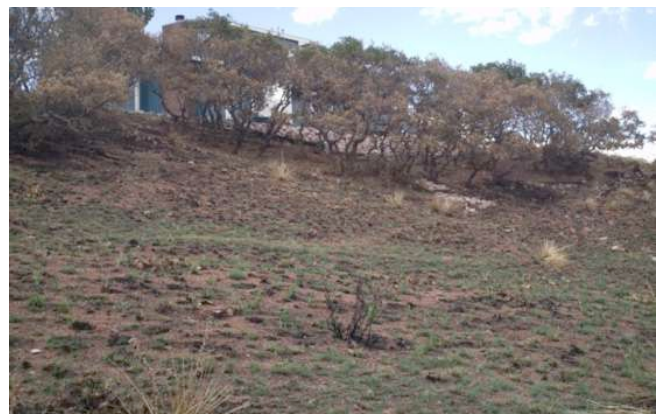
Figure C3: Ember ignition and under-burn below treated Gambel oak. Source: NFPA.

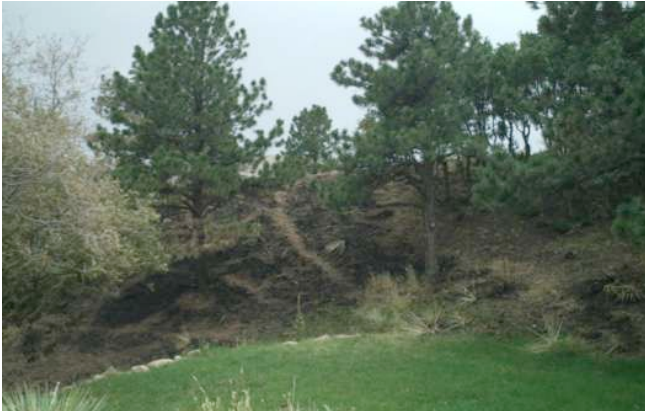
Figure C4: Ember ignition with treated ladder fuels in oak and pines. Source: NFPA.

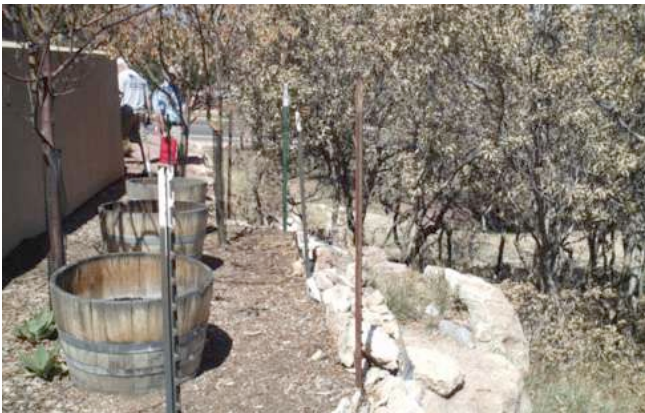
Figure C5: Scorched deciduous trees in foundation planting below deck. Source: NFPA.

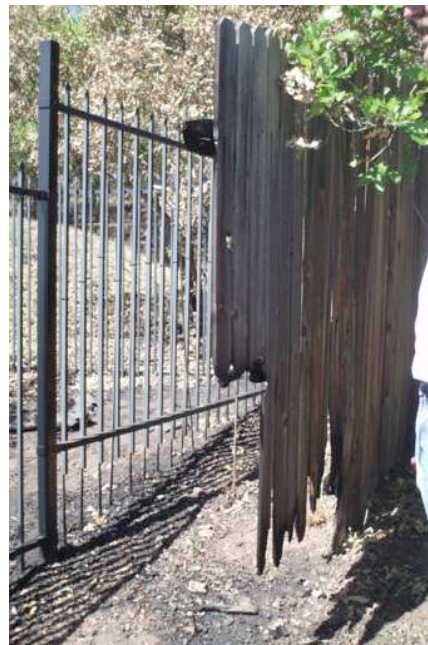
Figure C7: A partially burned cedar privacy fence. Source: NFPA.

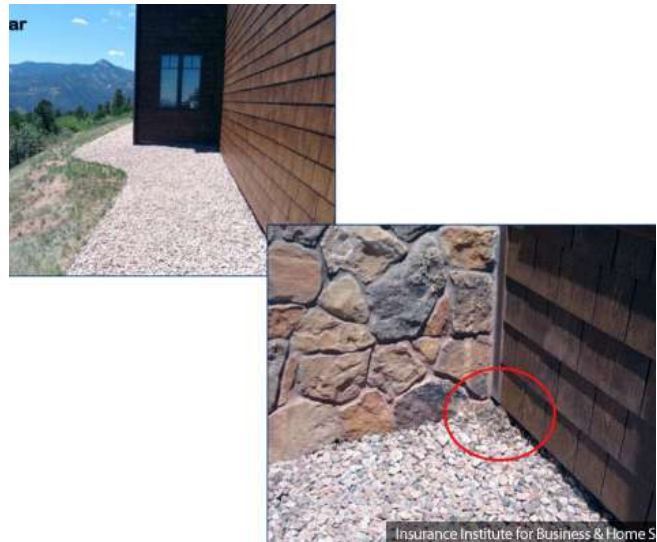
Figure D5: The upper left photograph depicts the vegetation management (defensible space) at the rear of the house. The lower right photograph shows an accumulation of dried vegetative debris in the corner, on top of the rock mulch. Source: IBHS.

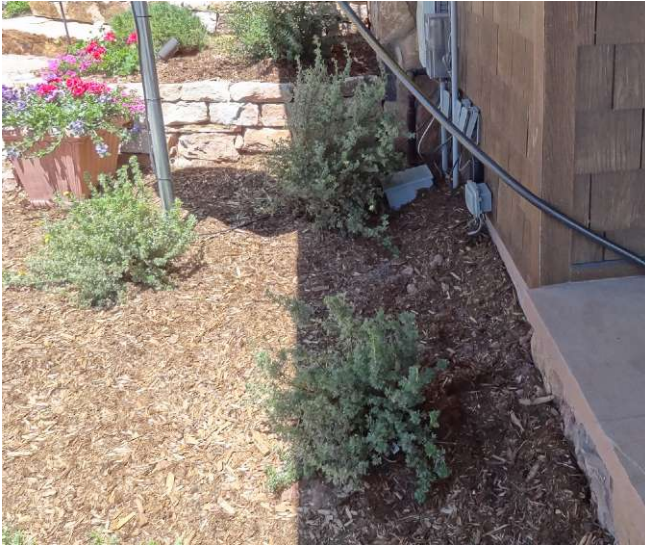
Figure D6: The upper photograph depicts the vegetation management (defensible space) in the 0-to-5 foot zone on the right side of the house. The lower photograph shows low earth-to-siding clearance. Source: IBHS.

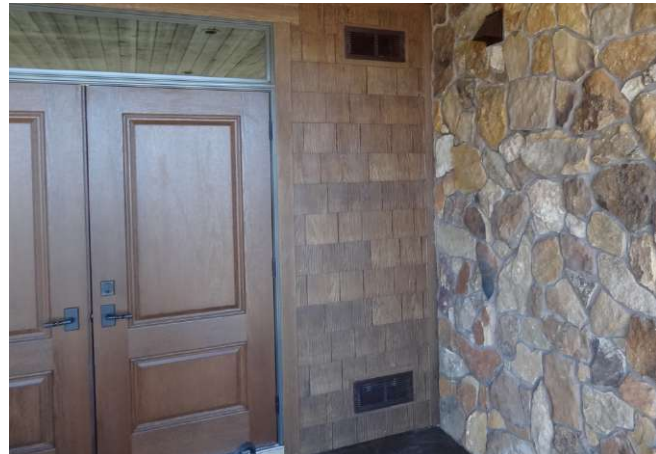
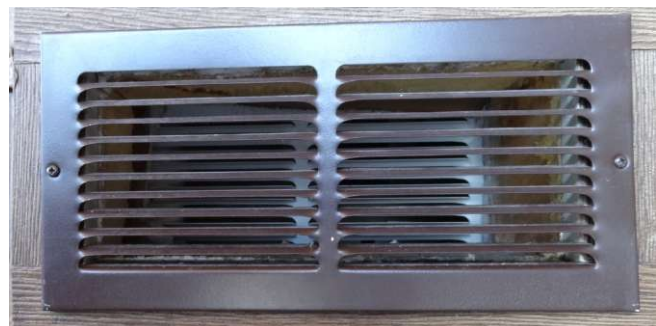
Figure D7: These photographs show venting for the make-up air to a room containing gas appliances. Metal screening was missing from these vents, as seen in the lower photograph. Source: IBHS.

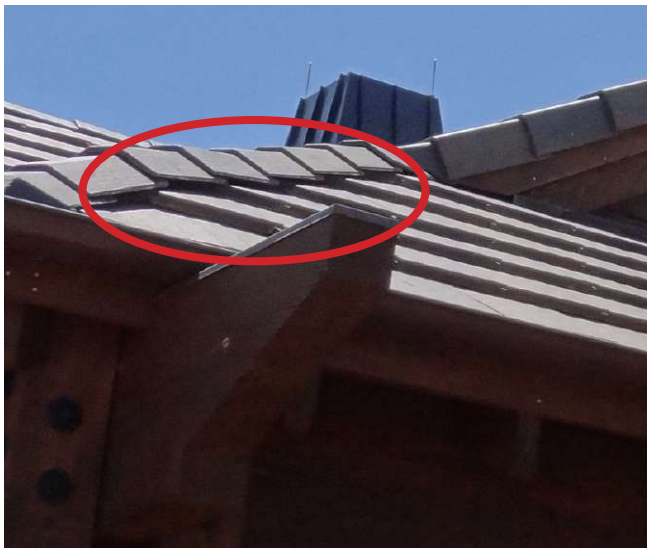
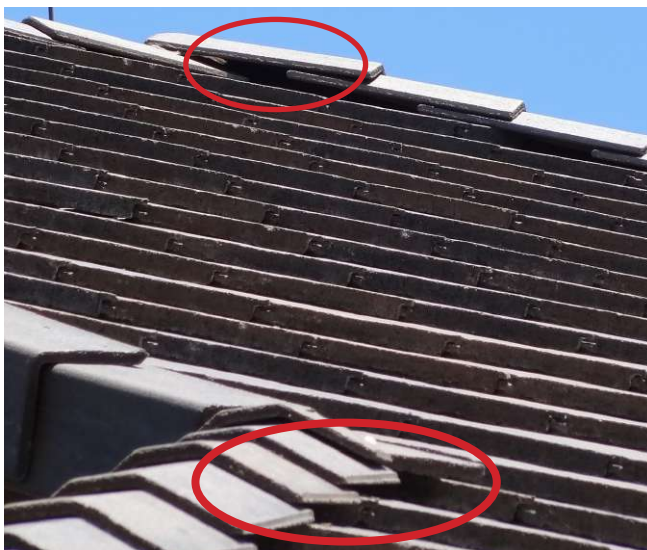
Figure D8: Un-stopped/unblocked openings at the hips of the flat-tile roof. Source: IBHS.

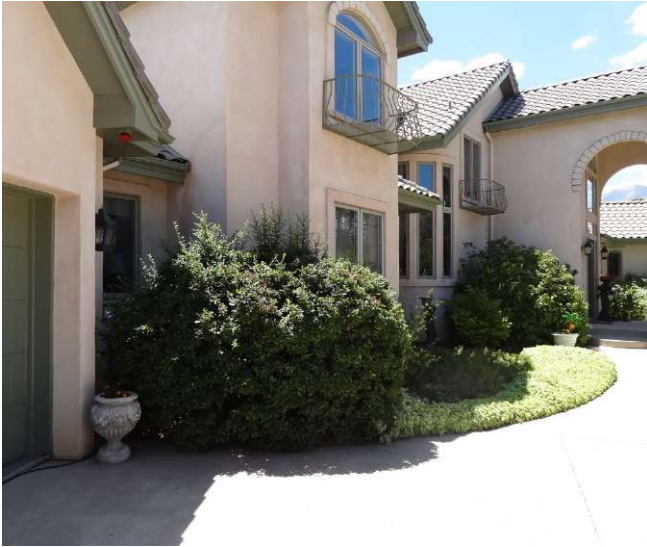
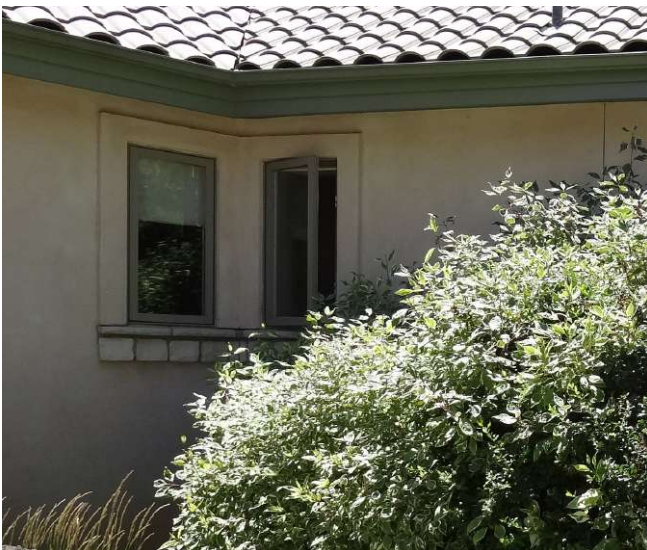
Figure D10: Near-home vegetation was prevalent at the front of this home. Note the open window in the lower photograph. Source: IBHS.

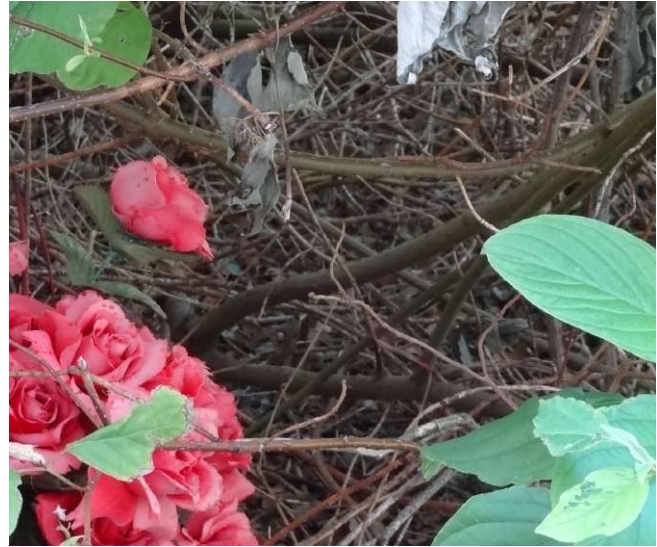
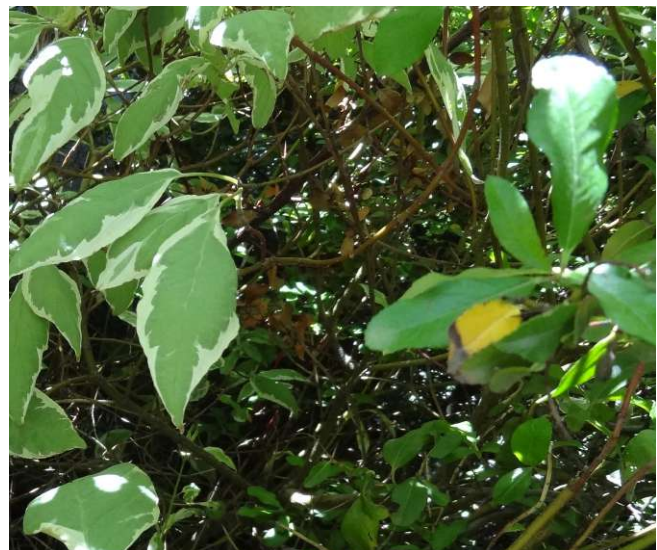
Figure D11: Near-home vegetation located at the front of the home. Note the fine fuels on the ground and in the vegetation. This fine fuel would facilitate ignition by wind-blown embers. Source: IBHS.

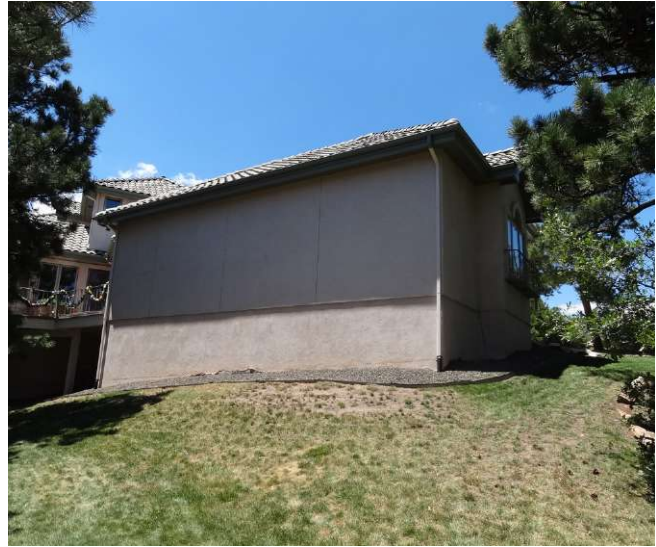
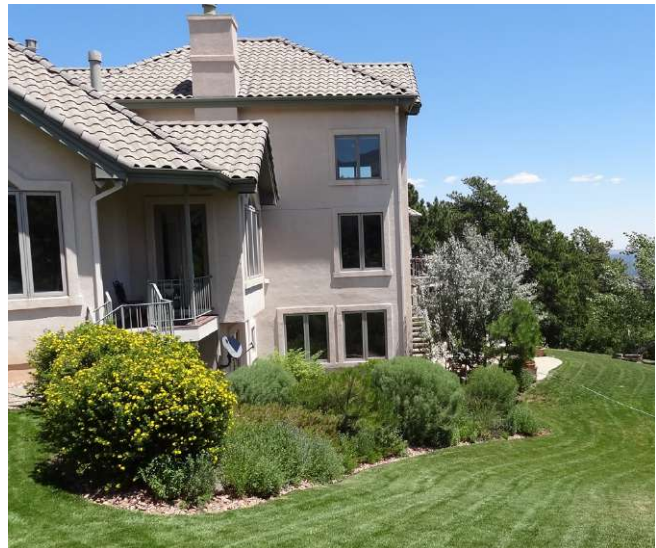
Figure D13: The defensible space at the rear of the home was very good on one side on one side (top photograph). The near home zone was poor on the other corner (bottom photograph). Source: IBHS.

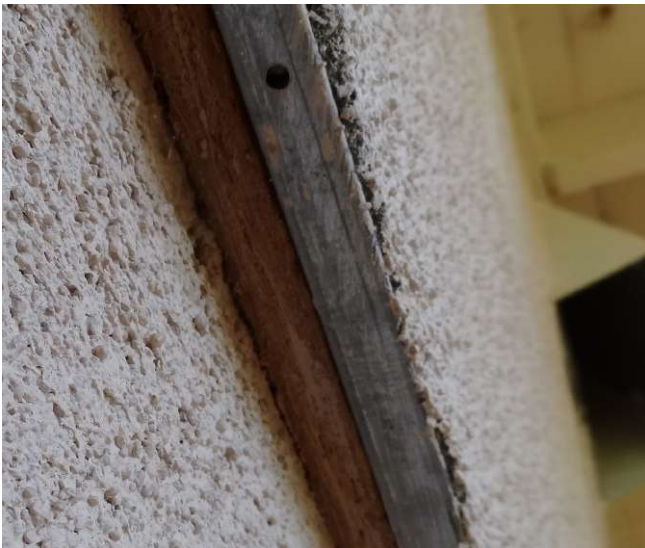
Figure D14: Bark mulch was used in areas at the rear of the home, under one of the decks. Note that the wood-based sheathing product is exposed (lower photograph). Source: IBHS

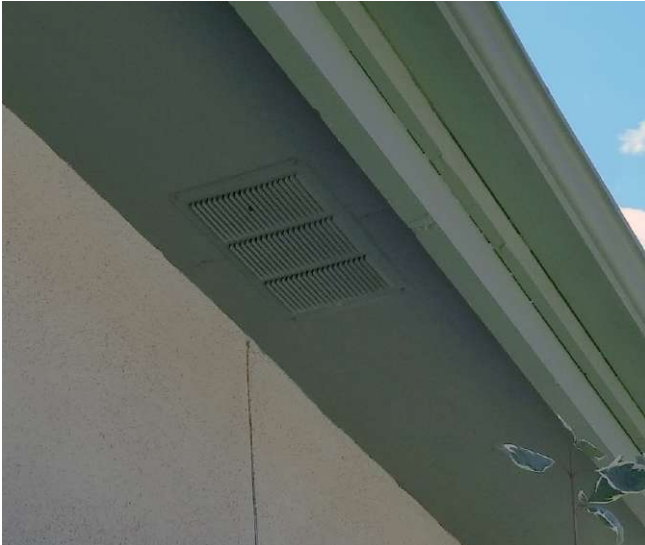
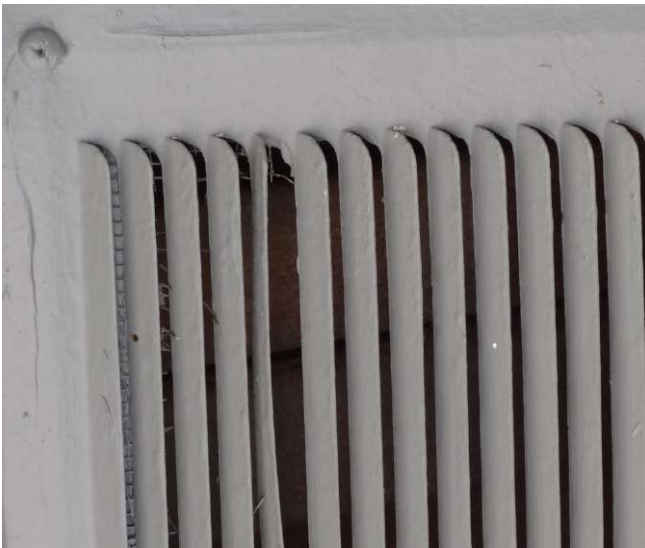
Figure D16: A soffited eave was used on this home. Some of the under-eave vents did not have mesh screening. Source: IBHS.

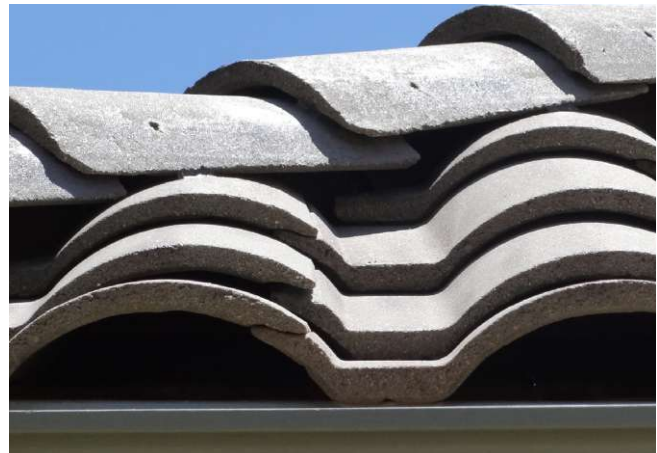
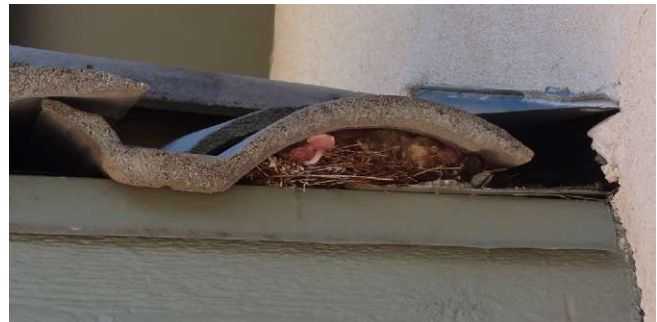
Figure D17: The ends of the barrel-tile roof covering on this home were not “bird-stopped.” Note the debris in the under-roof area at the end of the roof (lower photograph). Source: IBHS.

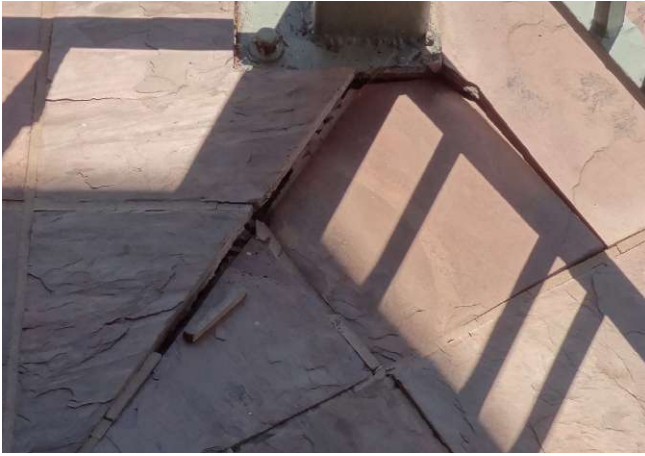
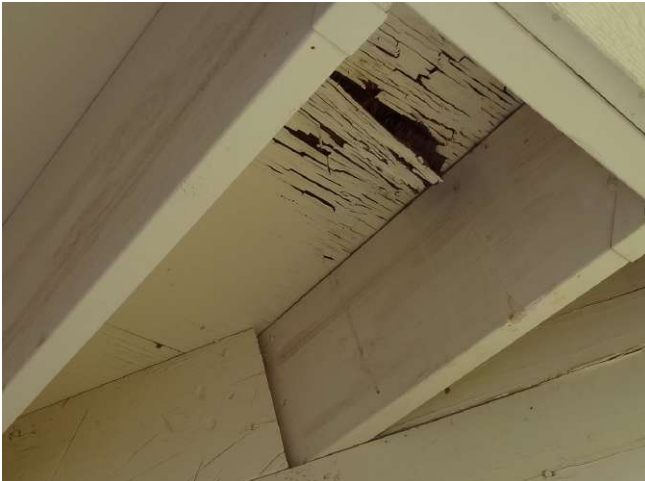
Figure D19: The flagstone covering on this solid surface (noncombustible) deck had failed (upper) allowing water to get below the covering, eventually resulting in fungal decay in the horizontal wood-based sheathing (lower). Source: IBHS.

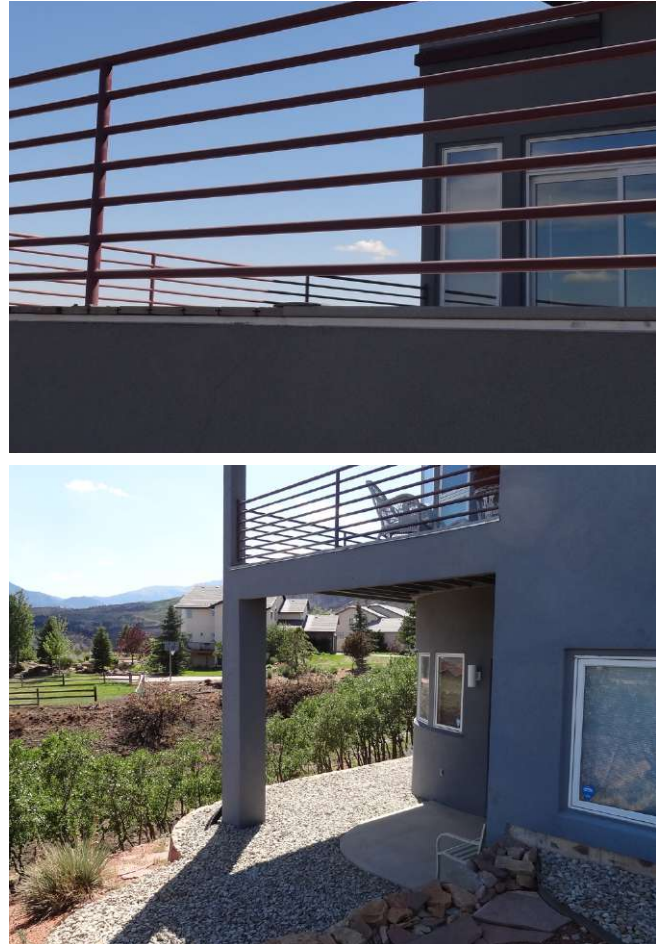
Figure D23: The decks at this home used wood for the structural support system and a combustible wood-plastic composite decking (walking surface) product. Source: IBHS.

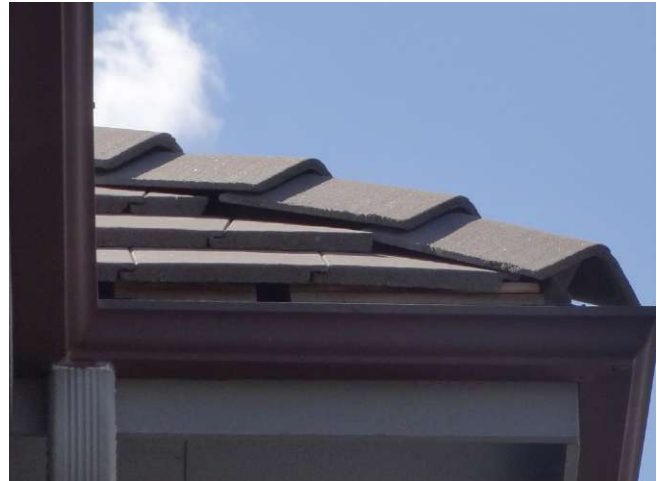
Figure D25: A flat concrete tile was used for the roof covering on this house. Note the openings at the hip and edge of the roof. Source: IBHS.
