**AIRCRAFT ACCIDENT REPORT**  
**PAN AMERICAN WORLD AIRWAYS INC**  
**BOEING 747, N747PA**  
**FLIGHT 845**  
**SAN FRANCISCO, CALIFORNIA**  
**JULY 30, 1971**

**NATIONAL TRANSPORTATION SAFETY BOARD**

REPORT NUMBER: NTSB-AAR-72-17

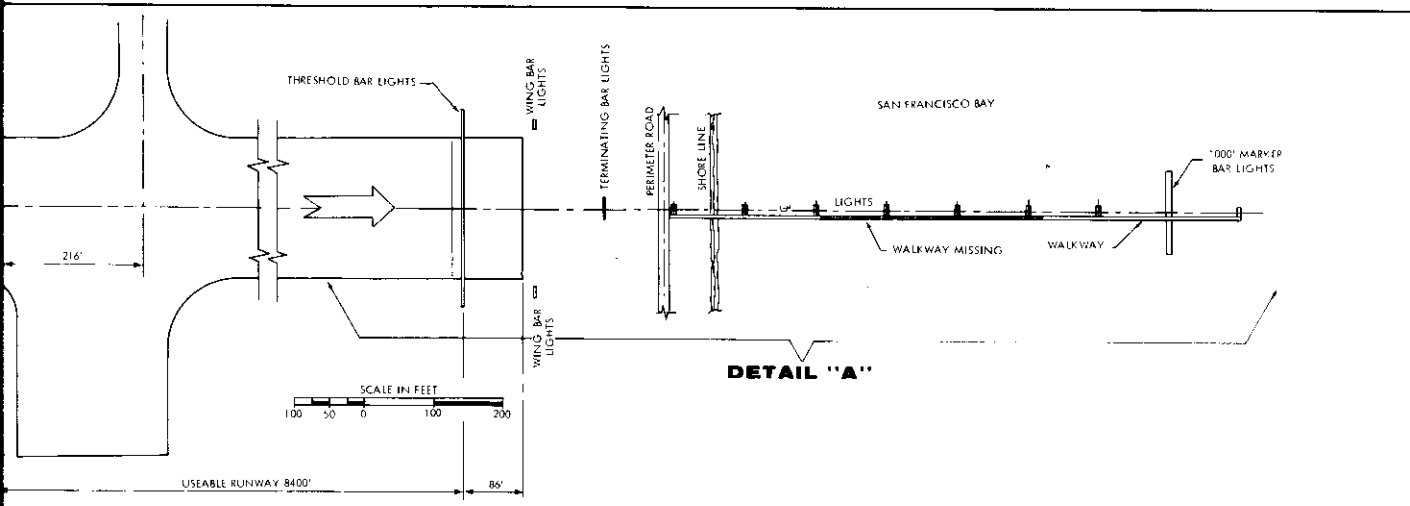
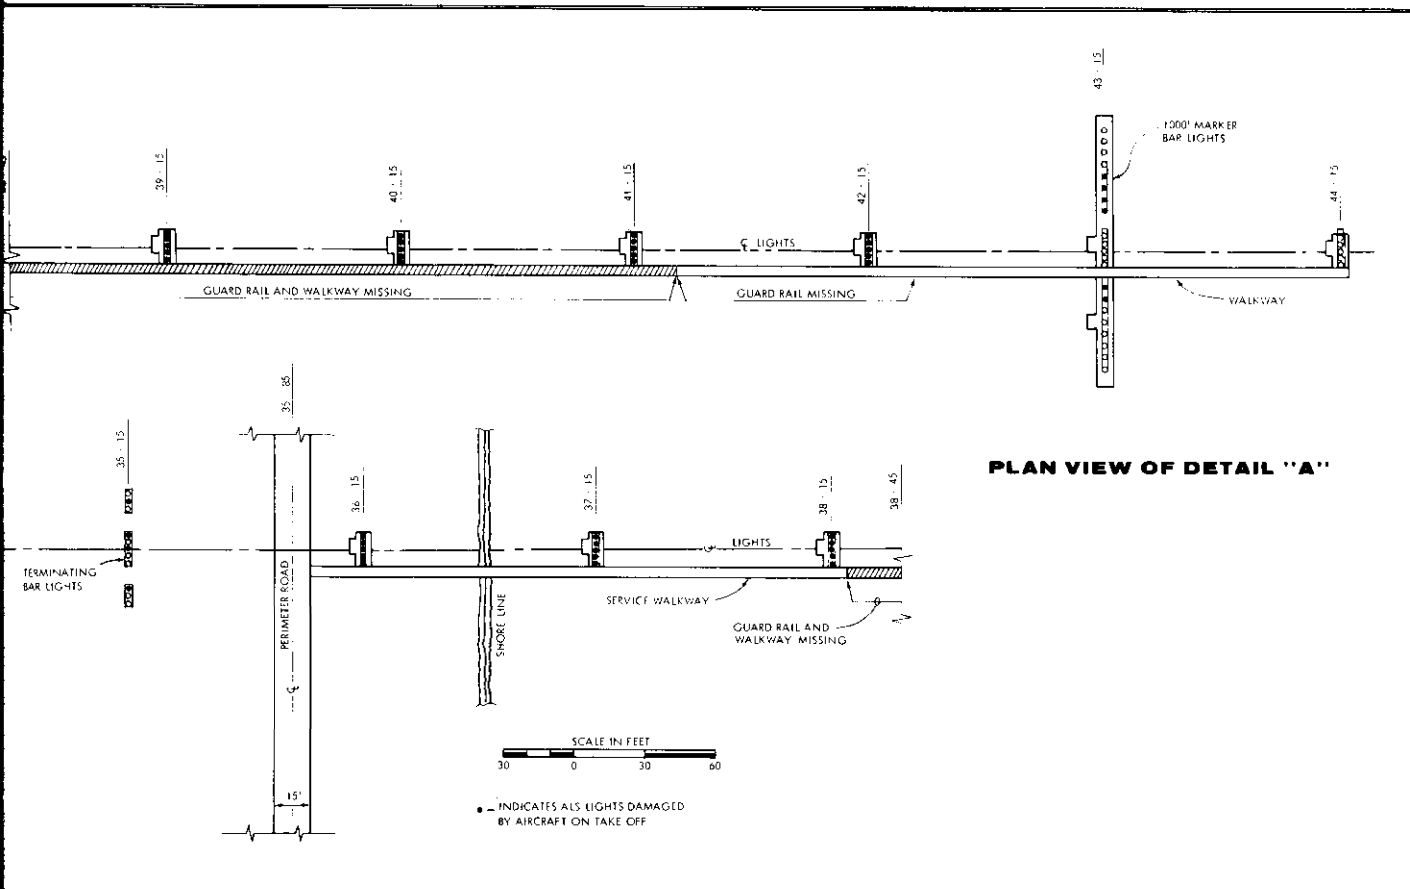
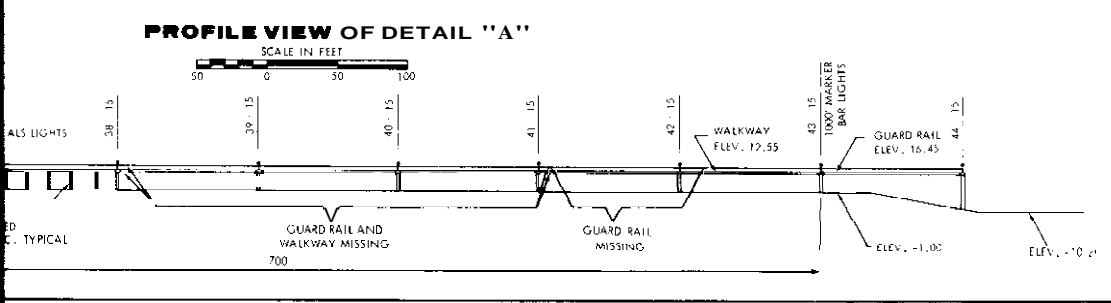
**Attachment 1**

The Approach Light System for Runway 19L sustained major damage. Four terminating bar light stanchions were broken off at their frangible fittings.

Approximately 120 feet past the end of the asphalt blast pad, four terminating bar lights were broken off at the frangible base fittings and one light housing exhibited black scuff marks 6-1/2 inches below the top.

The handrail on the service walkway was torn loose and was missing from the third approach light support piling to approximately 20 feet beyond the sixth light.

**DAMAGE TO APPROACH LIGHTING SYSTEM RUNWAY 19L**

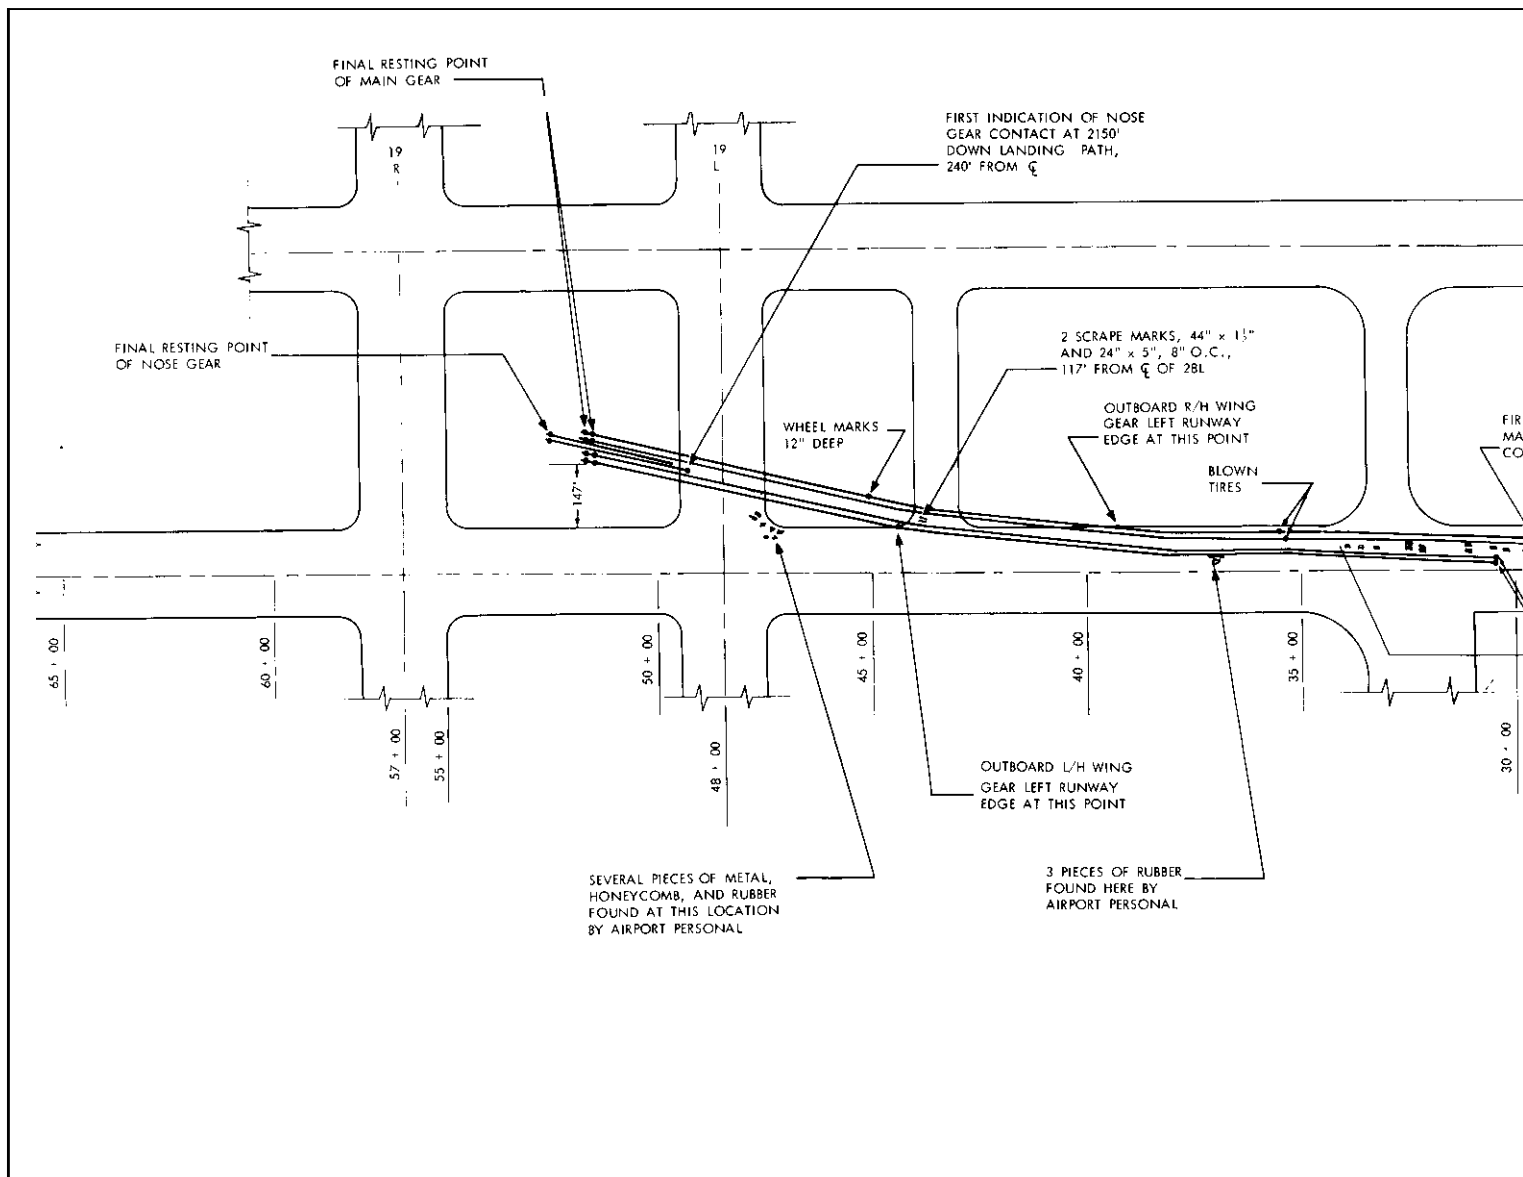
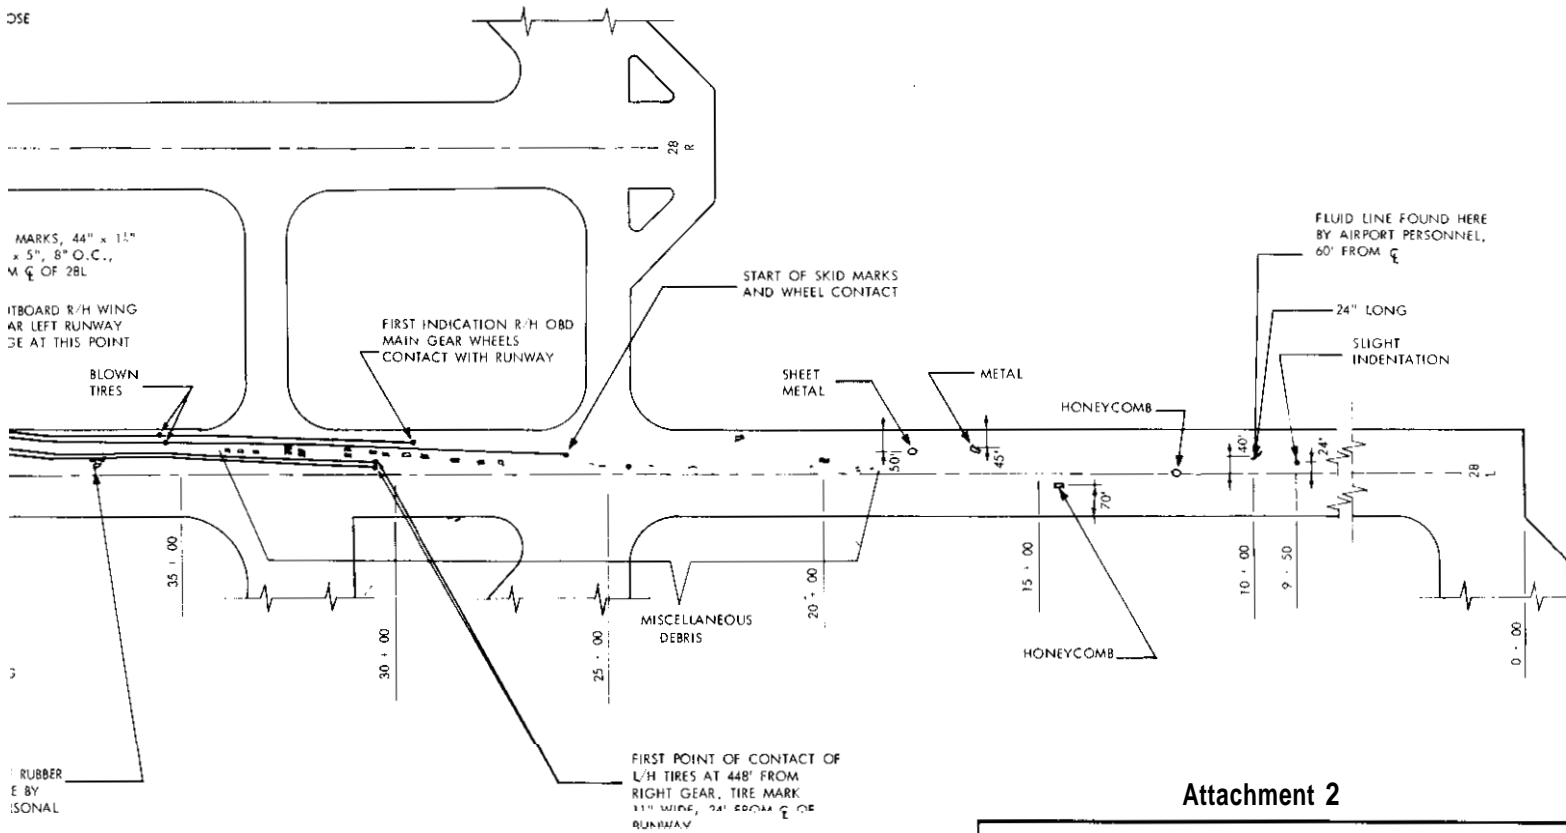
**Attachment 2**

**LANDING DATA AND WRECKAGE DISTRIBUTION ON RUNWAY 28L  
PAN AMERICAN AIRWAYS, INC. BOEING 747-121, N-747PA**

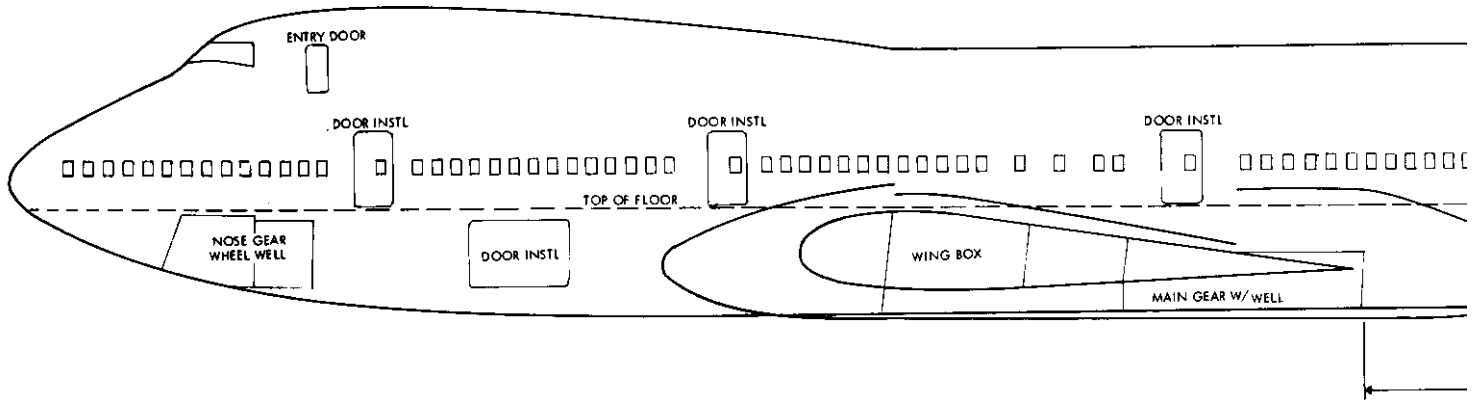
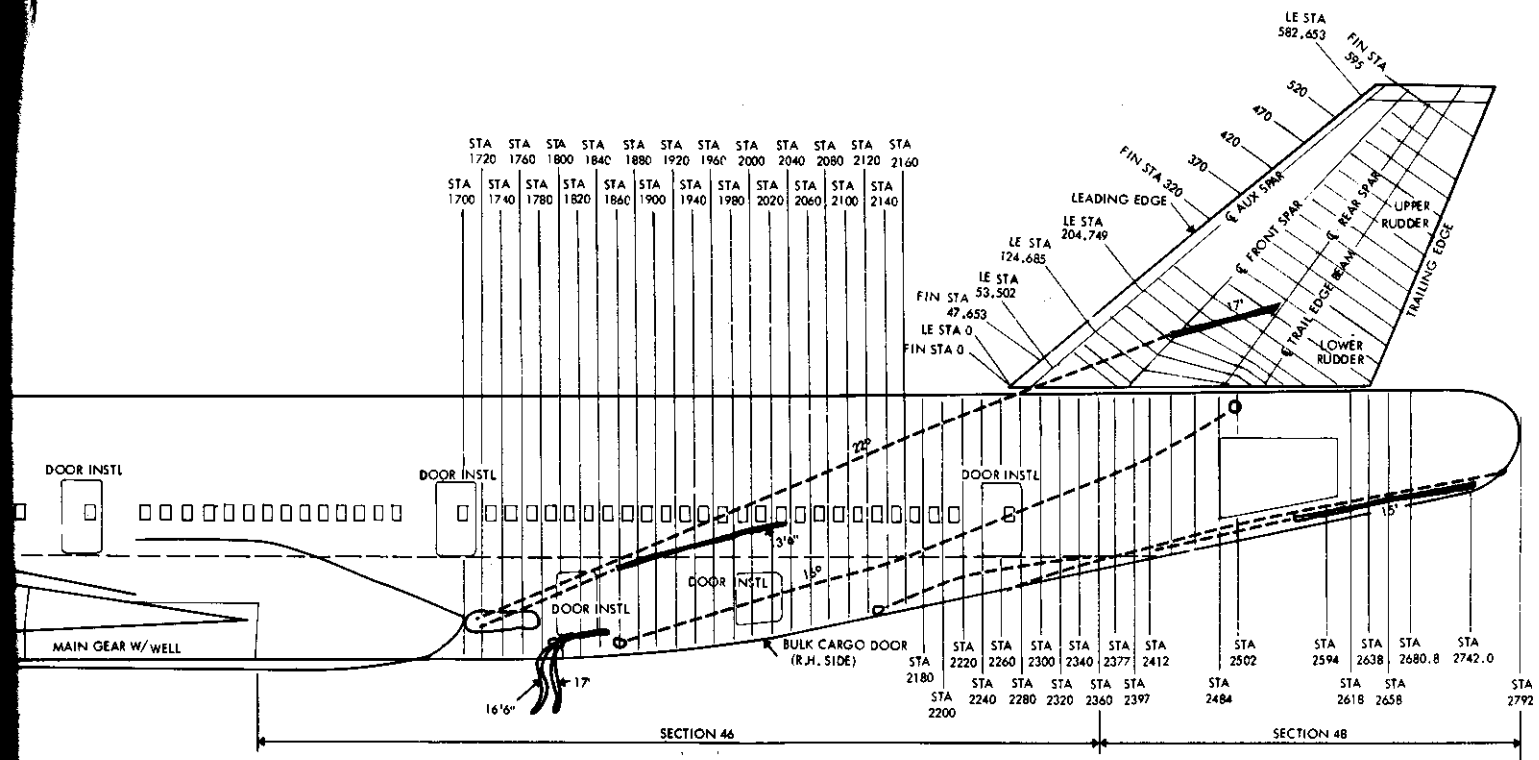
The right main landing body gear was forced back and up through the fuselage. The main passenger cabin floor had been raised **6** to **12** inches in a large area immediately aft of **BS-1480**. Cabin occupants reported that the floor was displaced approximately **2** feet while the aircraft was in flight. This damage was confined to the area of the left seats **36C** and **B**, the center four seats of Rows **34**, **35**, **36**, **37**, and the right aisle between seat Rows **35** and **38**.

The body landing gears of PA 845 struck the pilings and railings of the approach light pier at the end of the runway during takeoff. Hydraulic systems Nos. 1, 3, and 4 failed immediately thereafter. The right body gear was forced aft and upward into the aft cargo compartment and passenger cabin floor. The left body gear was broken loose and was dangling beneath the aircraft. The bulkhead, to which the body gear was mounted, had failed on both sides of the fuselage. The No. 1 hydraulic system lines for both body gear extend and retract mechanisms were mounted on this bulkhead and were severed during the impact with the ALS structure.
