AIRCRAFT ACCIDENT REPORT

TRANS WORLD AIRLINES, INC.
BOEING 707-331B, N8705T
LOS ANGELES, CALIFORNIA
AUGUST 28, 1973

NATIONAL TRANSPORTATION SAFETY BOARD
Washington, D.C. 20591
REPORT NUMBER: NTSB-AAR-74-8

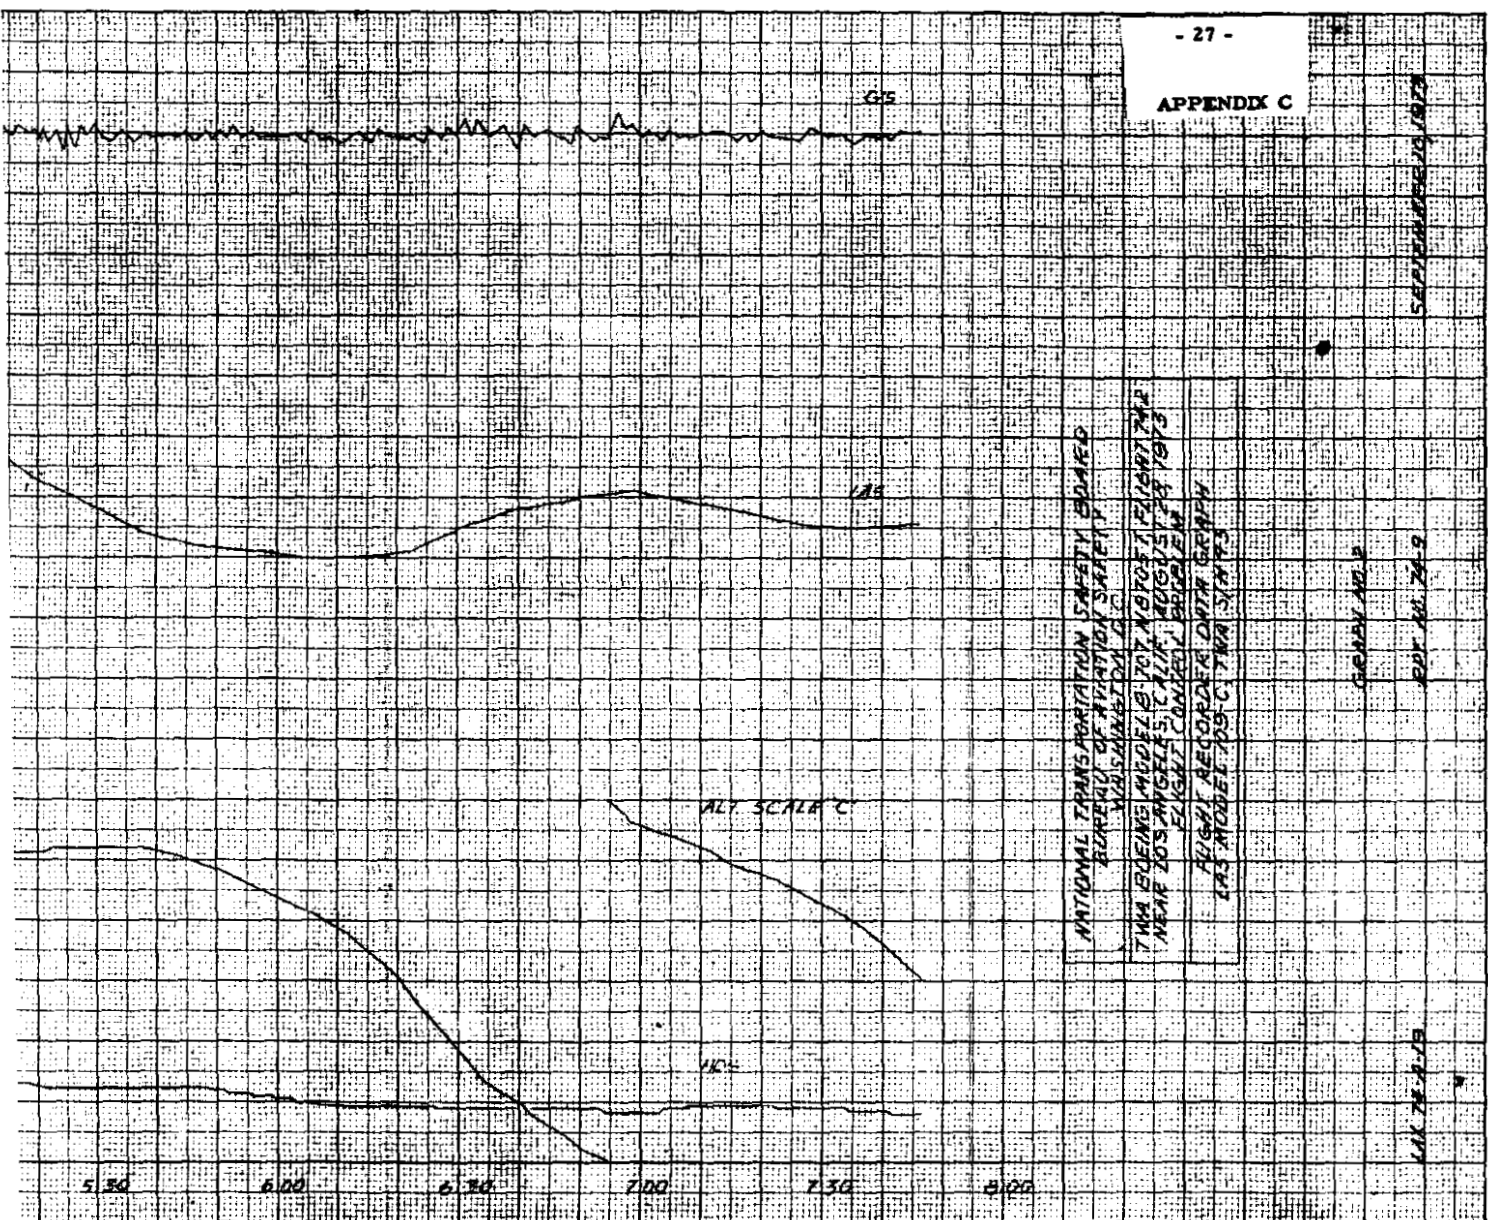
APPENDIX C

The FDR metal foil was removed and examined. (See Appendix C.) The porpoising was evident on the vertical acceleration trace as approximately 55 cycles occurring during a 2-minute period. The indicated airspeed and pressure altitude traces showed that the aircraft was descending about 2,100 feet per minute and was passing through 22,400 feet altitude at 352 kn. when the first significant vertical acceleration peak occurred. The airspeed reduced to 340 kn. during the next 20 seconds and remained between 340 to 345 kn. for about 1 minute. The airspeed then decayed to 300 kn. where the vertical acceleration excursions converged. The altitude remained constant at 22,400 feet for about 25 seconds, after which the aircraft descended. The aircraft was leveled at 19,500 feet as the pitching oscillations ceased.

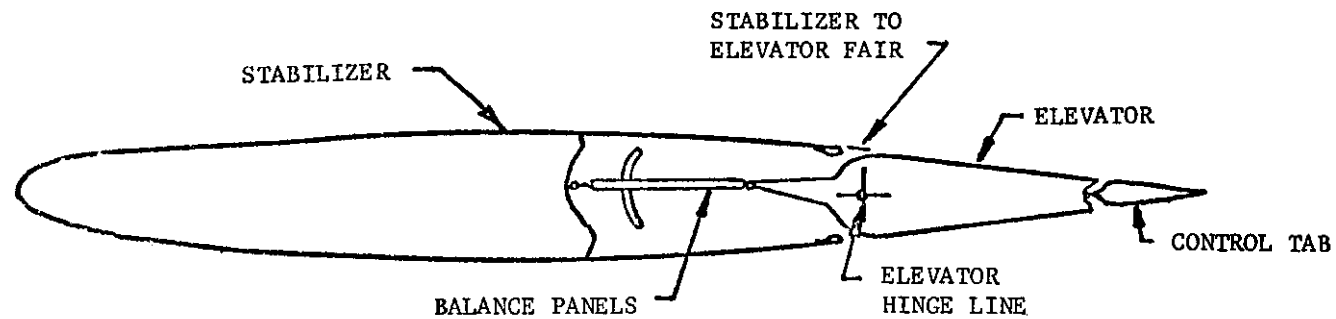
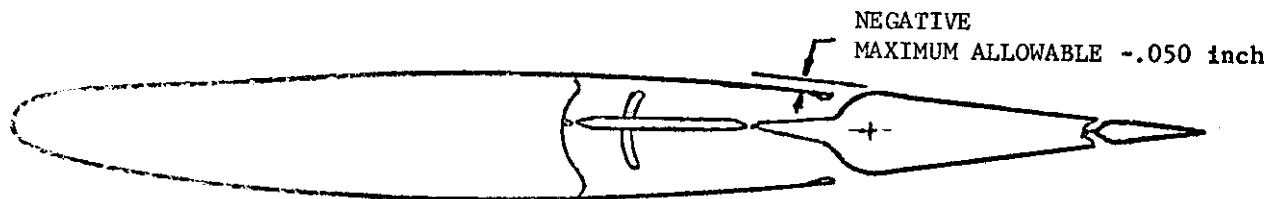
BOEING 707/720 STABILIZER-ELEVATOR CONTOUR FAIR

Boeing Company engineers theorized that the boundary layer effects caused by the upper surface skin waviness would be aggravated by the step down that was predominant at the hinge line on the left elevator.

(c) The upper nose contour of the left elevator at its hinge line was predominantly below the faired contour extension of the upper stabilizer surface. Although the alignment was within prescribed limits, the resulting step down caused further disturbance to the thickened boundary layer. The disturbed flow of air within the boundary layer affected the pressure distribution and thus the resultant lift vector acted on the elevator so that the moment about the elevator hinge caused by air loads on a deflected control surface was lower than normal.

The low control forces were caused by the effect of a thickened boundary layer on the left stabilizer which was produced by waviness on the stabilizer upper surface combined with the step down at the stabilizer-to-elevator contour fair.

The stabilizer to elevator contour fair was changed on both assemblies to produce a condition wherein the elevator nose contour was predominantly above the stabilizer contour extensions. The alteration was accomplished by removing shims between the stabilizer trailing edge beam and the elevator hinge support structure.
