NATIONAL TRANSPORTATION SAFETY BOARD

AIRCRAFT ACCIDENT REPORT

**TRANS-COLORADO AIRLINES, INC., FLIGHT 2286
FAIRCHILD METRO III, SA227 AC, N68TC
BAYFIELD, COLORADO
JANUARY 19, 1988**

NTSB/AAR-89/01

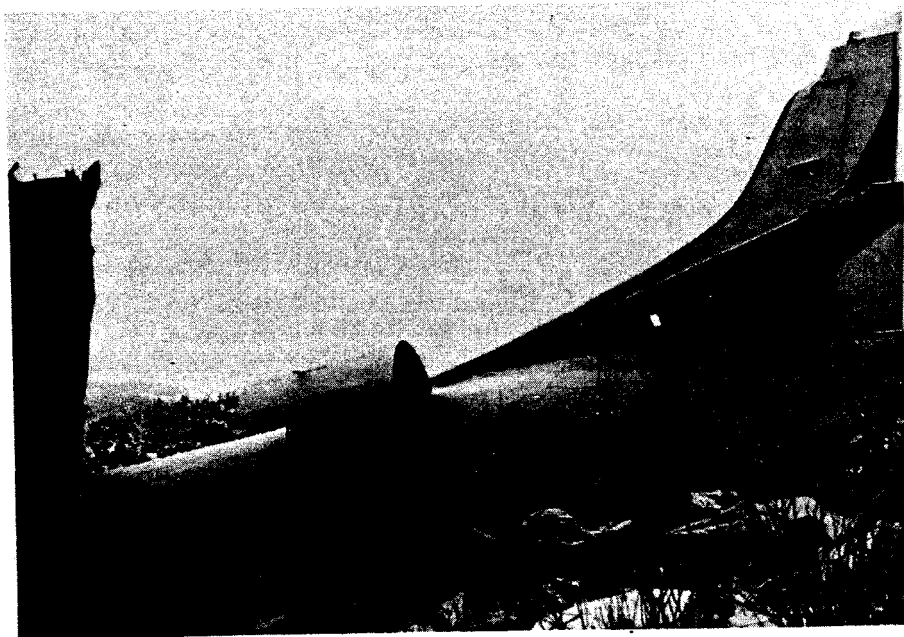
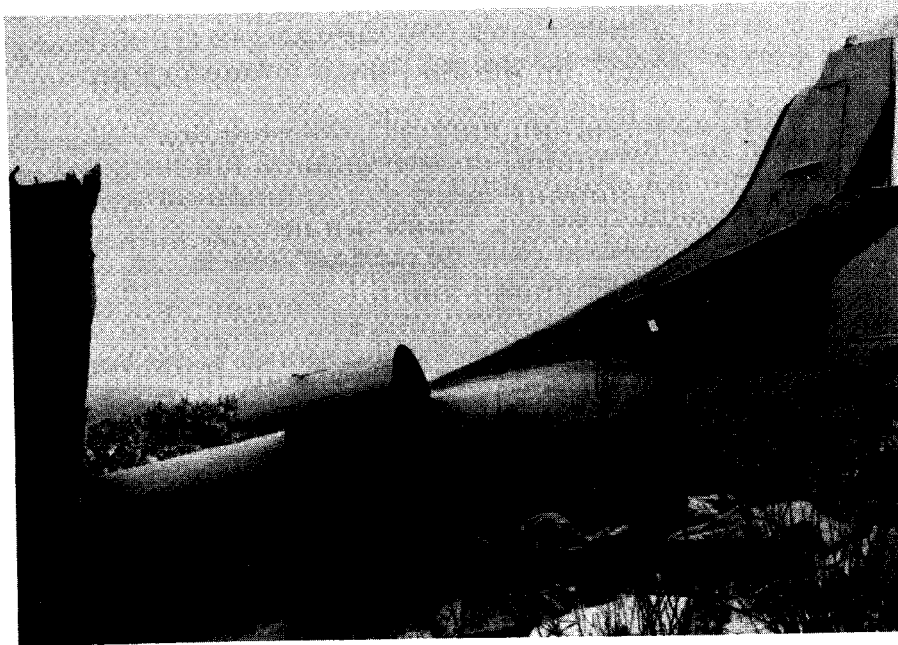
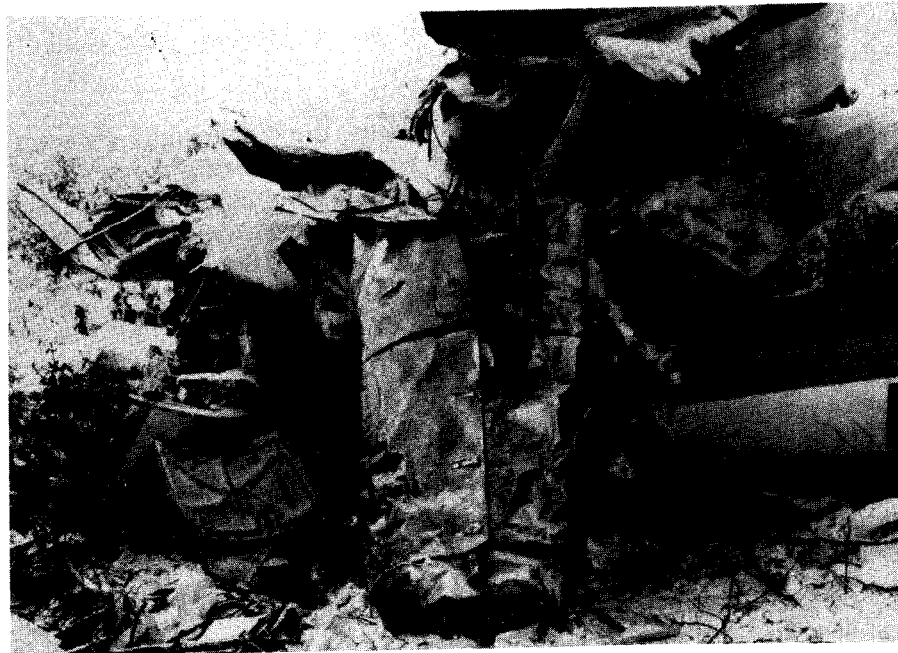
Figure 3.--Wreckage of Tram-Colorado 2286

The main wreckage was found on a heading of 104°. The fuselage was essentially upright, although lying nose down on a hill. (See figure 3.) The wing had separated from the fuselage at the attachment fittings and was lying inverted above the fuselage. (The Metro III is constructed of a single wing that is mated to the fuselage.) The right engine and its nacelle were hanging nose down from the wing, restrained primarily by control cables, tubing, and torn sheet metal. The left engine had been torn from its mounting and was found buried in the snow, adjacent to the right forward fuselage.

About 2/3 of the left part of the wing was fragmented from the tip inward. The left wing tip was found away from the main wreckage near the site of the initial impact with the trees. About 1/4 of the right part of the wing from the tip inward had separated from the remainder of the wing and came to rest about 250 feet from the fuselage within the wreckage path. The left flap actuator was found extended 5 inches, corresponding to a fully extended position.

The left aileron and trim tab were destroyed. The right aileron and trim tab were deflected fully downward and compressed forward. The horizontal stabilizer trim actuator had come apart in the accident and the drive gears were visible. The horizontal stabilizer trim position was about

1 inch above the green takeoff arc. The trim actuating arms were extended to different lengths, with the right arm about 1 inch further extended than the left.

Both main landing gear strut castings failed. The four main gear and one nose gear actuators were found, all in the extended position. The gear was found in the wreckage path.

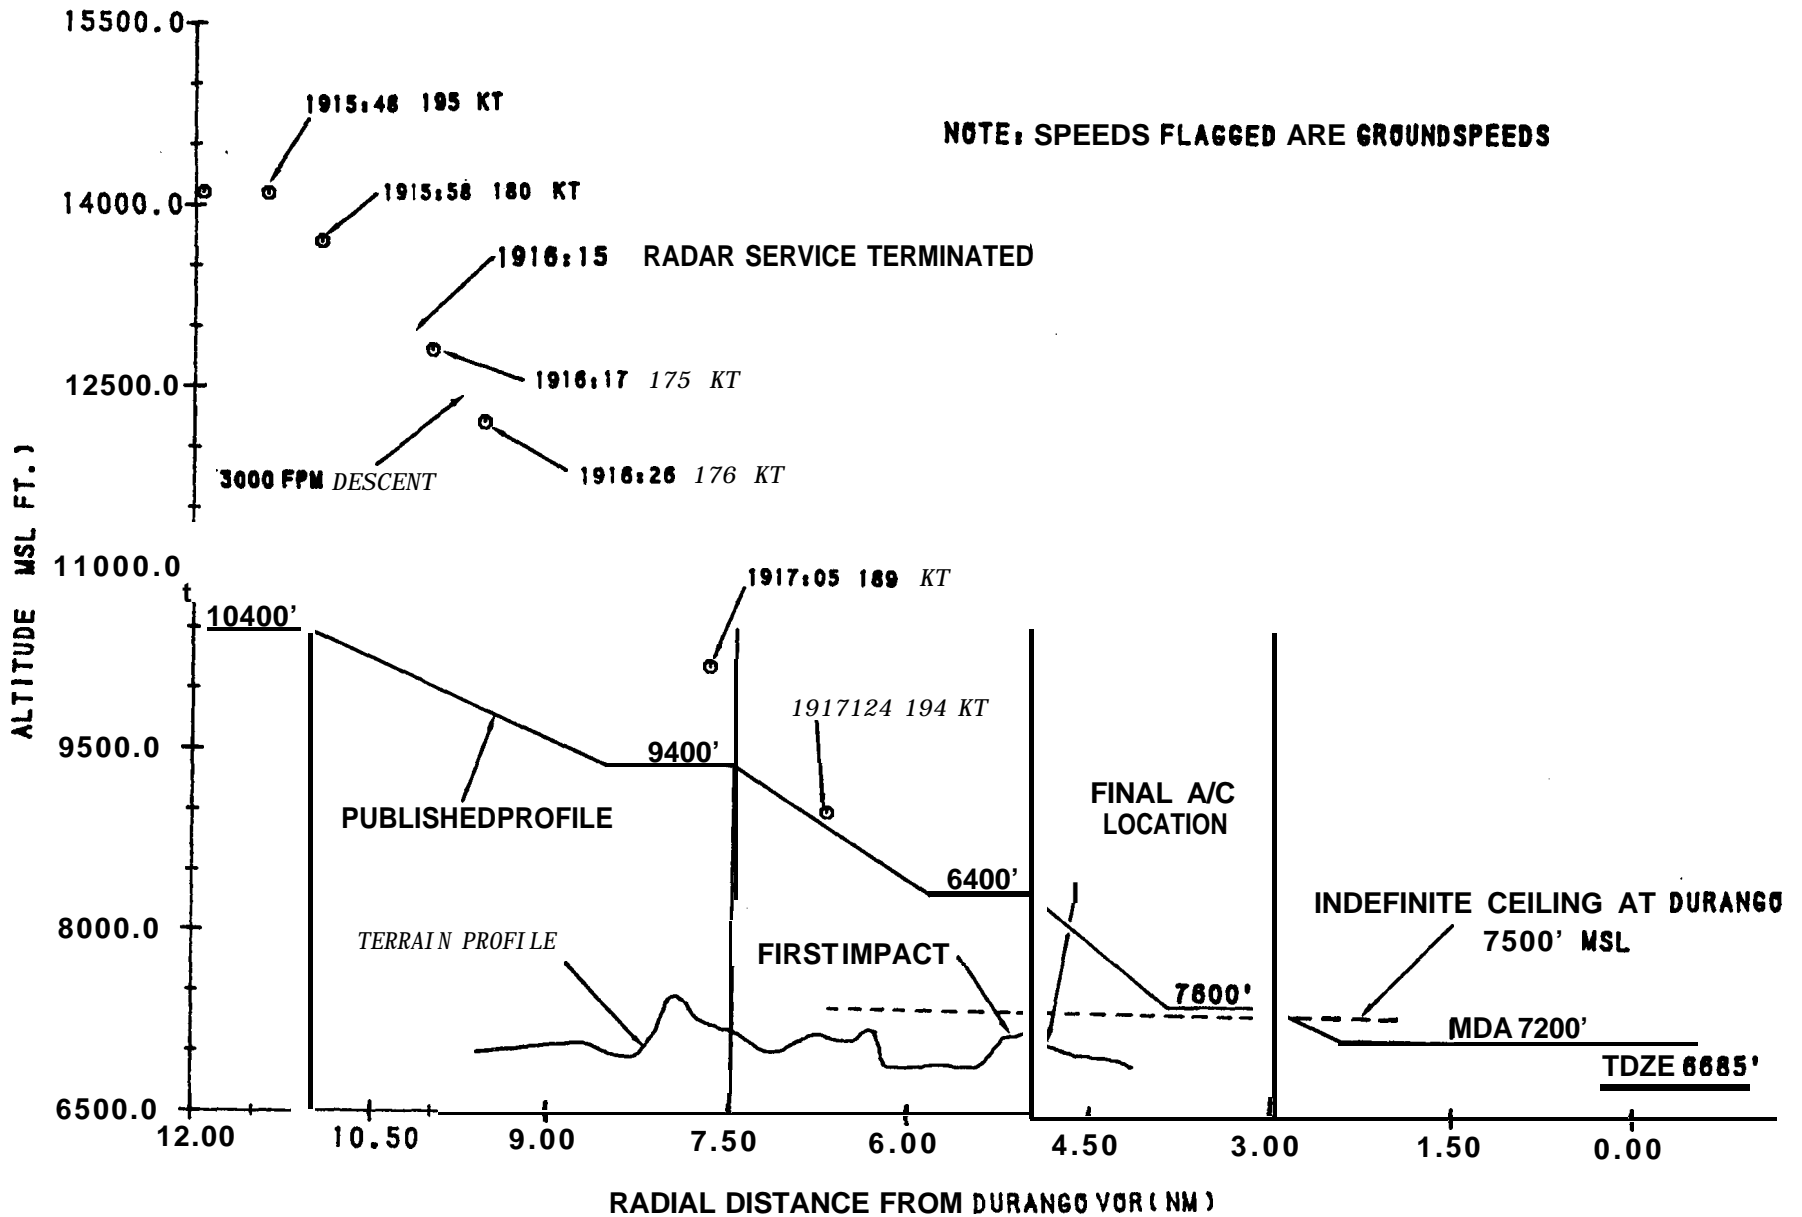
Figure k--Profile of the approach of Trans-Colorado 2286 with ground speeds, altitudes, and local times.

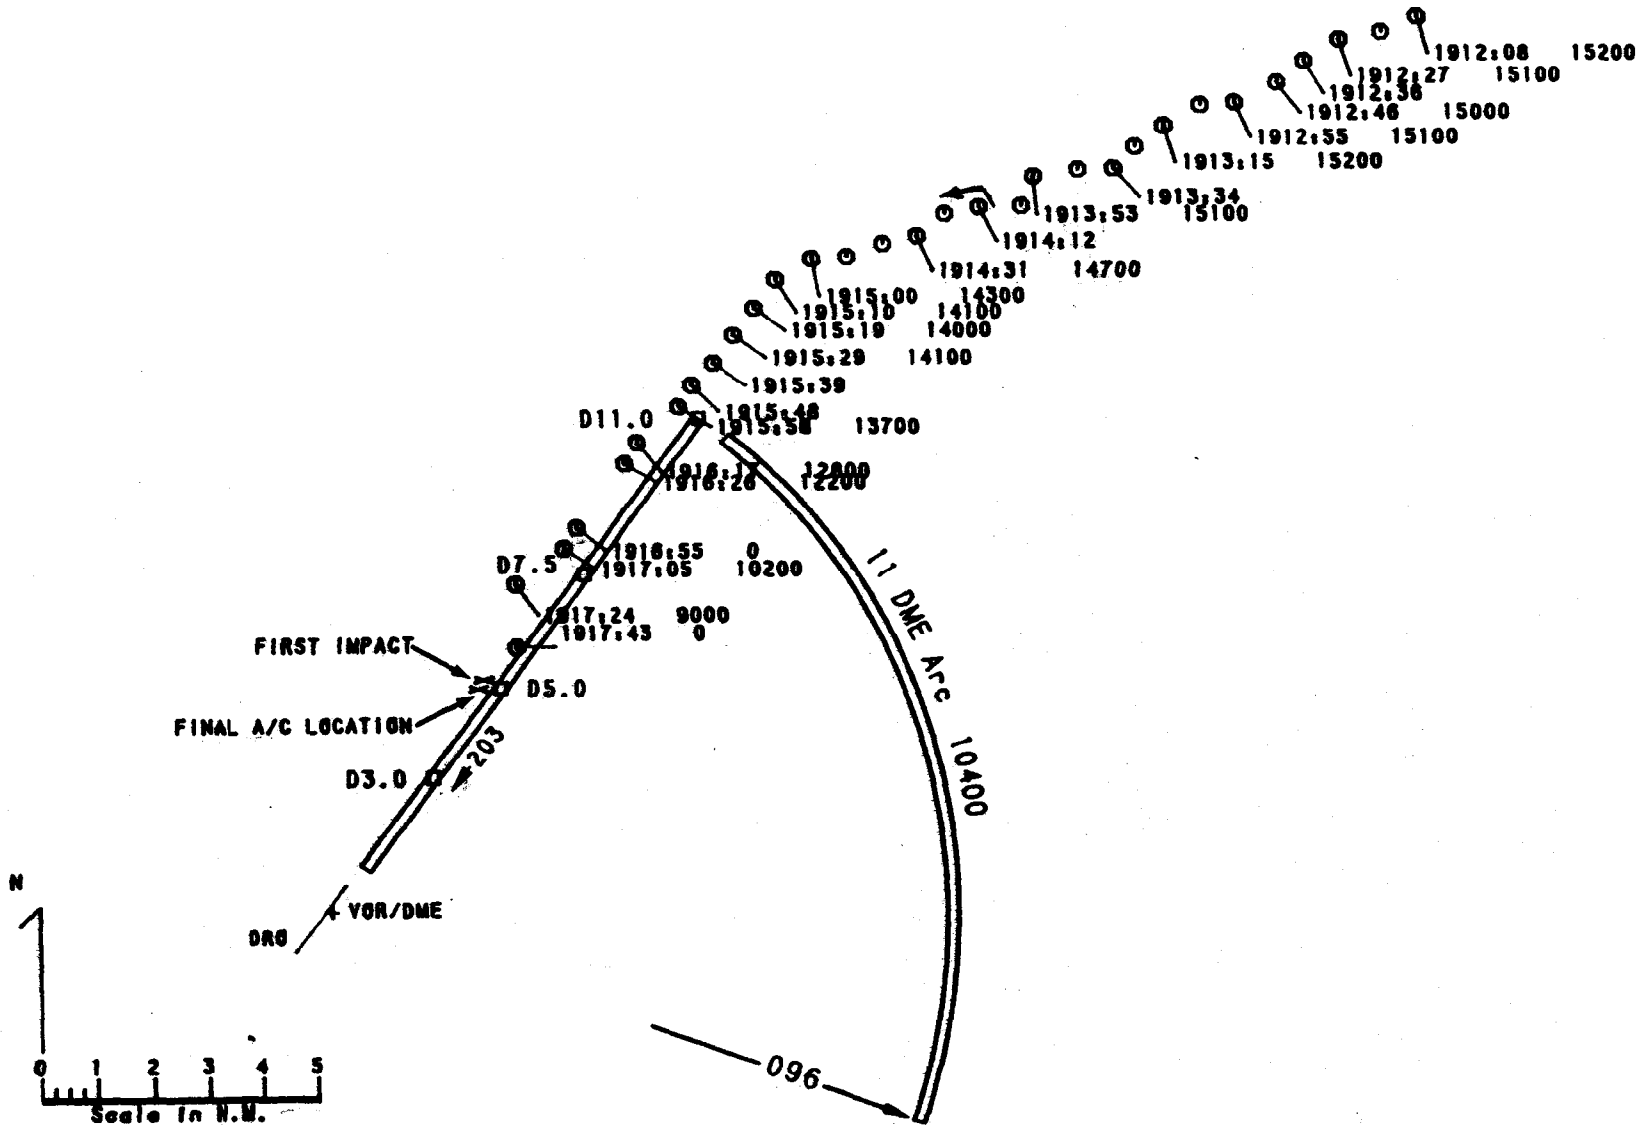
Figure S.-Overhead view of approach of Trans-Colorado 2286 with local times and altitudes using unprocessed, secondary radar returns
