NATIONAL TRANSPORTATION SAFETY BOARD

AIRCRAFT ACCIDENT REPORT

**NORTHWEST AIRLINES, INC.
McDONNELL DOUGLAS DC-9-82, N312RC
DETROIT METROPOLITAN WAYNE COUNTY AIRPORT
ROMULUS, MICHIGAN
AUGUST 16, 1987**

NTSB/AAR-88/05

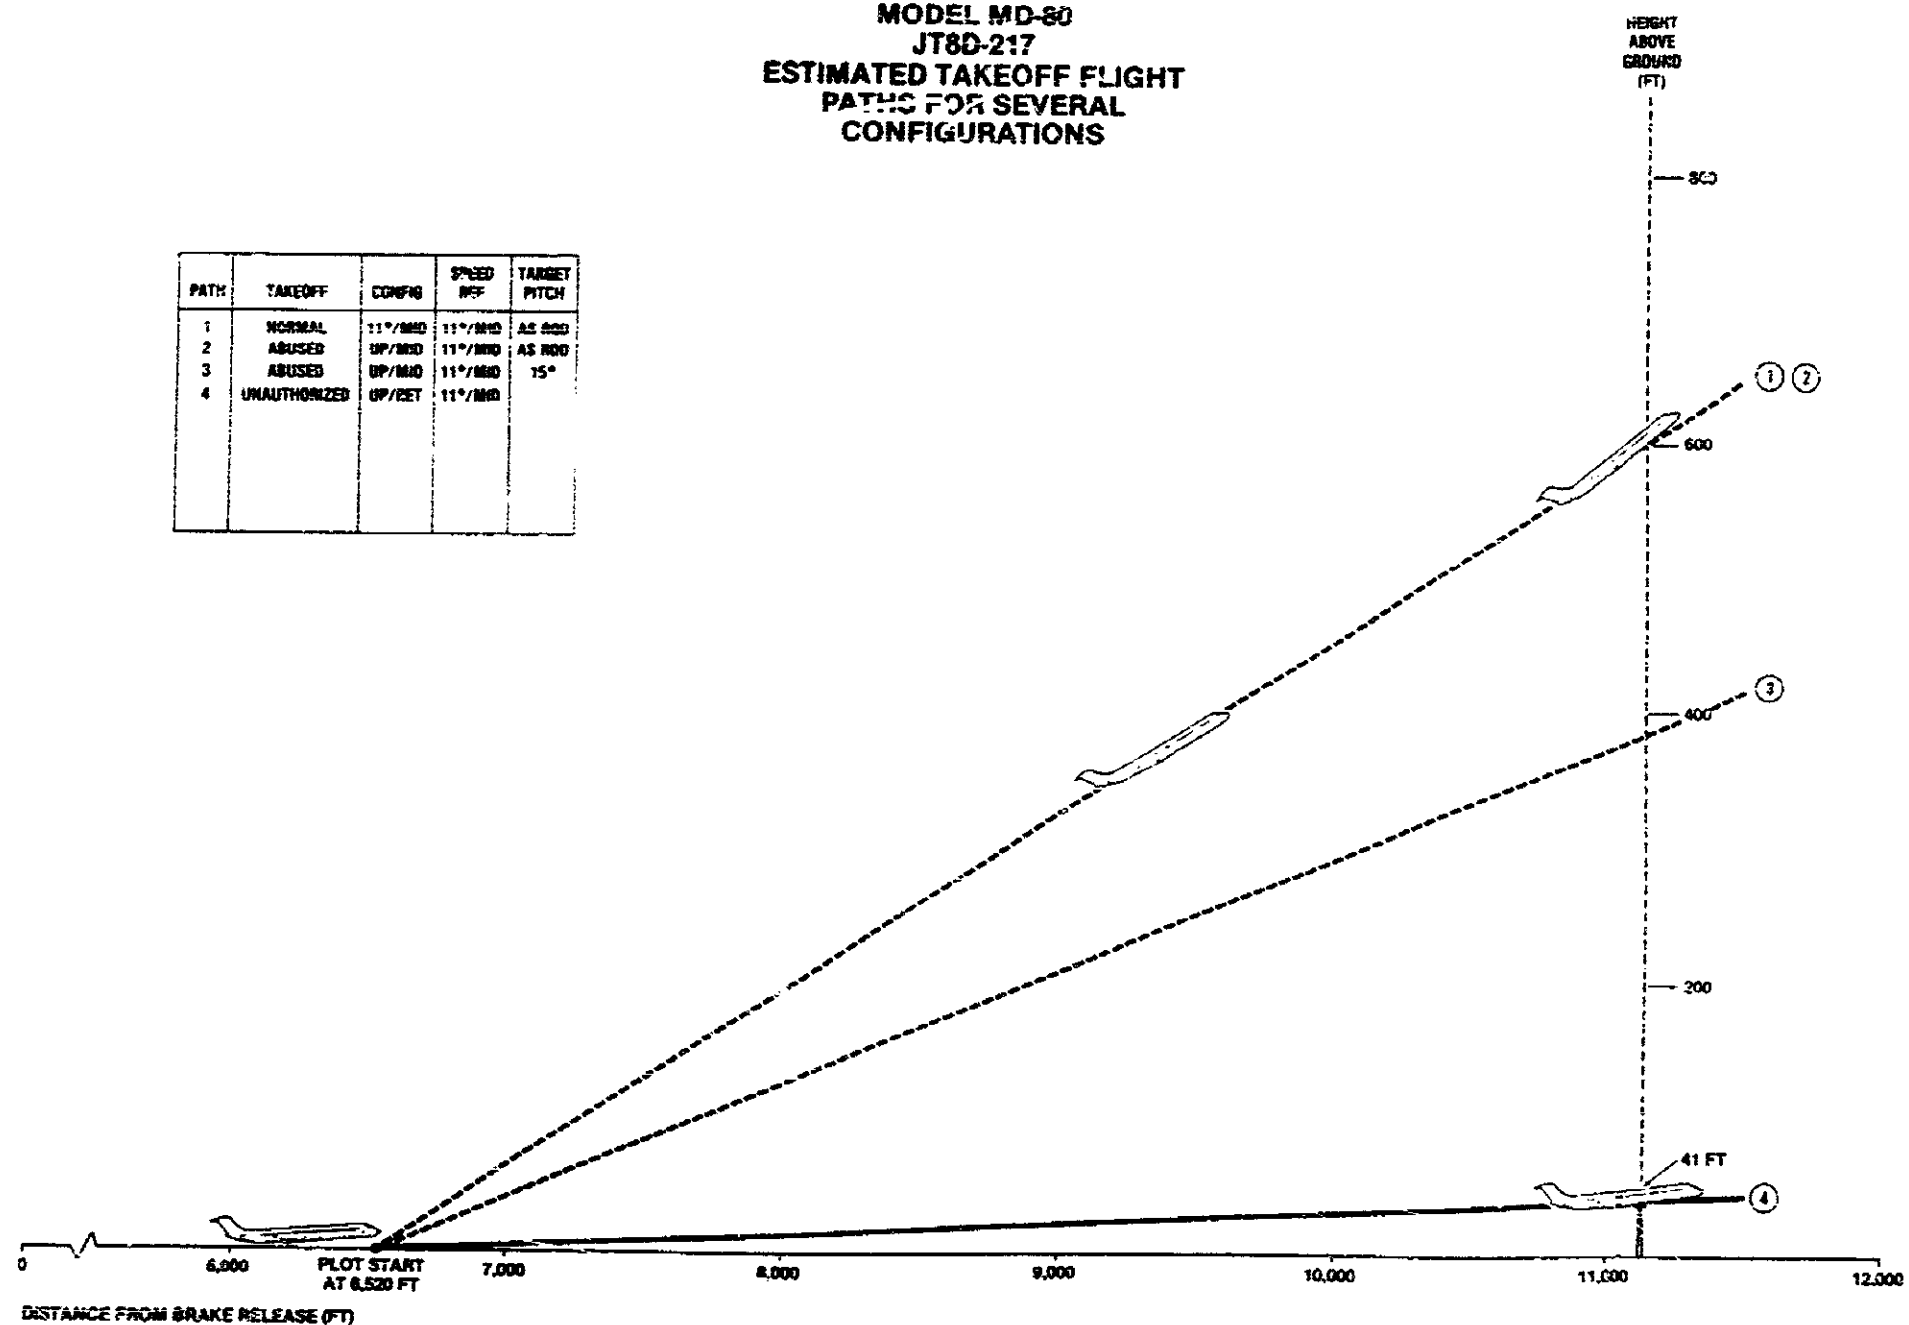
Figure 2.--Model MD-80, JT8D-17.
Estimated takeoff flightpaths for several configurations.

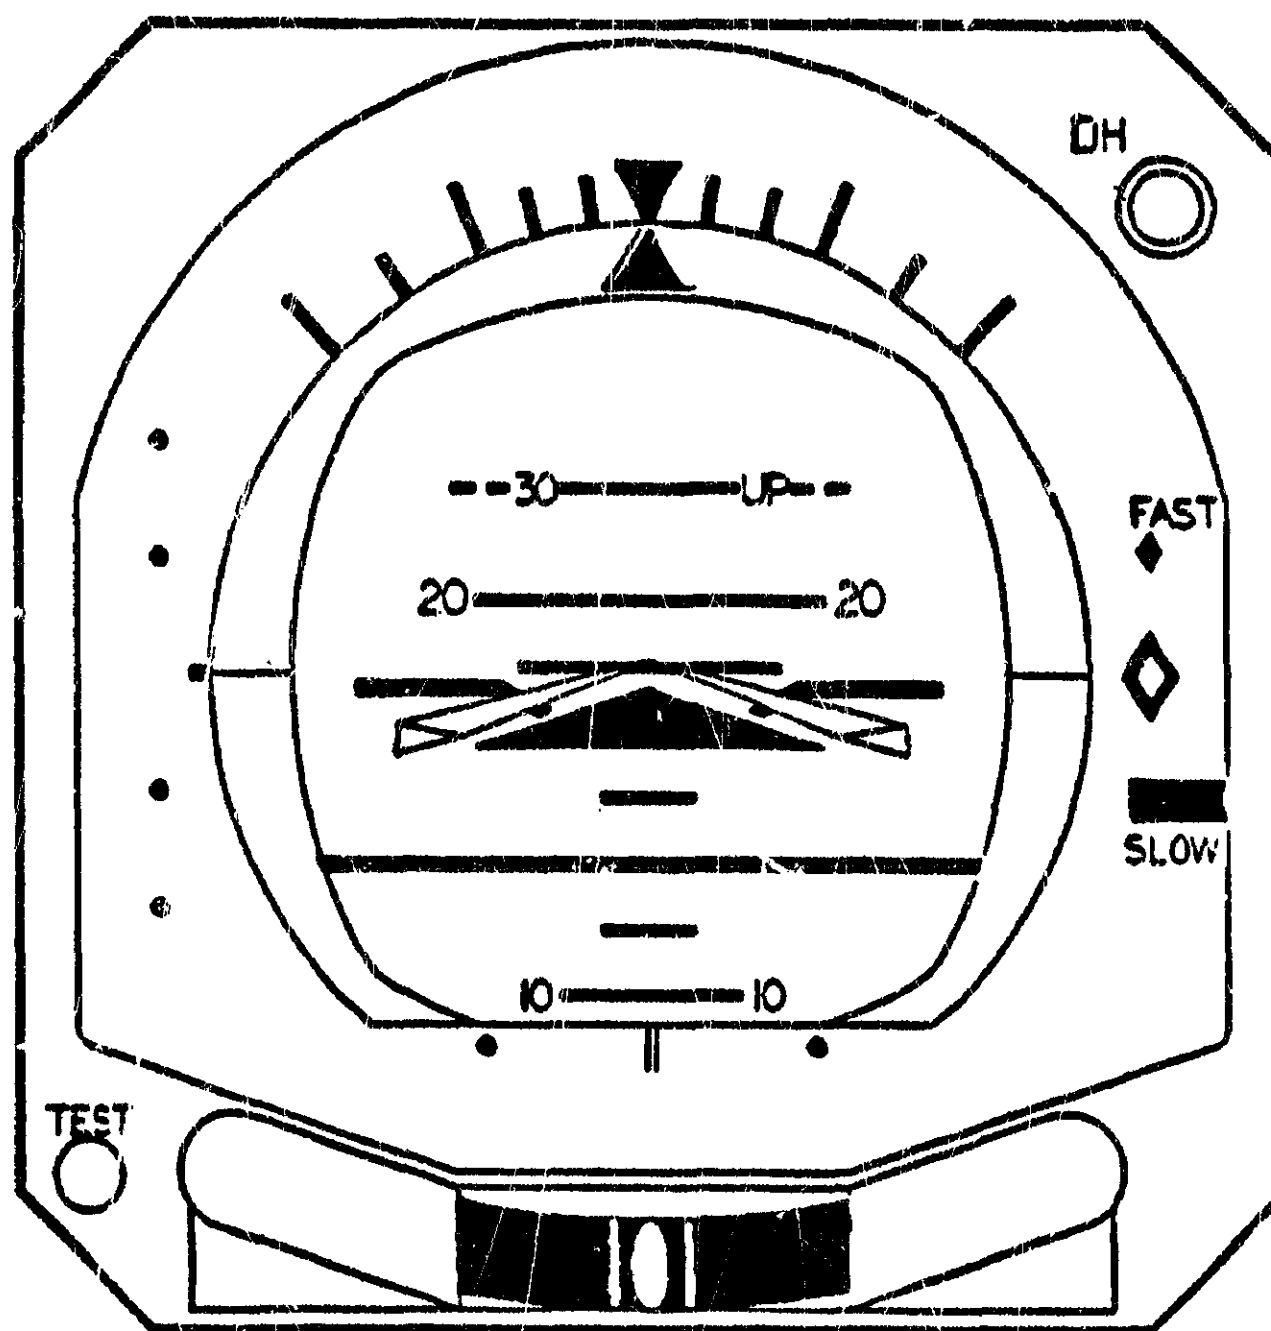
Figure 3.--Displays theoretical pitch attitude information presented by the ADI and the F/D command bar for the conditions existing 65 seconds after the start of the takeoff roll and after the F/D has entered the go-around mode. Roll attitude information and command bar roll guidance information is not displayed.

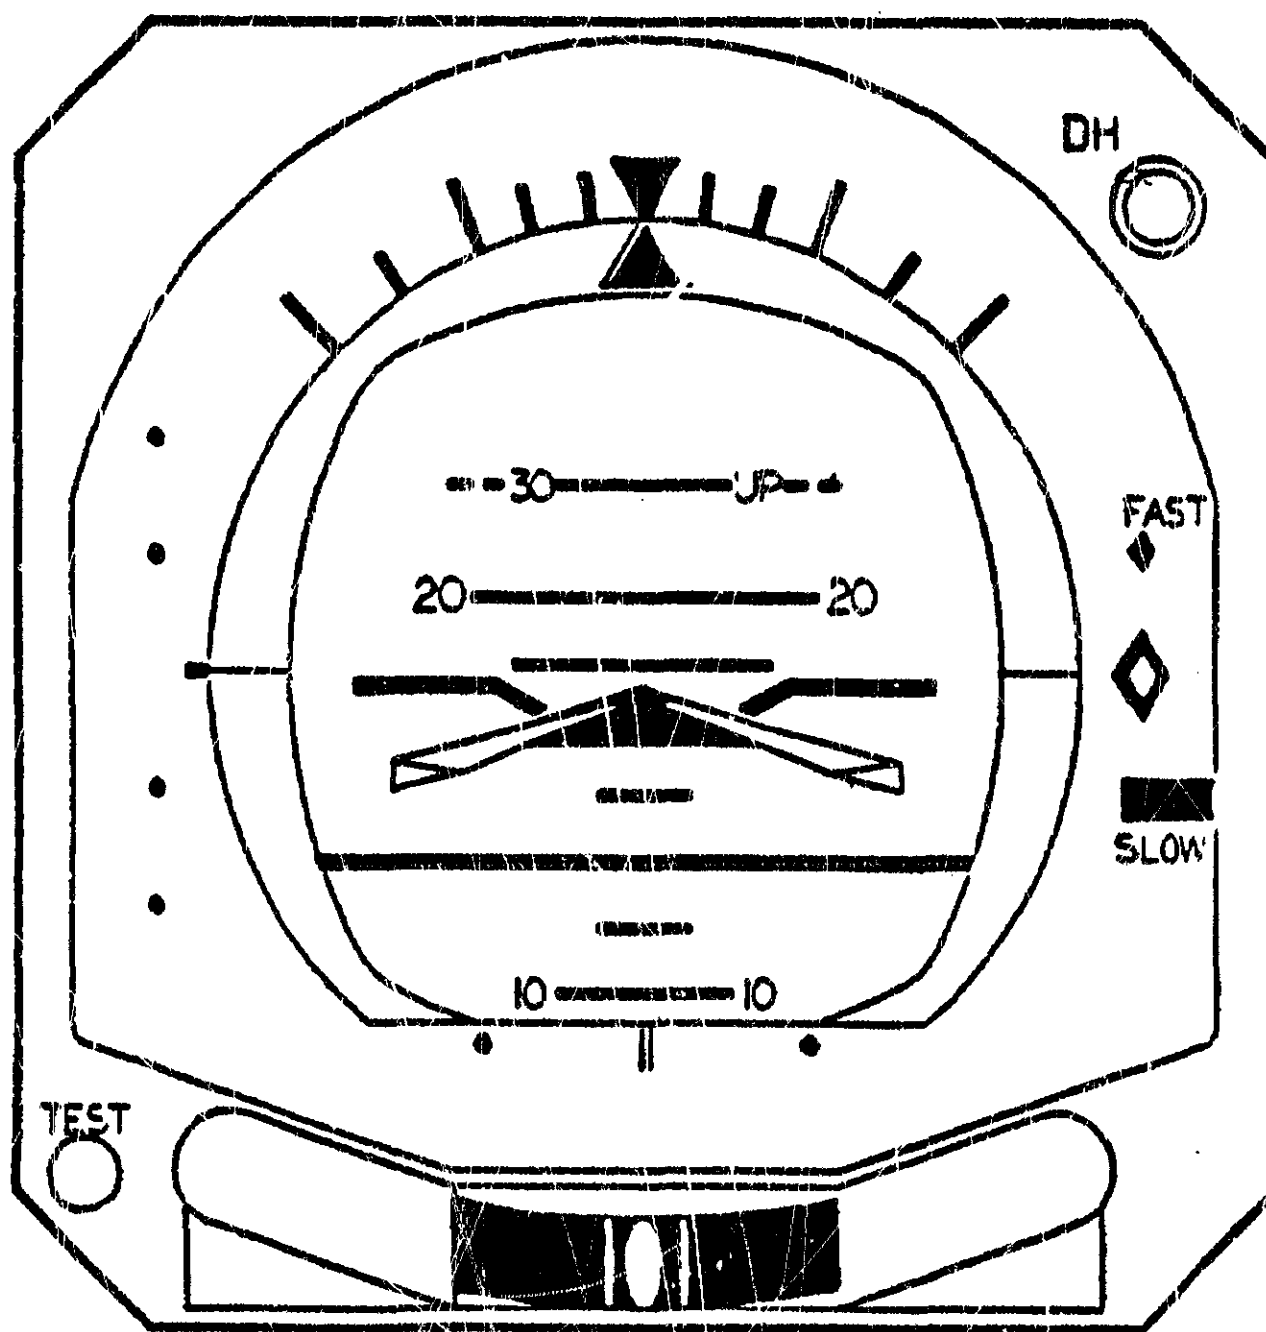
Figure 4.--Displays theoretical pitch attitude information presented by the ADI and the F/D command 65 seconds after the start of the takeoff roll with the F/D in Takeoff mode. Roll attitude information and command bar roll guidance is not displayed.
