PE93-910402  
NTSB/AAR-93/02

## AIRCRAFT ACCIDENT REPORT

TAKEOFF STALL IN ICING CONDITIONS  
USAIR FLIGHT 405  
FOKKER F-28, N485US  
LAGUARDIA AIRPORT  
FLUSHING, NEW YORK  
MARCH 22, 1992

**Adopted: February 17, 1993  
Notation 5732A**

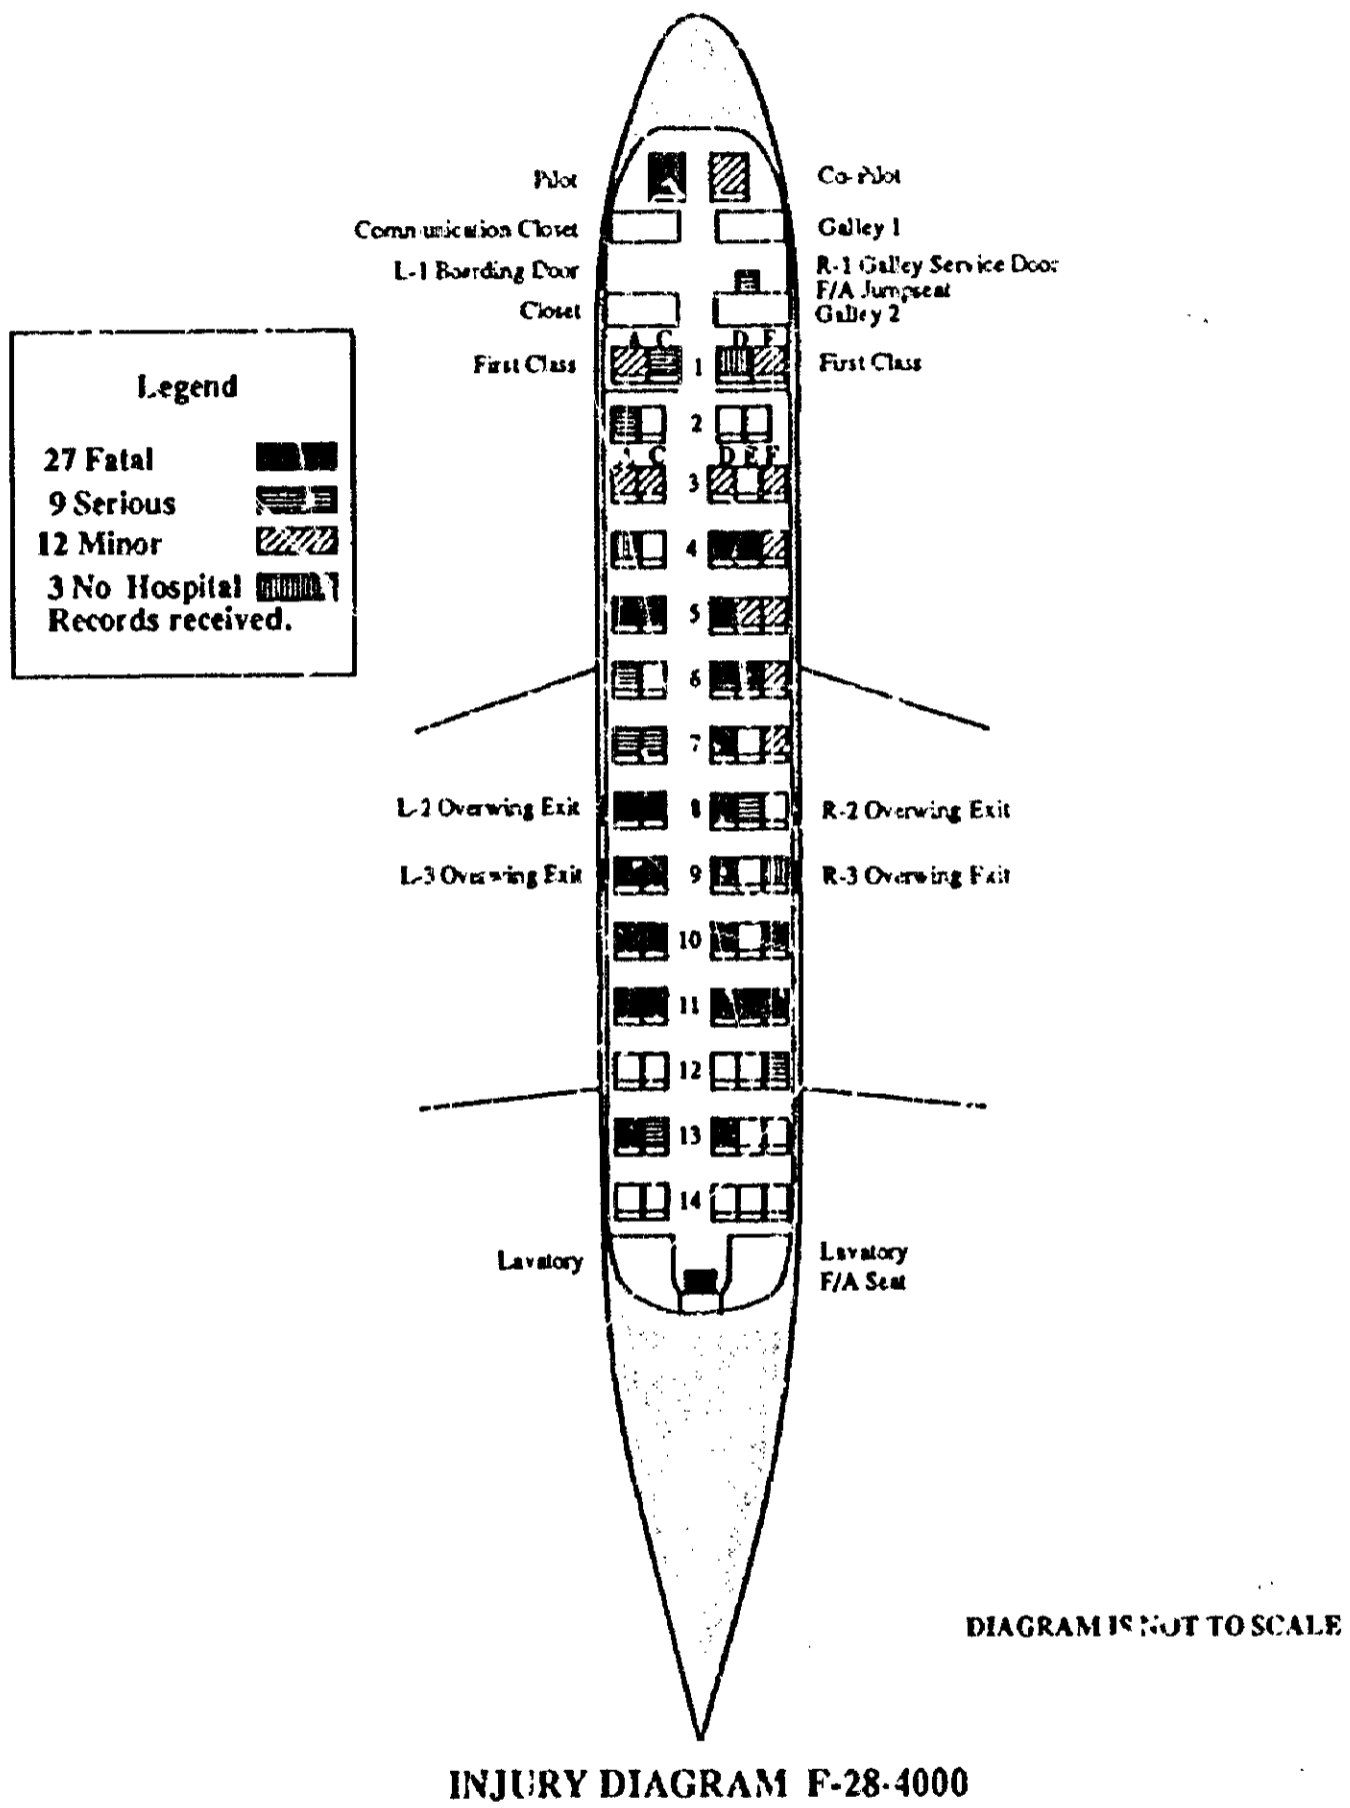
Figure 2.--Cabin diagram and injury information.

The cockpit was of the standard captain and first officer configuration. The cabin was configured into two sections. (See figure 2). The first class section had a forward-facing double occupancy seat unit on the left side labeled 1A, C and one forward-facing double occupancy seat unit on the right side labeled 1D, F, for a total of four seats.

The coach cabin was configured with 13 rows of forward-facing double occupancy seat units on the left side of the cabin labeled 2A, C through 14A, C and one forward-facing double occupancy seat unit labeled 2D, F followed by 12 rows of forward-facing triple occupancy seats units on the right labeled 3D, E, F through 14D, E, F. There were 64 seats in the coach section. There were two cabincrew jumpseat locations in the cabin that were single units and forward facing. One cabincrew seat was in the right front of the airplane between Galley 1 and Galley 2. The second cabincrew seat was in the rear of the fuselage between the left and right lavatories.
