UNITED STATES AIR FORCE
AIRCRAFT ACCIDENT INVESTIGATION
BOARD REPORT

B-1B, T/N 85-0089

7TH AIRCRAFT MAINTENANCE SQUADRON
7TH BOMB WING
DYESS AIR FORCE BASE, TEXAS

DATE OF ACCIDENT: 20 APRIL 2022

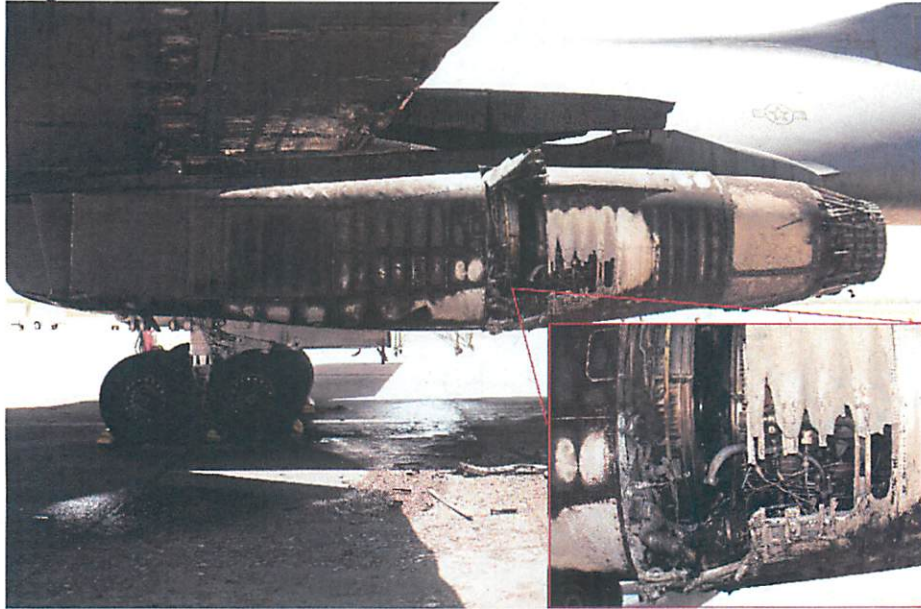
Figure 1. Engine Post-Accident (Tab Z-2)

During the accident, the ME's 2nd Stage Fan Disk was ejected (Tab J-3). The 2nd Stage Fan Disk was recovered with most of its fan blades stripped off (Tab J-7). The 2nd Stage Fan Disk was broken into three large sections and many smaller ones (Tab J-7). All significant sections of the disk were recovered (Tab J-7). The ejection of the 2nd Stage Fan Disk created a large hole in the outboard side of the ME and liberated many accessory components from the engine (Tab J-3). Post-fire investigation identified charring and burning on the left side of the aircraft (Tab J-3). The worst burn damage was focused on the mid-section of the ME (Tab J-3).

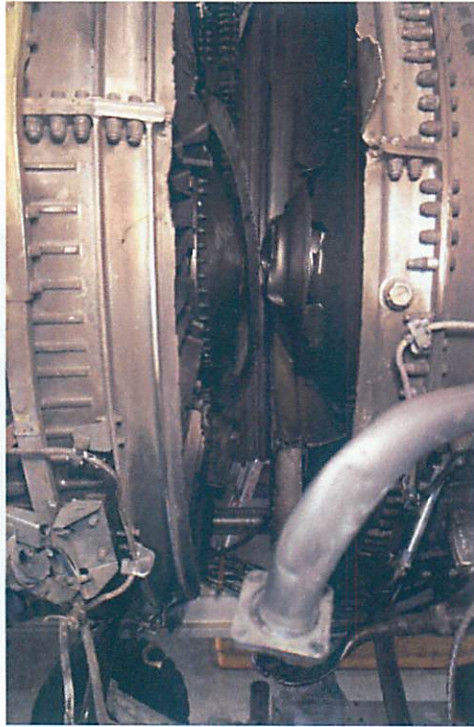
Figure 3. #1 Engine Fan Section Post Accident (Tab S-8)

The ejection of the 2nd Stage Fan Disk tore an approximately five-inch-wide strip of metal from both the engine casing and the engine nacelle skin (Tab J-4). The engine augments fuel filter housing (AFFH), along with many other accessory components, were torn from the engine by the 2nd Stage Fan Disk's ejection (Tab J-6).

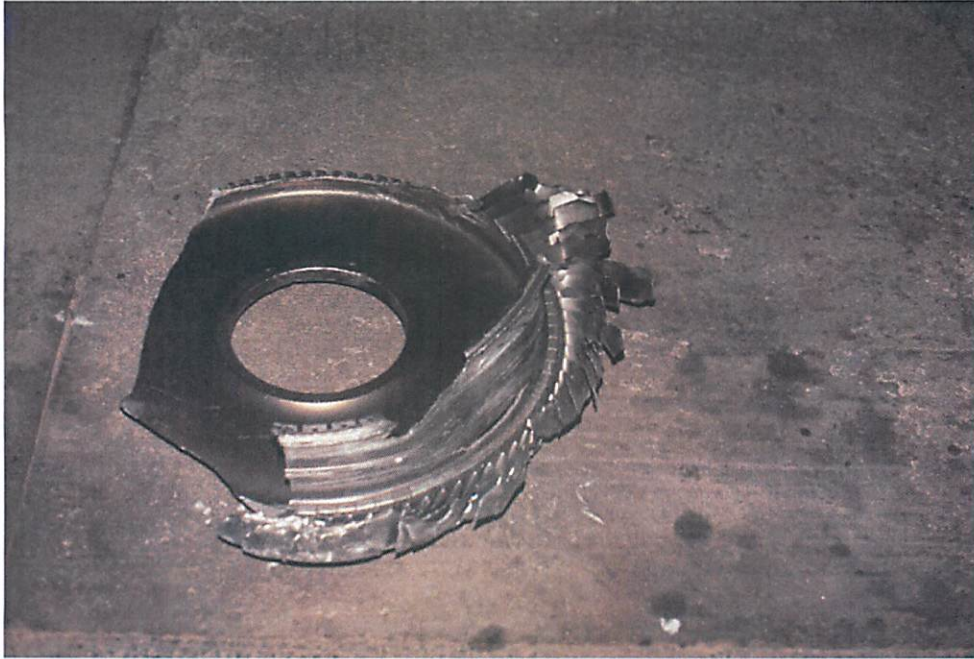
Figure 4. #2 Fan Disk (S-22)

The 2nd Stage Fan Disk was ejected from the #1 engine and found approximately 564 feet away from the aircraft, stripped of most of its fan blades (Tab Z-20).

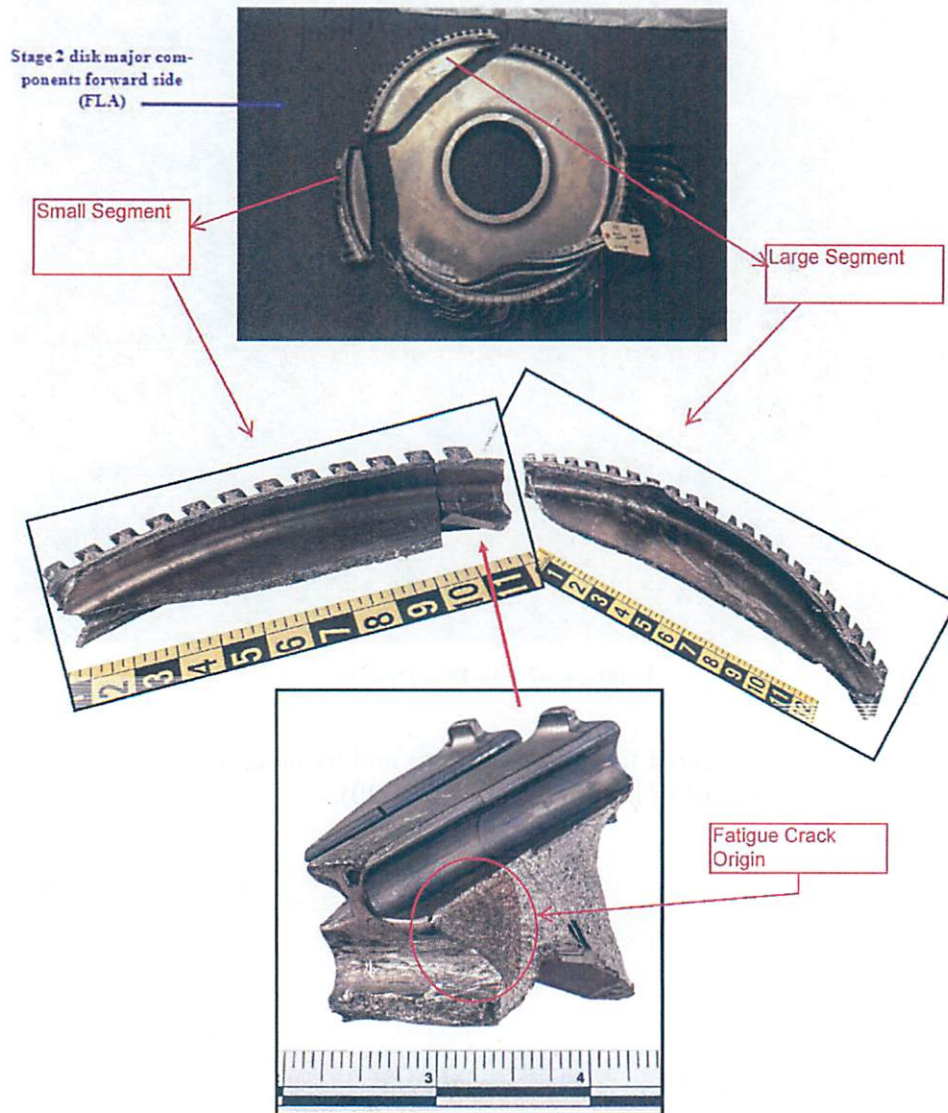
Figure 5. 2nd Stage Fan Disk Crack Origin (Tab Z-3)

The 2nd Stage Fan Disk was found broken into three large sections and many smaller ones (Tab J-7). All major sections of the fan disk were recovered (Tab J-7). Using a variety of laboratory techniques, technicians at AFLCMC were able to determine the exact point of the origin of the crack that led to the failure of the 2nd Stage Fan Disk (Tab EE-56).

Using a variety of techniques, the lab was able to identify the origin of a crack that led to the disk's failure (Tab EE-8). The crack began at a single point on the disk's surface at the corner of a blade slot and the forward face of the disk (Tab EE-24 and EE-55 to EE-56). High cycle fatigue of an unknown origin initiated the crack on 2nd Stage Fan Disk (Tab EE-24 and EE-55 to EE-56). High cycle fatigue is a low-stress event that causes an engine component to deform within its elastic range during engine acceleration and return to its original form when the engine decelerates (Tab EE-4). High cycle fatigue occurs due to the heating and cooling of the material during engine acceleration and deceleration and is accounted for during the design of engine components (Tab EE-4). Abnormal engine vibrations can provide an additional source of high cycle fatigue; however, testing could not identify a source of abnormal vibrations on the ME (Tabs BB-2 and EE-55 to EE-56). High cycle fatigue is commonly found in rotating engine components such as a fan disk (Tab EE-4). The source of the high cycle fatigue that initiated the crack in the 2nd Stage Fan Disk could not be determined (Tab EE-56).

Laboratory testing demonstrated that the progression of the crack at or near its origin was consistent with high cycle fatigue; additionally, evidence of low cycle fatigue was found towards the end of the crack propagation (Tab EE-30). Low cycle fatigue is a high-stress event that exceeds the elastic strength of the material, causing permanent deformation and leading to component failure within a few engine cycles (Tab EE-4). The crack and its initial growth increased the stress beyond the 2nd Stage Fan Disk's elastic strength, which left it susceptible to low cycle fatigue (Tab EE-3). The crack propagated to an approximate depth of 0.7 inches before the 2nd Stage Fan Disk failed, broke into pieces, and was ejected from the ME (Tab EE-24). In addition, the ME's AFFH was examined at AFLCMC, and technicians determined that the AFFH was not relevant to the incident (Tab J-6).

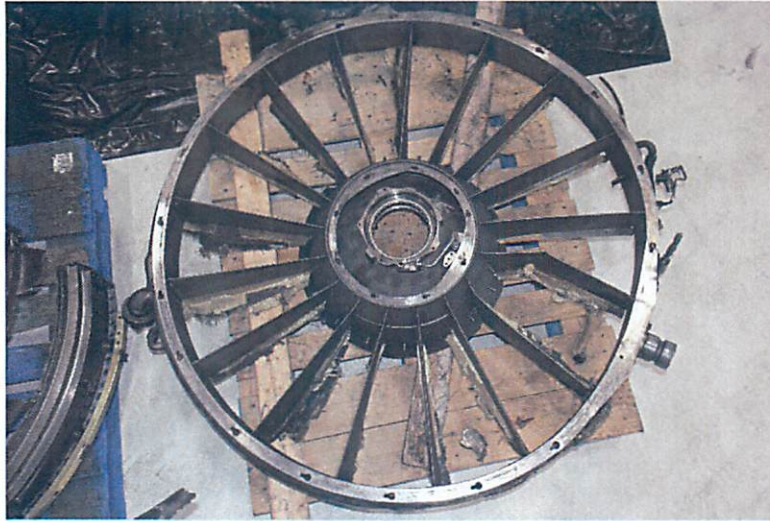
Figure 7. #1 Engine Inlet Guide Vanes Damage (Tab S-9)

The engine front frame suffered buckling failure (Tab J-4). The compressor section and turbine section suffered foreign object damage as a result of the 2nd Stage Fan Disk separating from the engine; this caused significant damage to the blades of the compressor and turbine section of the engine resulting in rounded compressor blades instead of the normal squared ones (Tab J-4 to J-7).

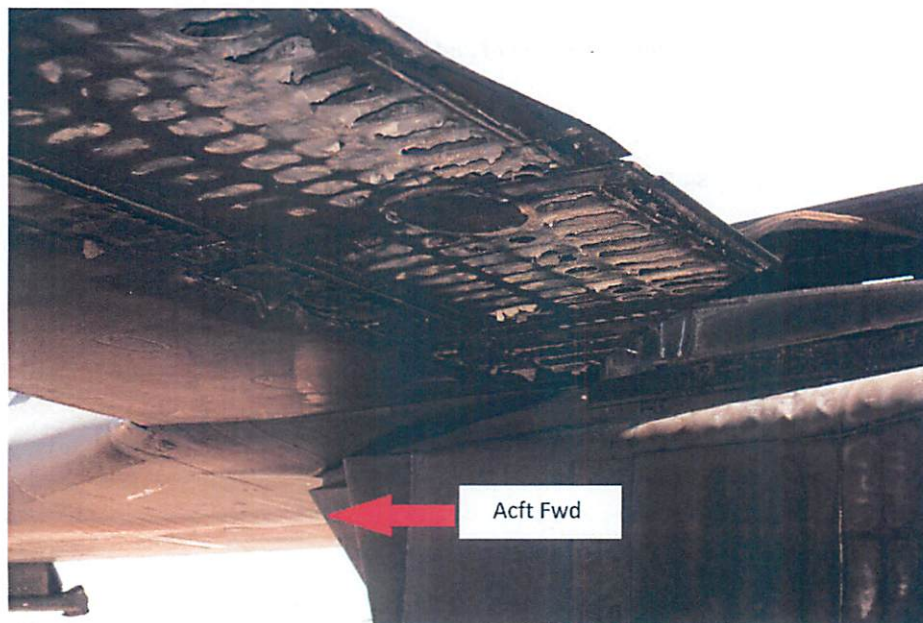
Figure 8. Left Wing Fire Damage (Tab Z-5)

As a result of the fire, the left wing suffered extensive surface level fire damage (Tab S-5 to S-6 and S-10 to S-18). The damage on the wing is most extensive near the wing root with the physical melting of the MA skin due to the intense heat from the fire (Tab S-5 to S-6 and S-10 to S-18).

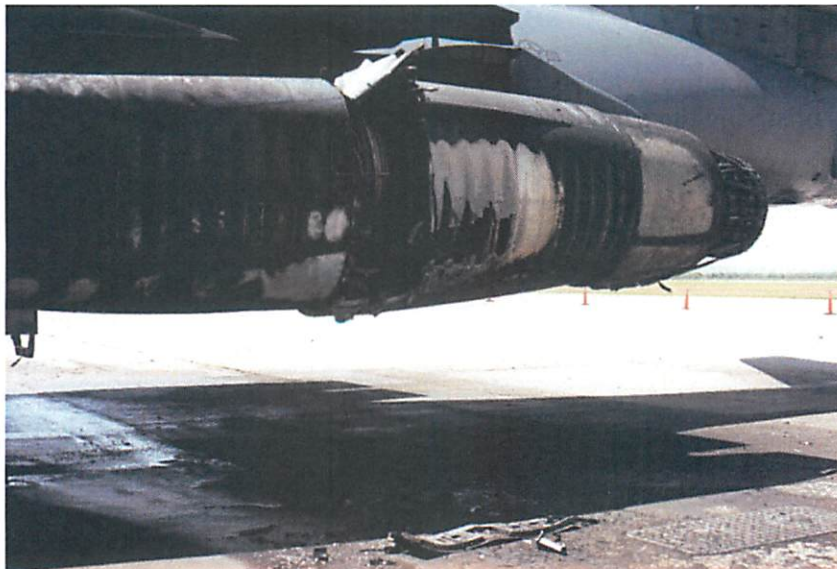
Figure 10. Left Nacelle Damage (Tab S-23)

The #1 Engine nacelle showed signs of fire damage, and metal components were peeled away from the nacelle structure by the ejection of the 2nd Stage Fan Disk (Tab J-3).

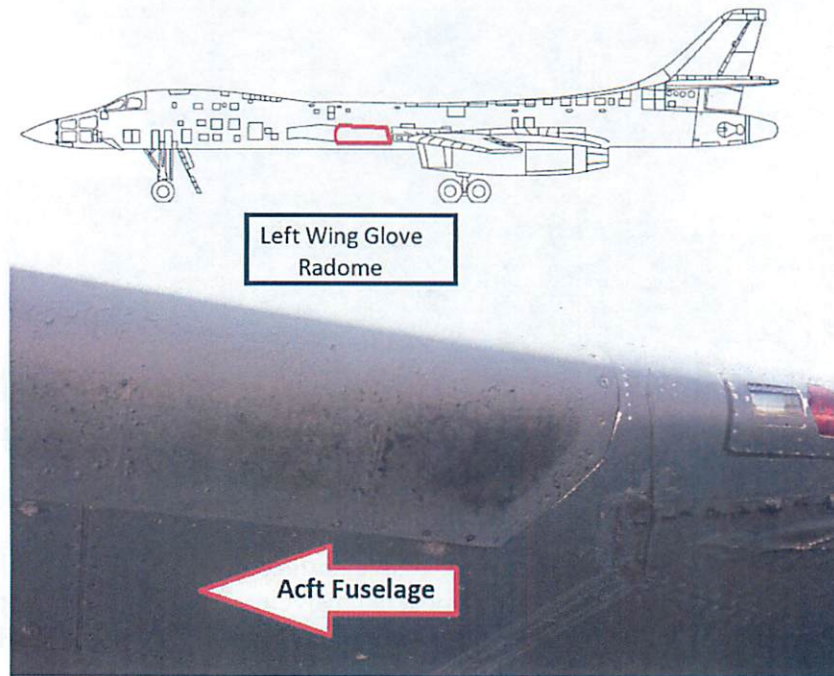
Figure 11. Left Wing Glove (Tab Z-6)

Heat damage from the fire extended forward to the left wing glove radome area, just forward of the left wing, blistering the paint (Tab J-3).

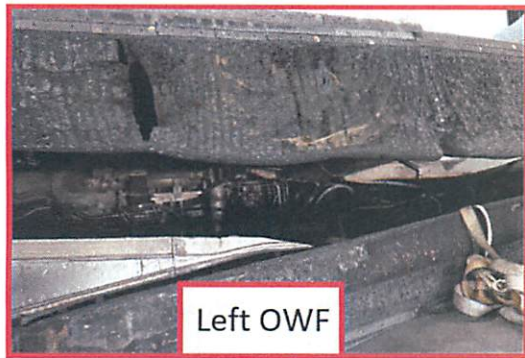
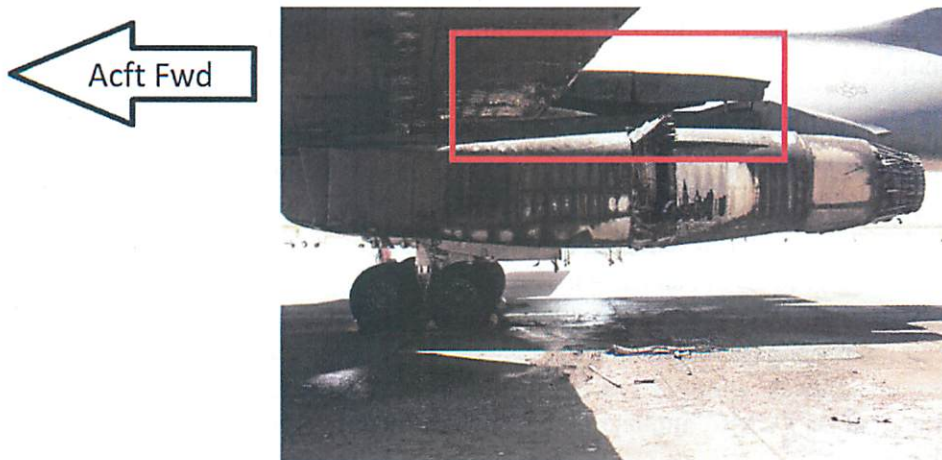
Figure 12. Left Overwing Fairing (Tab Z-7)

The engine fire reached the left overwing fairing (OWF), damaging numerous structures and components. The overwing fairing is part of the B-1's variable wing sweep design that allows for uninterrupted airflow over the wing of the B-1 when the wings are swept to an aft position (Tab BB-2). During high-speed flight, the aircrew manually position the wings to an aft position, where they are tucked inside the overwing fairing for improved aerodynamic performance (Tab BB-2). The overwing fairing also houses many critical mechanical, electrical, and hydraulic system components (Tab BB-2).
