AIRCRAFT ACCIDENT

**Air New Zealand
McDonnell-Douglas DC10-30 ZK-NZP
Ross Island, Antarctica
28 November 1979**

REPORT 79-139

**AIRCRAFT ACCIDENT
REPORT No. 79-139**

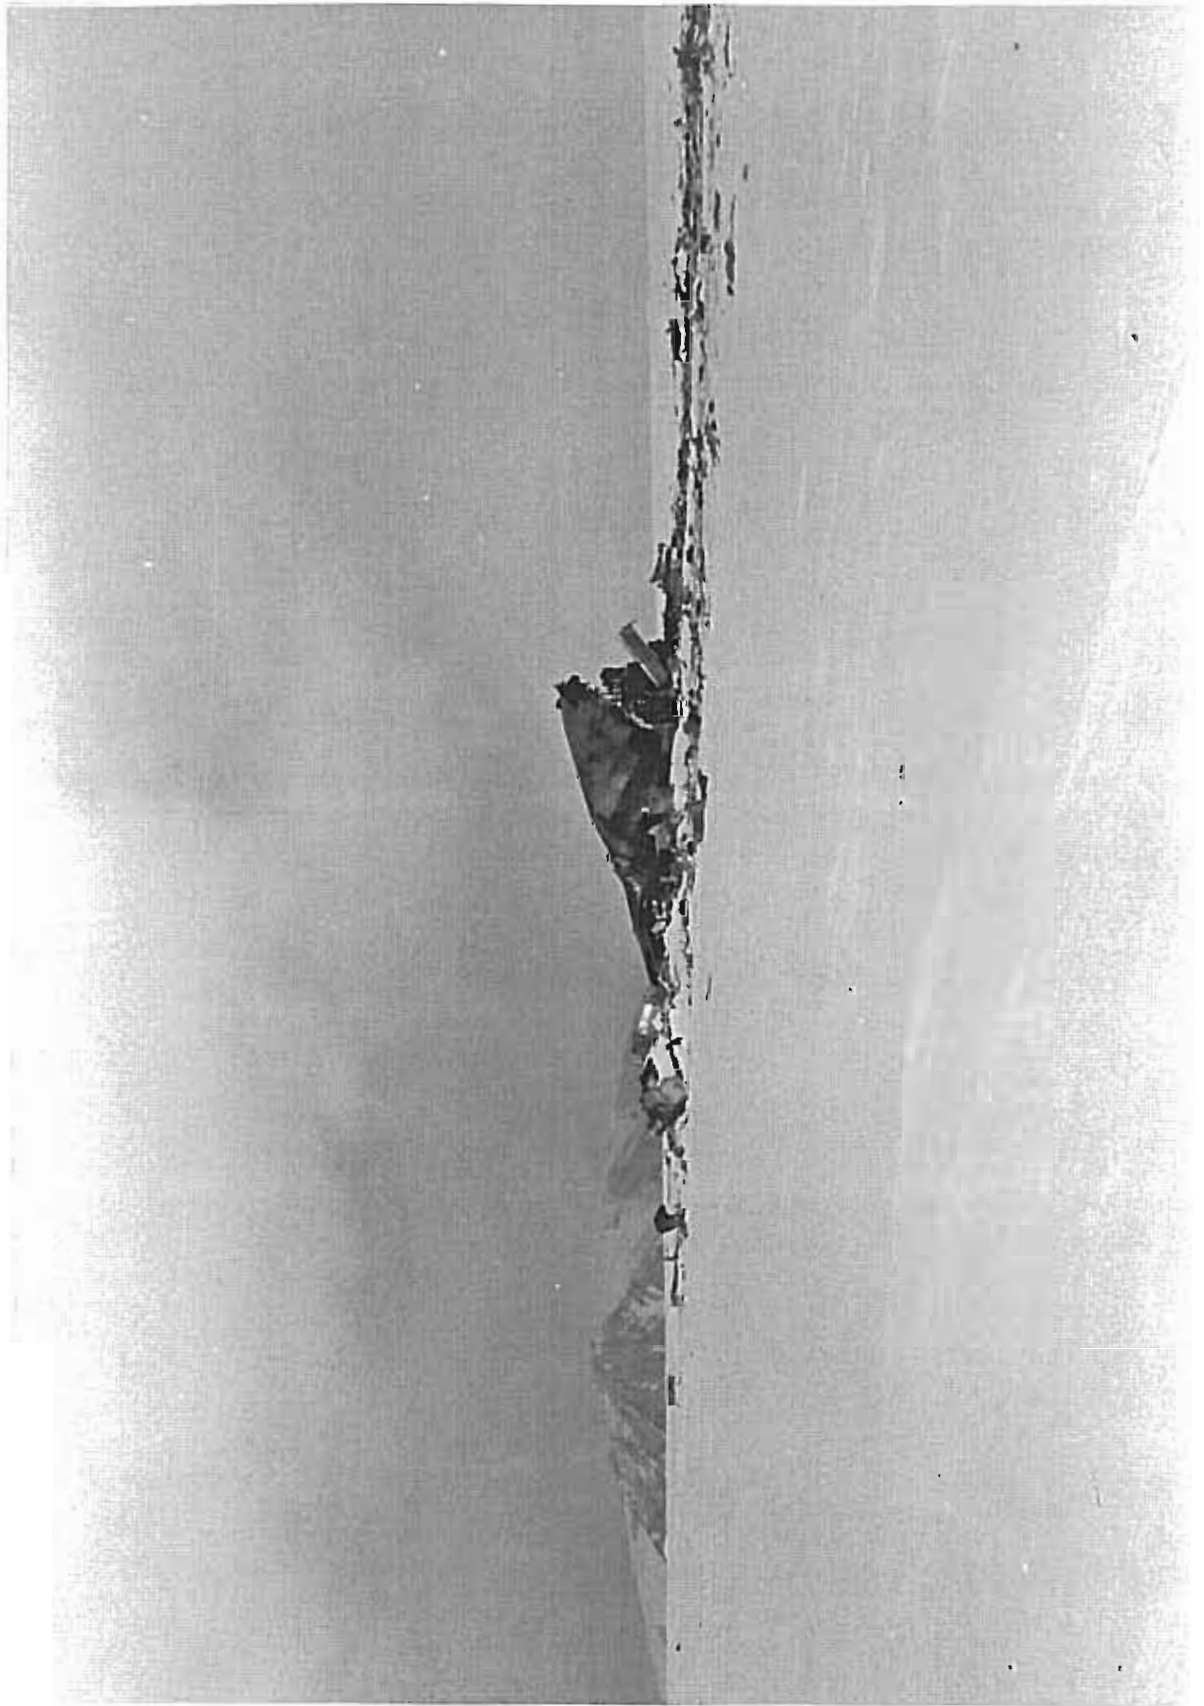
FIG 2 LOOKING SOUTHWEST PAST BURNT OUT CABIN TOWARDS MT EREBUS

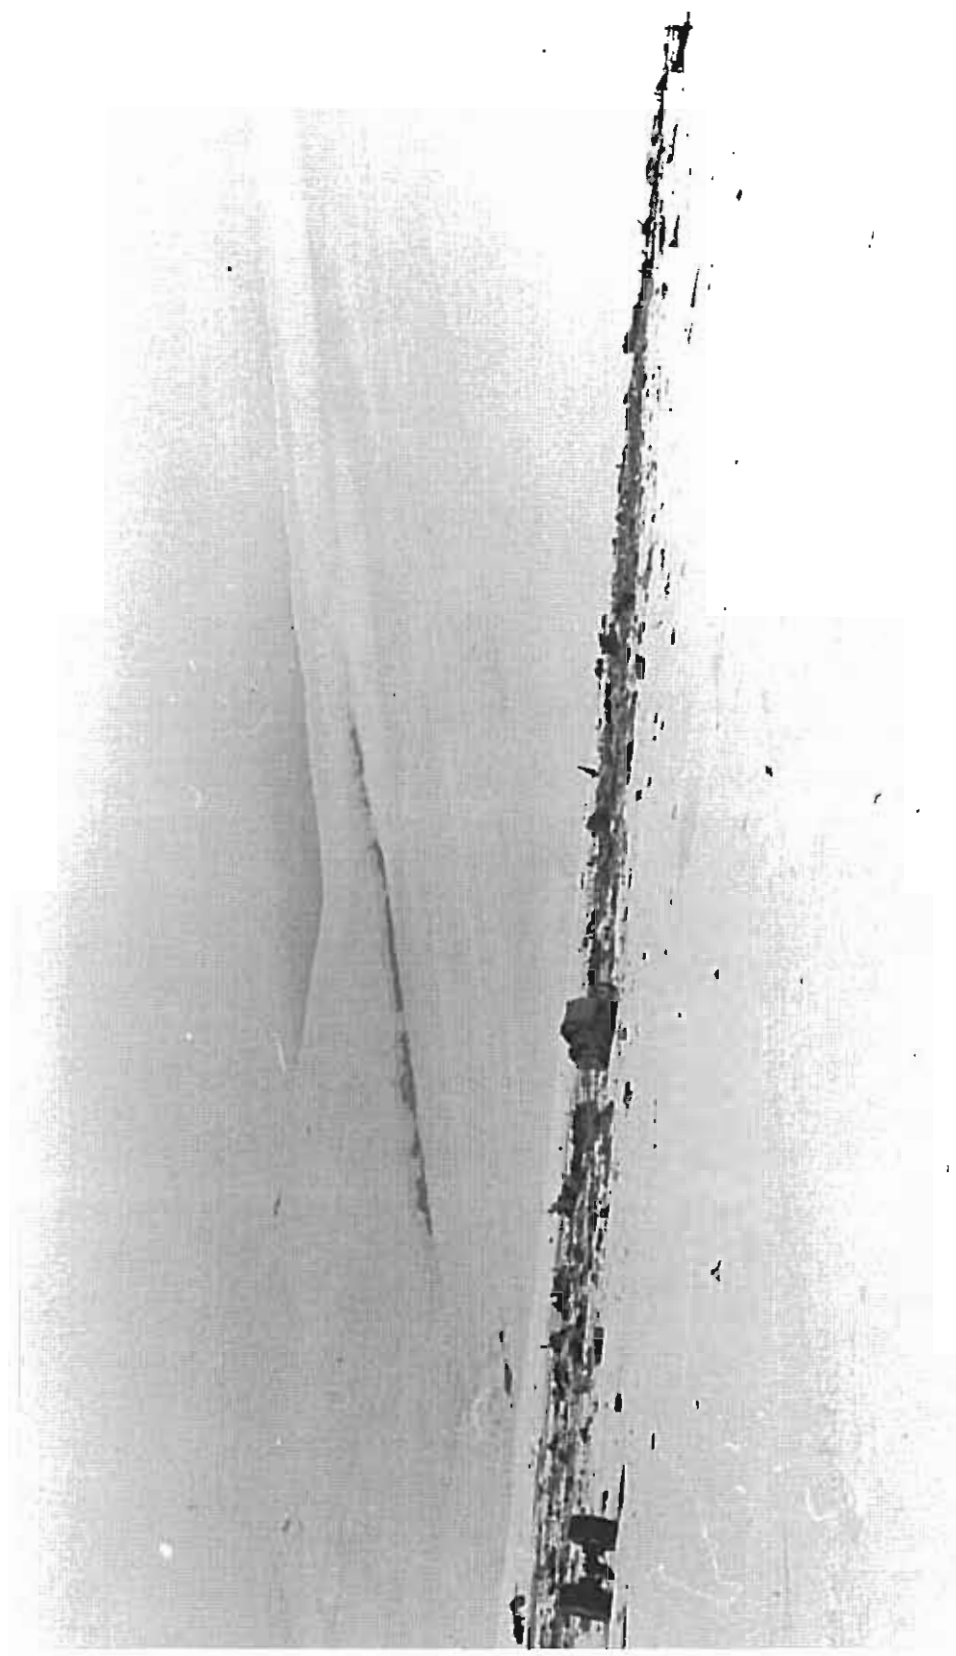
FIG 3 LOOKING WEST ACROSS WRECKAGE OF ZK-NZP TOWARDS NORTH-WEST SHORE OF LEWIS BAY

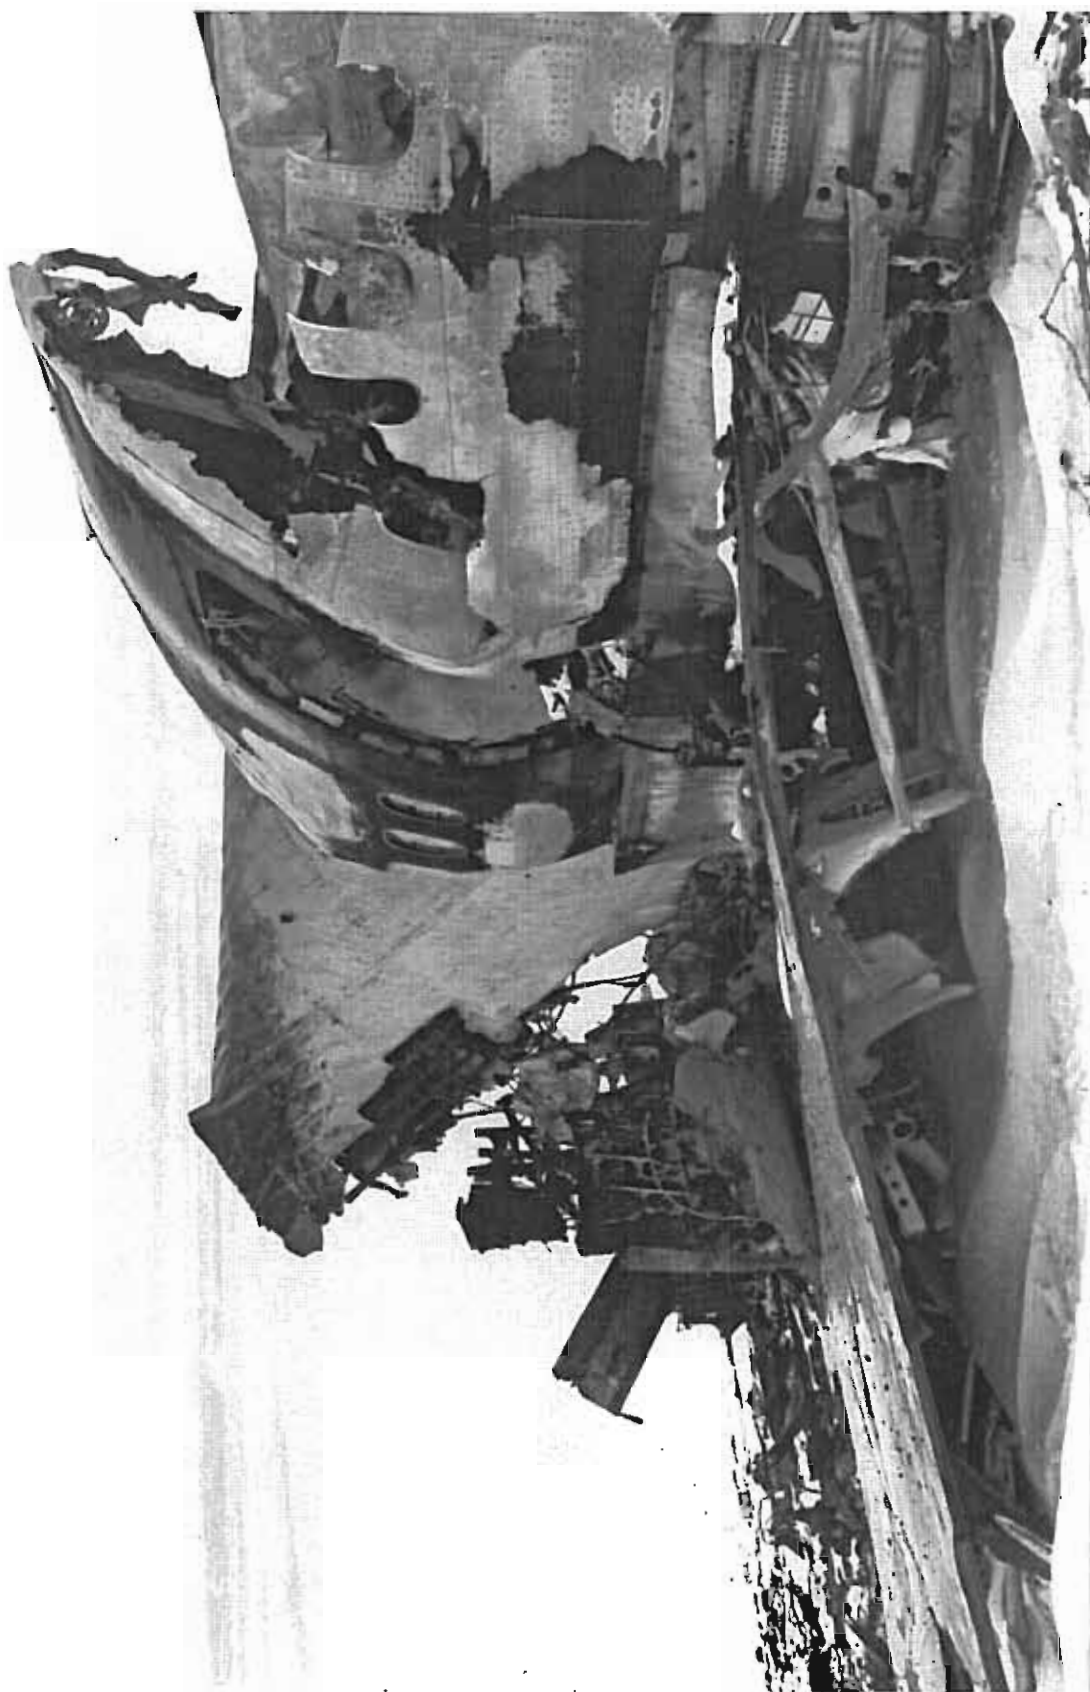
FIG 5 TOP OF RIGHT WING AND RIGHT CABIN SIDE OVER WING DOOR AREA
