**AIRCRAFT ACCIDENT REPORT NO 01/89**

**REPORT ON THE ACCIDENT OF THE  
BOEING 747-200 (N807FT)  
AT 9.8 NM SOUTH EAST OF SUBANG INTERNATIONAL  
AIRPORT, SELANGOR, MALAYSIA  
ON 18 FEBRUARY 1989**

REPORT NO: 01/89

OPERATOR : FLYING TIGER LINE, INC.

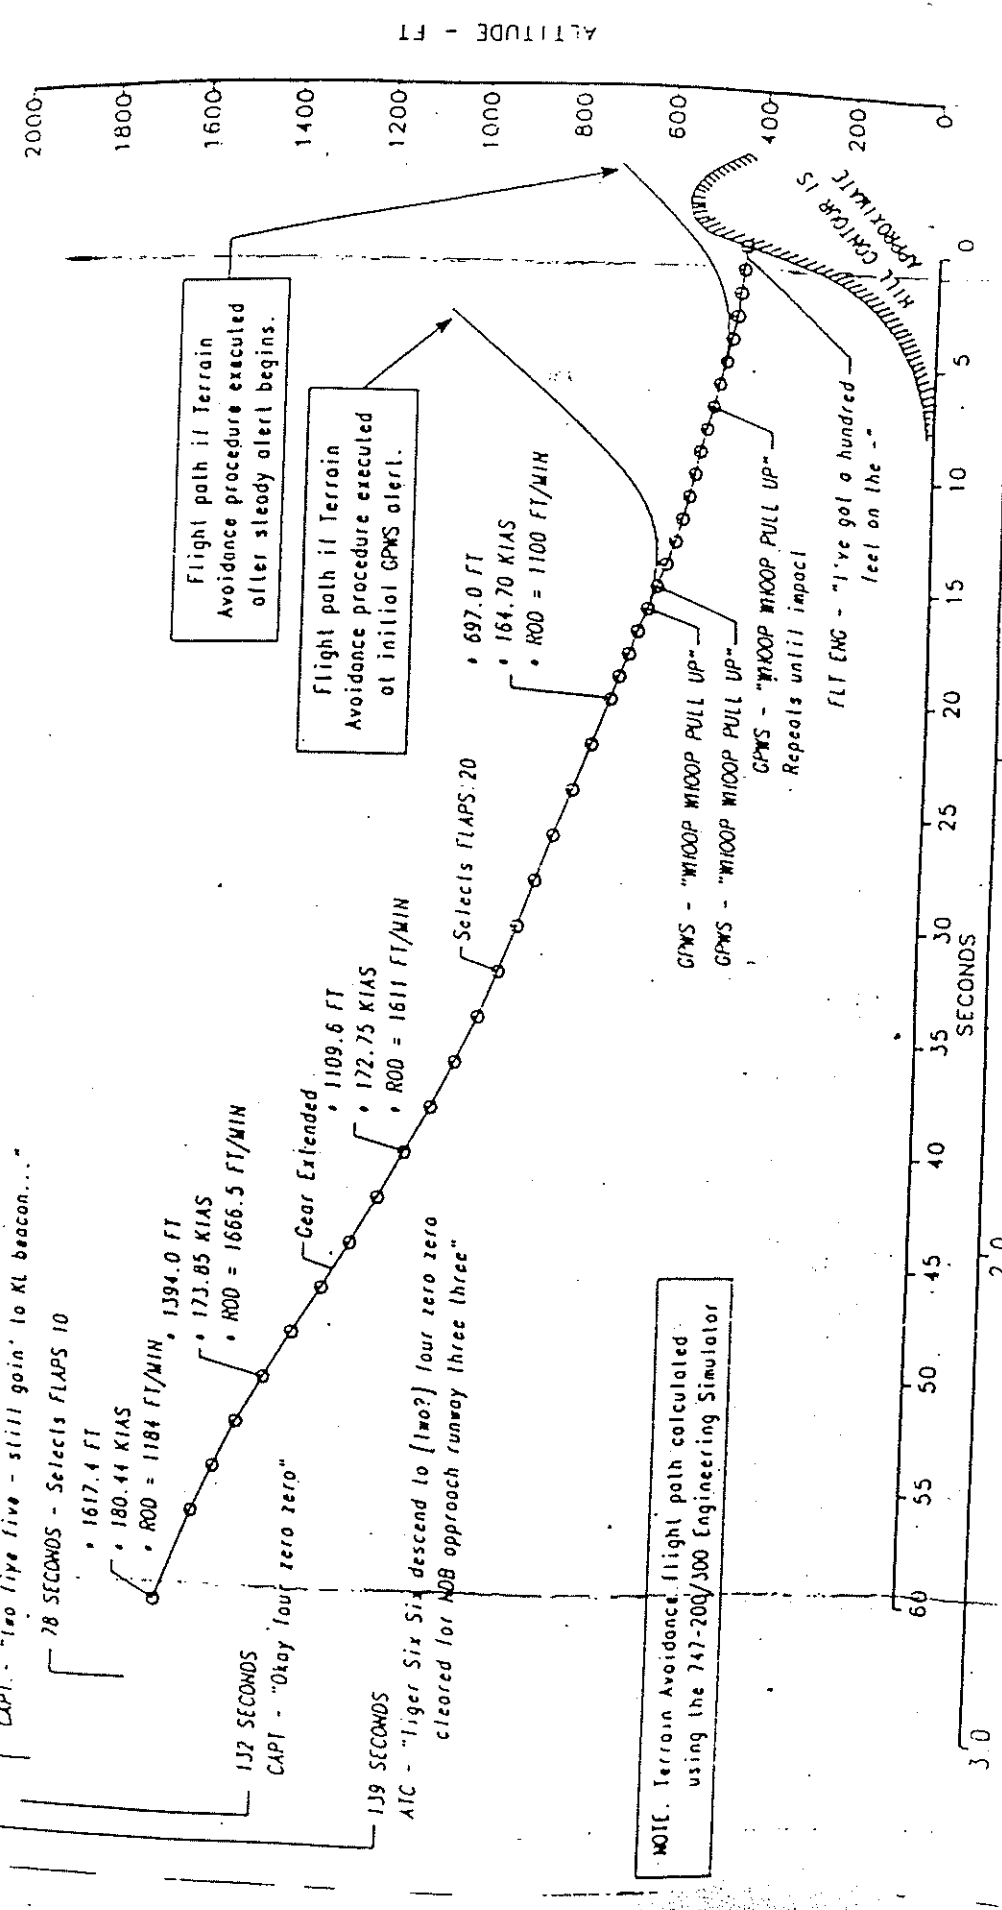
A plot of the last 179 seconds of flight 066 flight path profile was derived by integration of pertinent CVR data and with FDR's altitude trace. (See appendix C).

NOTE: Terrain Avoidance flight path calculated using the 747-200/300 Engineering Simulator
